Inspection Report, Lorencito, C-1996-084

Attached for your records is a copy of the Division's inspection report for the Lorencito Canyon Mine, C-1996-084.

Permit Number: C-1996-084 Mine Name: Lorencito Canyon Mine Operator: New Elk Coal Company, LLC Operator Address: Mr. John Terry 12250 Highway 12 Weston, CO 81091	County: Las Animas Operation Type: Surface Permit Status: Permanent Cessation Ownership: Private
	Operator Representative Present: None
Operator Representative Signature: (Field Issuance Only)

Inspection Start Date: September 5, 2024 Inspection Start Time: 11:37 Inspection End Date: September 5, 2024 Inspection End Time: 12:21	Inspection Type: Coal Partial Inspection Inspection Reason: Normal I&E Program Weather: Raining
Joint Inspection Agency: None	Joint Inspection Contacts:
Post Inspection Agency: None	Post Inspection Contacts:
Inspector(s): Amber M. Gibson	Inspector's Signature:

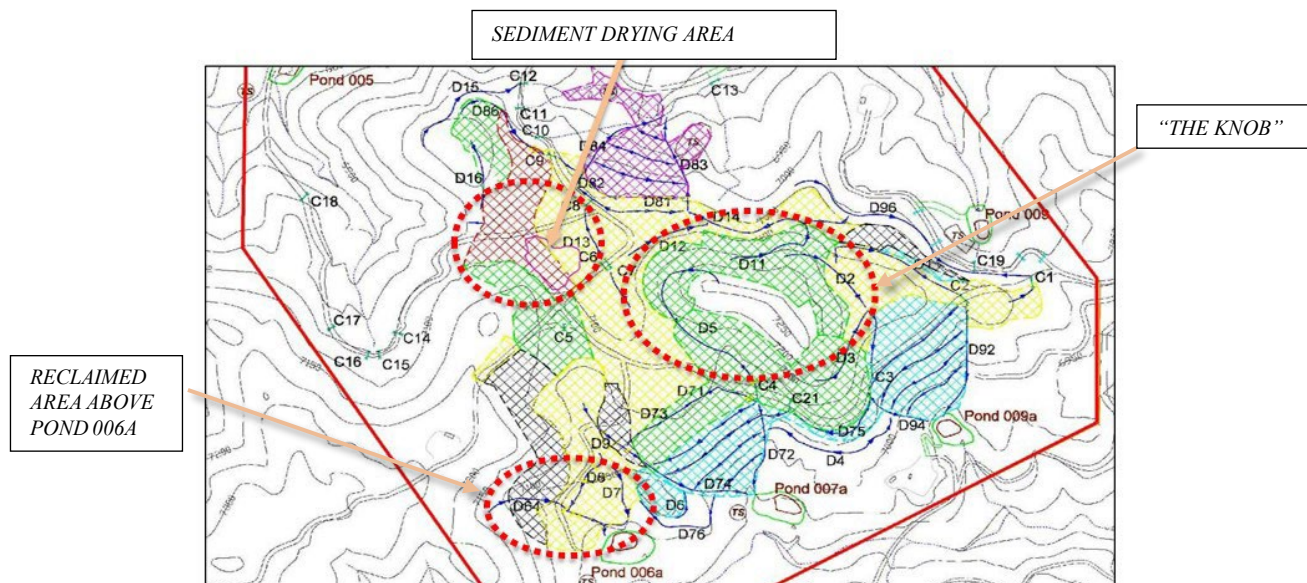
4. The following items pertain to ongoing erosional issues in the areas shown in Figure 1, that pursuant to Rule 4.14.6 need to be addressed. A Technical Revision will be required to expand on the current Rill and Gully plan in the PAP. **The Operator shall submit the technical revision, obtain approval, repair the erosion, and stabilize the slopes pursuant to the approved plan by December 31, 2024.**

FIGURE 1. AREAS WHERE RILLS, GULLIES AND SPARSE VEGETATION HAS BEEN FOUND TO BE A PERSISTENT PROBLEM AT THE SITE ARE WITHIN THE DOTTED CIRCLE AREAS. BACKGROUND IMAGE IS THE 2020 ANNUAL REPORT MAP.

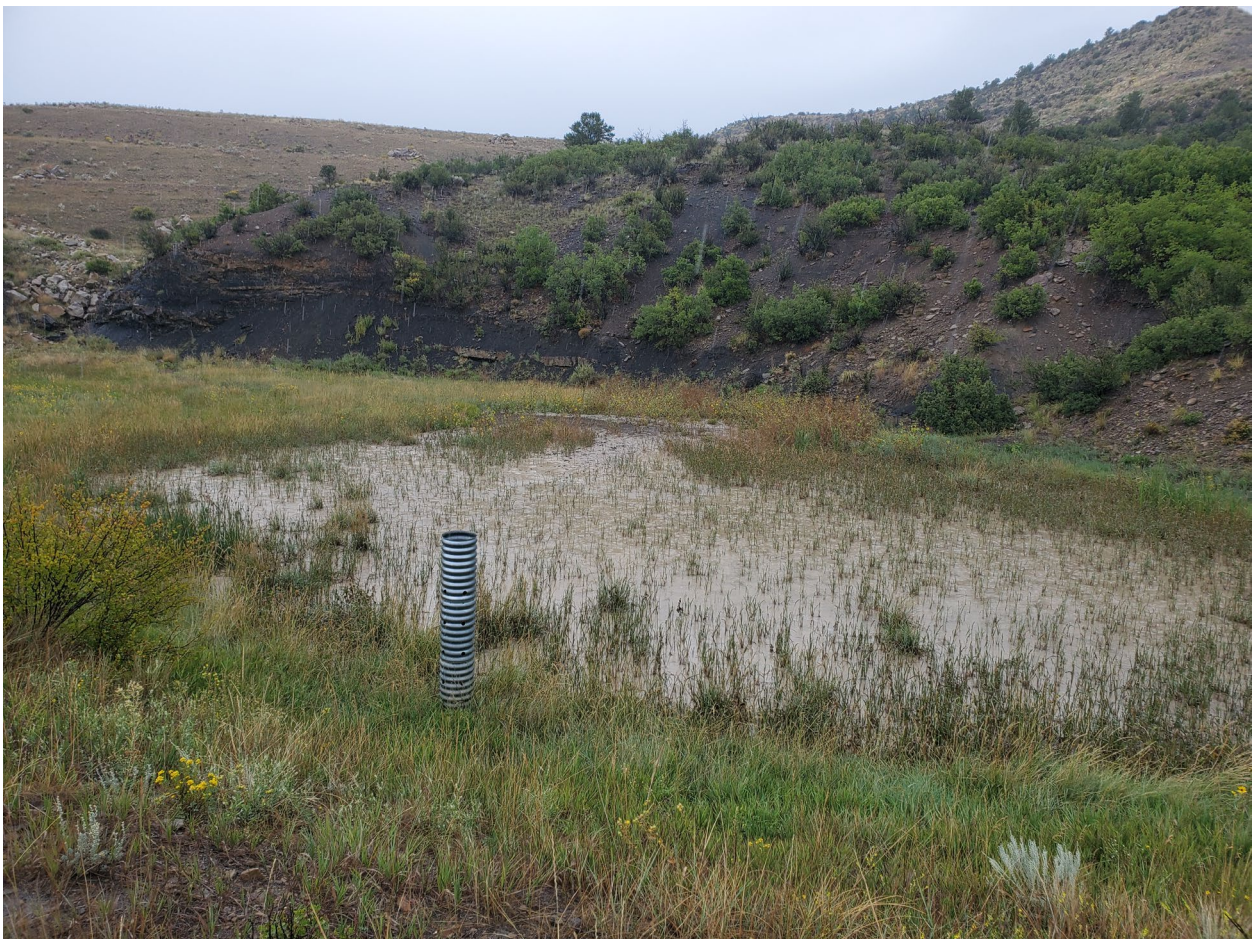
Photo 1: Pond 007a

- Pond 007a:
 - The pond contained some water at the time of the inspection (Photo 1).
 - The pond embankment appeared to be stable and vegetated.
 - The primary and emergency spillways appeared clear and functional.
 - The flume contained some water but was not discharging (Photo 2).

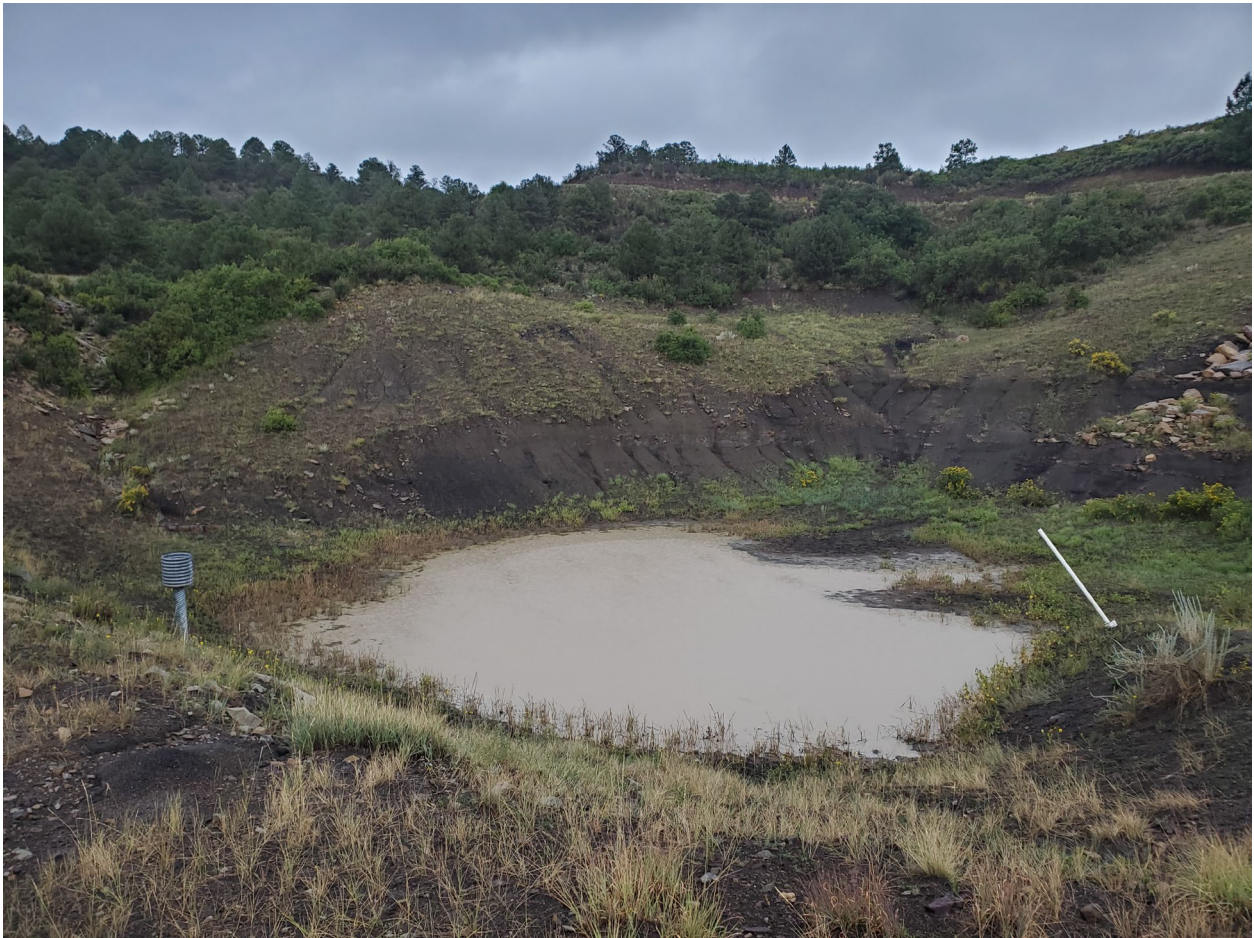
Photo 3: Pond 009

- Pond 009:
 - The pond held some water at the time of the inspection. (Photo 3).
 - The pond embankment appeared to be stable and vegetated. **The rills above the bank do not appear to have worsened, but the Operator shall continue to monitor this area.**
 - The primary and emergency spillways appeared clear and functional.
 - The flume contained some water but was not discharging.

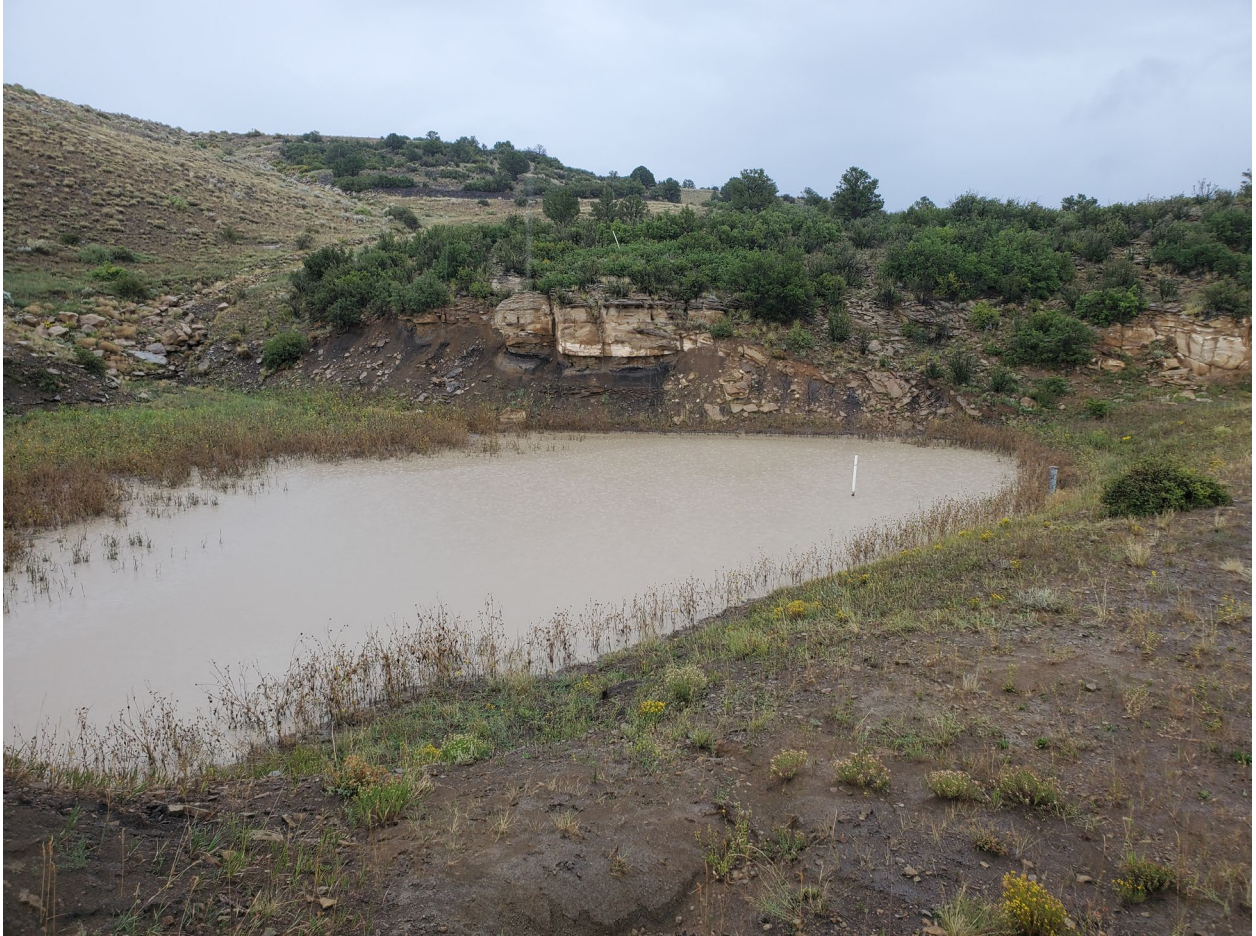
Photo 4: Pond 009a

- Pond 009a:
 - The pond contained water at the time of the inspection. (Photo 4).
 - The pond embankment appeared to be stable and vegetated.
 - The primary and emergency spillways appeared clear and functional.
 - The flume contained some water but was not discharging.

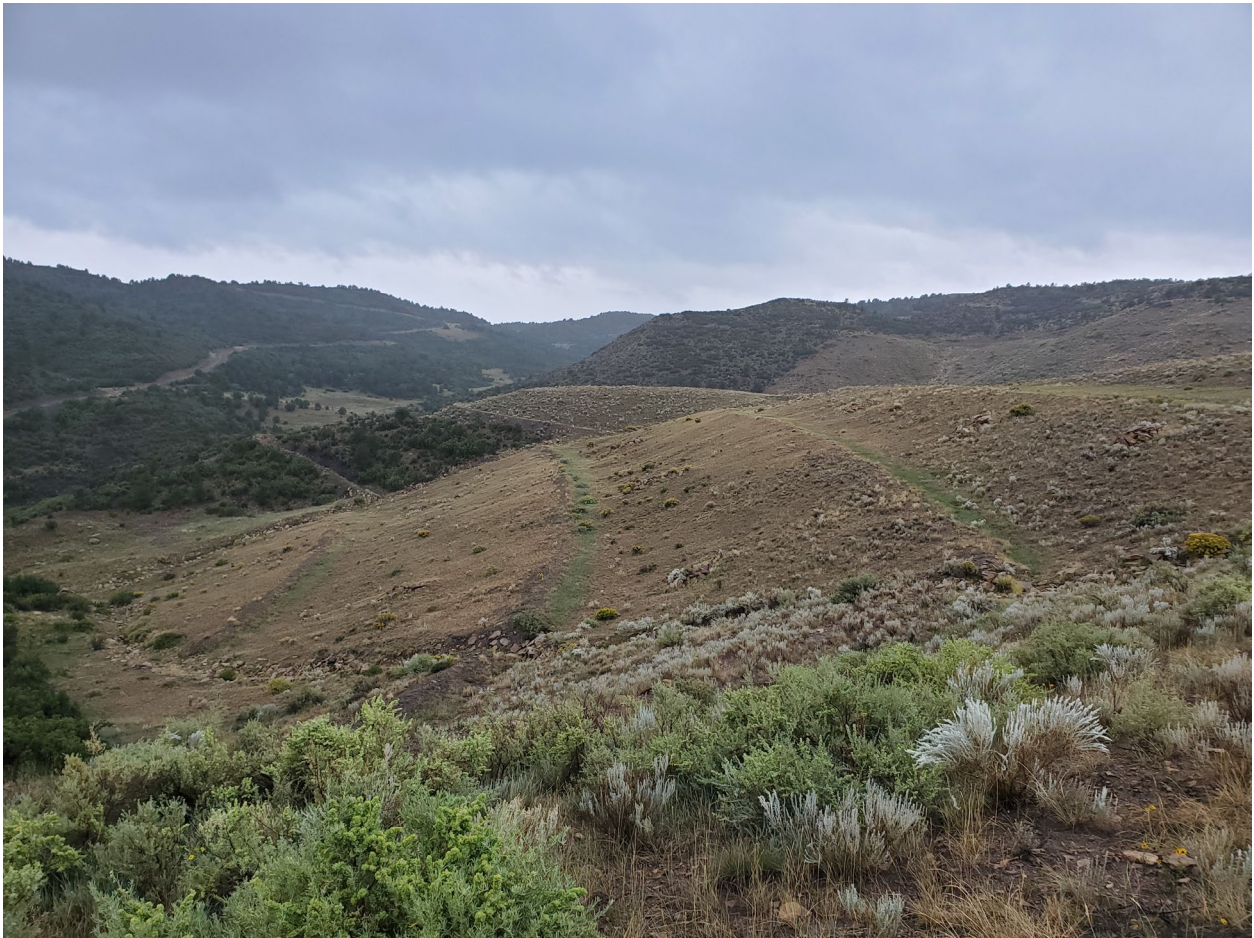
Photo 5: Fill 007

- Fill 007 was observed. Fill 007 was well vegetated and appeared stable (Photo 5).

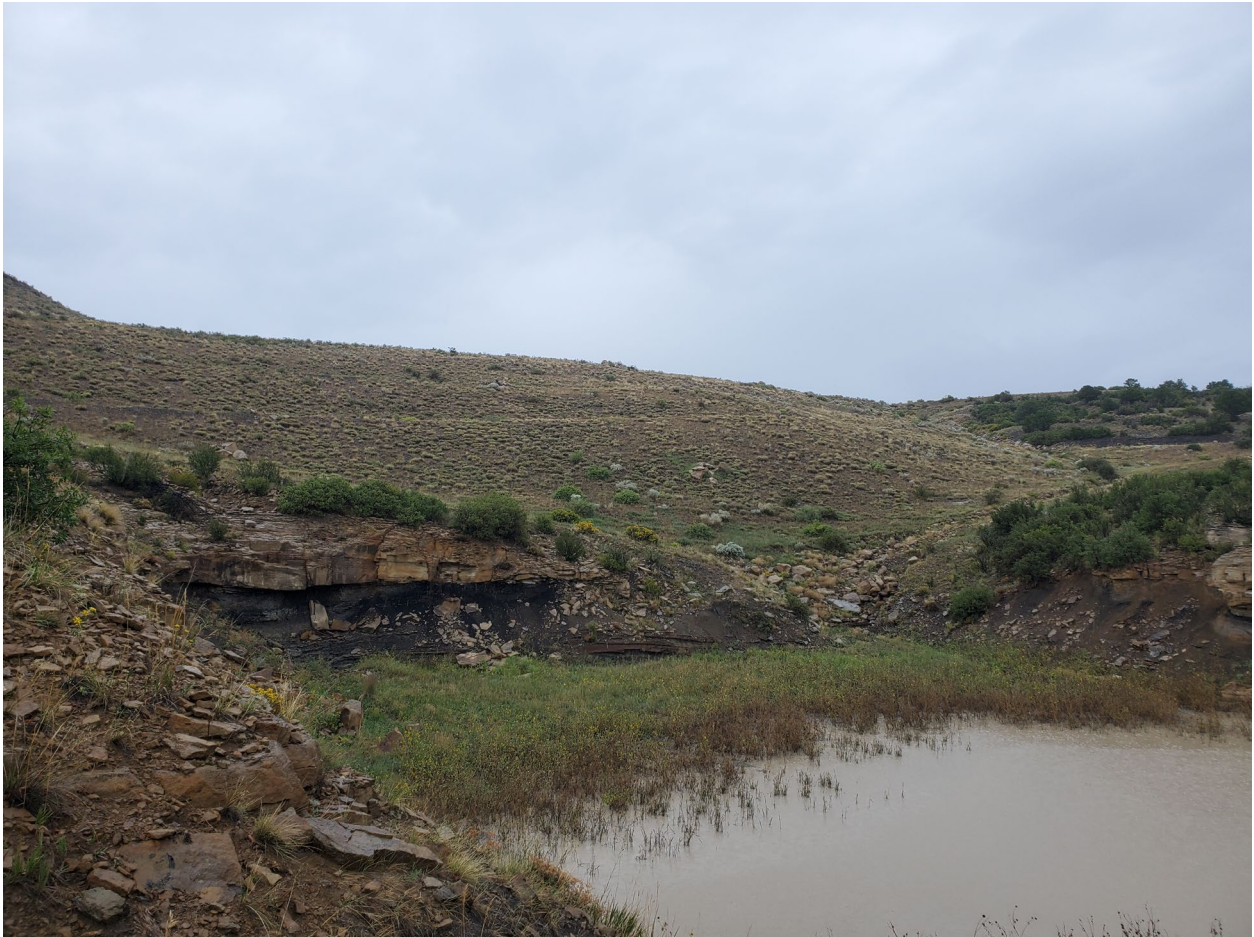
Photo 6: Fill 009

- Fill 009 was observed. Fill 009 was well vegetated and appeared stable (Photo 6).

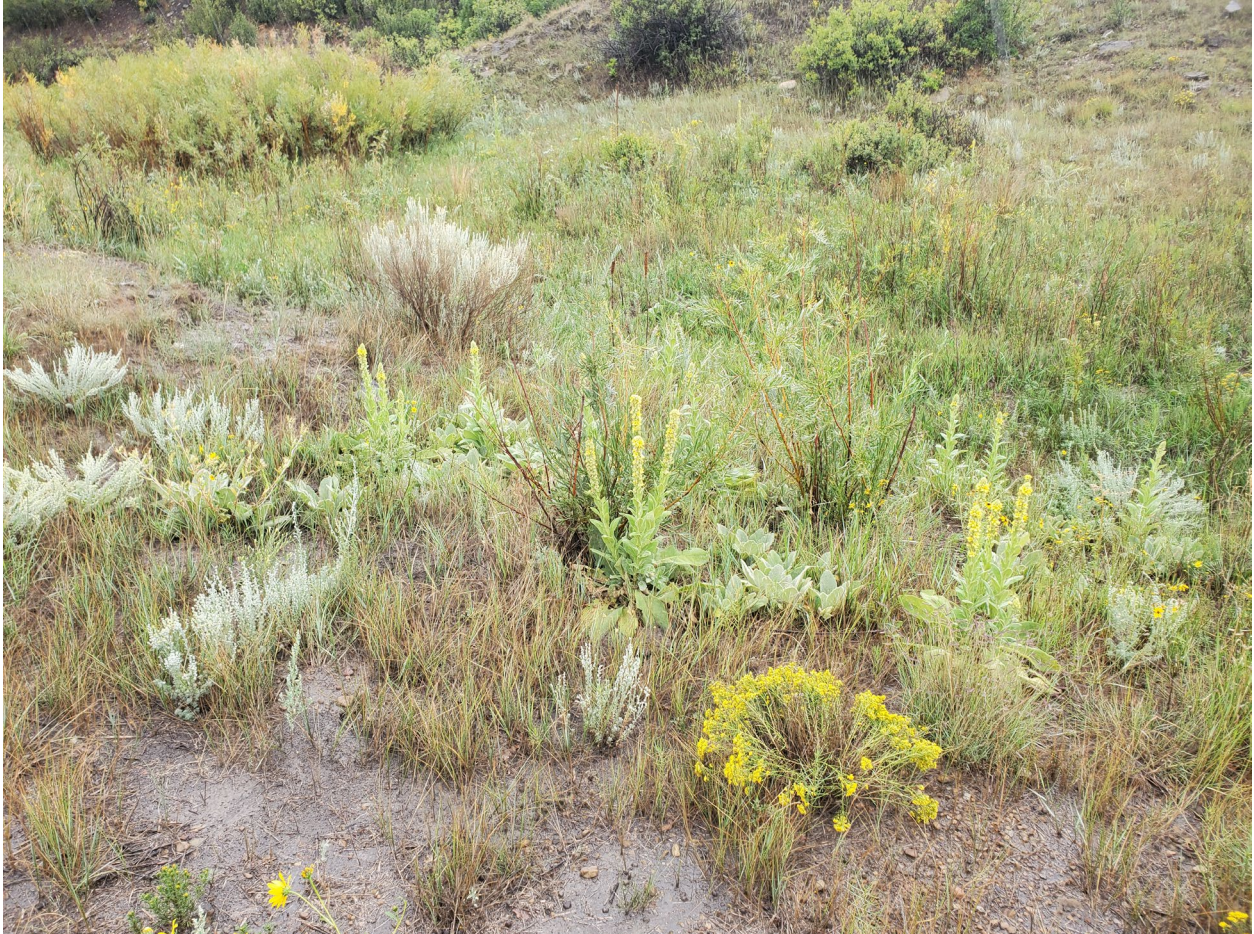
- Pursuant to Rule 4.15.1(5), the Operator shall employ weed control measures to prevent spreading of noxious weeds. The state listed noxious weed Mullein has been observed near Pond 007a (Photo 7) and during the previous inspection at Pond 008 and in the test plot area southwest of the ‘Knob’. **The Operator shall eradicate the weeds within all disturbed areas.**

Photo 7: Mullein observed near the flume for Pond 007a.

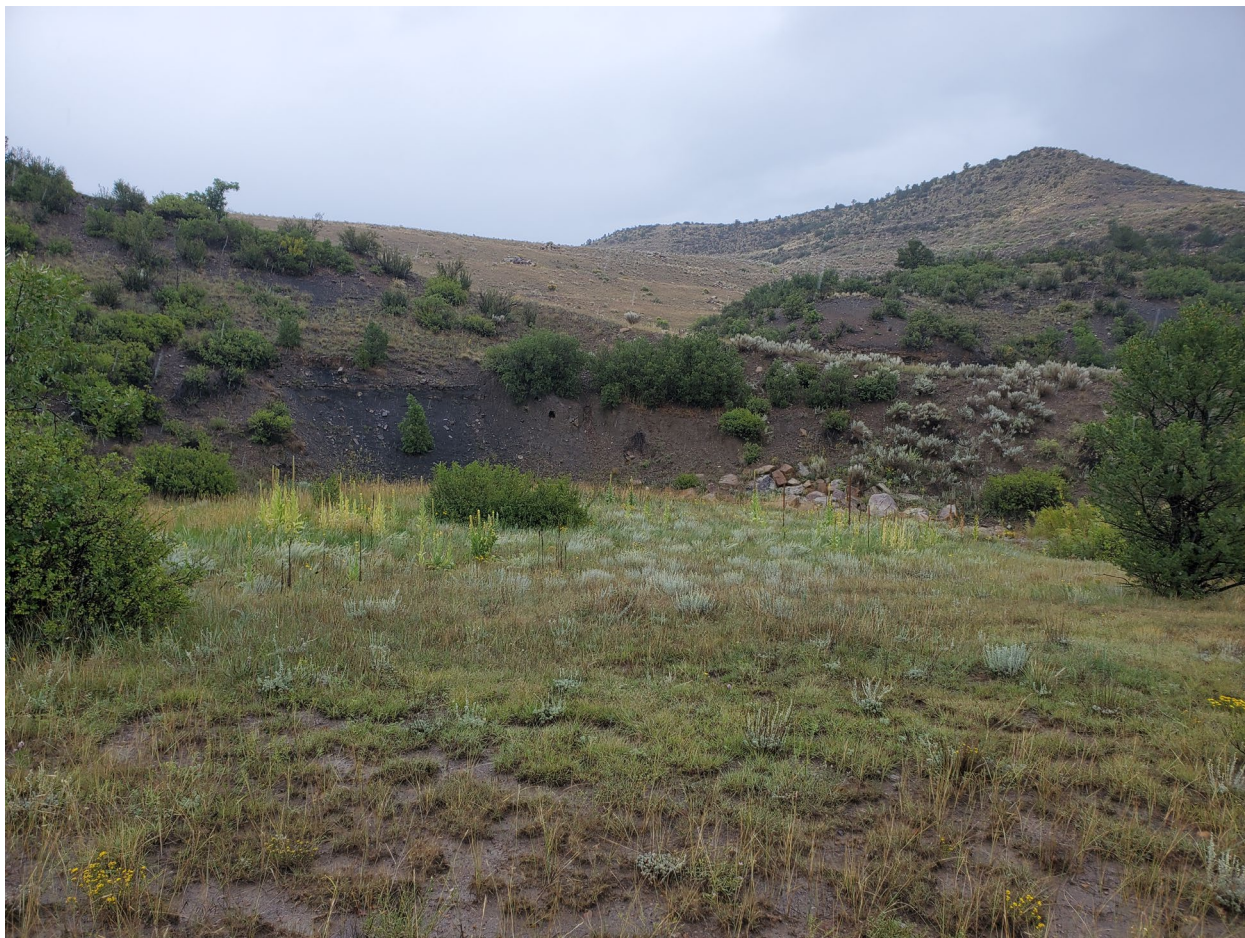
Photo 8: Mullein in an opening, southwest of Pond 007a.

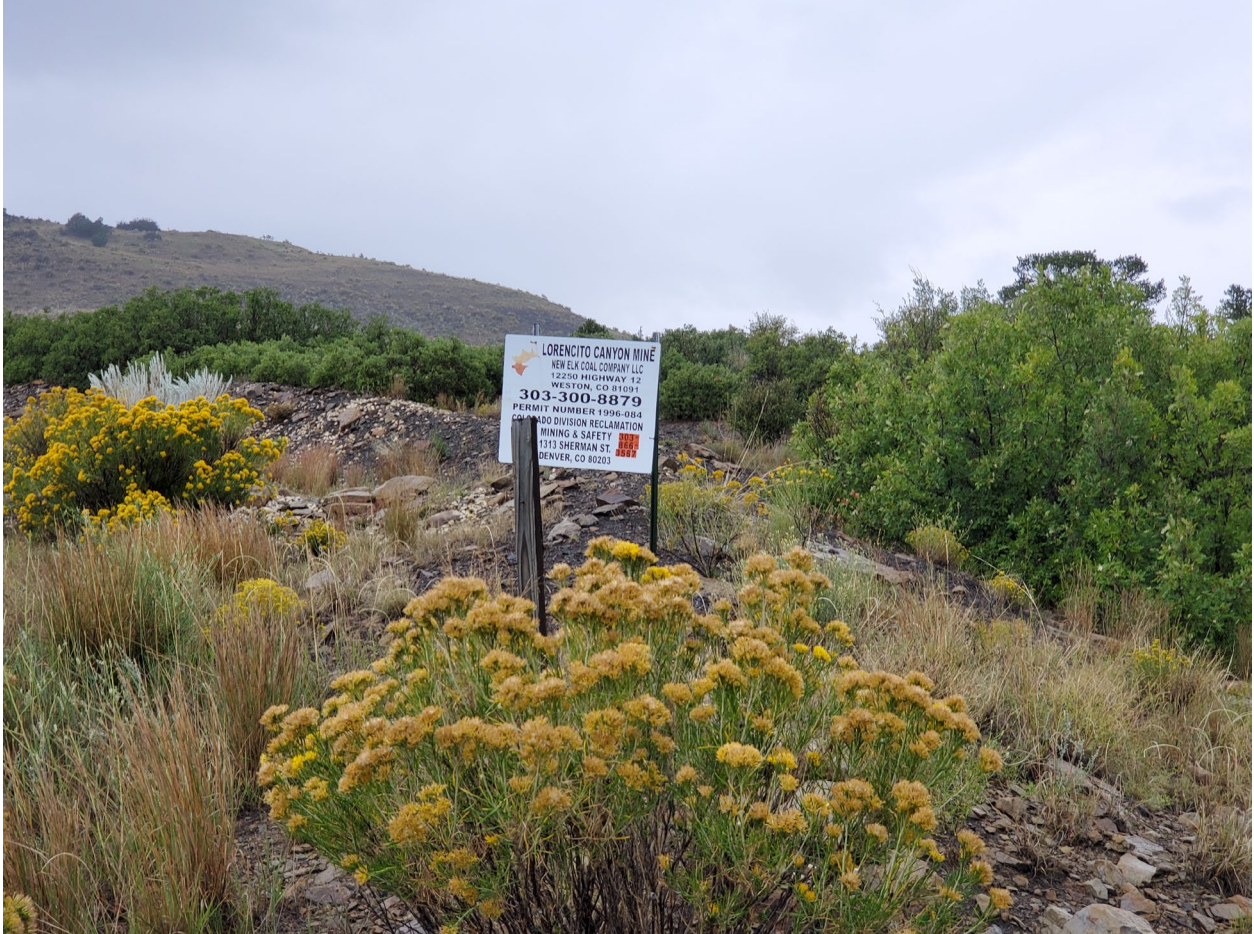
Photo 9: Mine sign

- Mine signs were posted at road entrances and at the entrance to the permit boundary in compliance with Rule 4.02 (Photo 9).
