C-1981-008 New Horizon September Partial Inspection Report

Permit Number: C-1981-008 Mine Name: New Horizon Mine Operator: Elk Ridge Mining and Reclamation, LLC Operator Address: Mr Tony Tennyson P.O. Box 628 27646 West 5th Avenue Nucla, CO 81424	County: Montrose Operation Type: Surface Permit Status: Active Ownership: Private
	Operator Representative Present: None
Operator Representative Signature: (Field Issuance Only)

Inspection Start Date: September 10, 2024 Inspection Start Time: 09:56 Inspection End Date: September 10, 2024 Inspection End Time: 10:30	Inspection Type: Coal Partial Inspection Inspection Reason: Normal I&E Program Weather: Clear
Joint Inspection Agency: None	Joint Inspection Contacts:
Post Inspection Agency: None	Post Inspection Contacts:
Inspector(s): Lucas West	Inspector's Signature:

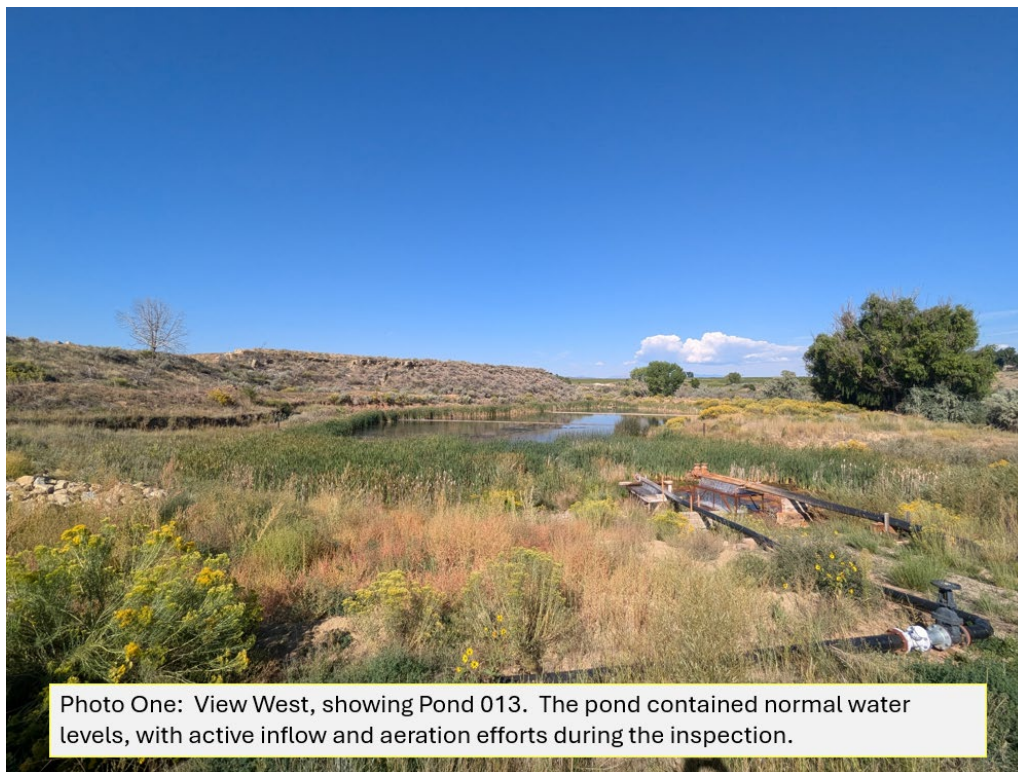
During this inspection, Ponds 013, 016 and 018 were observed. Pond 013 was noted to be in good condition, with normal water levels noted. The inflow pipe and adjacent aeration structure were flowing at the time of the inspection, and waterfowl was noted in the pond at the time. Pond 013 can be seen in Photo One. Pond 016, appeared to be stable and in good condition. No standing water or evidence of recent flow was noted. The banks were in good condition and well vegetated, as seen in Photo Two. Similarly, Pond 018 contained no standing water, with no evidence of recent flows. The banks are well vegetated and in good condition. Pond 018 can be seen in Photo Three.

Photo One: View West, showing Pond 013. The pond contained normal water levels, with active inflow and aeration efforts during the inspection.

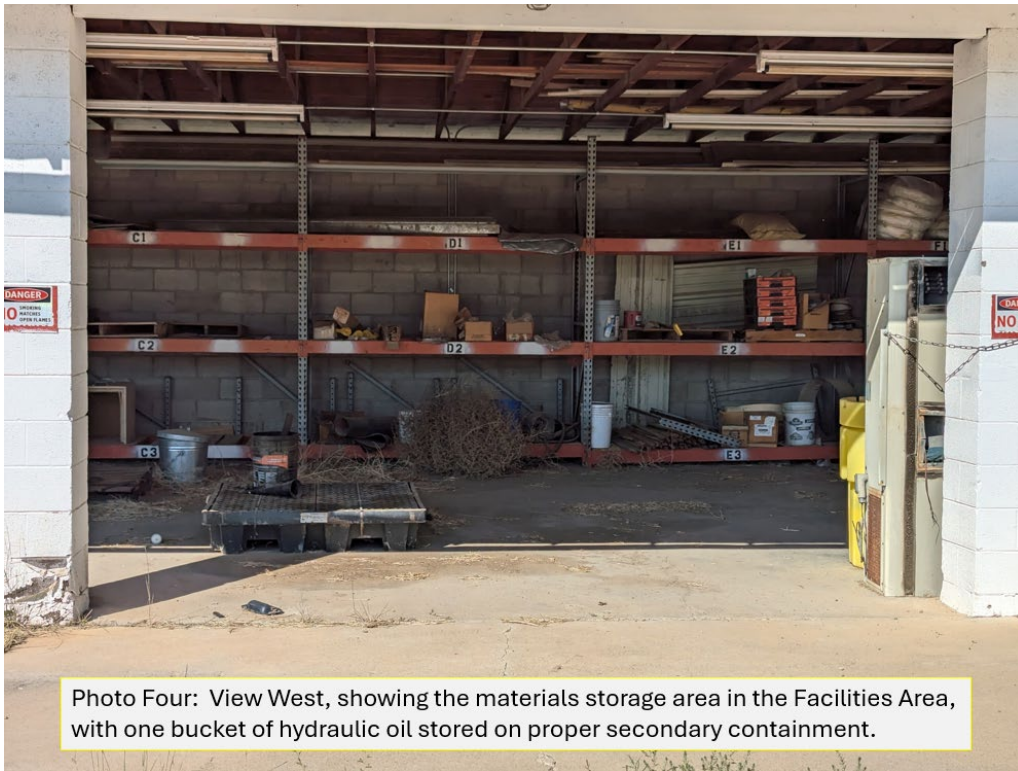
Also observed during the inspection was the small pole barn where miscellaneous materials have been previously stored, near the Facilities Area. One small bucket of hydraulic fluid was noted in the area and was properly stored on a spill pallet with adequate secondary containment. The materials storage area can be seen in Photo Four.

Photo Four: View West, showing the materials storage area in the Facilities Area, with one bucket of hydraulic oil stored on proper secondary containment.

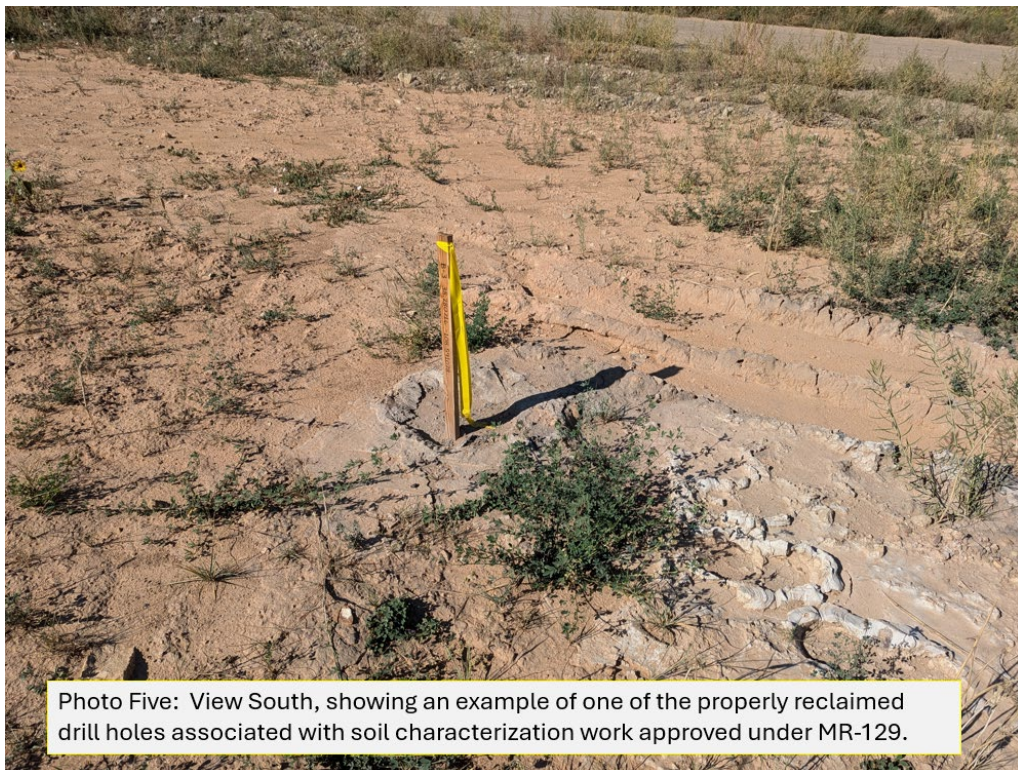
Also observed during the inspection were two of the three characterization drill holes associated with MR-129, adjacent to Pond 013. The holes appear to be properly plugged and abandoned after the completion of drilling and were marked with survey lathes. The reclaimed drill holes appeared to be in good condition, an example of the holes can be seen in Photo Five.

Photo Five: View South, showing an example of one of the properly reclaimed drill holes associated with soil characterization work approved under MR-129.
