TRAPPER MINING INC.  
CRAIG, COLORADO

HORSE GULCH FILL  
QUARTERLY FILL CERTIFICATION

# Horse Gulch Fill Quarterly Inspection Report

Third Quarter 2024

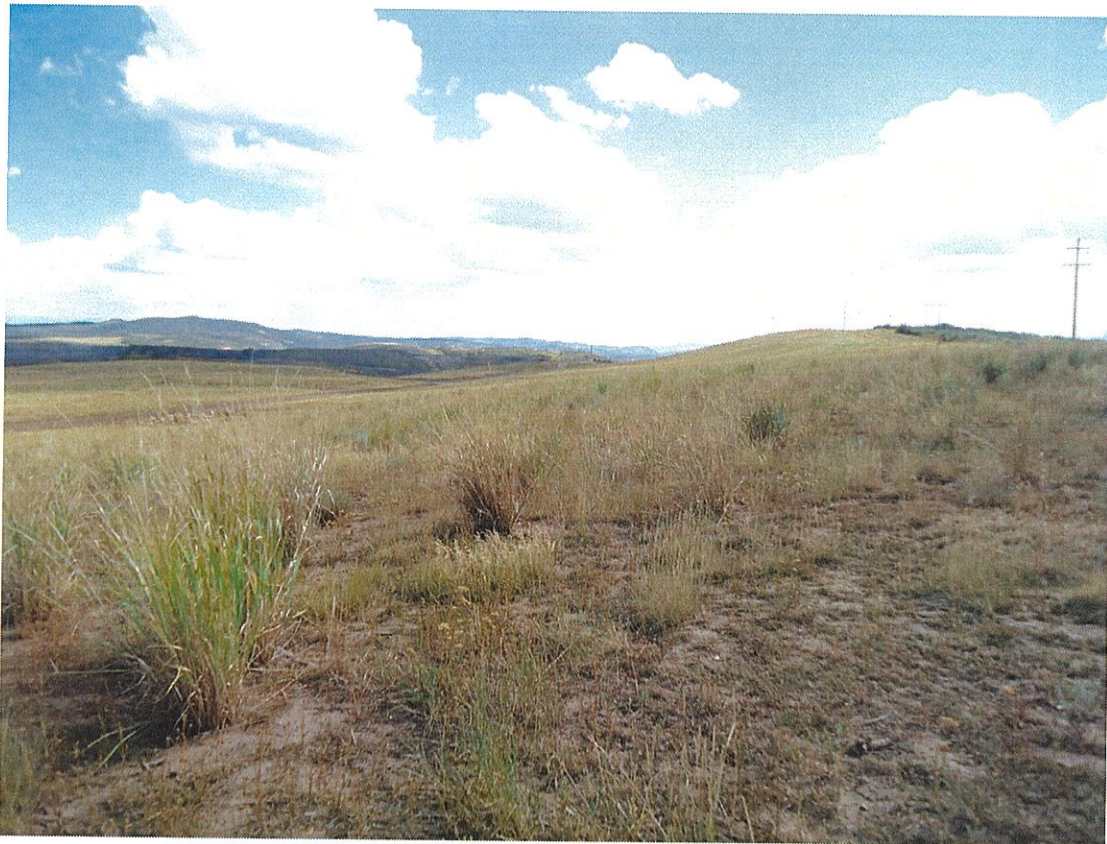
No appearances of instability, structural weakness, or other hazardous conditions were observed. Both the southeast side of the fill and the northeast side of the fill were inspected this quarter (Photographs 1 and 2). The area where cracks were detected on the top south portion of the dump during the first quarter of 2013 inspection was checked. There was no additional cracking found.

Photograph 1: North-east Side Looking South (9/10/2024)

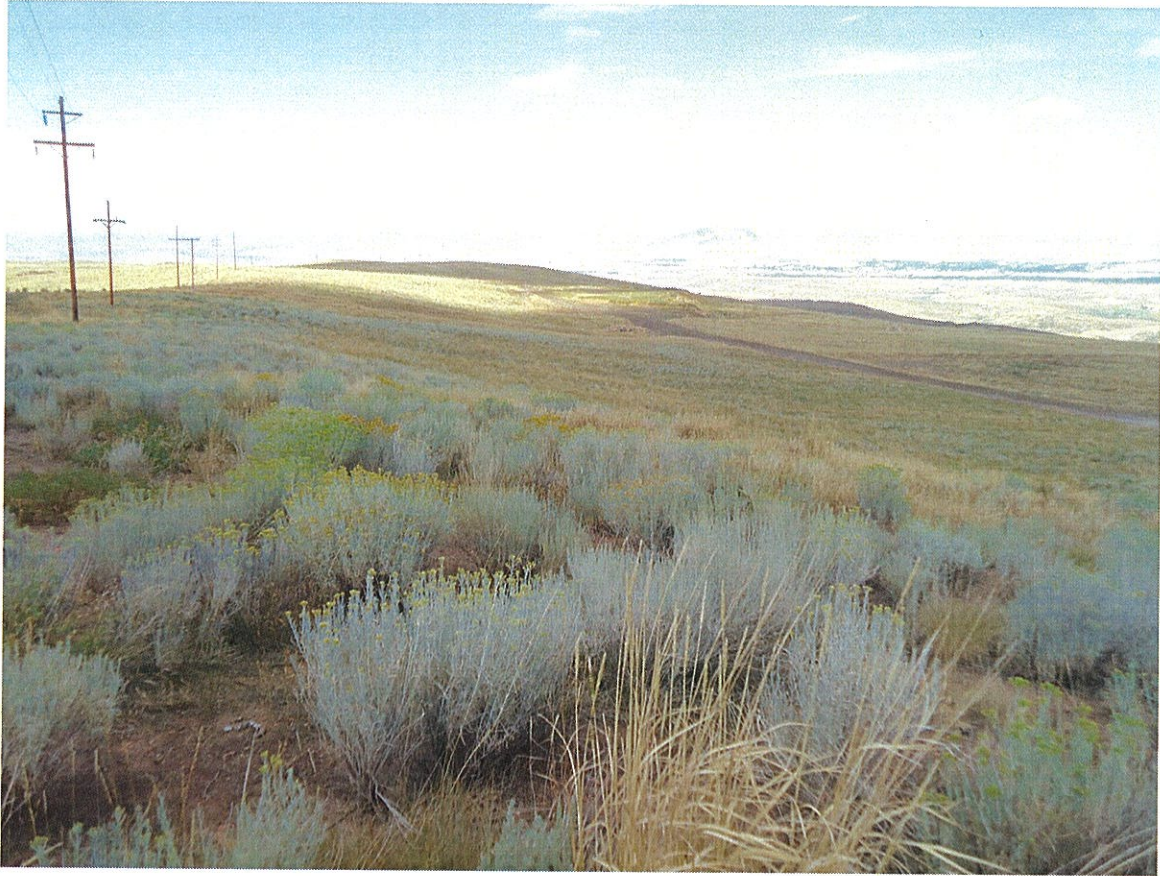
*Photograph 2: South Side Looking North (9/10/2024)*

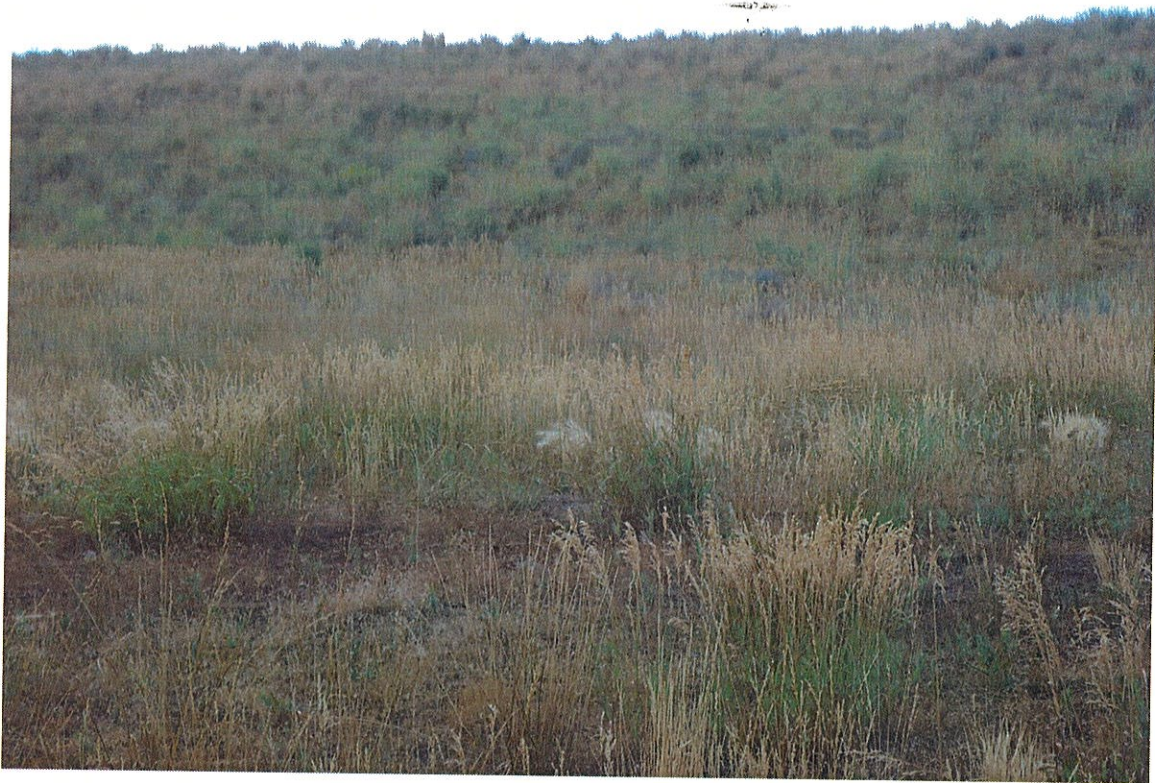
Photograph 3 depicts the east facing slope of the fill.

*Photograph 3: East Side of the Fill Looking South-west (9/10/2024)*
