Division of Reclamation,  
Mining and Safety

### PERMIT INFORMATION

<b>Permit Number:</b> X-2006-223-07 <b>Mine Name:</b> Oxbow 2006 North Elk Creek License <b>Operator:</b> Oxbow Mining, LLC <b>Operator Address:</b> Doug Smith 3737 Hwy 133 P. O. Box 535 Somerset, CO 81434	<b>County:</b> Gunnison <b>Operation Type:</b> Coal exploration <b>Permit Status:</b> Active <b>Ownership:</b> Private
	<b>Operator Representative Present:</b>  Chuck Shelden
<b>Operator Representative Signature: (Field Issuance Only)</b>

### INSPECTION INFORMATION

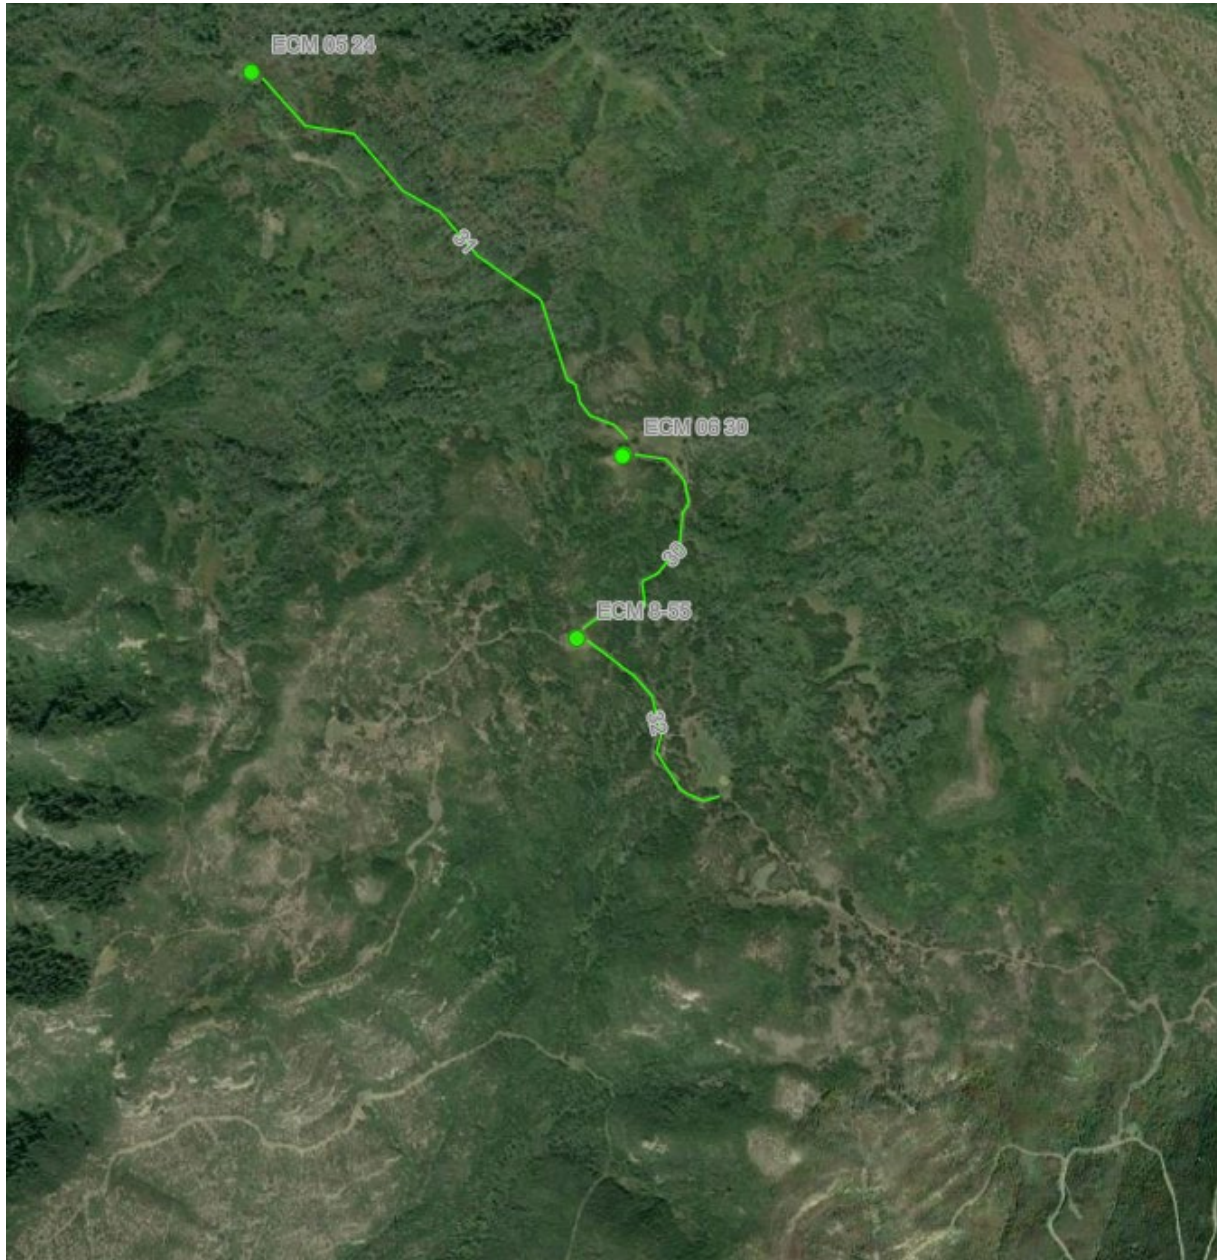
A screenshot of the webmap used during the inspection is shown in Figure 1, with inspection features in green. (Hole ECM 08-55, shown on the map, was inspected but was drilled under a different permit and has already received bond release)

*Figure 1: Screenshot of inspection map*

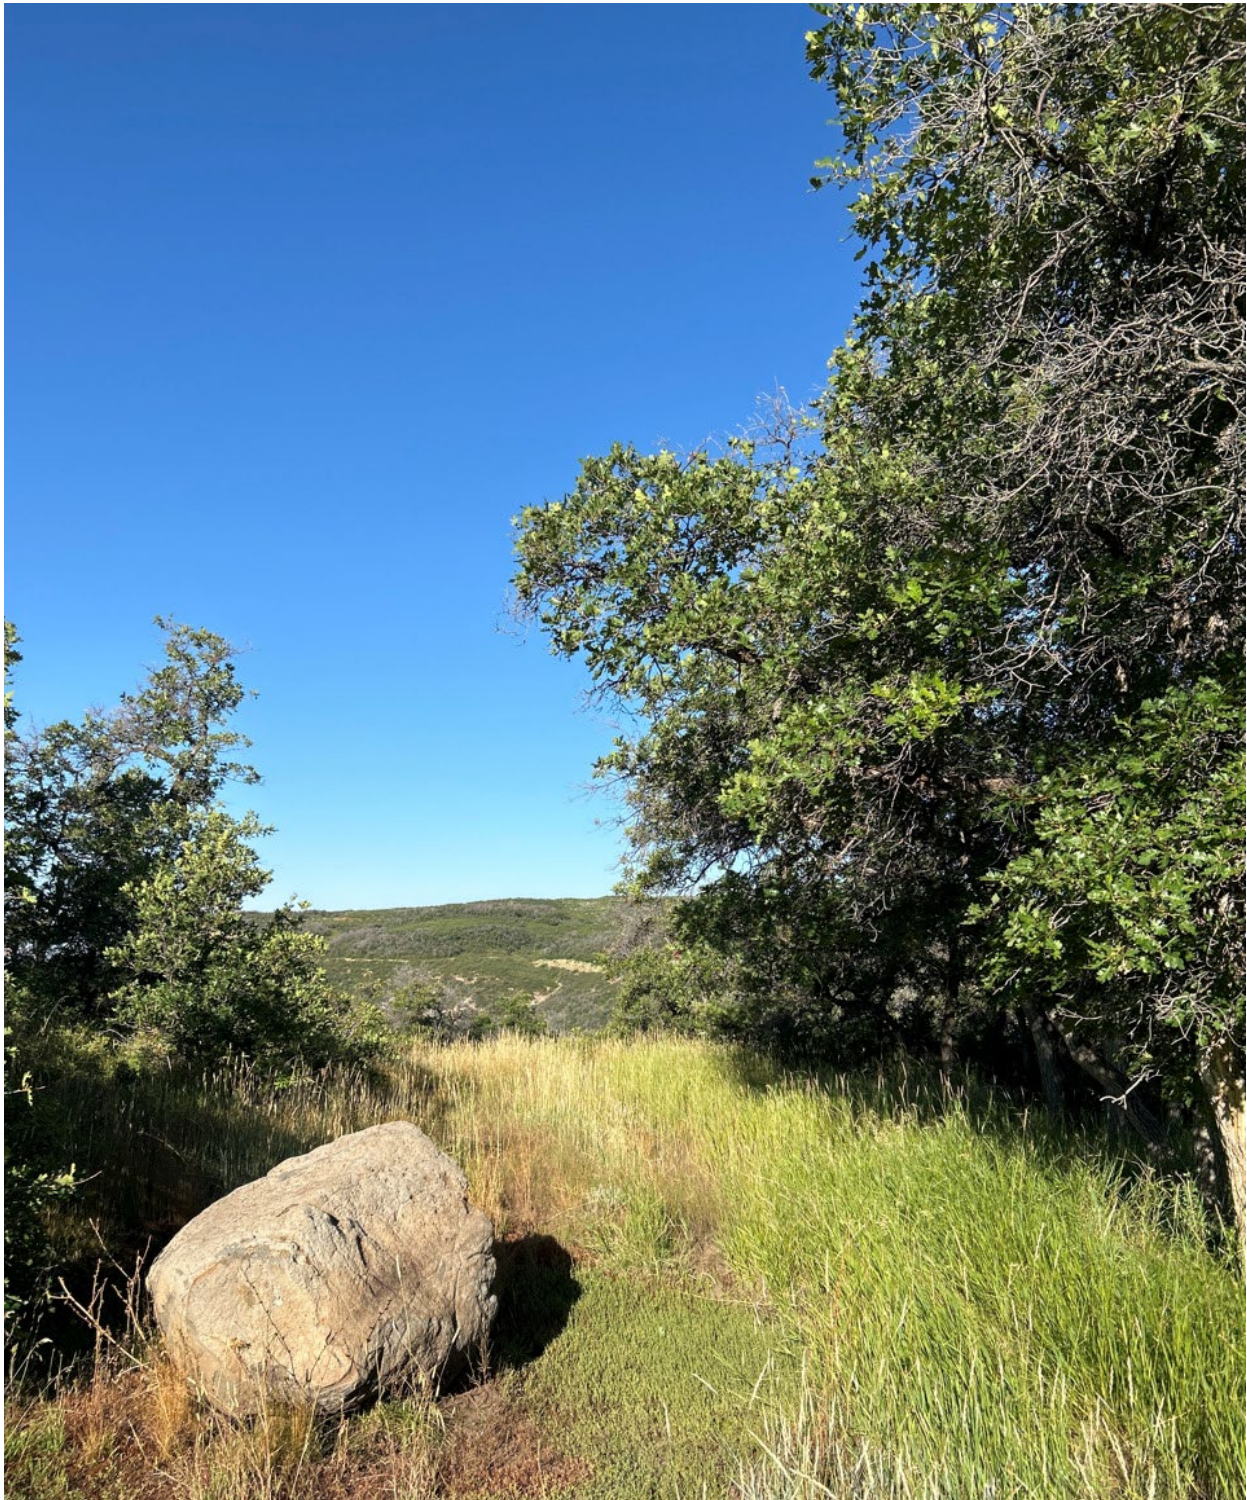
*Figure 2: Reclaimed road*

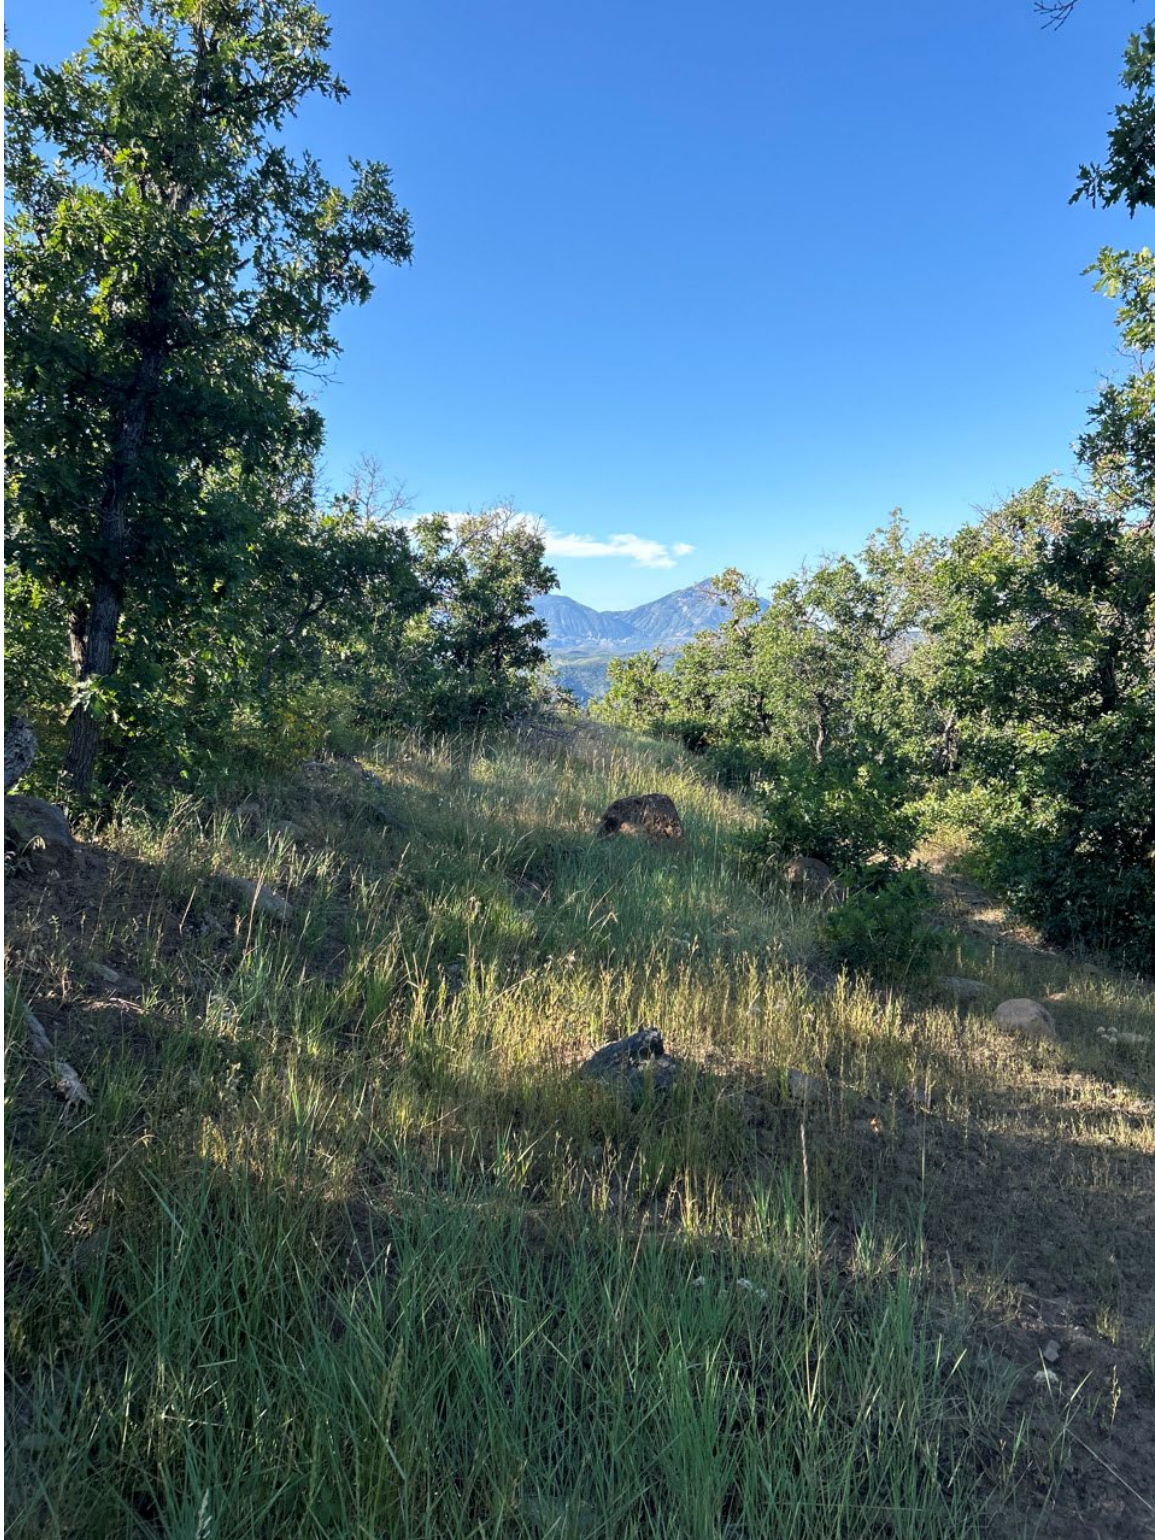
*Figure 3: Reclaimed road with volunteer shrubs*

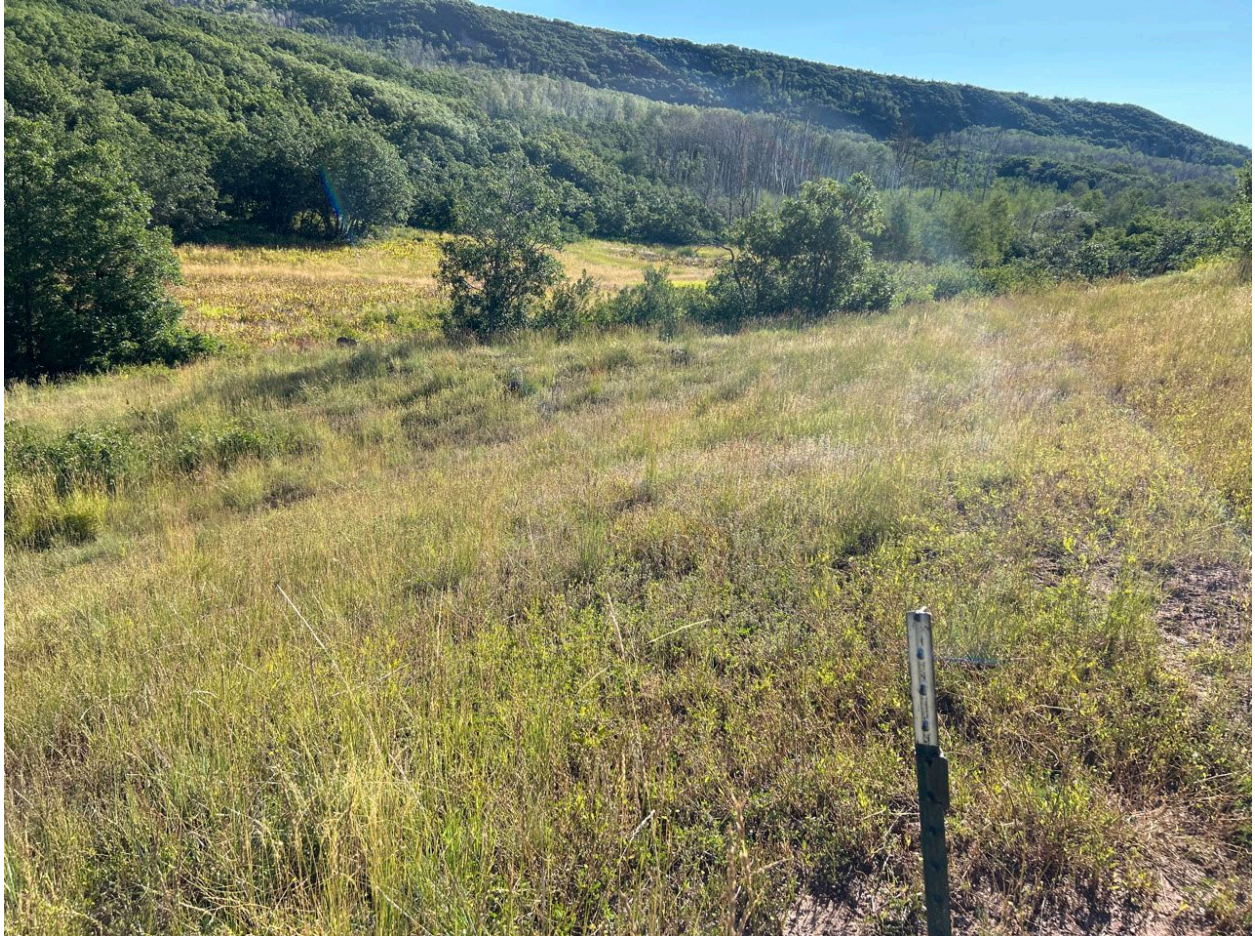
*Figure 6: ECM 06-30 pad*

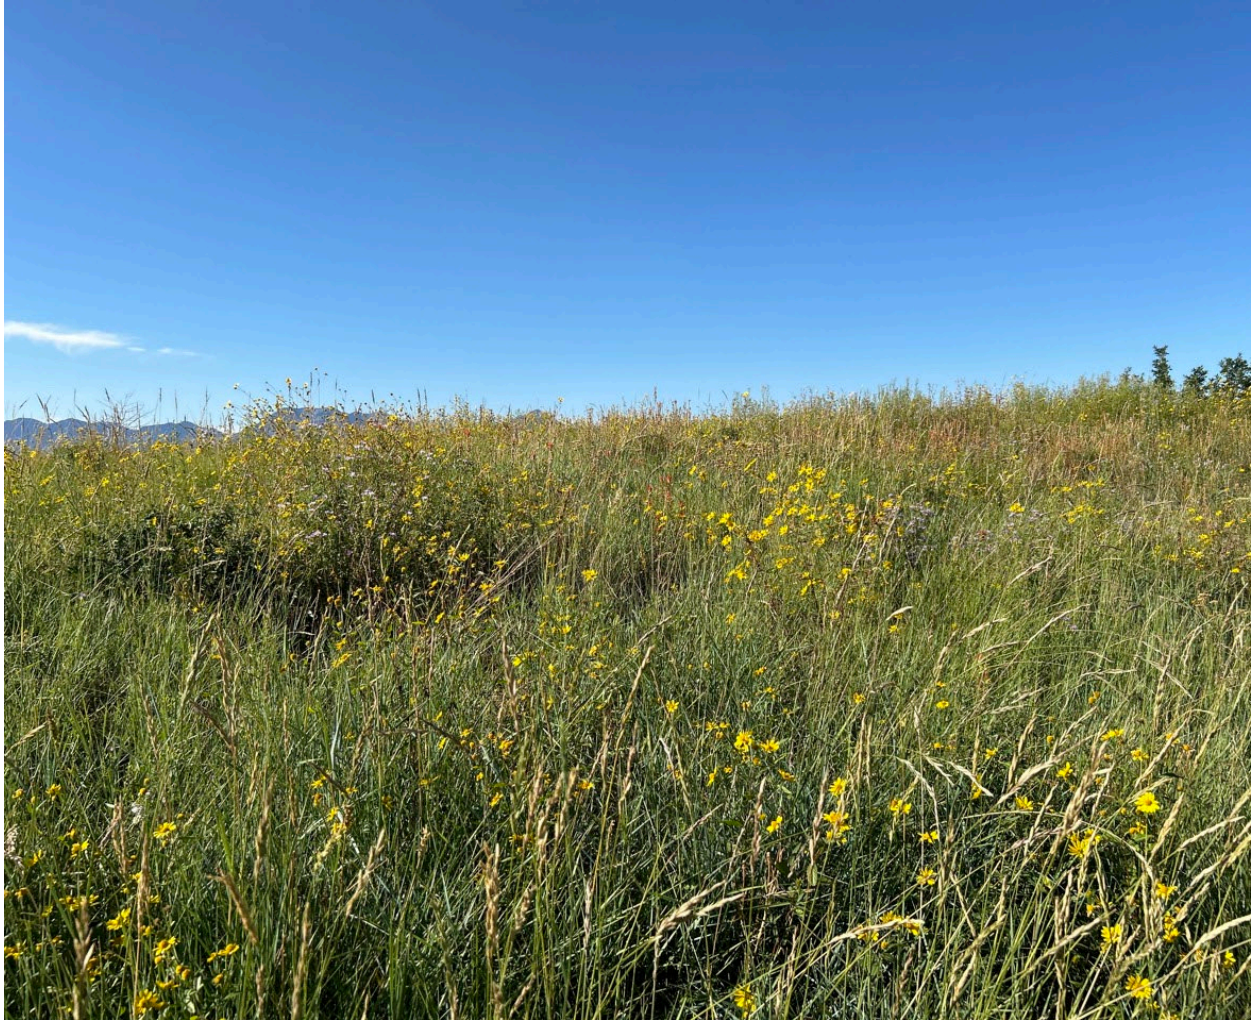
*Figure 8: ECM 05-24 pad*
