MINERALS PROGRAM INSPECTION REPORT
PHONE: (303) 866-3567

MINE NAME: Leyden Pit	MINE/PROSPECTING ID#: M-1983-139	MINERAL: Sand and gravel	COUNTY: Jefferson
INSPECTION TYPE: Monitoring	WEATHER: Clear	INSP. DATE: September 17, 2024	INSP. TIME: 09:30
OPERATOR: City of Arvada	OPERATOR REPRESENTATIVE: Ike Miller	TYPE OF OPERATION: 112c - Construction Regular Operation	
REASON FOR INSPECTION: Normal I&E Program	BOND CALCULATION TYPE: None	BOND AMOUNT: \$0.00	
DATE OF COMPLAINT: NA	POST INSP. CONTACTS: Local Government	JOINT INSP. AGENCY: None	
INSPECTOR(S): Ben Hammar Zach Trujillo	INSPECTOR'S SIGNATURE:

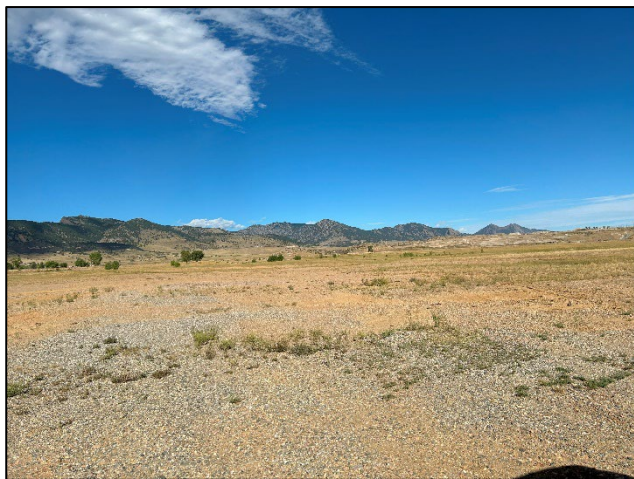
Regrading and revegetation of the remaining area has been successfully completed, with only a small section of relatively barren space existing immediately northwest of the central access road. As it is the Division's understanding that Arvada wishes to reduce or release this site in the near future, care should be taken to maintain weed control efforts and attempt to reseed the remaining areas in need of further reclamation. Weed control efforts have been fairly diligent previously, but emphasis should be placed on removing any remaining noxious weeds as the site is prepared for final release.

Photo 1 - Section of barren land northwest of the access road.

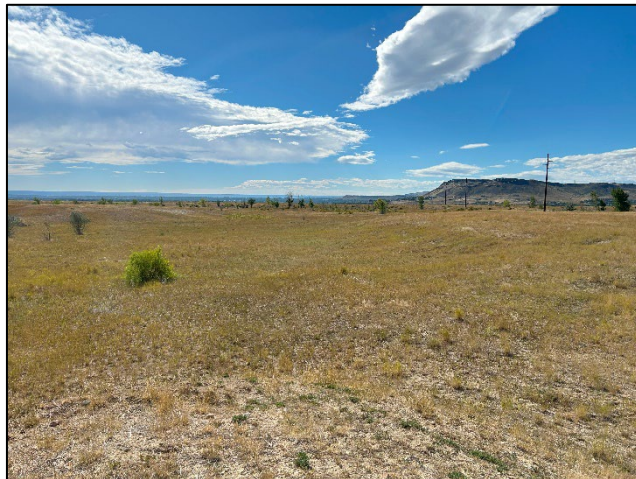
Photo 2 – Representative Section of reclaimed land located near the east site boundary.

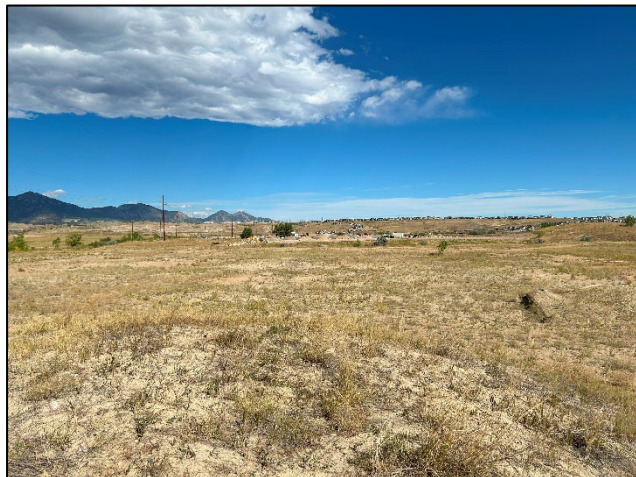
Photo 3 – Northern site boundary facing the release portion of land leased to Pioneer.
