## C-1981-035 King September 2024 Partial Inspection Report

**PERMIT INFORMATION**

| <b>Permit Number:</b> C-1981-035<br><b>Mine Name:</b> King Coal Mine<br><b>Operator:</b> GCC Energy, LLC<br><b>Operator Address:</b><br>Mr Jordan McCourt<br>6473 County Road 120<br>Hesperus, CO 81326 | <b>County:</b> La Plata<br><b>Operation Type:</b> Underground<br><b>Permit Status:</b> Active<br><b>Ownership:</b> Private |

| <b>Inspection Start Date:</b> September 10, 2024<br><b>Inspection Start Time:</b> 13:27<br><b>Inspection End Date:</b> September 10, 2024<br><b>Inspection End Time:</b> 14:50 | <b>Inspection Type:</b> Coal Partial Inspection<br><b>Inspection Reason:</b> Normal I&E Program<br><b>Weather:</b> Clear |

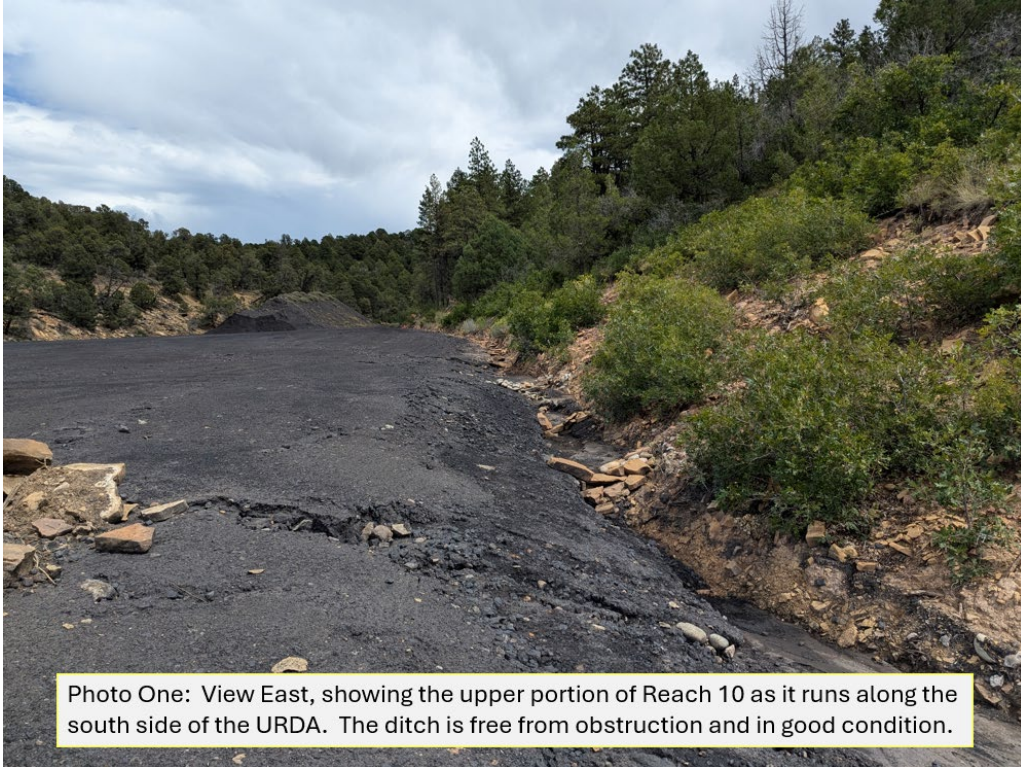
The Upper Refuse Disposal Area (URDA) and the upper section of Reach 10 of the internal drainage structure was observed to be in good condition. The upper section of Reach 10 flows the South side of the URDA to carry impacted water from the URDA to the Lower Refuse Disposal Area (LRDA). This section, shown in Photo One, was free from obstruction and appeared to be able to function as designed. Minor sedimentation along the way was noted, but not enough to warrant cleanout or to be considered a problem. Further down gradient, along reach 10 and below the shoulder of the slope, significant volumes of water had scoured the recently placed river rock, exposing the geotextile liner beneath the rock. The rock has been piled along the slope and was only transported a short distance. The flow, and transported rock did not migrate outside of the ditch, nor did it compromise the integrity of the ditch, therefore is not considered a problem at this time. The area can be seen in Photo Two. On site discussions with the Operator Representative indicate that more angular rock is on order, to repair the area in an effort to prevent any further rock transport. All ditches and culverts along the access road between the URDA

Photo One: View East, showing the upper portion of Reach 10 as it runs along the south side of the URDA. The ditch is free from obstruction and in good condition.

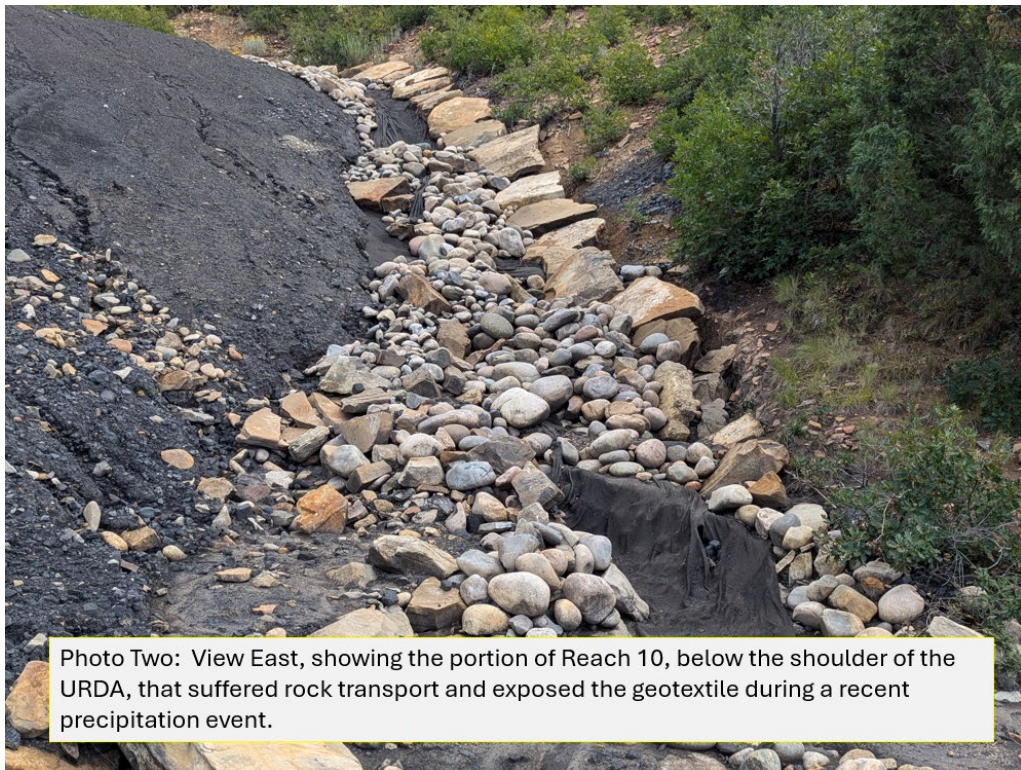
Photo Two: View East, showing the portion of Reach 10, below the shoulder of the URDA, that suffered rock transport and exposed the geotextile during a recent precipitation event.

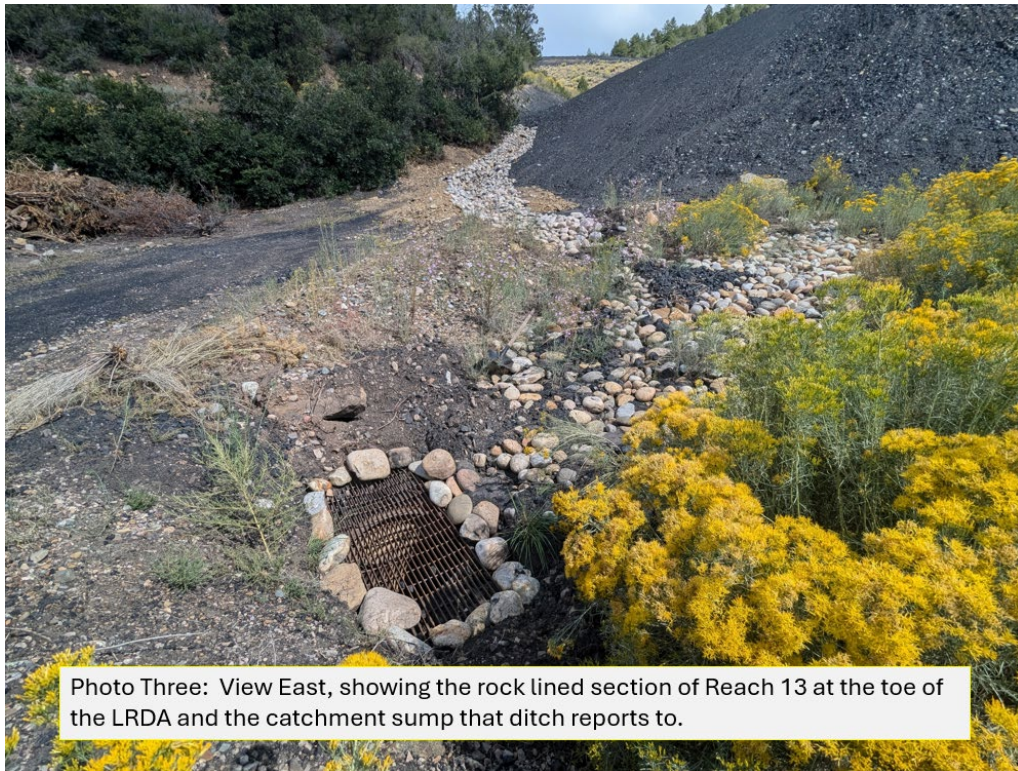
At the LRDA, Reach 13 was observed to be in excellent condition. The river rock lining has been extended down the slope and around the receiving sump near the toe of the LRDA. Photo Three shows the lined section of Reach 13 as well as the receiving sump. Reach 10, as it traverses the LRDA and extends down the access road toward the sediment pond was also noted to be in good condition and free from obstruction.

Photo Three: View East, showing the rock lined section of Reach 13 at the toe of the LRDA and the catchment sump that ditch reports to.

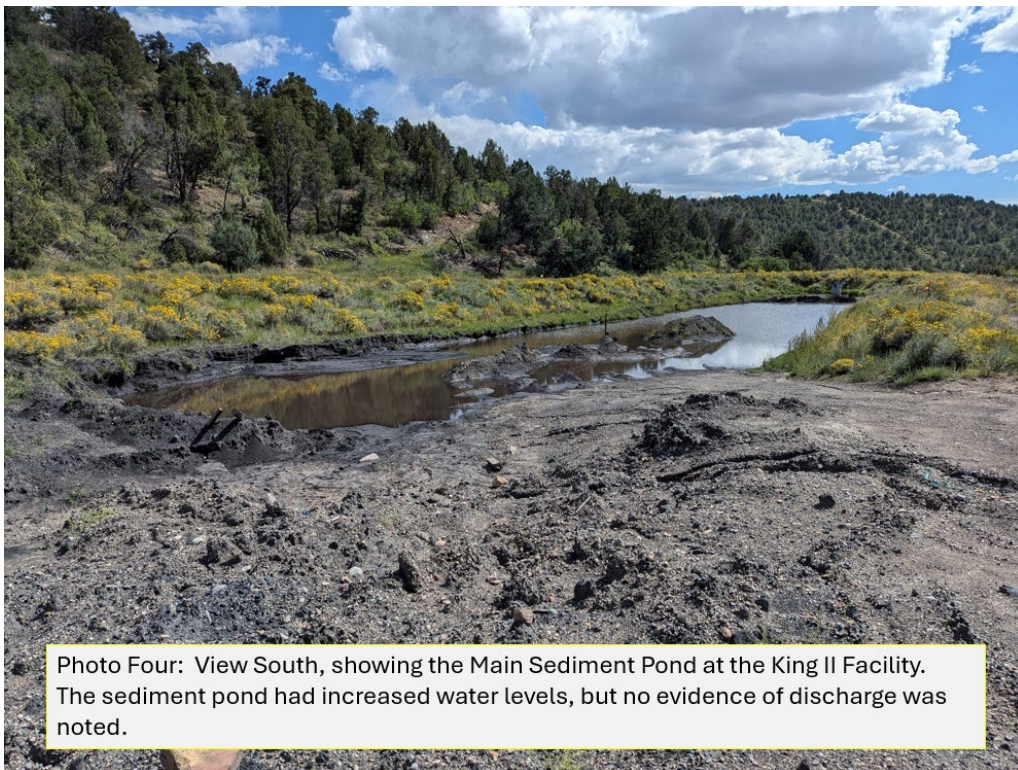
All observed ditches and culverts at the King II facility were in good condition, free from obstruction and appeared to be functioning as designed. No evidence of significant erosion or sedimentation was noted. The Sediment Pond was observed and had more standing water than is typical for the time of year, in response to the recent precipitation events. The water level was still noted to be well below the outlet structure, and no evidence of discharge was noted. The pond can be seen in Photo Four.

Photo Four: View South, showing the Main Sediment Pond at the King II Facility. The sediment pond had increased water levels, but no evidence of discharge was noted.

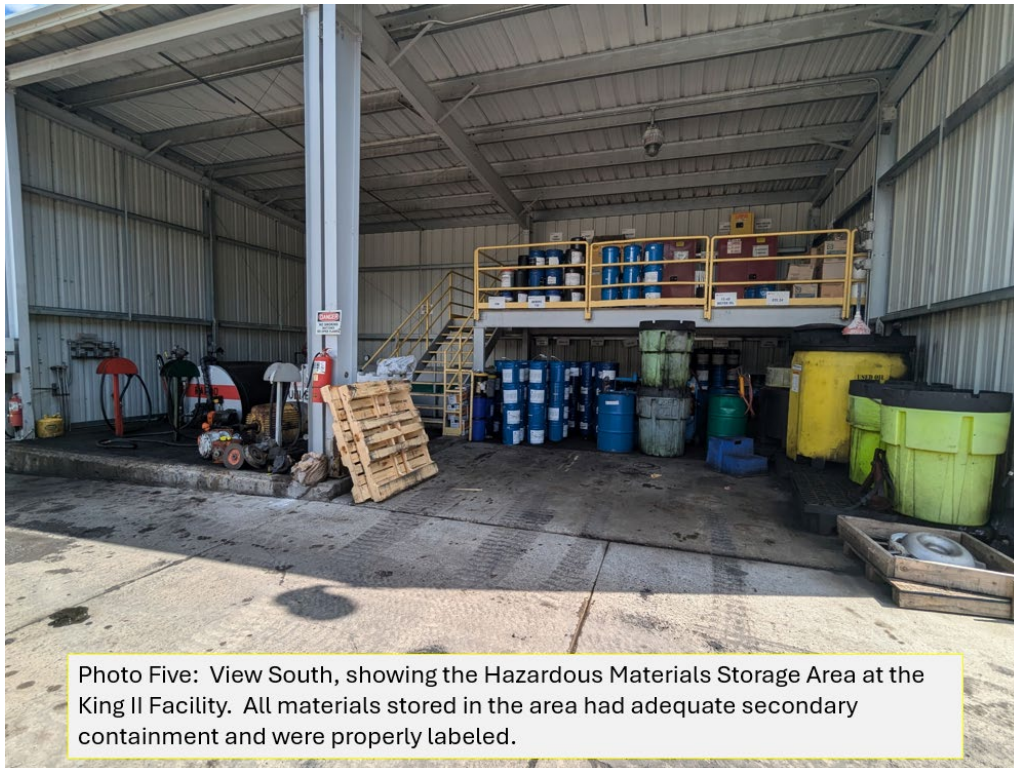
Also noted at the King II facility was the Hazardous Materials Storage Area adjacent to the parking lot near the office building. All items stored in the area were contained within secondary containment structures or spill pallets, were well organized and labeled. The storage area can be seen in Photo Five.

Photo Five: View South, showing the Hazardous Materials Storage Area at the King II Facility. All materials stored in the area had adequate secondary containment and were properly labeled.

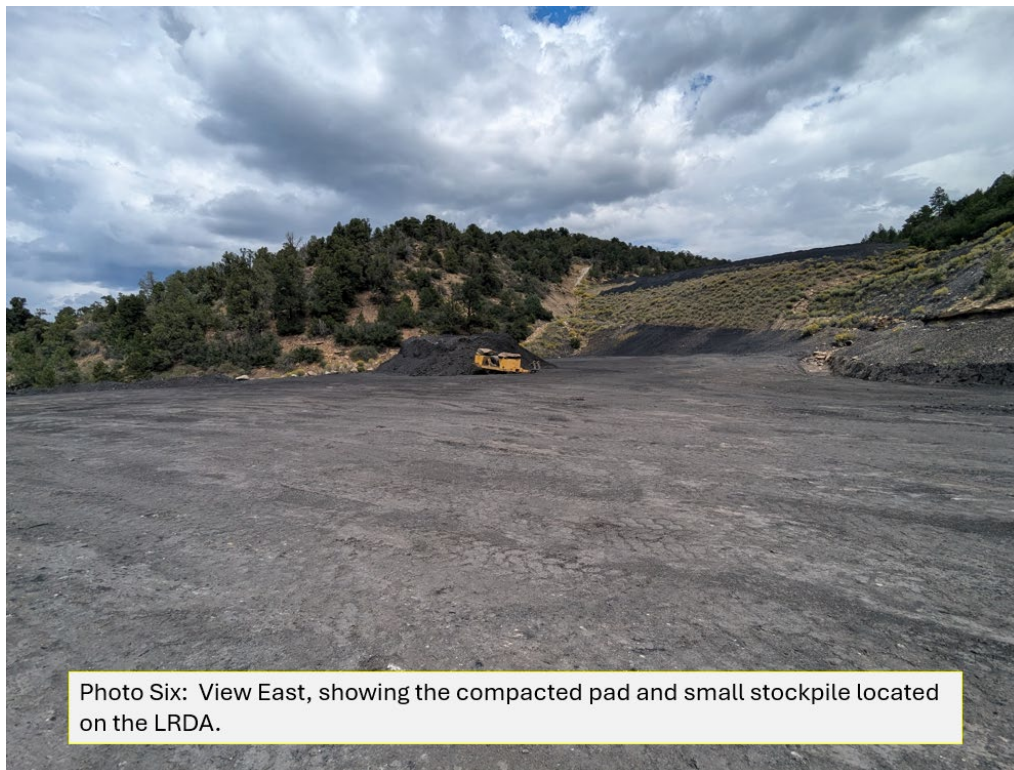
All processing waste for the site is stored at the King I Facility. Both the URDA and the LRDA were noted to be in excellent condition. The surfaces of both facilities appear to be well compacted, and no evidence of settling slumping or erosion was noted. The outslopes of both disposal areas appeared stable and in good condition. Both areas have small stockpiles of material to be spread. The stockpiles showed no evidence of significant erosion or sediment transport. Examples of the surfaces of the pads and stockpiles can be seen in Photos Six and Seven.

Photo Six: View East, showing the compacted pad and small stockpile located on the LRDA.

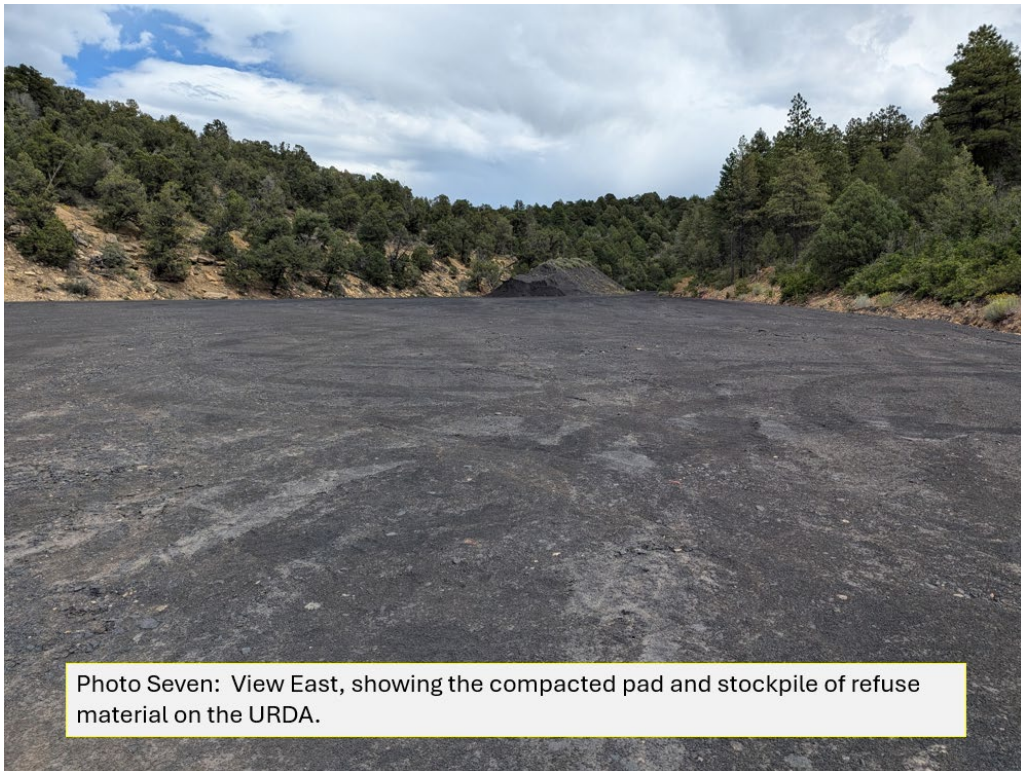
Photo Seven: View East, showing the compacted pad and stockpile of refuse material on the URDA.
