Inspection Report, New Elk Mine, C-1981-012

PERMIT INFORMATION

Permit Number: C-1981-012 Mine Name: New Elk Mine Operator: New Elk Coal Company, LLC Operator Address: Mr. John Terry 12250 Highway 12 Weston, CO 81091	County: Las Animas Operation Type: Underground Permit Status: Active Ownership: Private
	Operator Representative Present: None
Operator Representative Signature: (Field Issuance Only)

Inspection Start Date: September 4, 2024 Inspection Start Time: 13:43 Inspection End Date: September 5, 2024 Inspection End Time: 11:21	Inspection Type: Coal Complete Inspection Inspection Reason: Normal I&E Program Weather: Raining
Joint Inspection Agency: None	Joint Inspection Contacts:
Post Inspection Agency: None	Post Inspection Contacts:
Inspector(s): Amber M. Gibson	Inspector's Signature:

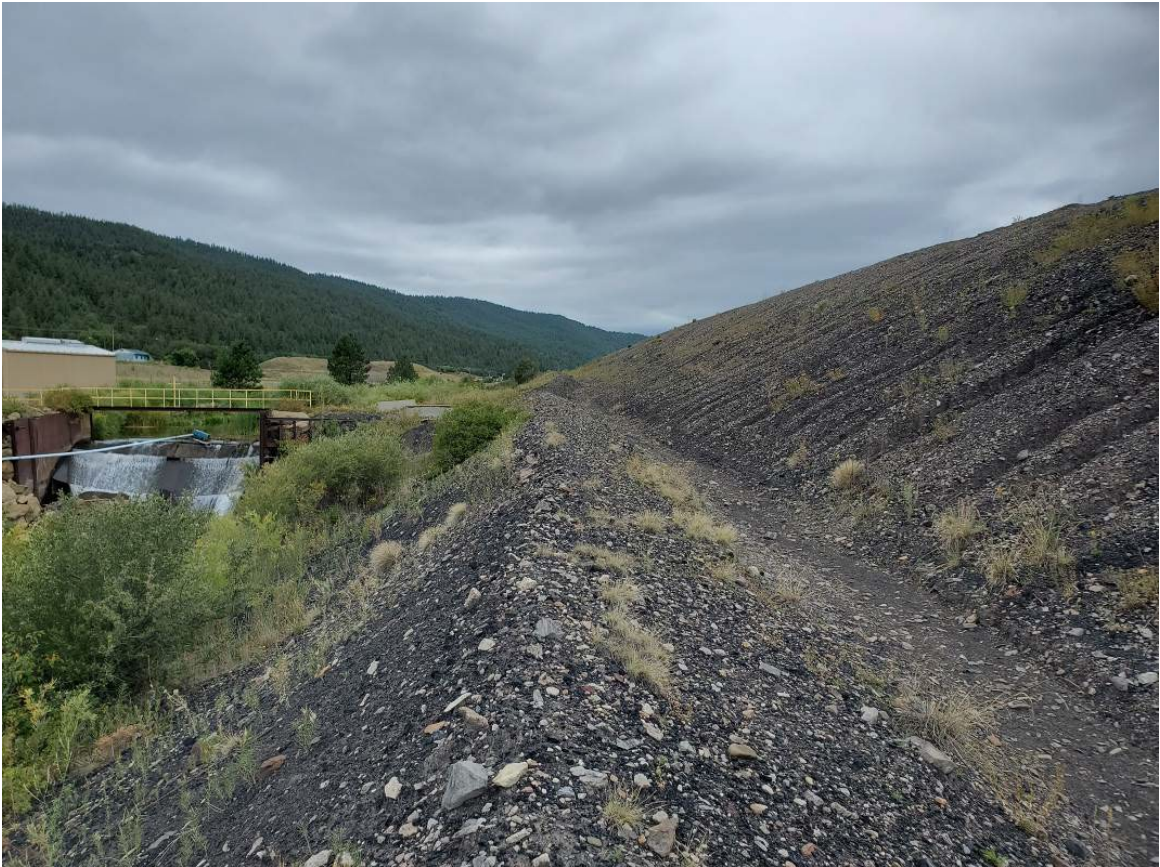
- The Division walked along the berm around the south side of DWDA #2 (Photo 1). The berm appeared to be stable and functional at the time of the inspection.

Photo 1: Bank along south side of DWDA #2.

- Ditch D14 leading into the basin from the south side is clear (see Photo 1 above).

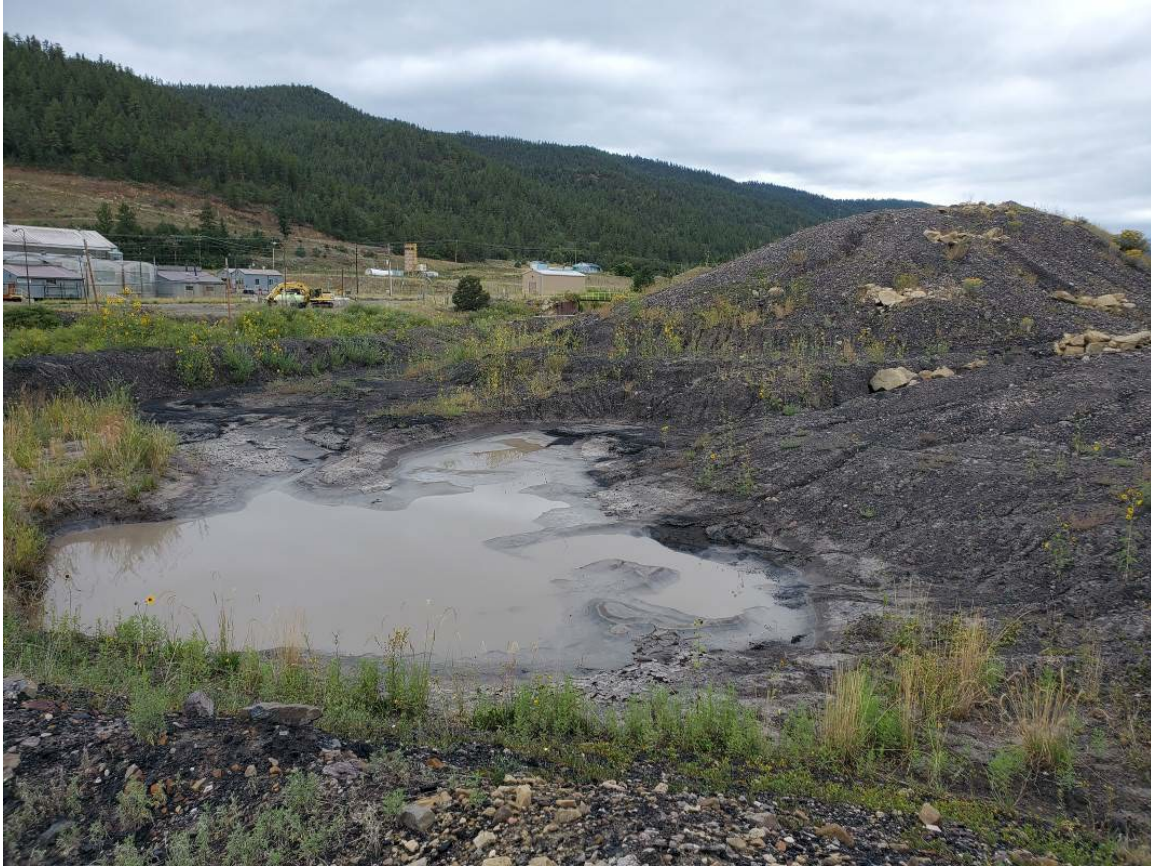
- The sediment basin at the east end of DWDA #2 held water at the time of the inspection (Photo 2). The berm around the basin appeared to be stable. The Operator shall monitor the check dams and clean them of sediment within the next few months. The check dams still appear to be functional at this time.

Photo 2: Sediment basin at southeast side of DWDA #2.

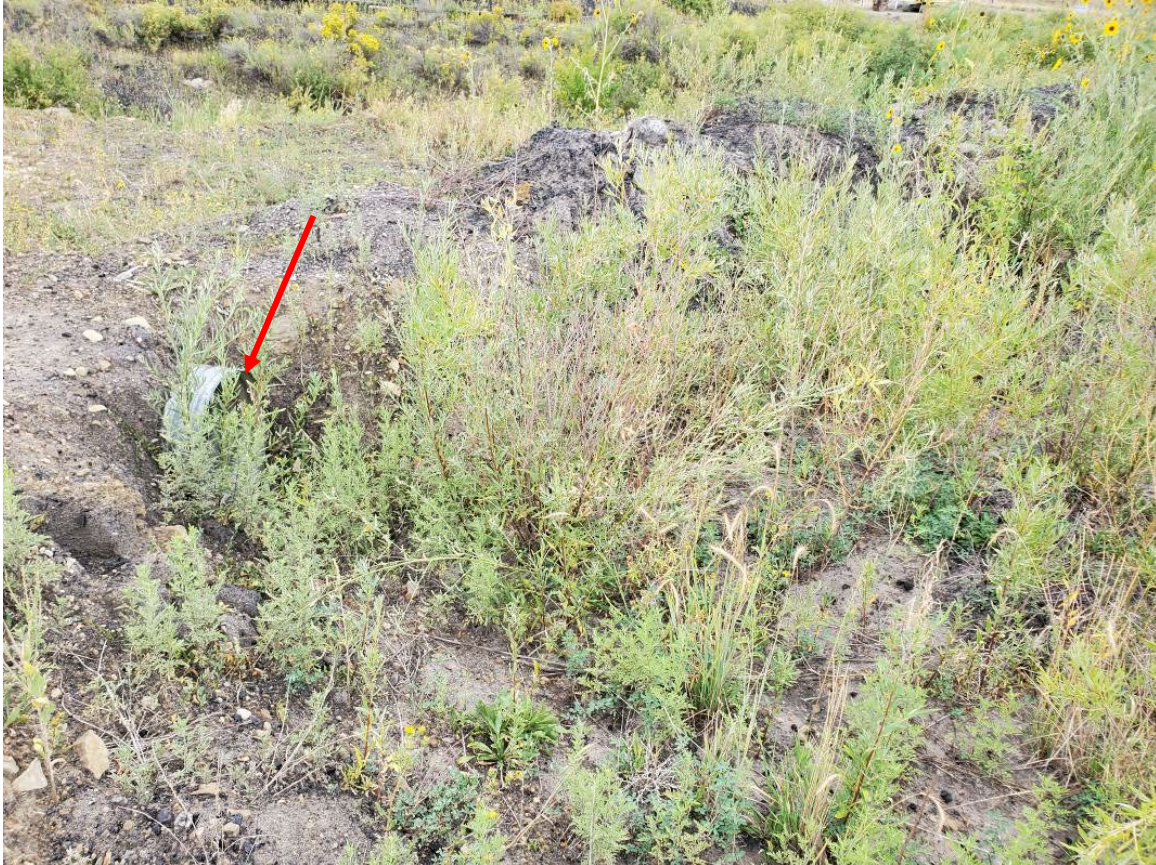
- Culvert C13 was free of obstructions. However, the vegetation in-front of C13 (Photo 3) should be cleared before next spring.

Photo 3: Culvert C13. The area directly in front of the culvert is clear. However, the vegetation surrounding the culvert should be cleared in the near future.

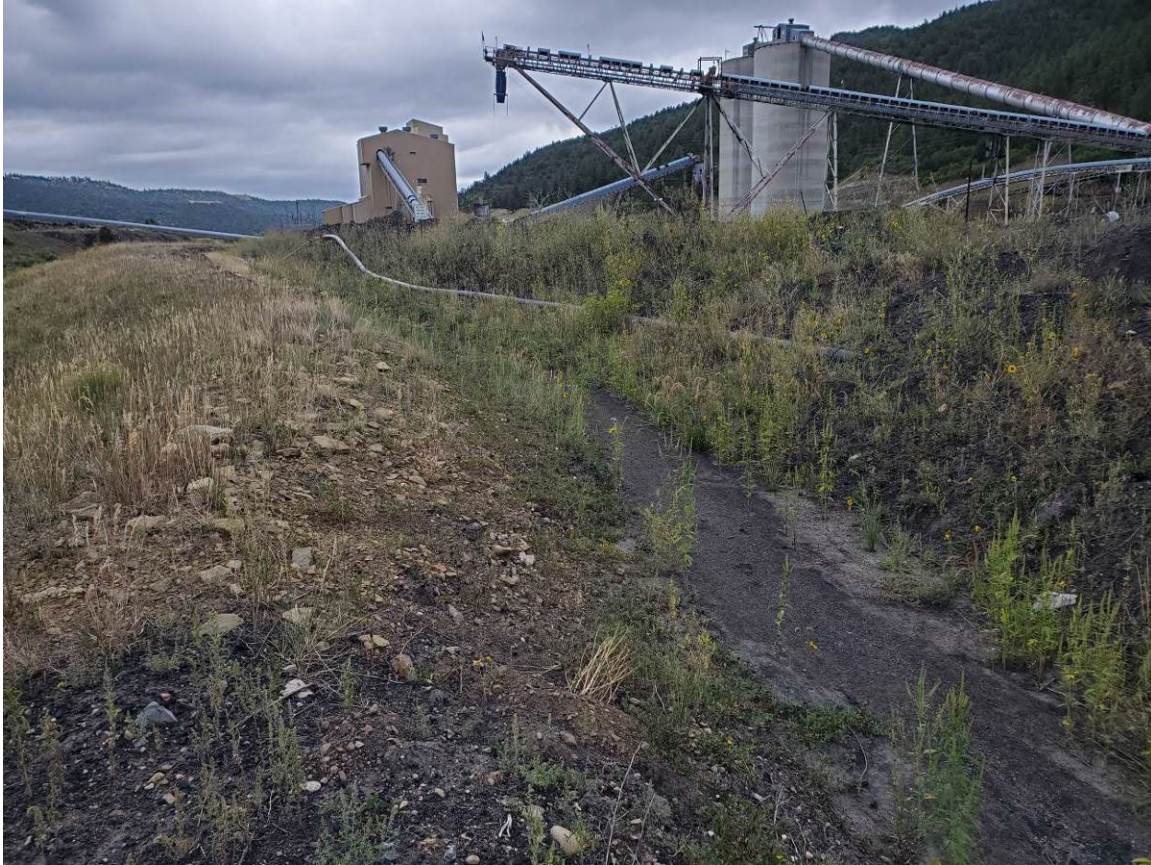
- Ditch D32 was clear and appears to be functioning adequately (Photo 4).

Photo 4: Looking east down D32

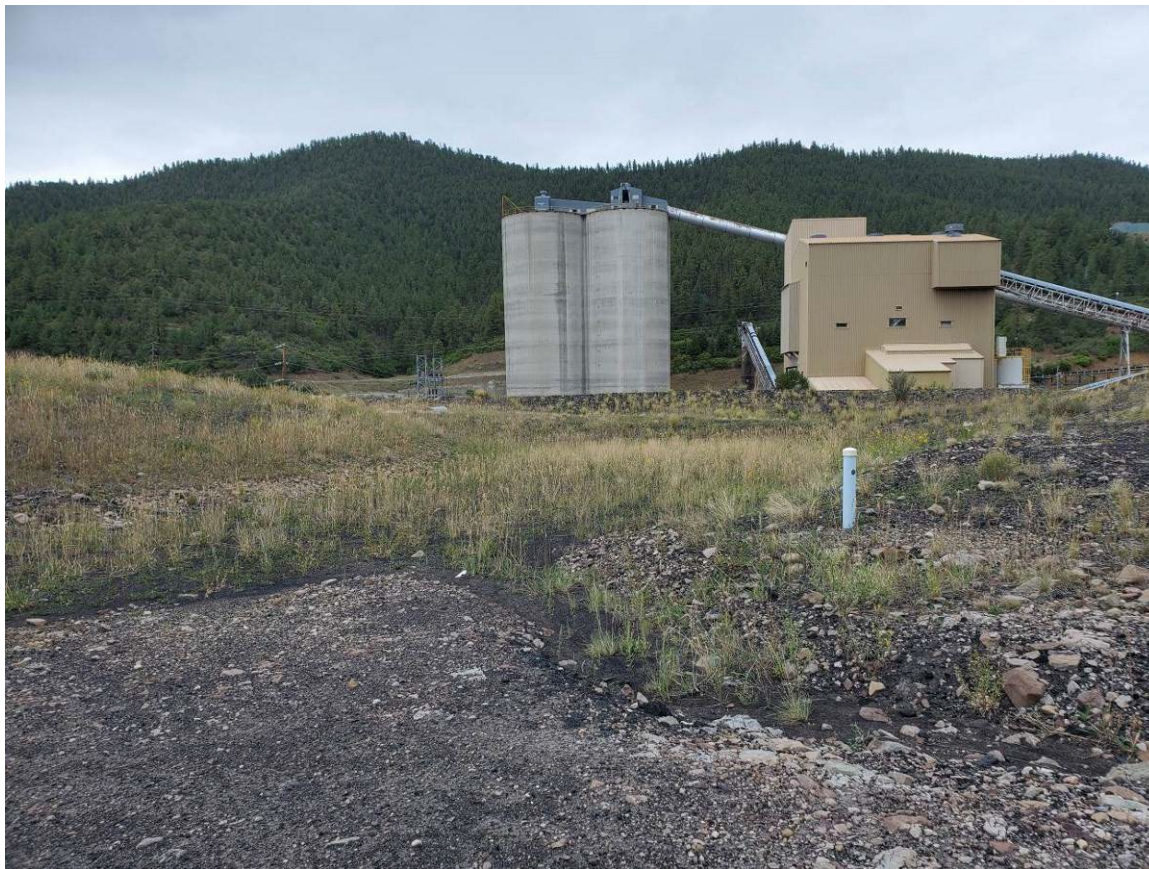
- Containment area #3 was dry. No signs of erosion were observed (Photo 5).

Photo 5: Containment Area 3

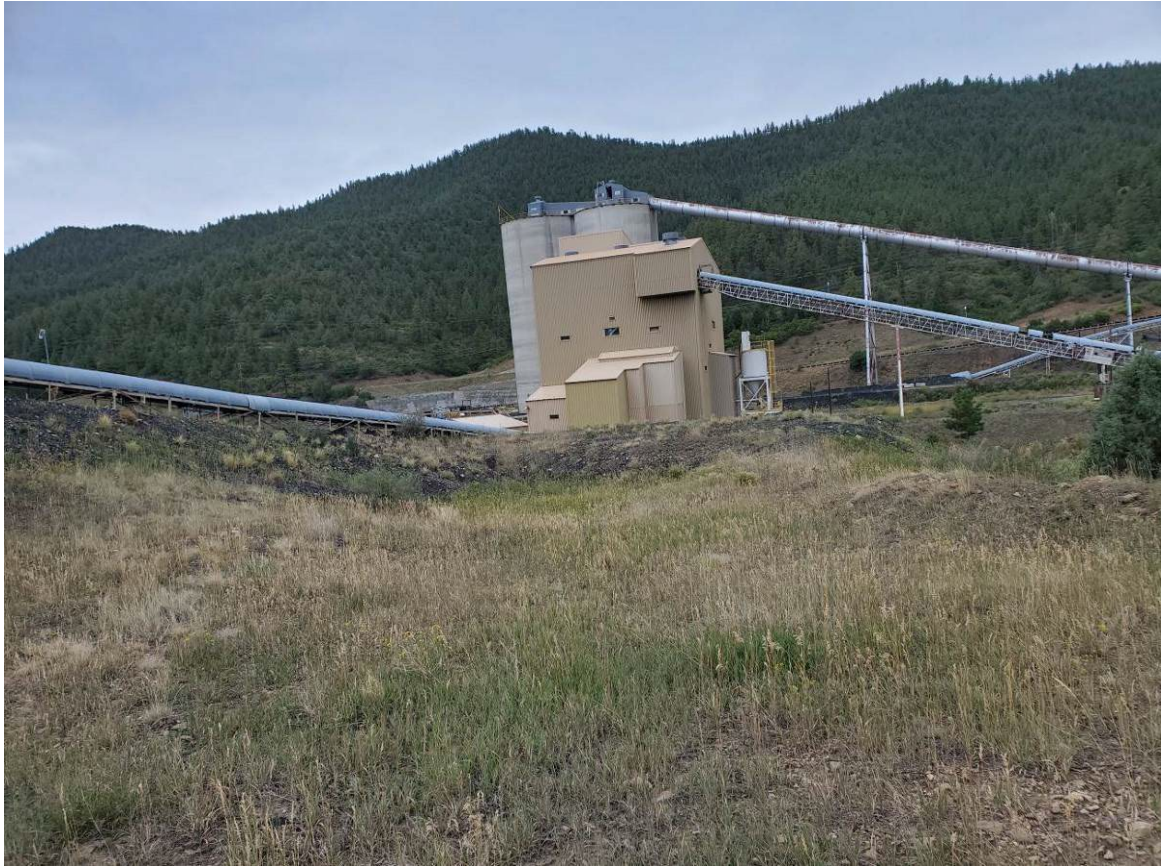
- Containment area #4 was dry. No signs of erosion were observed (Photo 6).

Photo 6: Containment Area

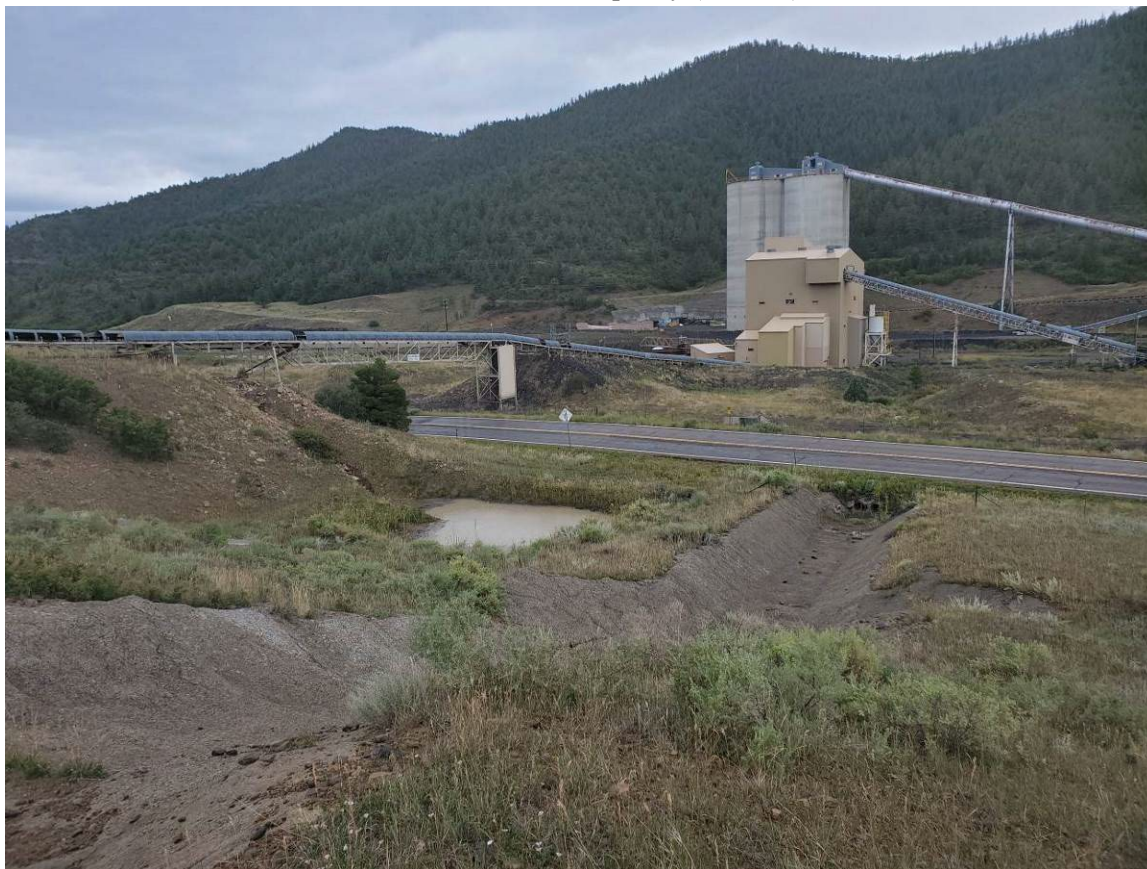
- Containment area #5 contains water and is below capacity (Photo 7).

Photo 7: Containment Area 5

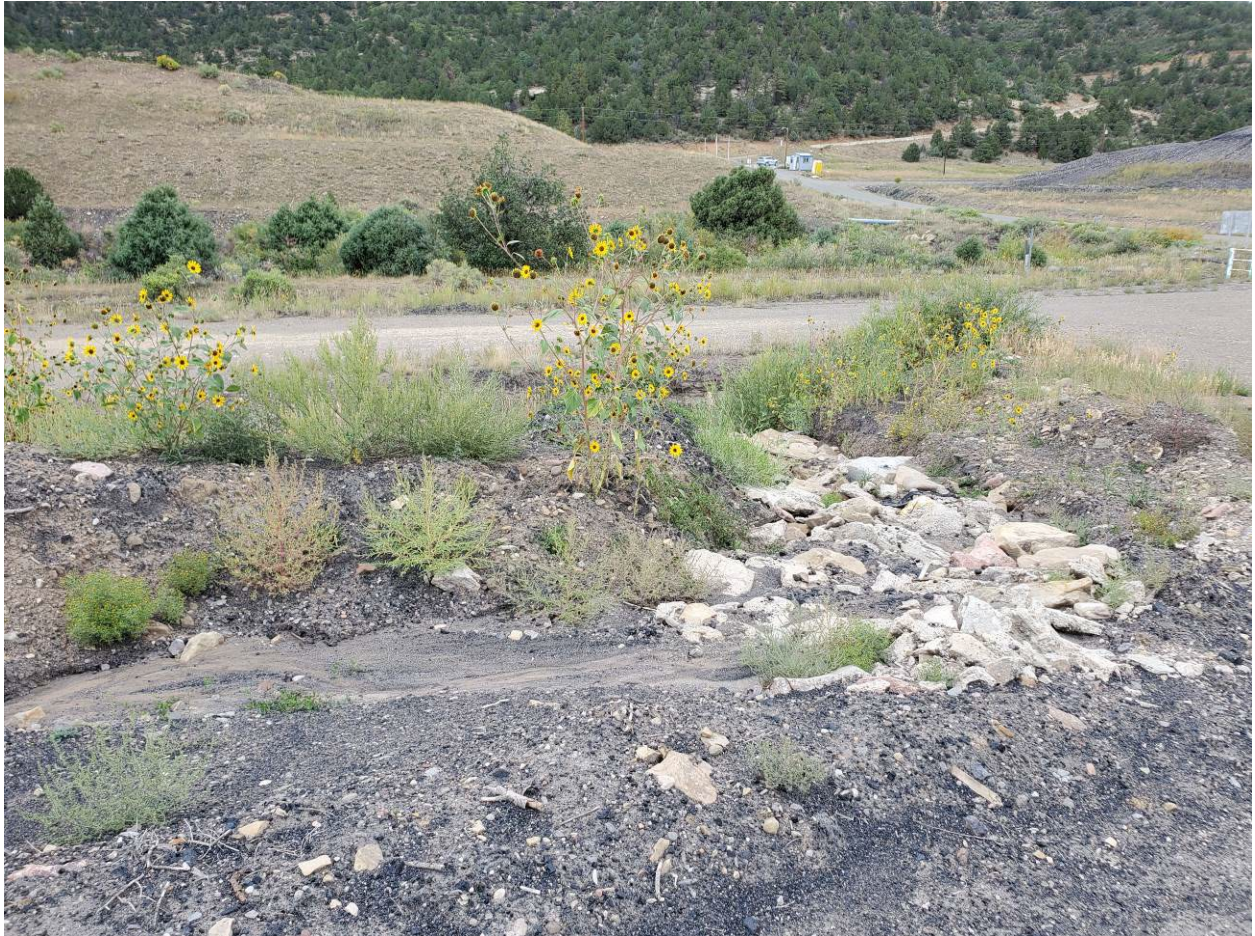
- The check dams located along the north side of the Soil Storage Area are beginning to fill with sediment (Photo 8). The Operator should monitor these check dams to ensure they continue to function adequately.

Photo 8: Check dam along northeast corner of the Soil Storage Area.

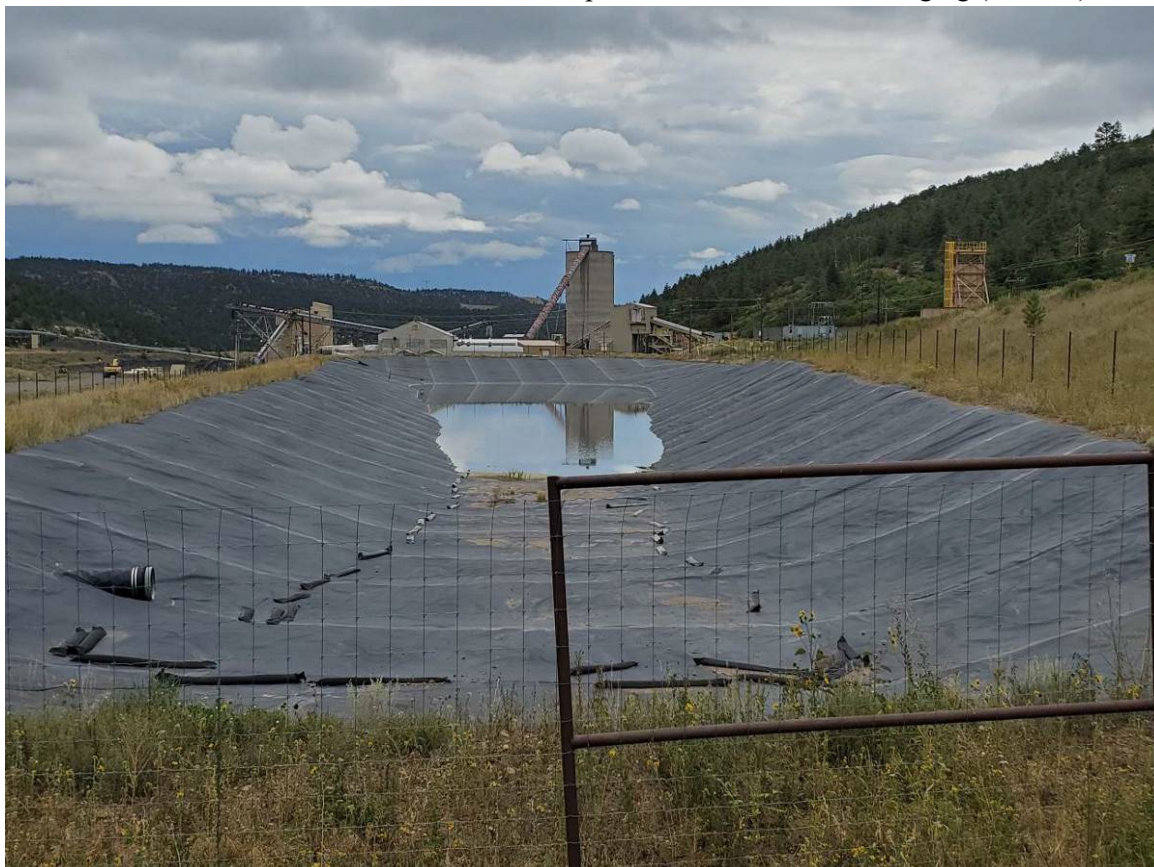
- Pond 001A held some water at the time of the inspection, and was not discharging (Photo 9).

Photo 9: Pond 001A

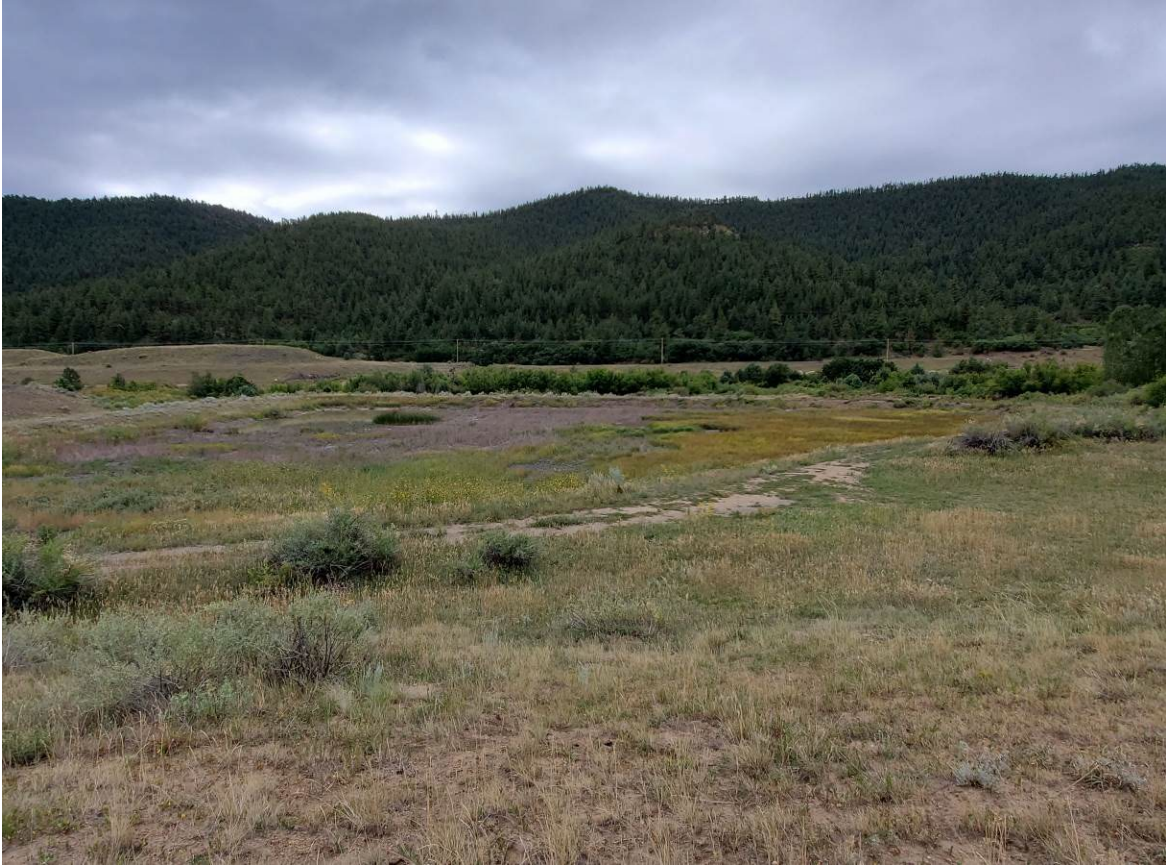
- Pond 004A contained a small amount of water, presumably being left over water pumped from Ponds 007a, 006a, and 08 (Photo 10). Pond 004A was not discharging. The bank appeared to be stable.

Photo 10: Looking at Pond 004A from the barbed wire fence, south of Highway 12. Water is mostly contained to the south-east corner of the pond.

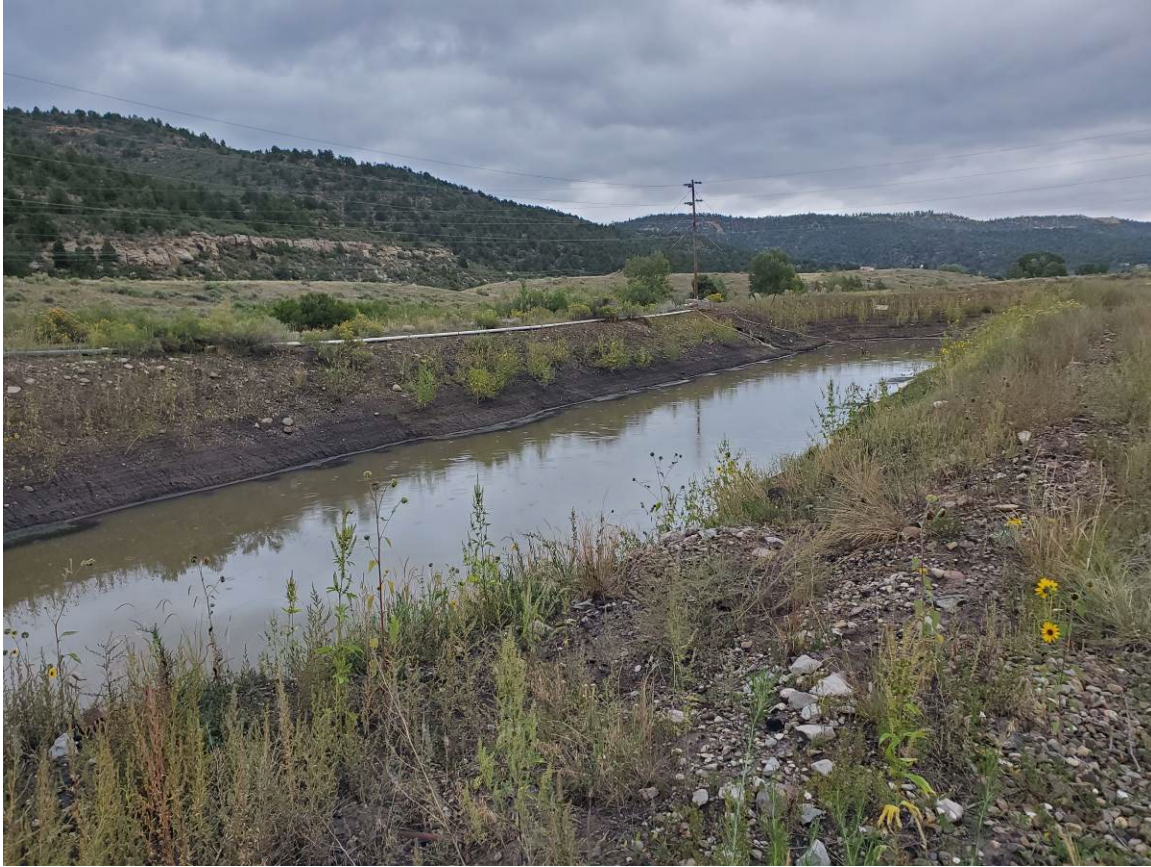
- Pond 006A contained some water at the time of the inspection (Photo 11). The banks of the pond appeared to be stable at this time.

Photo 11: Looking east at Pond 006A

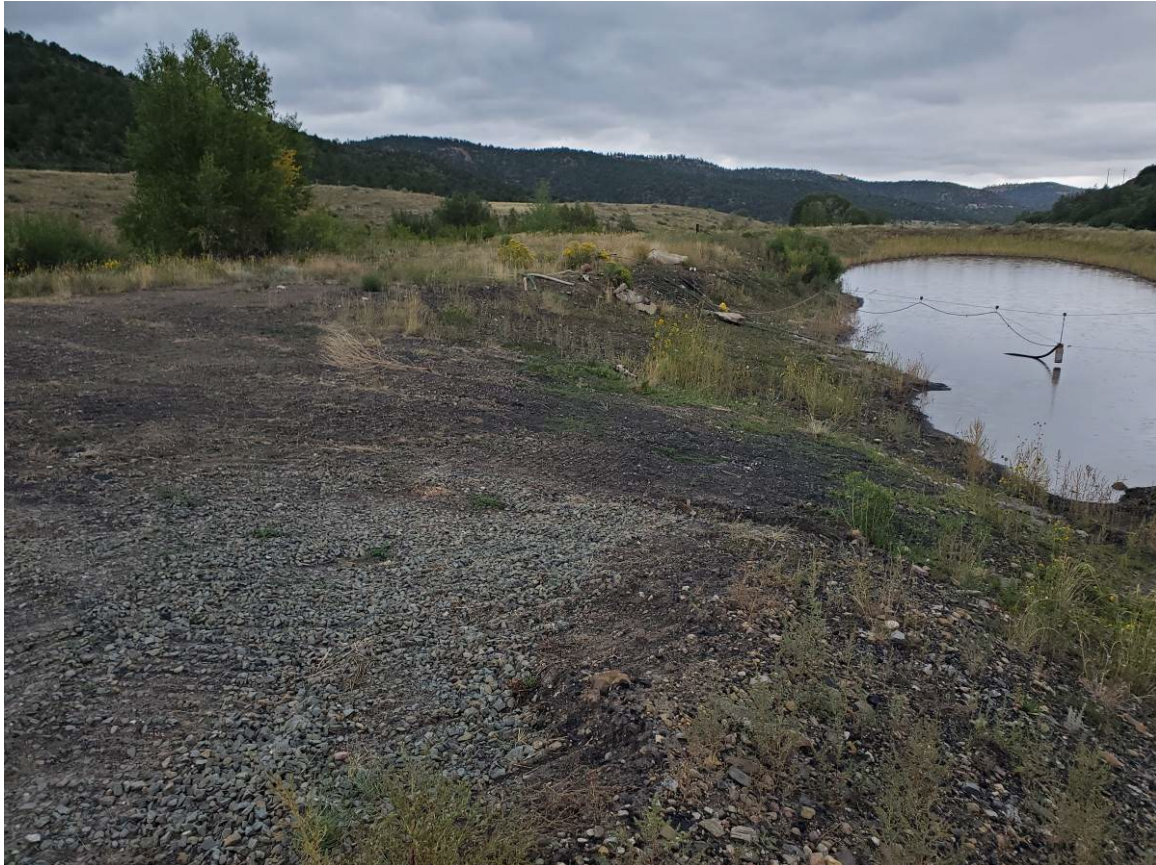
- Pond 007A contained a small amount of water but was not discharging. The emergency spillway was free of obstructions and the embankment appeared to be stable. In previous reports, the Division observed what seemed to be new erosion on the north-west side of the northern bank. This appears to have been repaired since the Division's August 2024 inspection (Photo 12).

Photo 12: Repaired bank along the north-west side of Pond 007A.

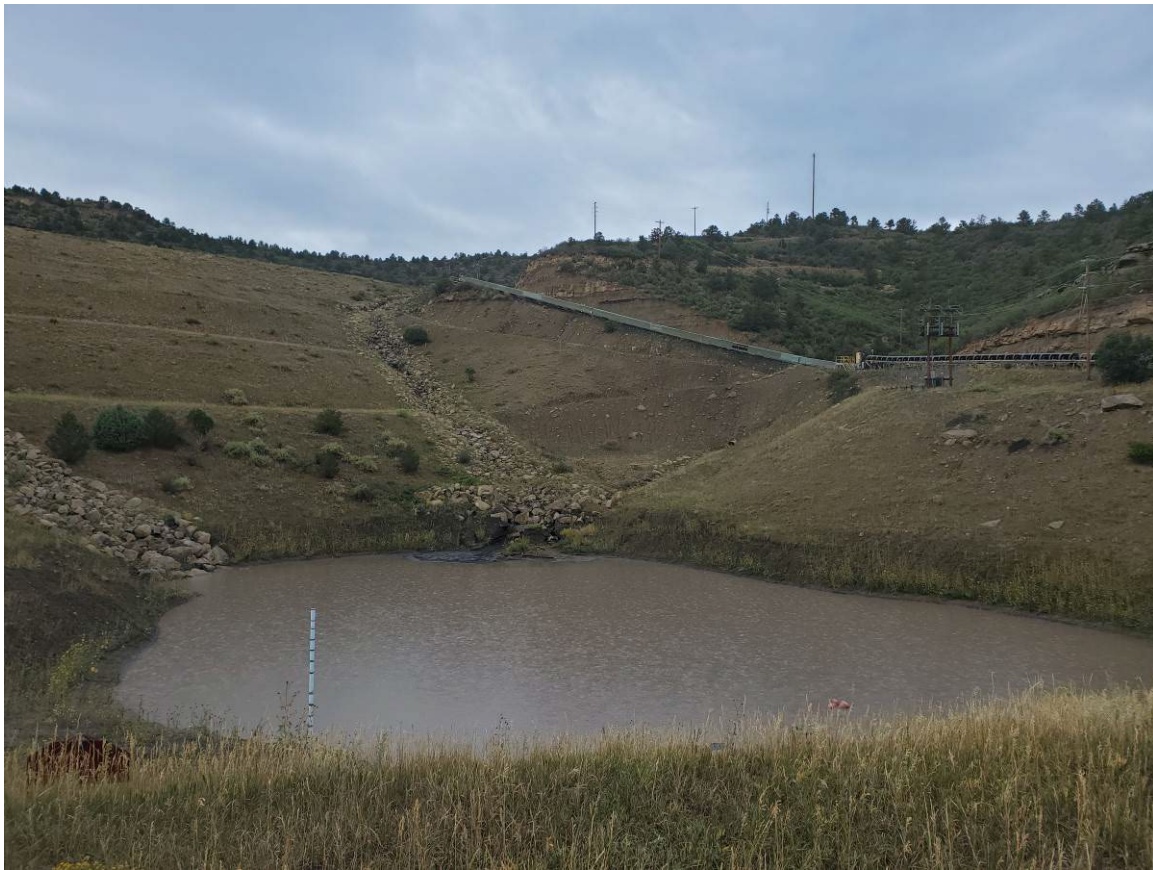
- Pond 08 contained some water and was well below its capacity (Photo 13). The spillways appeared clear, and the banks were stable. Pond 08 was not discharging.

Photo 13: Pond 008

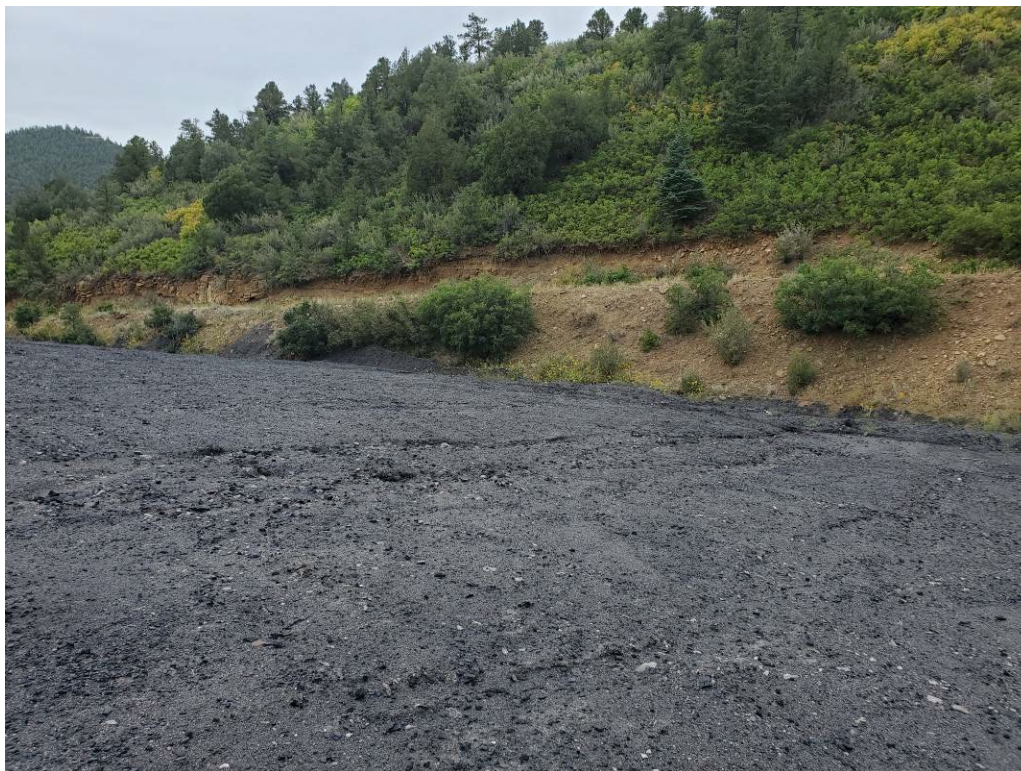
- The mine was idle at the time of the inspection. Therefore, the wash plant was not processing coal at the time of the inspection. The RDA appears to exhibit positive drainage at this time (Photo 14). The underdrains in the northeast and northwest corners appear to be clear of obstructions, and appear to be functioning as intended.

Photo 14: Positive drainage on the RDA.

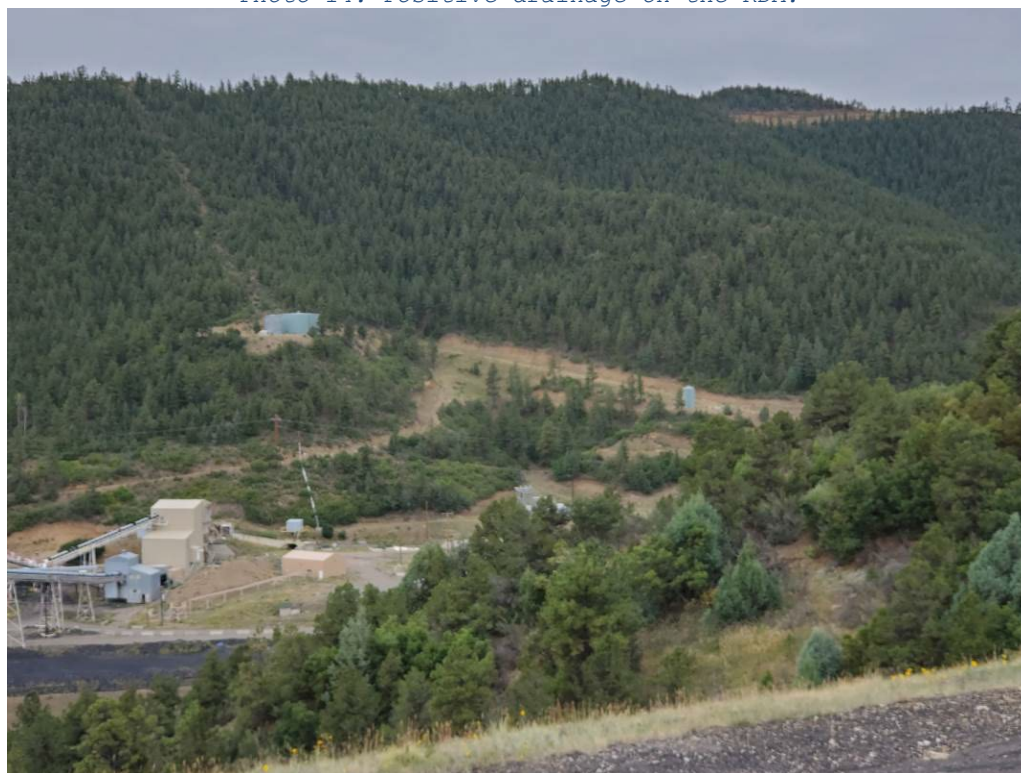
Photo 15: View of the unreachable portion of the south side of the permit, from the RDA.

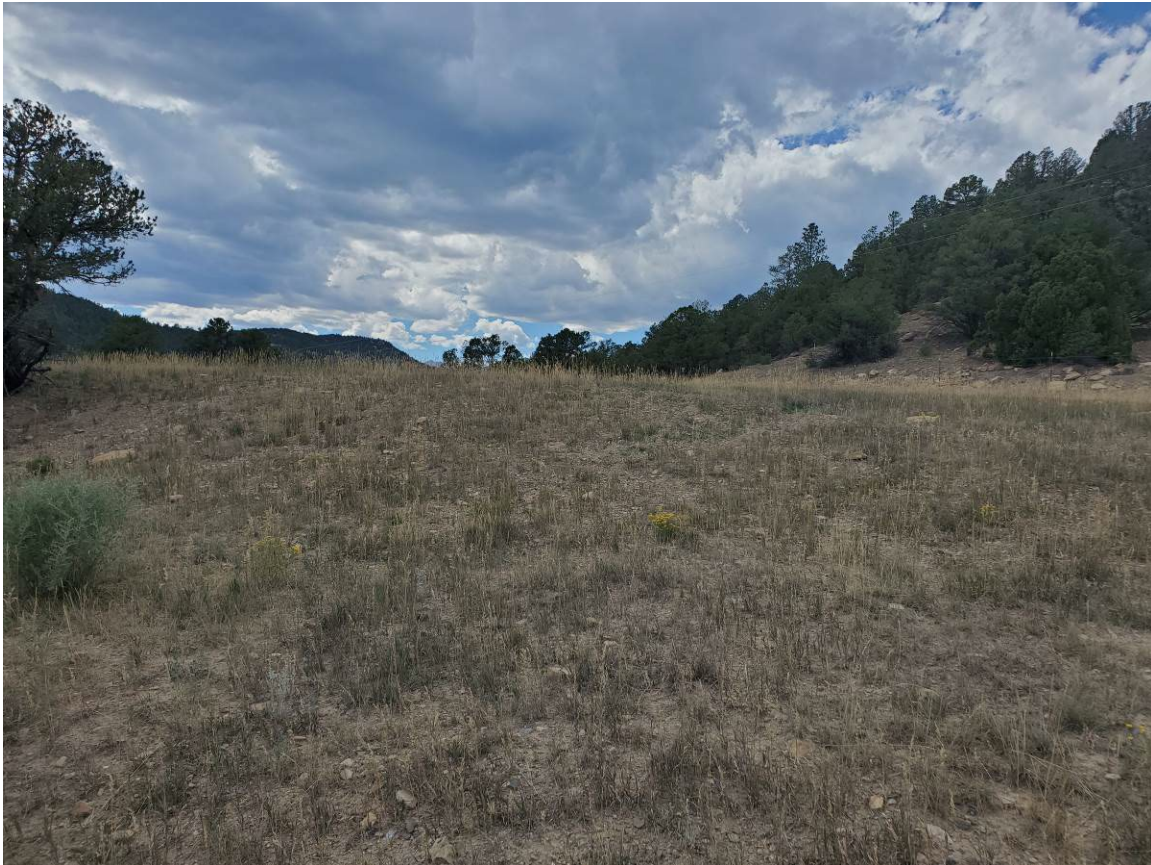
- During the Division's June 2024 inspection, it was noted that a lot more vegetation had established since the Division observed the area in November 2023, however there were still a few bare spots. During this September 2024 inspection, the vegetation cover seems to be recovering (Photo 16), but the Operator may want to assess the area to determine species diversity. The Operator is advised to monitor this area and consider re-seeding if necessary.

Photo 16: Establishment of some grasses in the Golden Eagle ventilation shaft area.

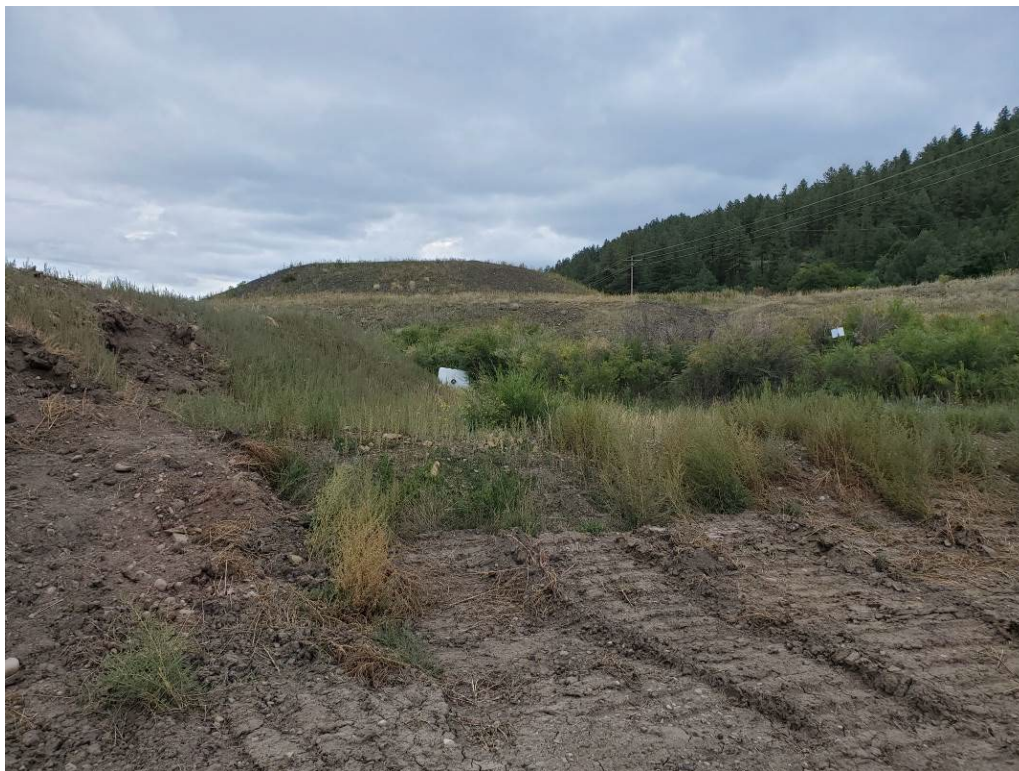
- The Portable Explosives and Chemical Storage area was overall stable. However, the Division observed what seemed to be an empty tank in the ditch to the east of the storage area (Photo 17). **The Operator shall remove this tank and place it within the storage area.** The broken empty/mostly empty storage containers noted in the Division's recent inspection reports appear to be grouped together in the north-west corner of the storage area (Photo 18). **The Operator shall either replace or remove any broken tanks.**

Photo 17: Tank blown into nearby ditch.

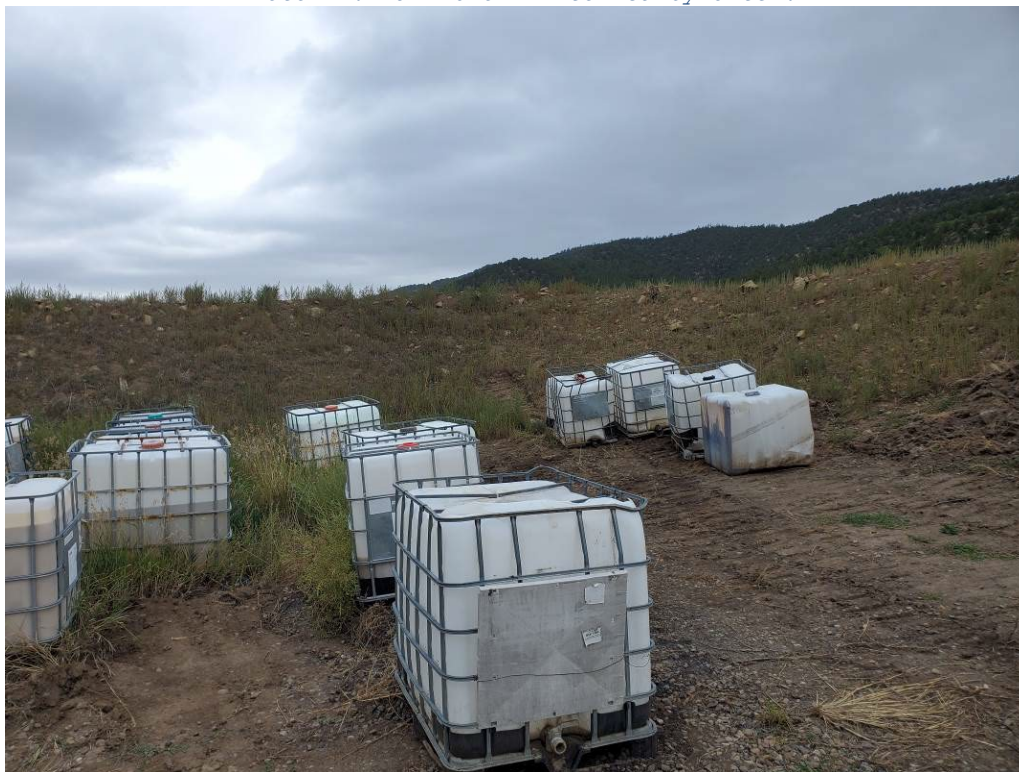
Photo 18: Broken and empty/mostly empty storage tanks in northwest corner of storage area.

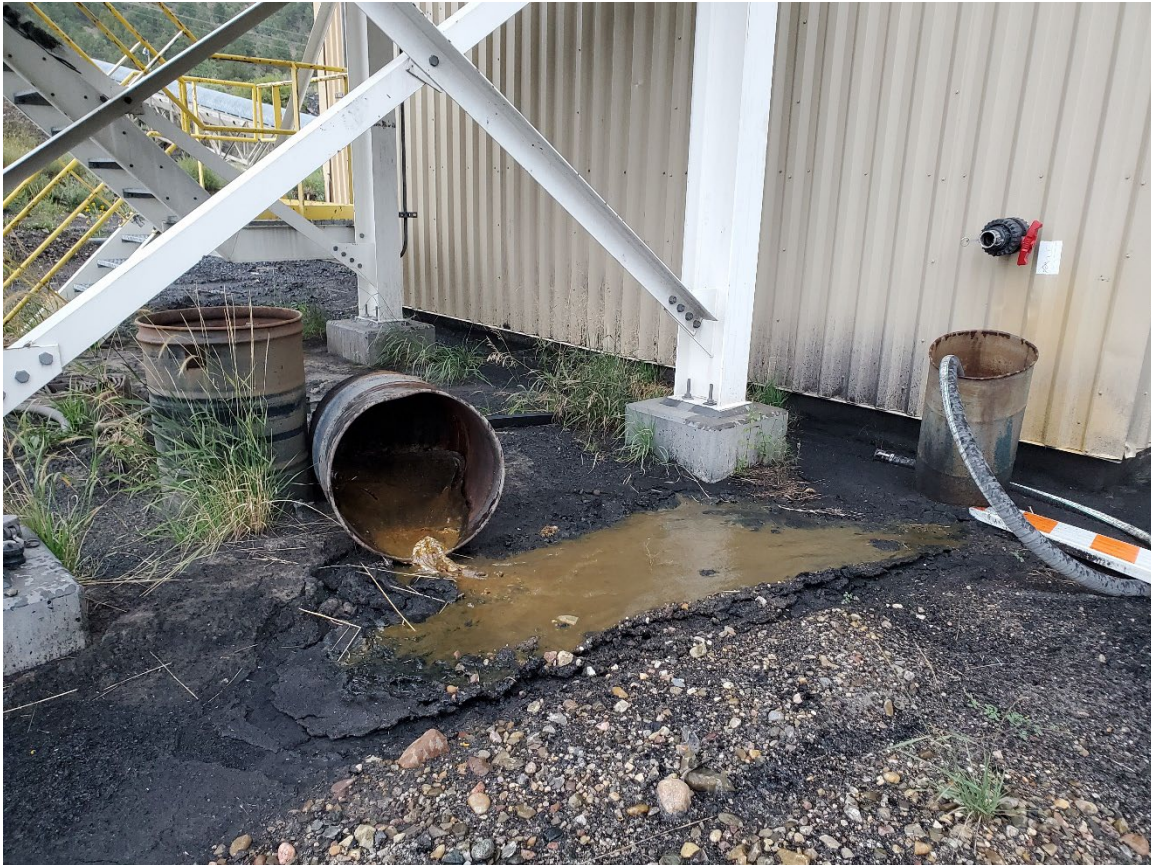
- Within the raw coal storage area, a few barrels were observed along the west side of the wash plant building (Photo 19). The Division believes the barrels may contain rusty storm water, but the substance is unknown. One of the barrels had fallen over, and its liquid contents have spilled onto the ground next to the wash plant building. **The Operator shall clean the spill and explain, to the Division, what material has been spilt.**

Photo 19: Tipped over barrel containing unknown substance within the raw coal processing area, west of the wash plant building.

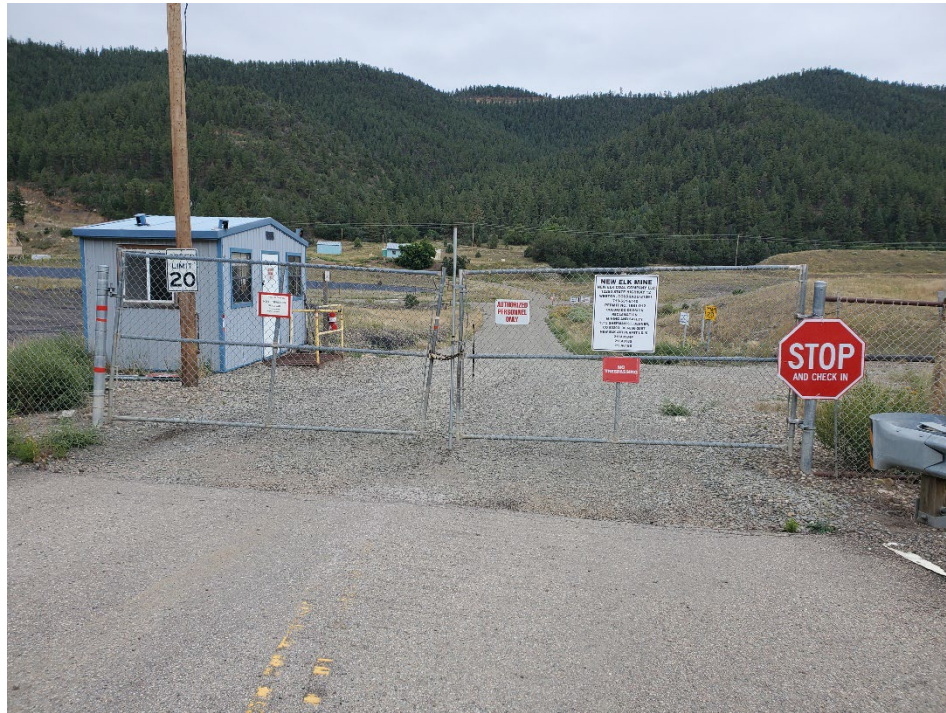
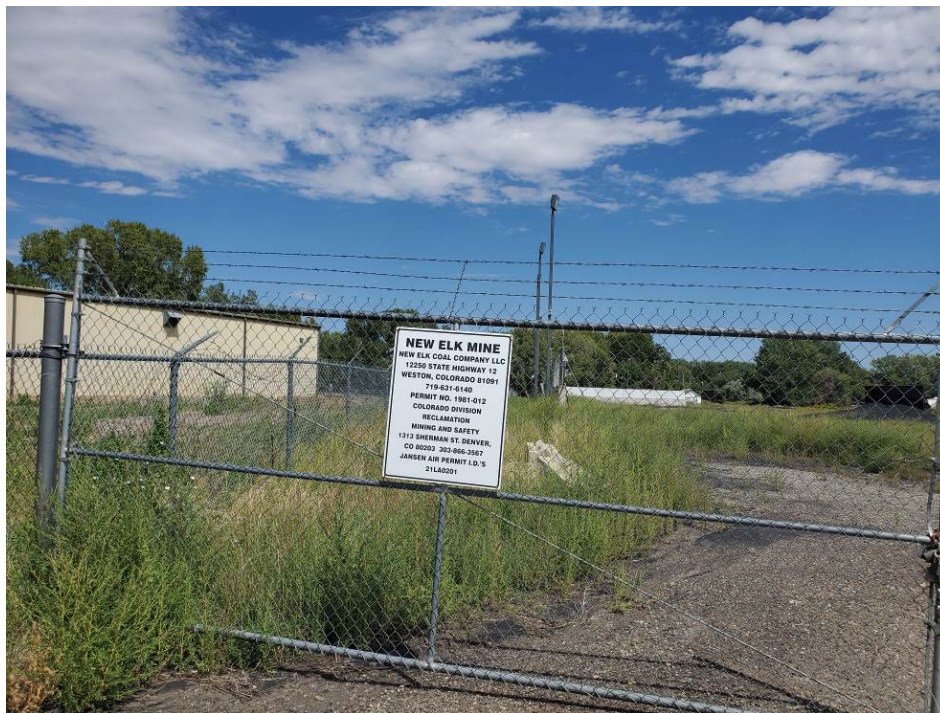
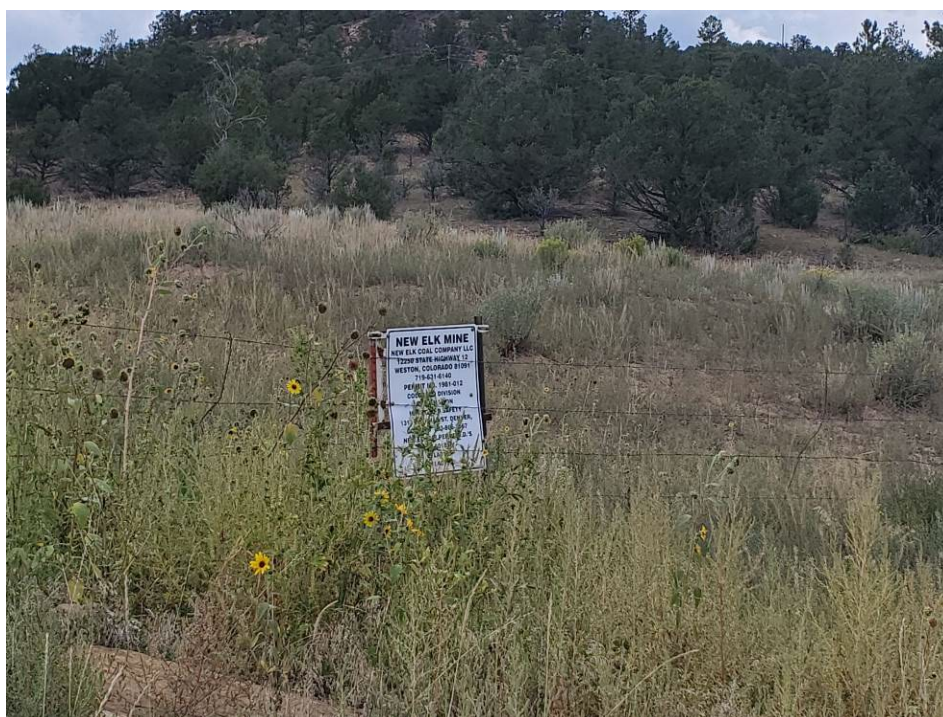
- A mine sign was posted at the main entrance to the New Elk mine site, the Golden Eagle ventilation shaft area, and at the Jansen Loadout in compliance with Rule 4.02 (Photo 20).

Photo 20: From top to bottom - Sign at entrance gate to site, sign at Jansen Loadout, sign at Golden Eagle Entrance.

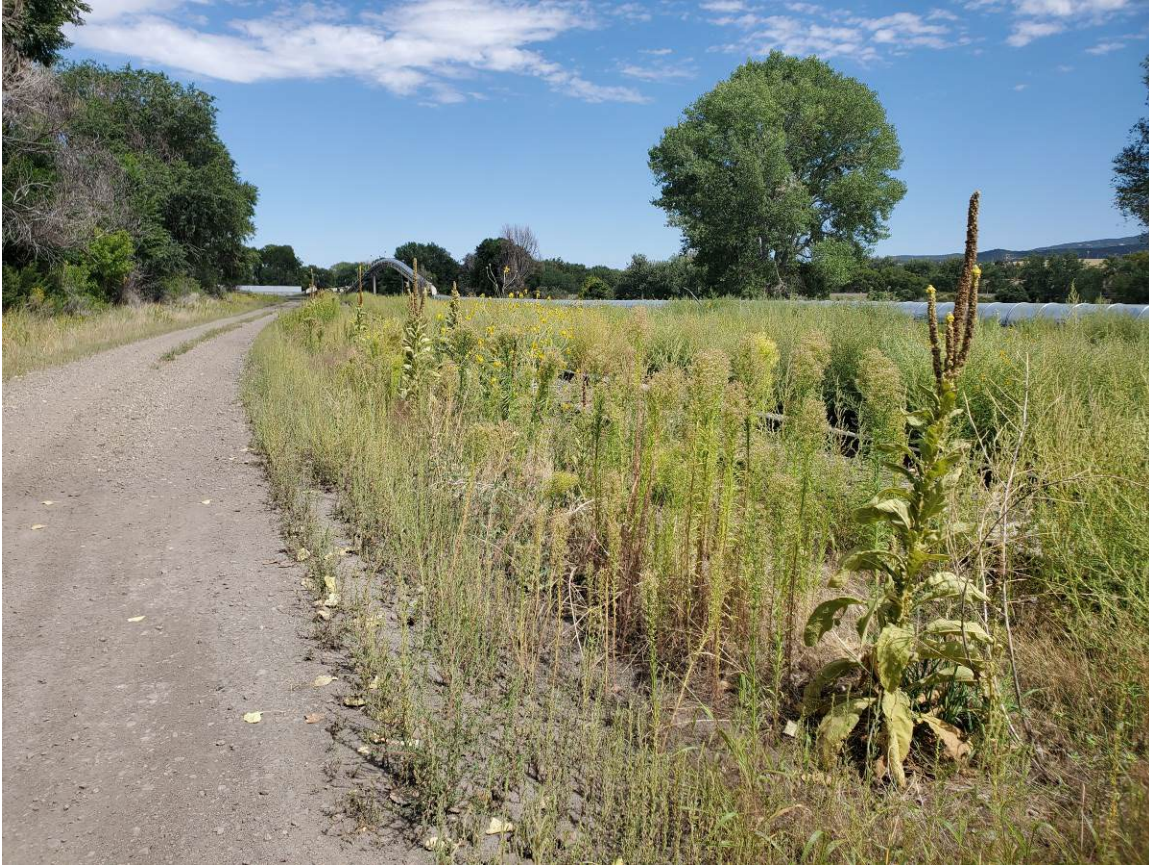
- The facilities at the Jansen Loadout were observed. All equipment on-site appears to be stable at the time of the inspection. However, the state listed noxious weed Mullein was observed along both north and south sides of the conveyor system and the rails (Photo 21). Pursuant to 4.15.1(5), **the Operator shall employ weed control methods to eradicate the weeds within the affected area and prevent further spread of weeds to nearby area**

Photo 21: Mullein along the north side of the conveyor.
