Inspection Report, New Elk Mine, C-1981-012

PERMIT INFORMATION

Permit Number: C-1981-012 Mine Name: New Elk Mine Operator: New Elk Coal Company, LLC Operator Address: Mr. John Terry 12250 Highway 12 Weston, CO 81091	County: Las Animas Operation Type: Underground Permit Status: Active Ownership: Private
	Operator Representative Present: None
Operator Representative Signature: (Field Issuance Only)

Inspection Start Date: September 4, 2024 Inspection Start Time: 13:43 Inspection End Date: September 5, 2024 Inspection End Time: 11:21	Inspection Type: Coal Complete Inspection Inspection Reason: Normal I&E Program Weather: Raining
Joint Inspection Agency: None	Joint Inspection Contacts:
Post Inspection Agency: None	Post Inspection Contacts:
Inspector(s): Amber M. Gibson	Inspector's Signature:

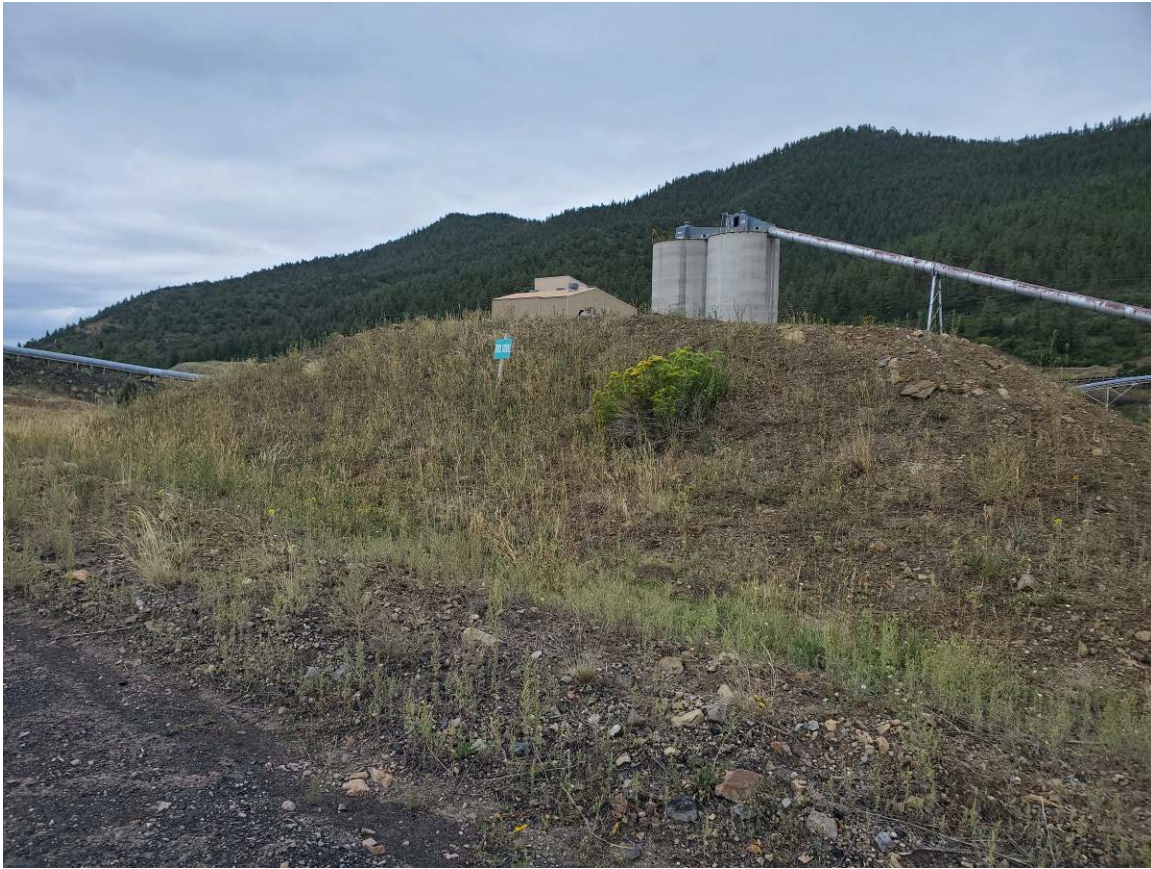
of Topsoil Stockpile #1), and was out of the way of on-going mining operations. Topsoil identification signs were observed on each pile (Photo 22).

Photo 22: Topsoil sign observed on topsoil pile #2.
