**MINERALS PROGRAM INSPECTION REPORT**  
**PHONE: (303) 866-3567**

<b>MINE NAME:</b> Marcovich Mining Resource	<b>MINE/PROSPECTING ID#:</b> M-2024-034	<b>MINERAL:</b> Sand and gravel	<b>COUNTY:</b> Weld
<b>INSPECTION TYPE:</b> Preoperation Inspection	<b>WEATHER:</b> Clear	<b>INSP. DATE:</b> August 28, 2024	<b>INSP. TIME:</b> 09:00
<b>OPERATOR:</b> Asphalt Specialties Co., Inc.	<b>OPERATOR REPRESENTATIVE:</b> Greg Geras and Ben Langenfeld	<b>TYPE OF OPERATION:</b> 112c - Construction Regular Operation	
<b>REASON FOR INSPECTION:</b> Preoperation Inspection	<b>BOND CALCULATION TYPE:</b>	<b>BOND AMOUNT:</b>	
<b>DATE OF COMPLAINT:</b> NA	<b>POST INSP. CONTACTS:</b> None	<b>JOINT INSP. AGENCY:</b> None	
<b>INSPECTOR(S):</b> Nikie Gagnon	<b>INSPECTOR'S SIGNATURE:</b>

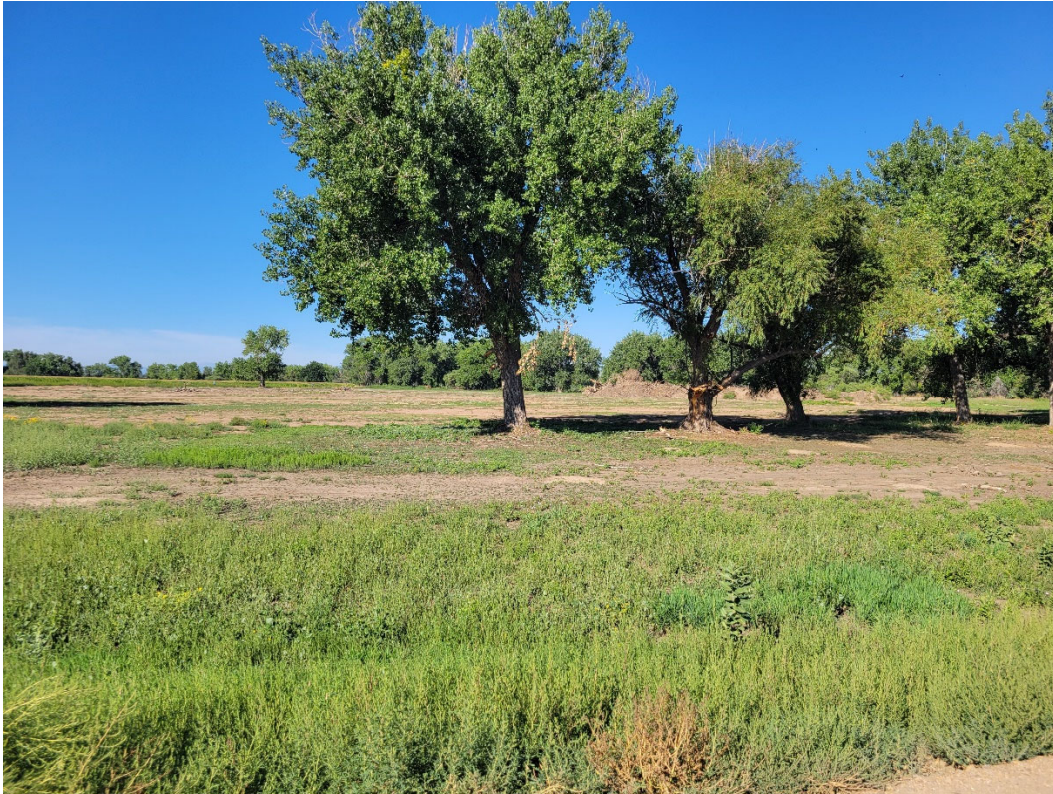
Photo 1: Looking south from the access road in the center of the site.

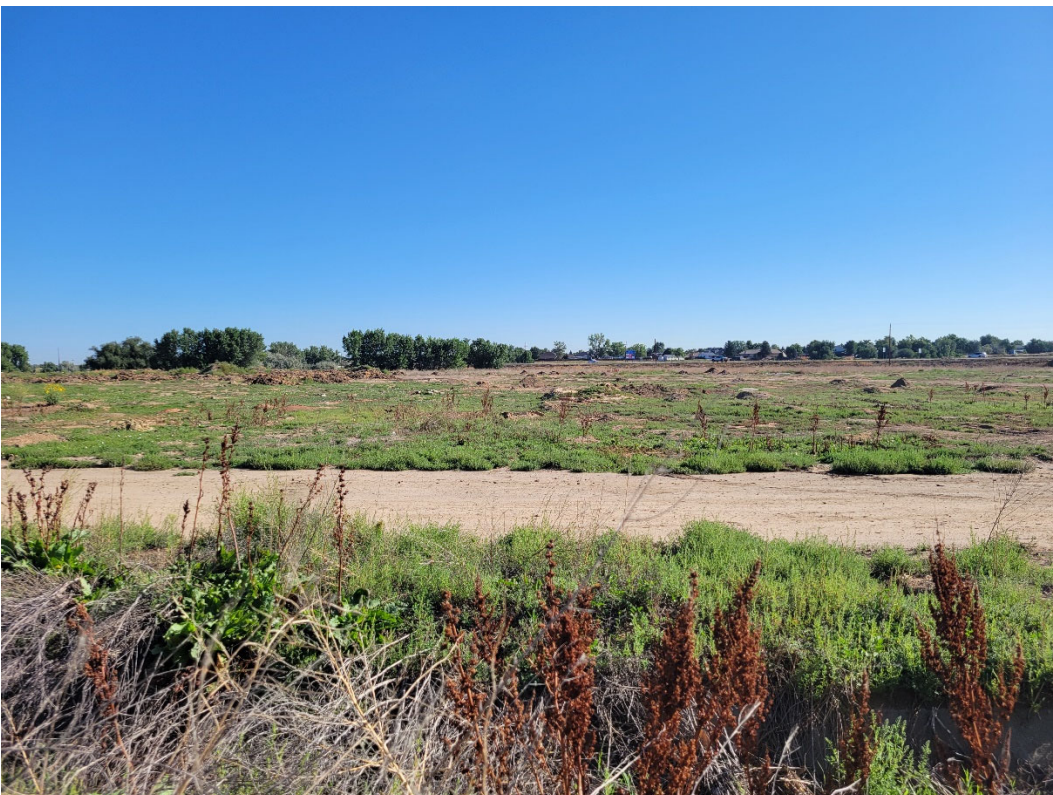
The topography of the proposed site is a relatively flat pasture adjacent to the South Platte River. Cottonwood trees dot the landscape along the west and south sides of the permit area. The site is sparsely vegetated with pasture grasses. The Division observed weedy vegetation, bare ground, and dirt pushed into piles throughout the site. Recently cut cottonwood limbs were observed indicating some vegetation clearing is occurring on site. Prairie dog colonies were observed on the north end of the permit area.

Photo 2: Looking north end from the access road in the center of the site. Prairie dog colonies observed here.

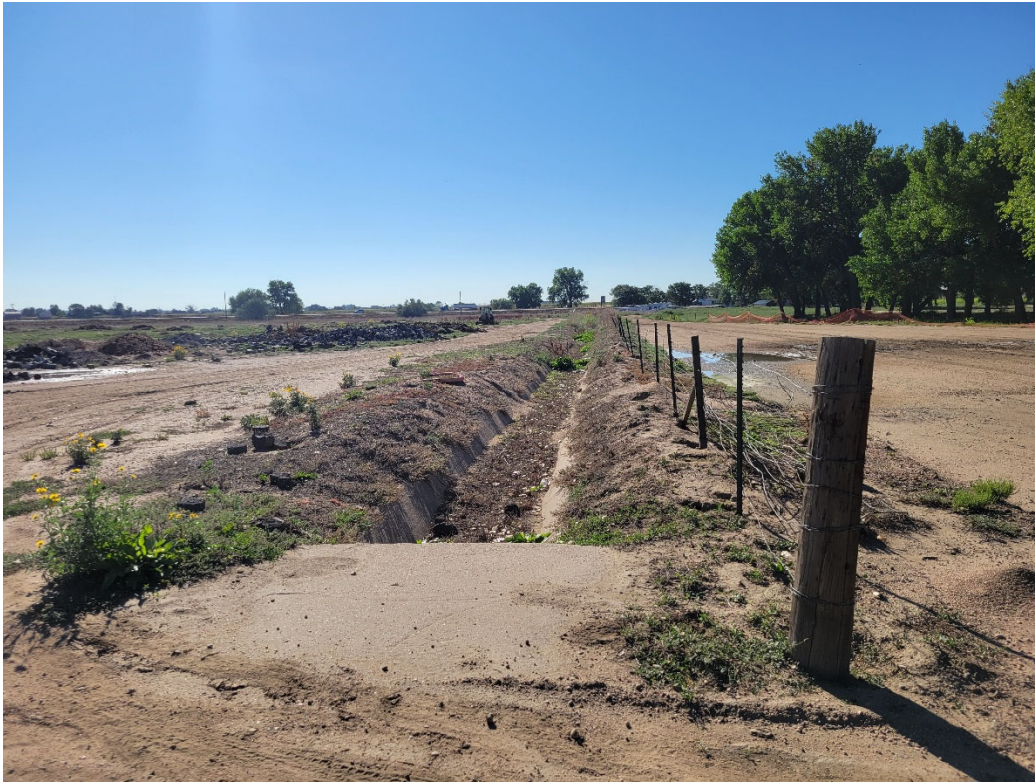
A concrete irrigation ditch was observed in the center of the site running east to west terminating in a one-acre pond on the west end in the northwest corner of the permit area. During this inspection, Mr. Langenfeld indicated the shallow groundwater pond is connected to the South Platte River. An irrigation ditch flowing from the east will be rerouted to the southern boundary of the permit area. During the inspection, the applicant pointed out two groundwater monitoring wells, one in the northwest corner, and one on the eastern side of the permit area.

Photo 3: Looking east at the concrete lined irrigation ditch in the center of the permit area.

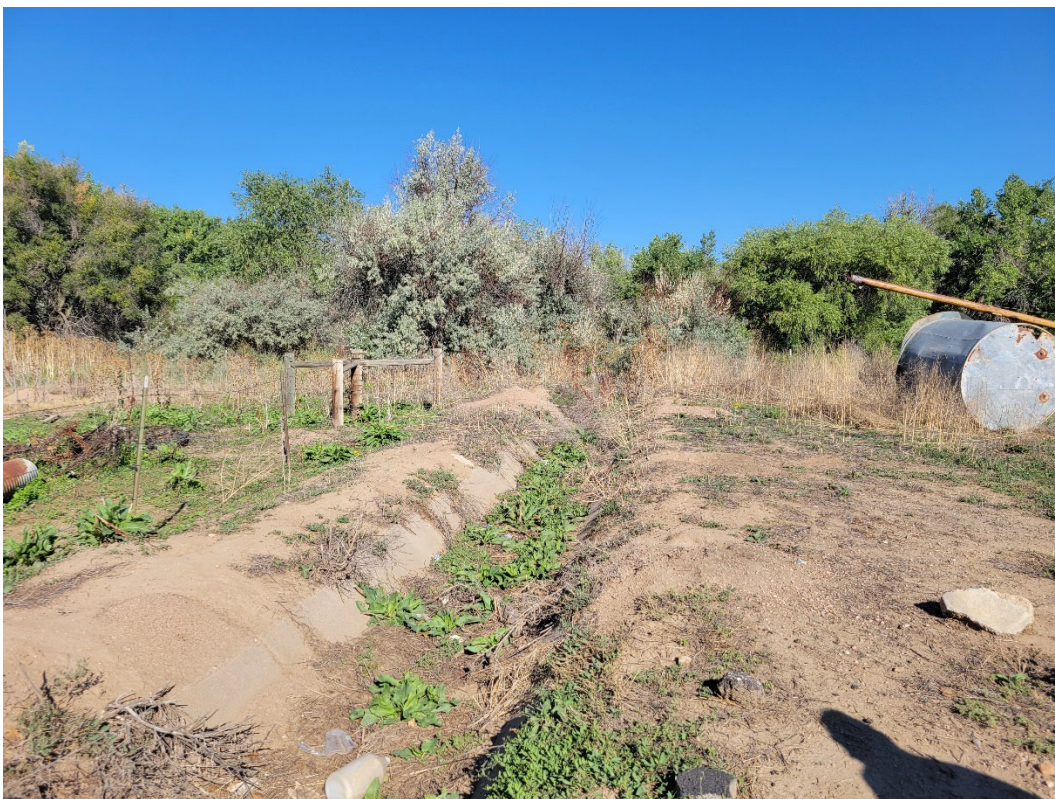
Photo 4: Looking west at the irrigation ditch where it discharges to a pond in the northwest corner of the site.

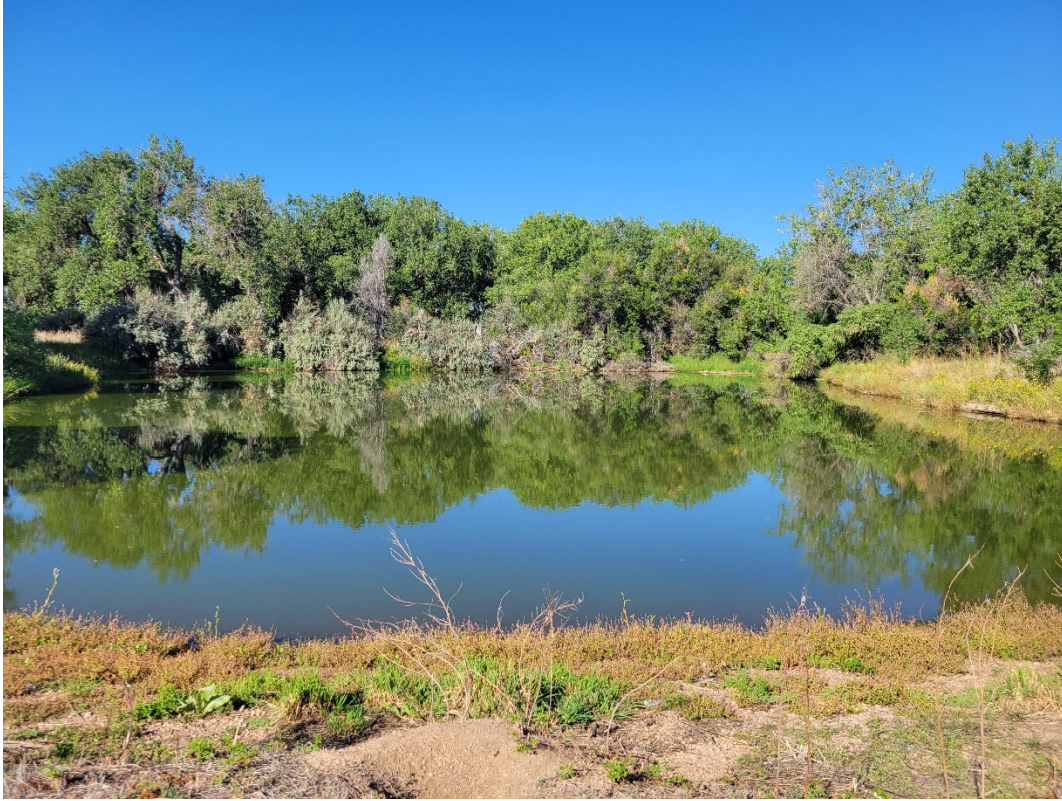
Photo 5: Looking at the groundwater pond in the northwest corner of the permit area.

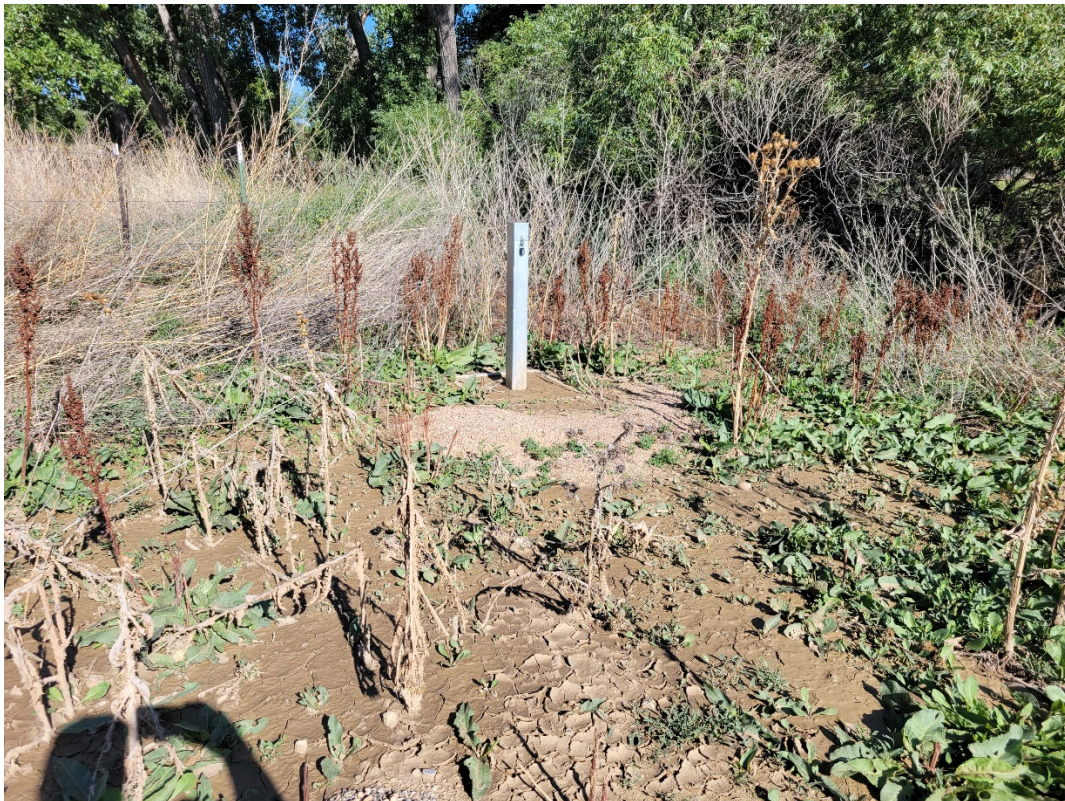
Photo 6: Groundwater monitoring well in the northwest corner of the permit area.

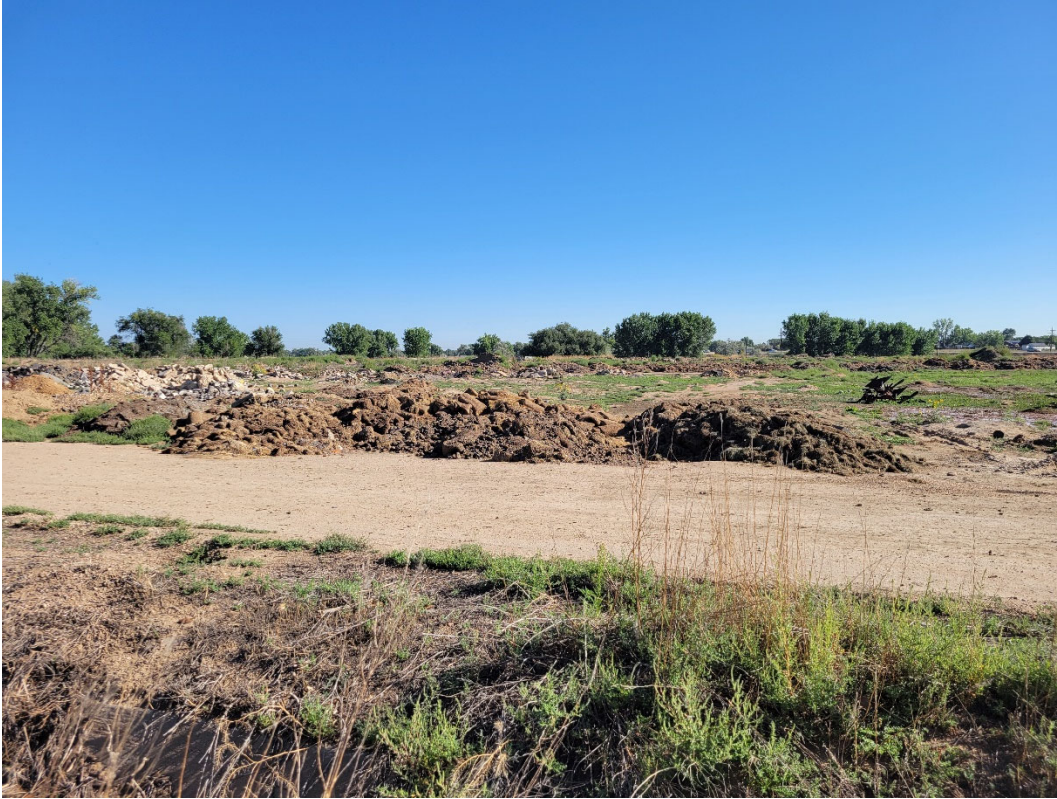
Photo 7: Looking dirt and debris piles on the northern side of the permit area.

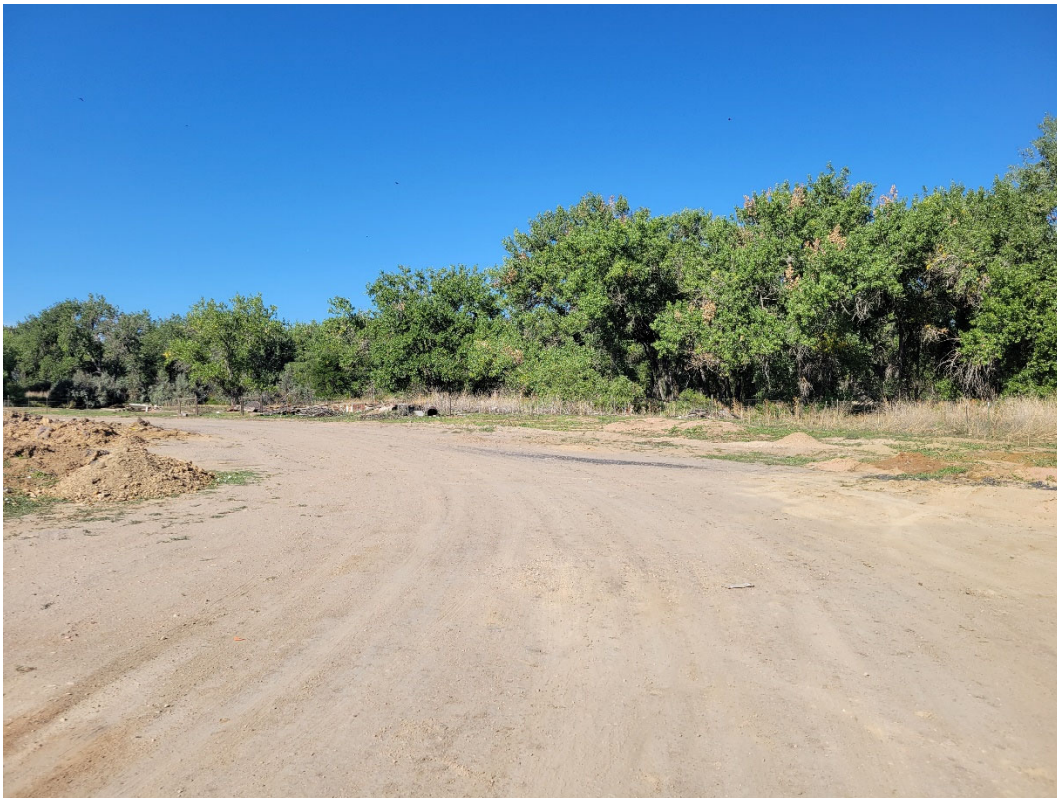
Photo 8: Looking south at the cottonwood canopy that runs along the entire western side of the permit area.

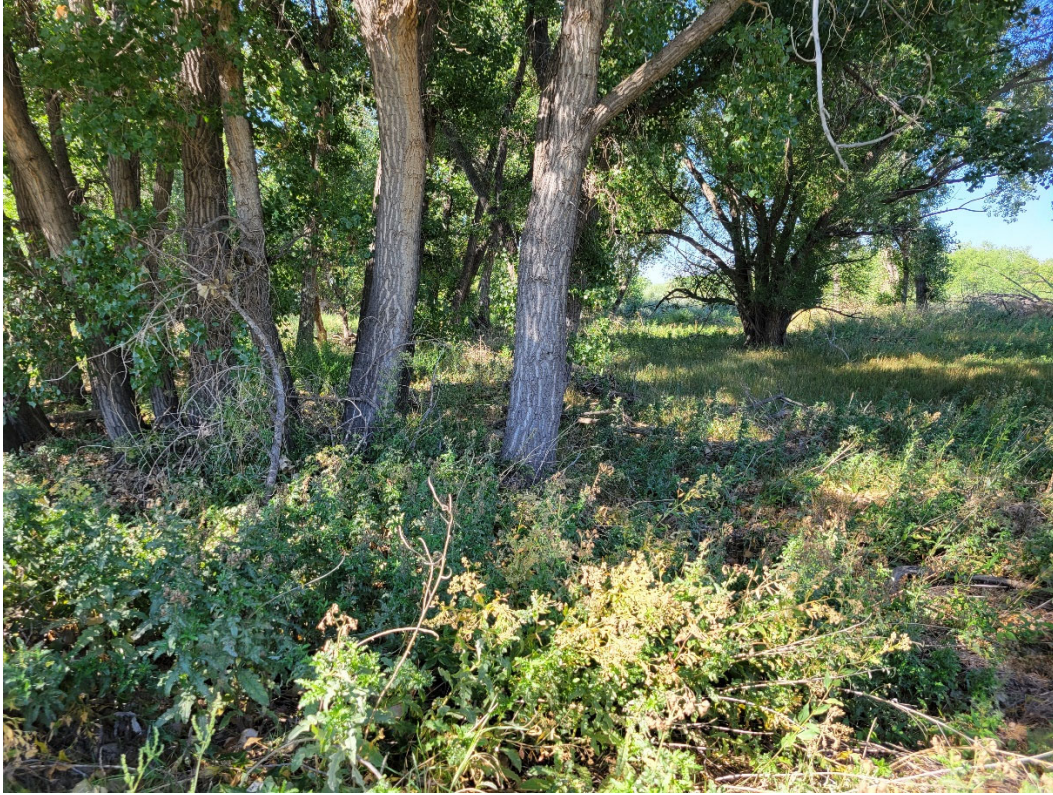
Photo 9: Looking west within in the cottonwood canopy.

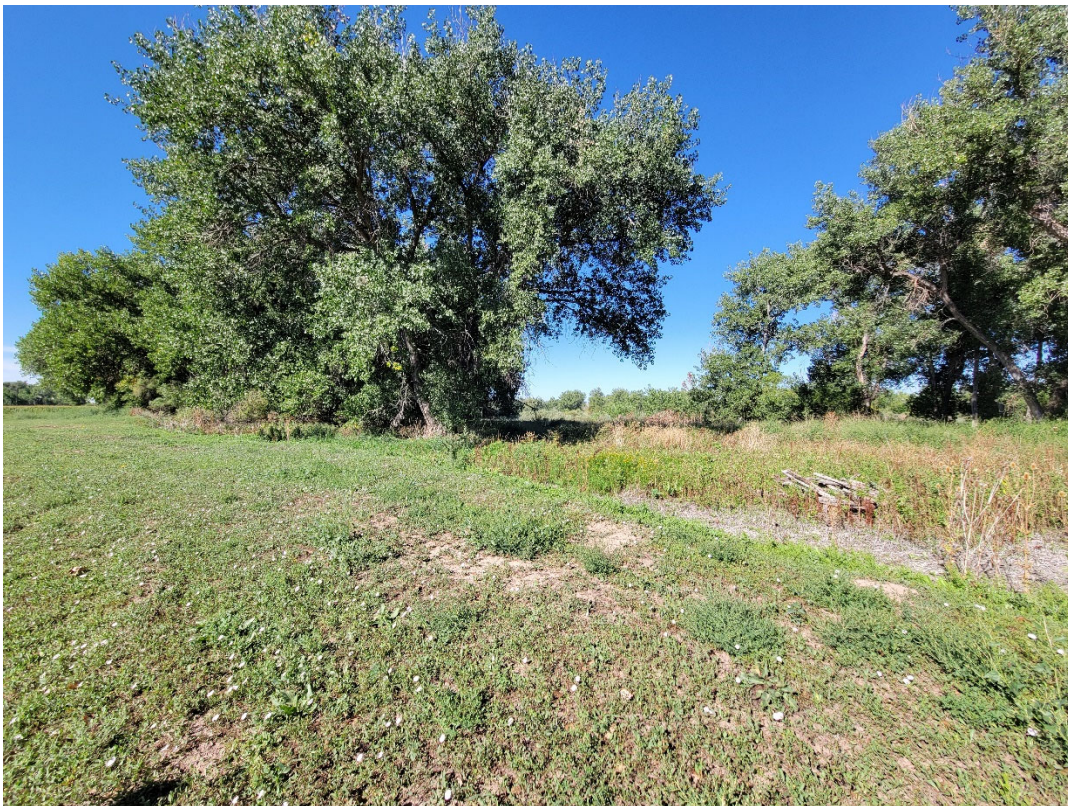
Photo 10: Looking towards the southwest corner of the permit area.

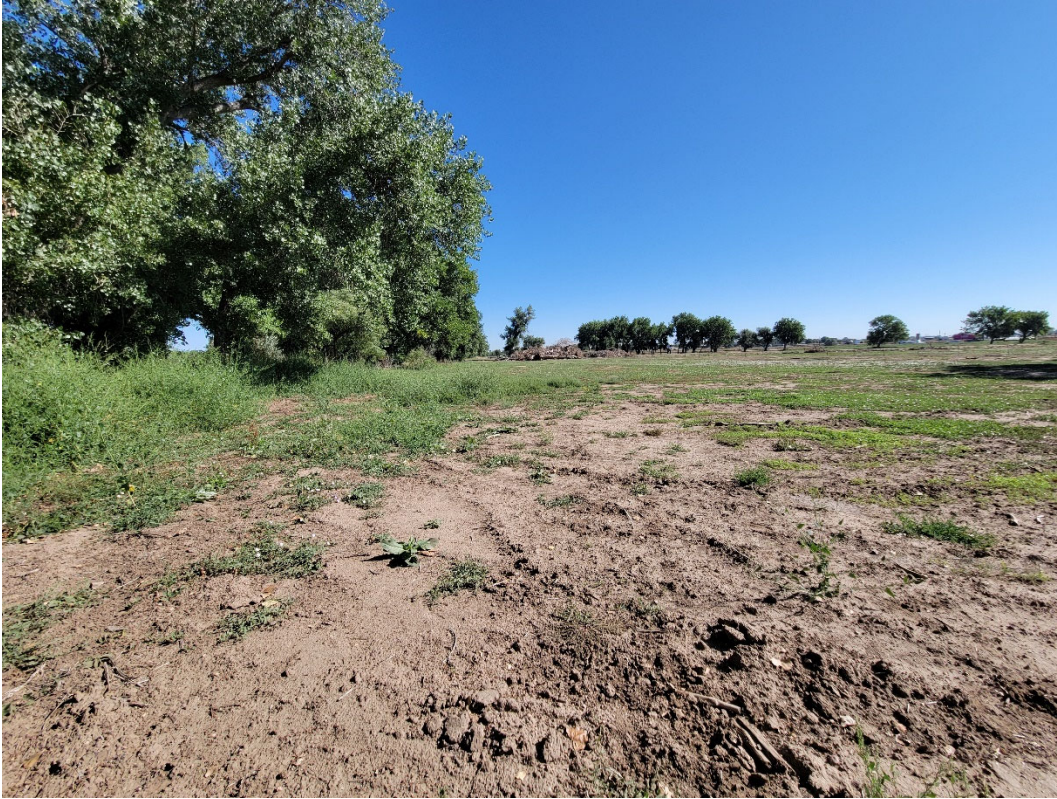
Photo 11: Looking northeast from the southwest corner of the proposed mining area.

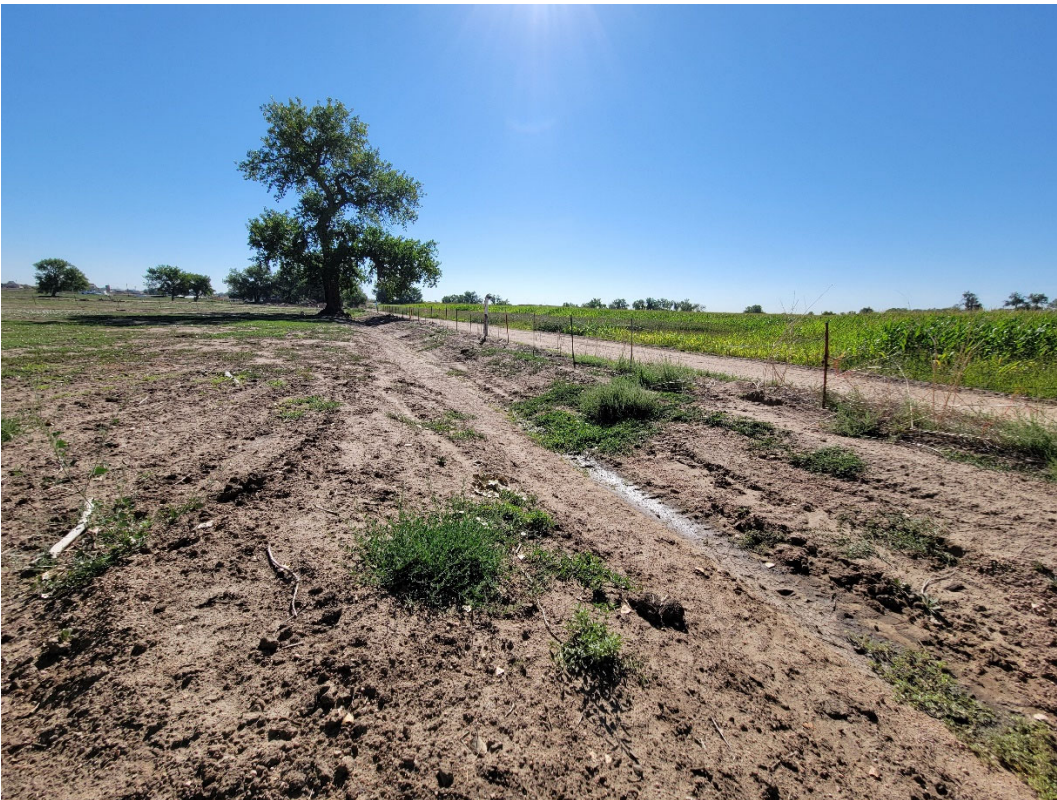
Photo 12: Looking east down the southern permit boundary where the ditch coming from the east will be rerouted.

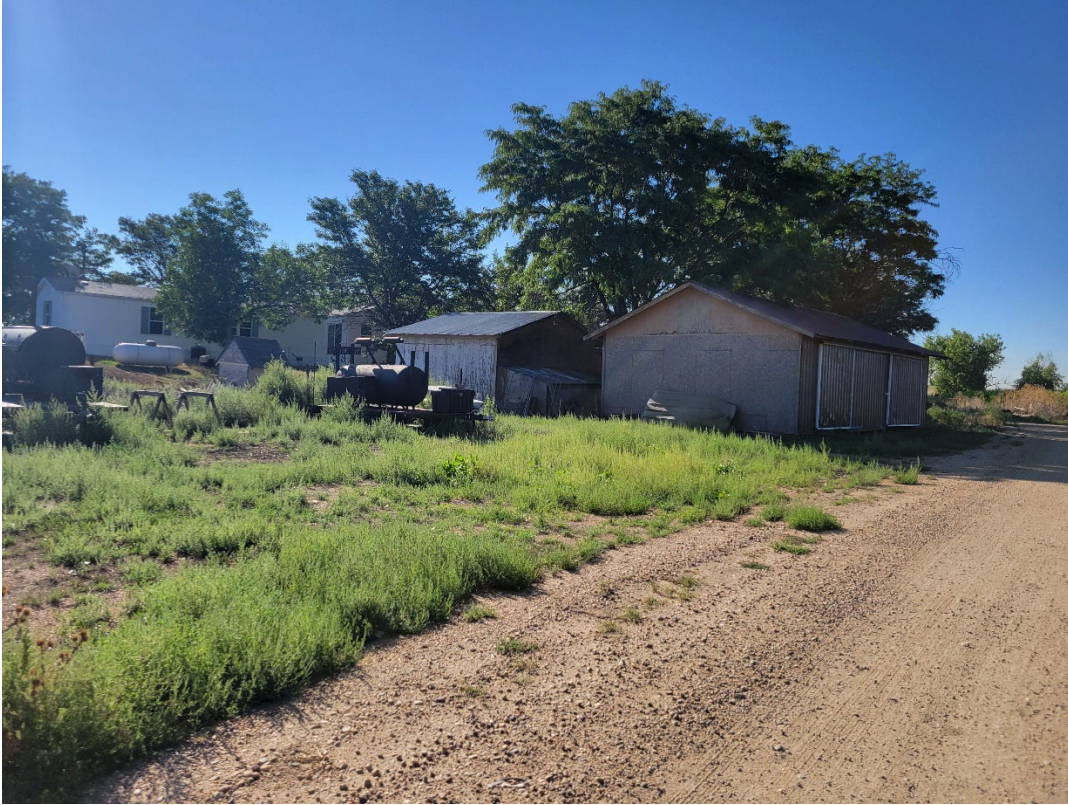
A modular home, sheds, trailers, and scattered equipment were observed in the southeast corner of the permit area, near the entrance off Highway 85. The applicant stated they will leave the home and remove the other structures and equipment for the landowner.

Photo 13: View of modular home, sheds and equipment near the entrance to the site.

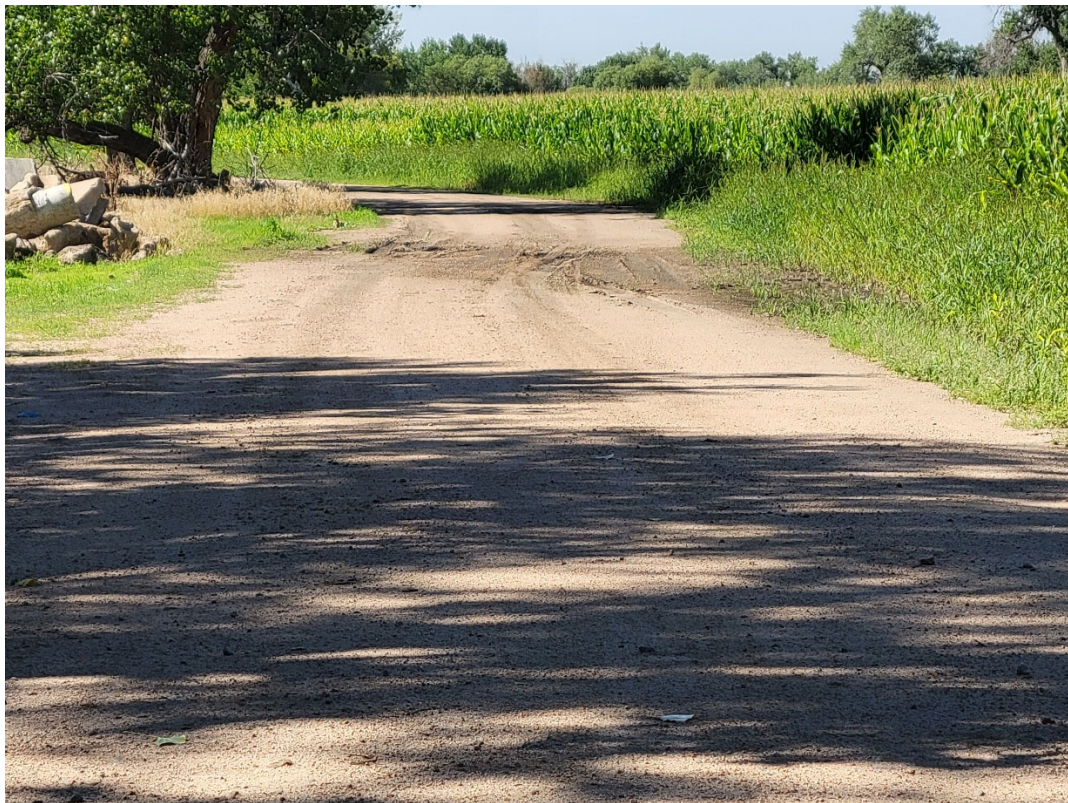
Photo 14: Looking south towards the area where the future haul road will be constructed.
