Bowie #1 inspection report

Permit Number: C-1981-038 Mine Name: Bowie No. 1 Mine Operator: Bowie Resources, LLC Operator Address: Mr. Basil R Bear P.O. Box 1488 Paonia, CO 81428	County: Delta Operation Type: Underground Permit Status: Active Ownership: Private
	Operator Representative Present: B. Bear, R. Wilson, A. Etter
Operator Representative Signature: (Field Issuance Only)

Inspection Start Date: September 17, 2024 Inspection Start Time: 17:00 Inspection End Date: September 18, 2024 Inspection End Time: 09:00		Inspection Type: Coal Complete Inspection Inspection Reason: Normal I&E Program Weather: Clear	
Joint Inspection Agency: None		Joint Inspection Contacts: 	
Post Inspection Agency: None		Post Inspection Contacts: 	
Inspector(s): Robert Zuber, P.E.	Inspector's Signature:

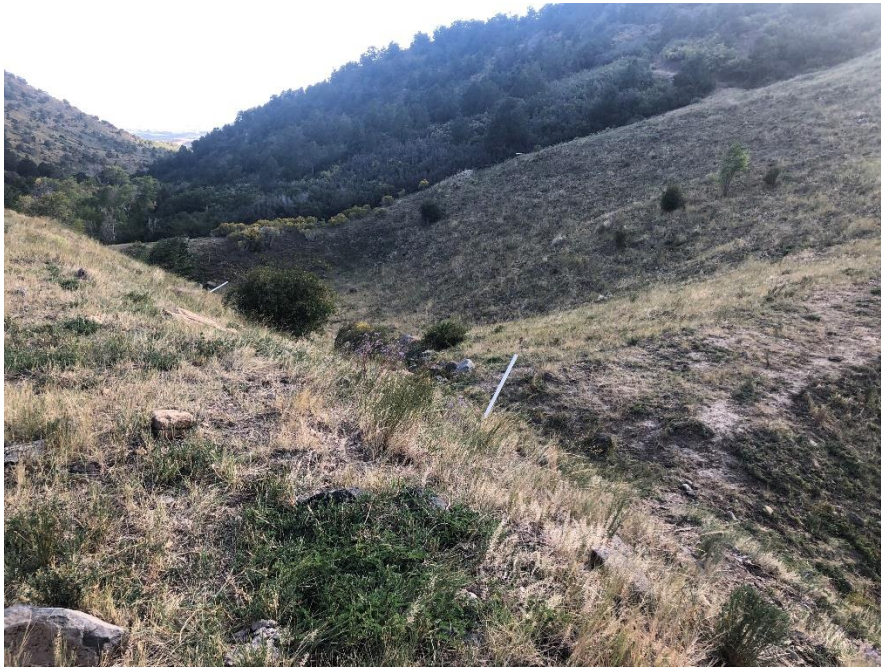
The ponds at the loadout, the Coal Storage Area (near Black Bridge Road), and the West Mine contained no water, and no problems were identified with these ponds.

West Mine ponds

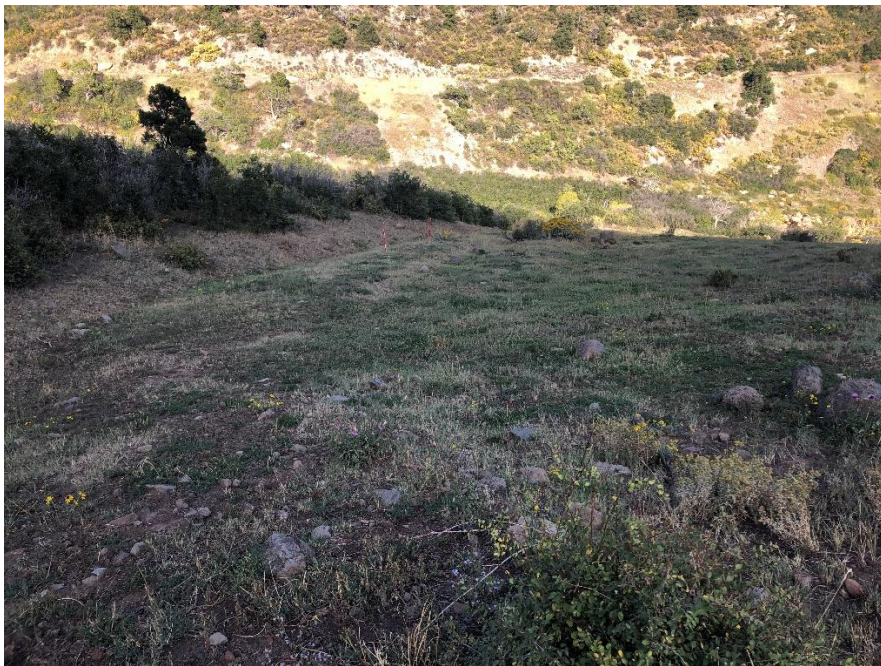
No erosion was seen at the West Mine, including the reclaimed road. The vegetation cover was good.

West Mine reclaimed road, looking downhill

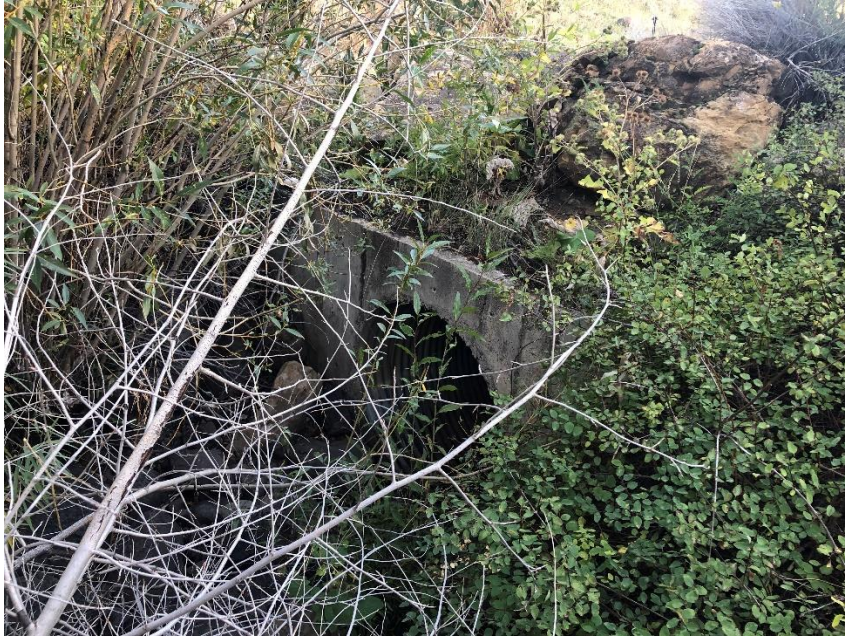
No problems were identified with culverts, including the large culvert under the loadout and the large culvert under the West Mine.

West Mine – upstream end of large culvert under ponds

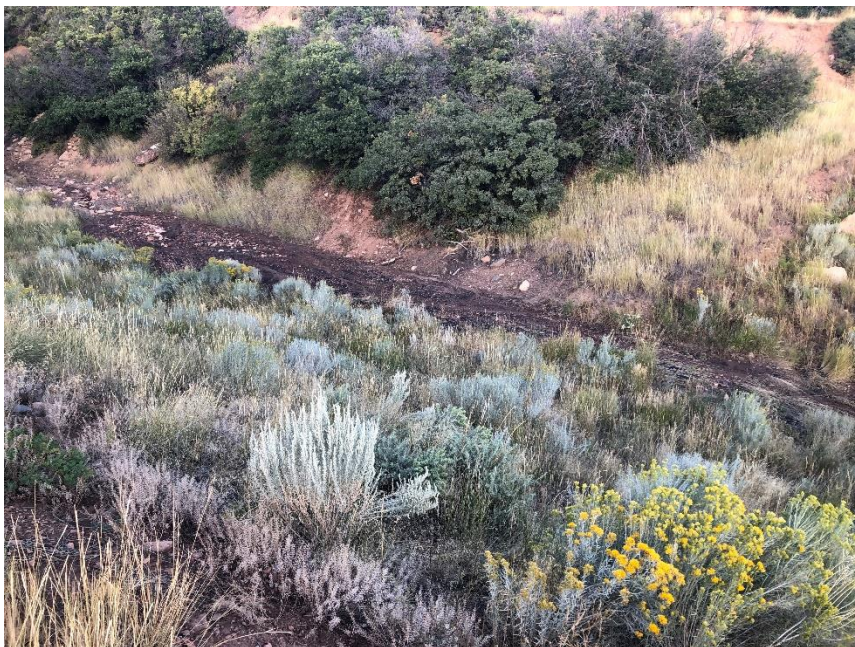
No problems were identified with the reclamation in the area of Ponds 1, 2, 3, and 4 (East Mine). The stream where Ponds 1 and 2 have been reclaimed should be monitored for erosion and check structures added, if needed.

East Mine – drainage at reclaimed Pond 1

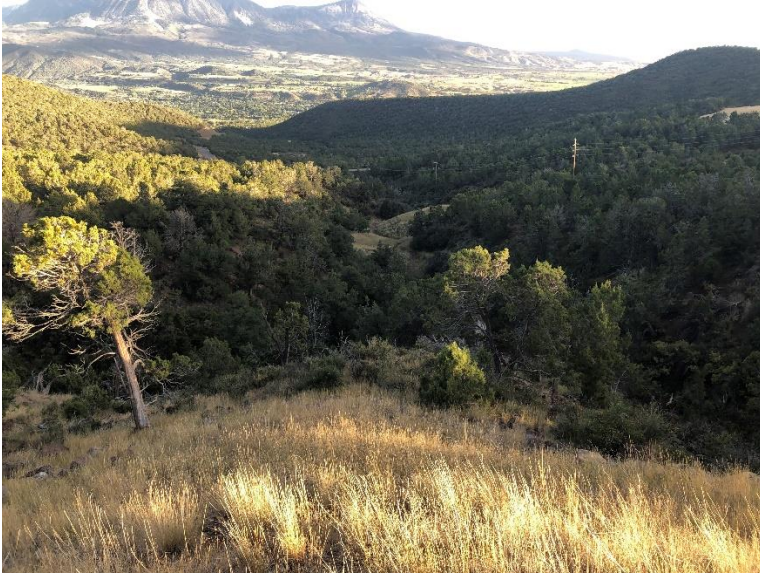
Drainage near reclaimed Ponds 3 and 4

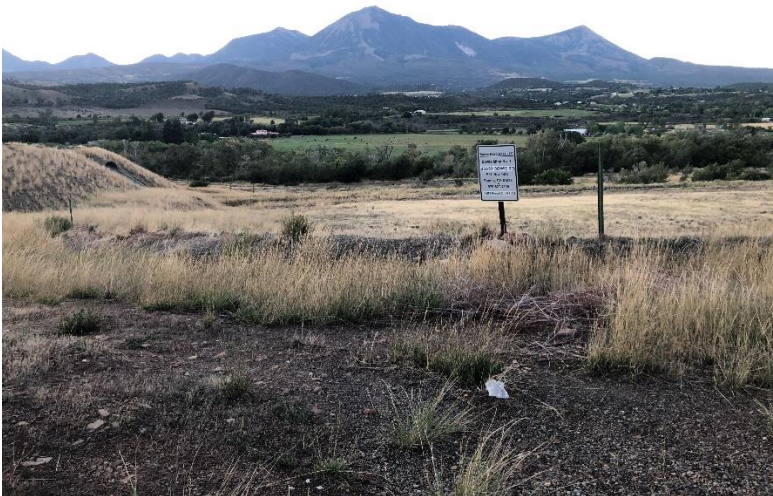
No erosion or other problems were seen with the Coal Storage Area beside the intersection of Highway 133 and Black Bridge Road.

Coal Storage near highway

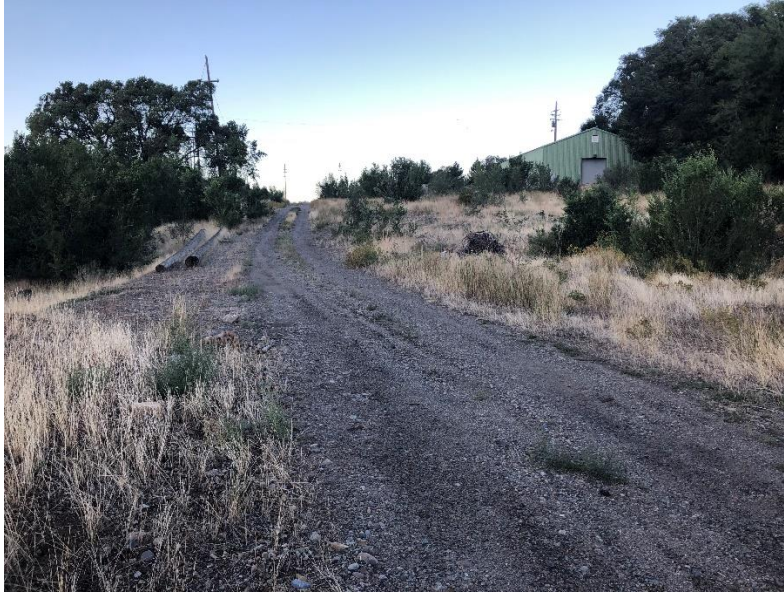
Loadout - road below shop and silo area

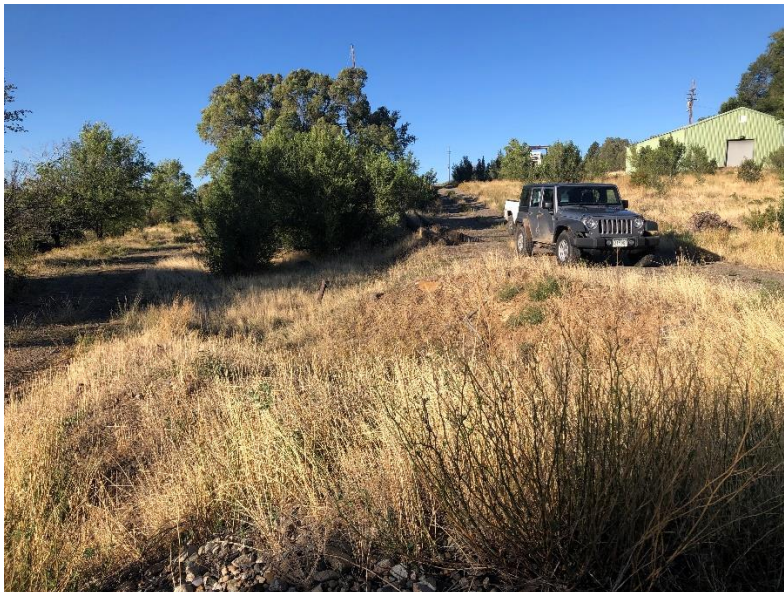
Ditch along south end of loadout where a sediment basin may be constructed
