Bowie #2 inspection

Permit Number: C-1996-083 Mine Name: Bowie No. 2 Mine Operator: Bowie Resources, LLC Operator Address: Mr. Basil Bear P.O. Box 1488 Paonia, CO 81428 County: Delta Operation Type: Underground Permit Status: Active Ownership: Private

Inspection Start Date: September 18, 2024 Inspection Start Time: 09:00 Inspection End Date: September 18, 2024 Inspection End Time: 13:00			Inspection Type: Coal Comp Inspection Reason: Normal I Weather: Clear	1
Joint Inspection Agency:		Joint Inspection Contacts:		
None				
Post Inspection Agency:		Post Inspection Contacts:		
None				
Inspector(s):	Inspecto	r's Sig	gnature:	Signature Date:
Robert Zuber, P.E.	Phot	D	21-	0/20/2024
				9/20/2024

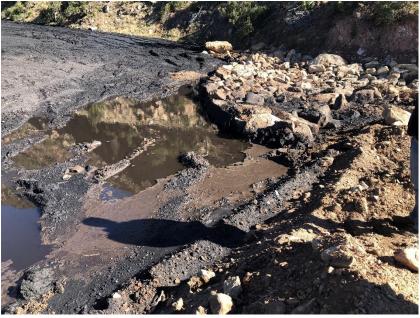
Placement of coverfill on Gob Pile #2 is still in progress on the upper slope. No erosion was identified. A small area of ponded water was seen at the low point on the upper (relatively flat) portion of Gob Pile #2. The sediment control structures have been partially built, including rocks and silt fence made of HDPE (product named E-Fence by ERTEC). BRL indicated that they will not allow this ponded water (from rain the day before the inspection) to be detained for more than a short time. BRL management indicated that small ditches will be re-built on the upper portion of this pile (as discussed in the August inspection report).

Sump area on Gob Pile #2 under construction – water from rain the day before the inspection

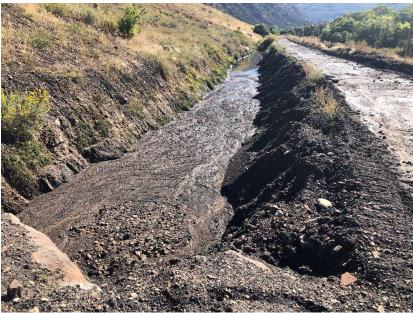
The ditch that flows into Pond F from the west (Ditch F7a) is need of cleaning. BRL indicated that it was cleaned recently, but recent rains dumped more sediment into it.

Ditch F7a in need of cleaning

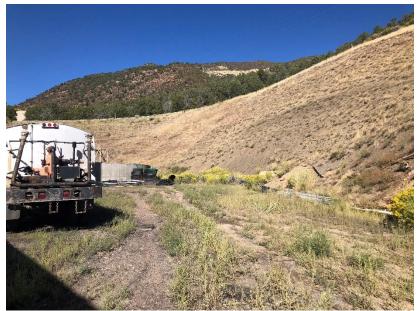
Slope behind the Prep Plant

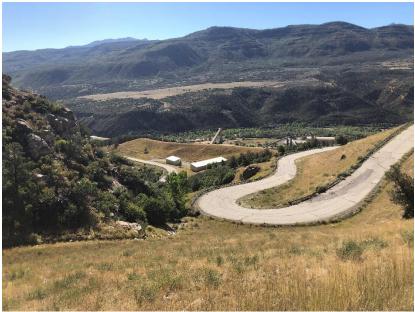
Curve 6 and Topsoil Stockpile A

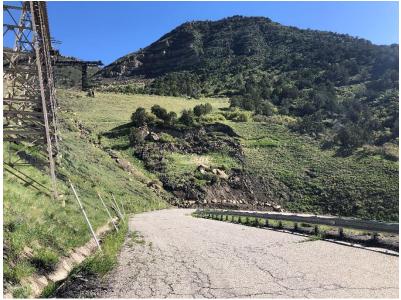
No problems were seen on the slopes above and below the benches. The slides above the B Portal Bench and Curve 11 (noted in the past) look stable. The slide above Curve Number 10 appears to have not moved in recent months. This is an ongoing project for BRL.

Curve 10 slide, taken in May 2024

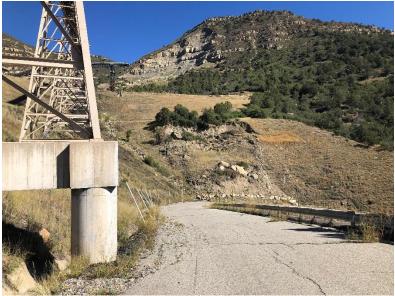
Curve 10 slide, taken in September 2024

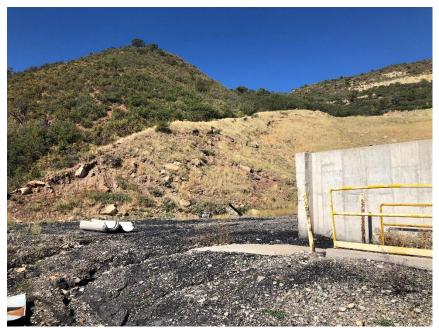
B Portal bench – slide appears to be healing

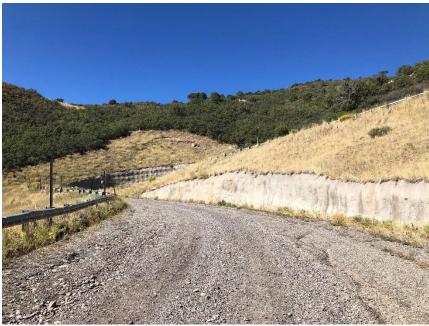
Curve 11 – slide appears to be healing

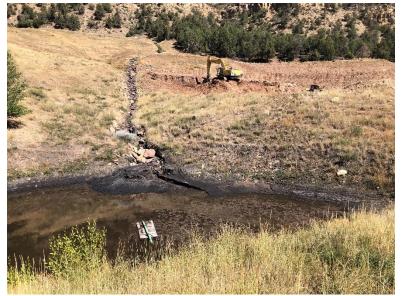
Pond F inlet and soil pile above

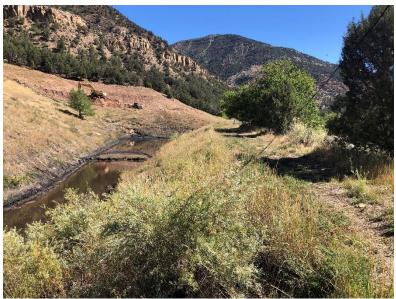
Pond F, looking east

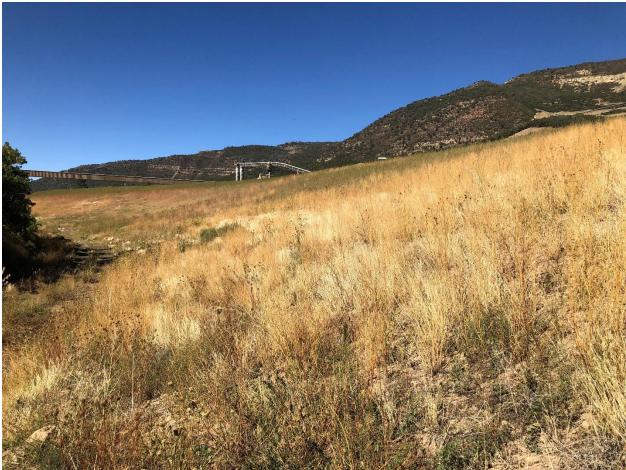
Water was seen in the ditch below Gob Pile #3, likely indicating that water was flowing through the underdrain.

Thistle plants have been killed near the southeast corner of Gob Pile #3.

Gob Pile #3, looking west at south side
