## M2011007, Robert Fulton Reclamation Project, Inspection Report

### MINERALS PROGRAM INSPECTION REPORT

<b>MINE NAME:</b> Robert Fulton Reclamation	<b>MINE/PROSPECTING ID#:</b> M-2011-007	<b>MINERAL:</b> Silver and gold	<b>COUNTY:</b> Gilpin
<b>INSPECTION TYPE:</b> Monitoring	<b>WEATHER:</b> Clear	<b>INSP. DATE:</b> September 17, 2024	<b>INSP. TIME:</b> 11:00
<b>OPERATOR:</b> Venture Resources, Inc.	<b>OPERATOR REPRESENTATIVE:</b> Mason Drake	<b>TYPE OF OPERATION:</b> 110d - Designated Limited Impact

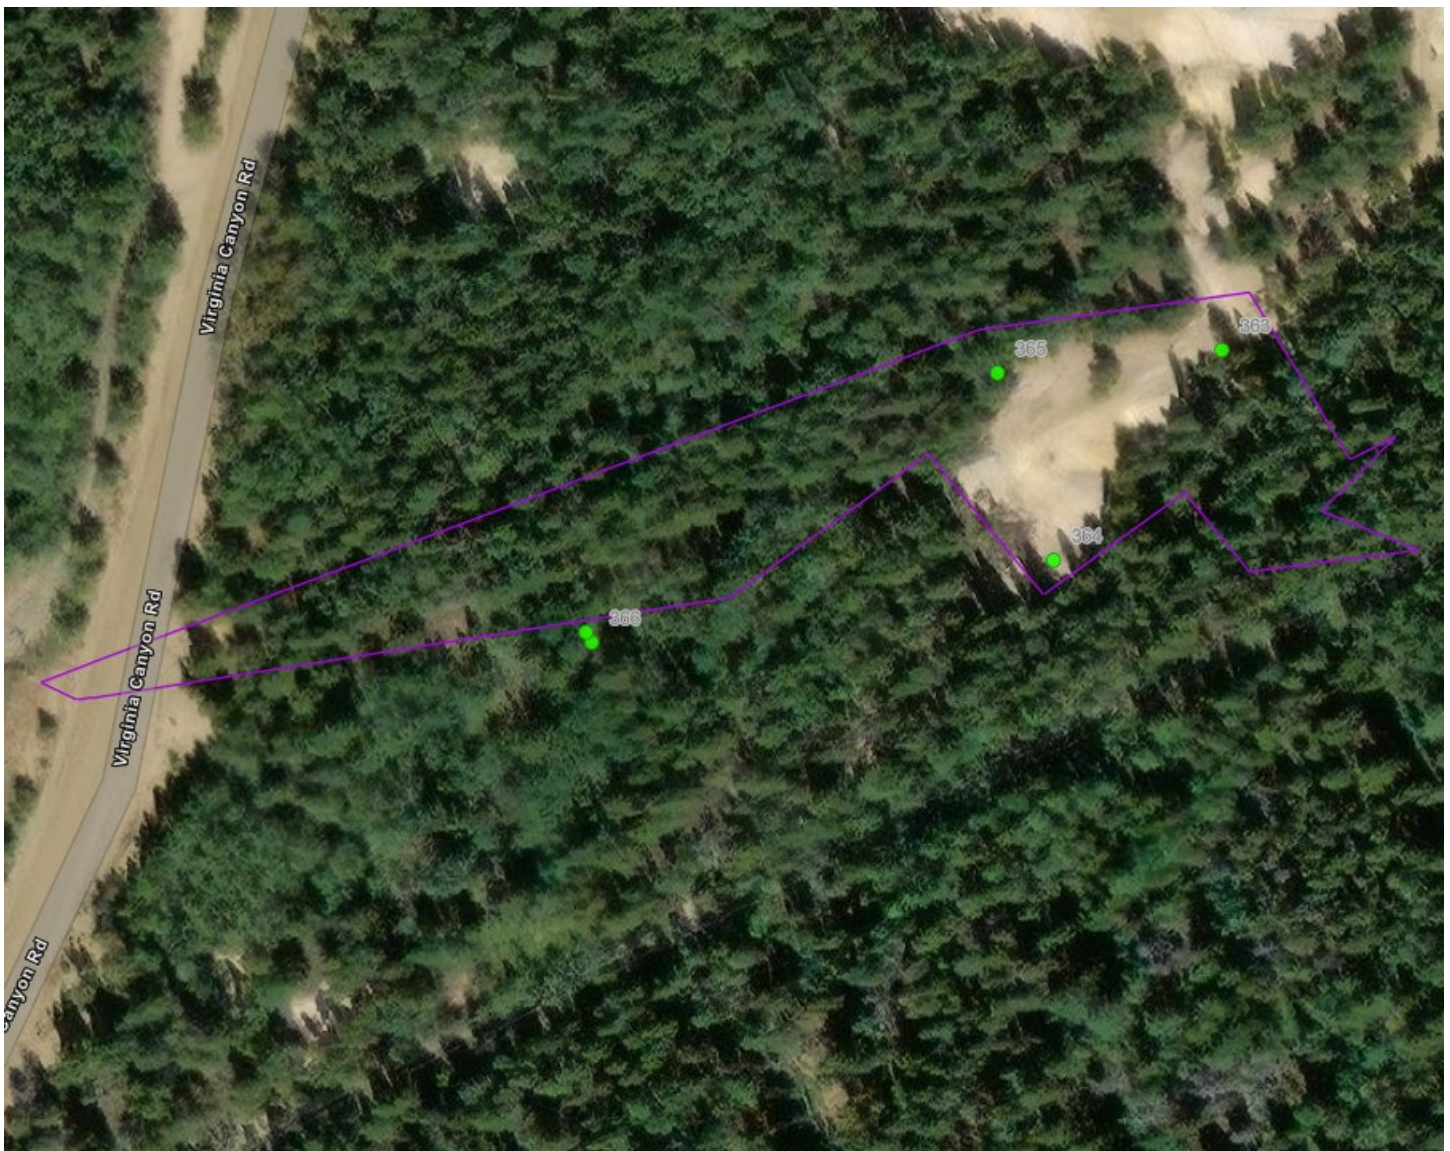
Figure 1: Screenshot of field map; approximate permit boundary in purple, inspection features in green

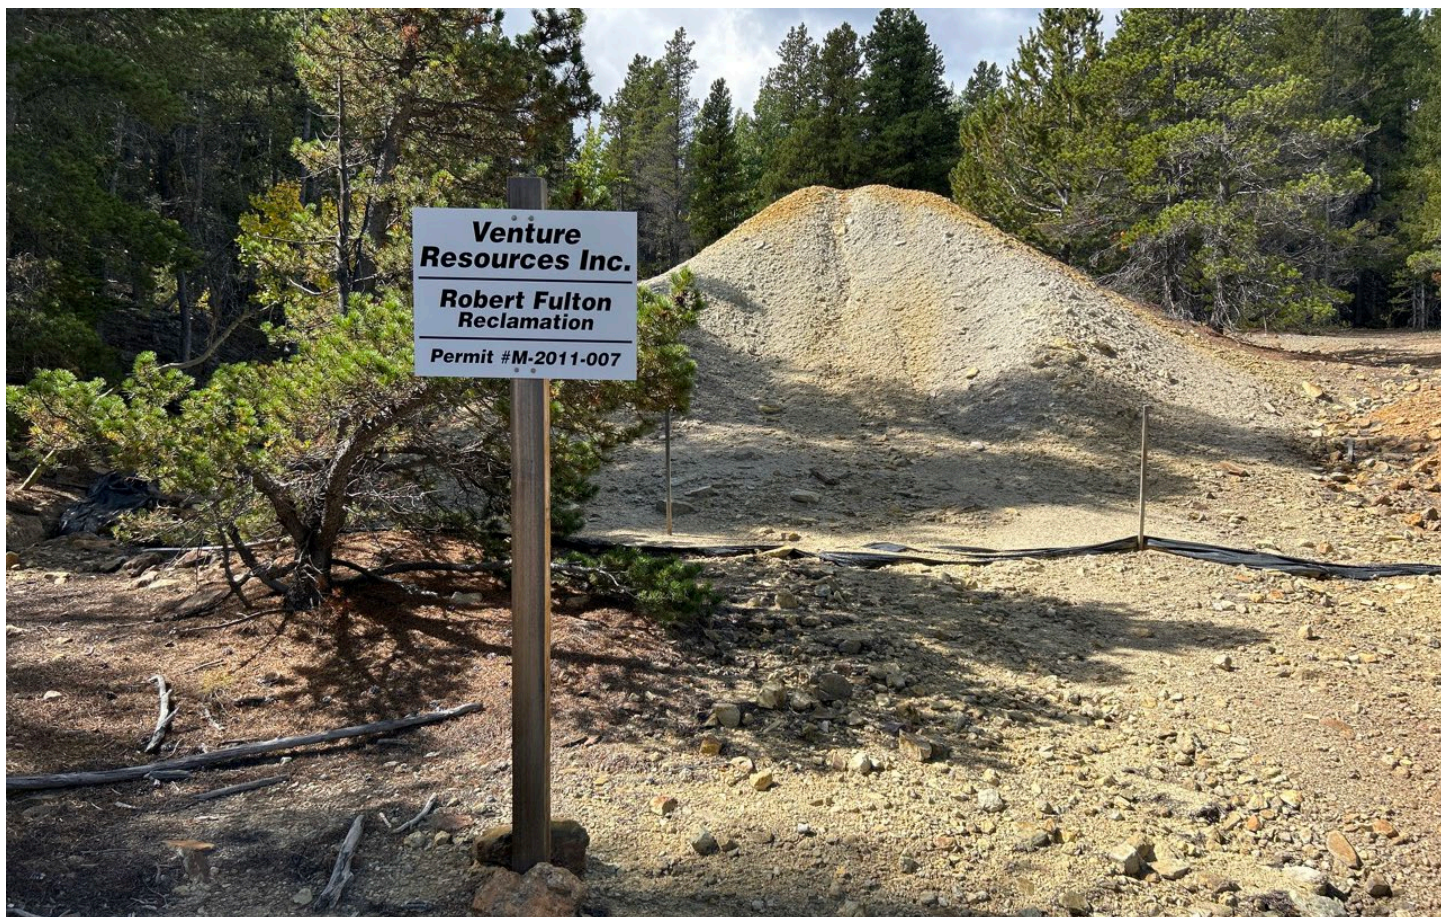
Figure 2: Mine ID sign, 363

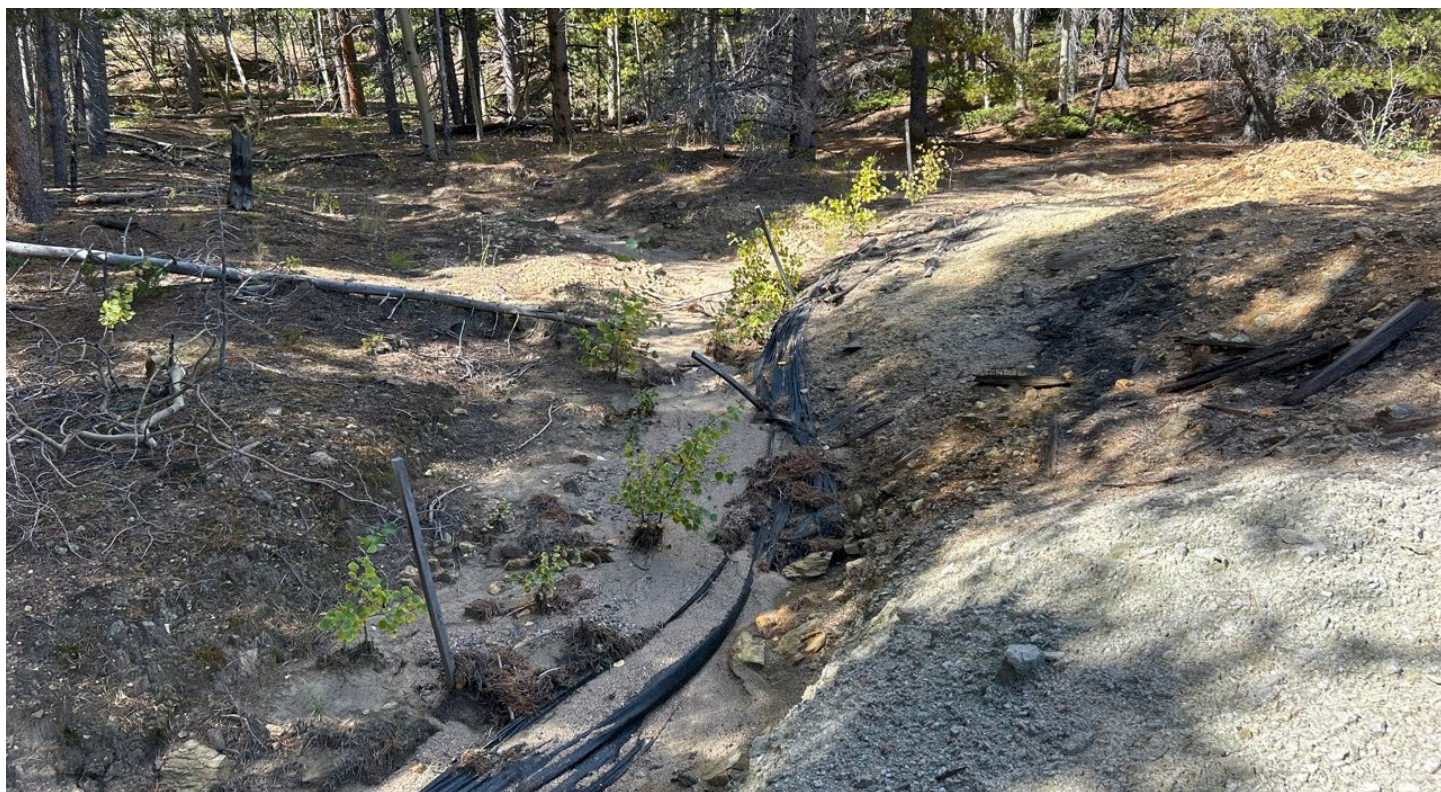
Silt fence had been installed around the toe of the historic waste dump but was in poor condition. The silt

Figure 3: Southern edge of historic waste dump, showing silt fence in poor repair, 364

fence should be either repaired (if the permit is to be maintained) or removed (if the operator seeks release).

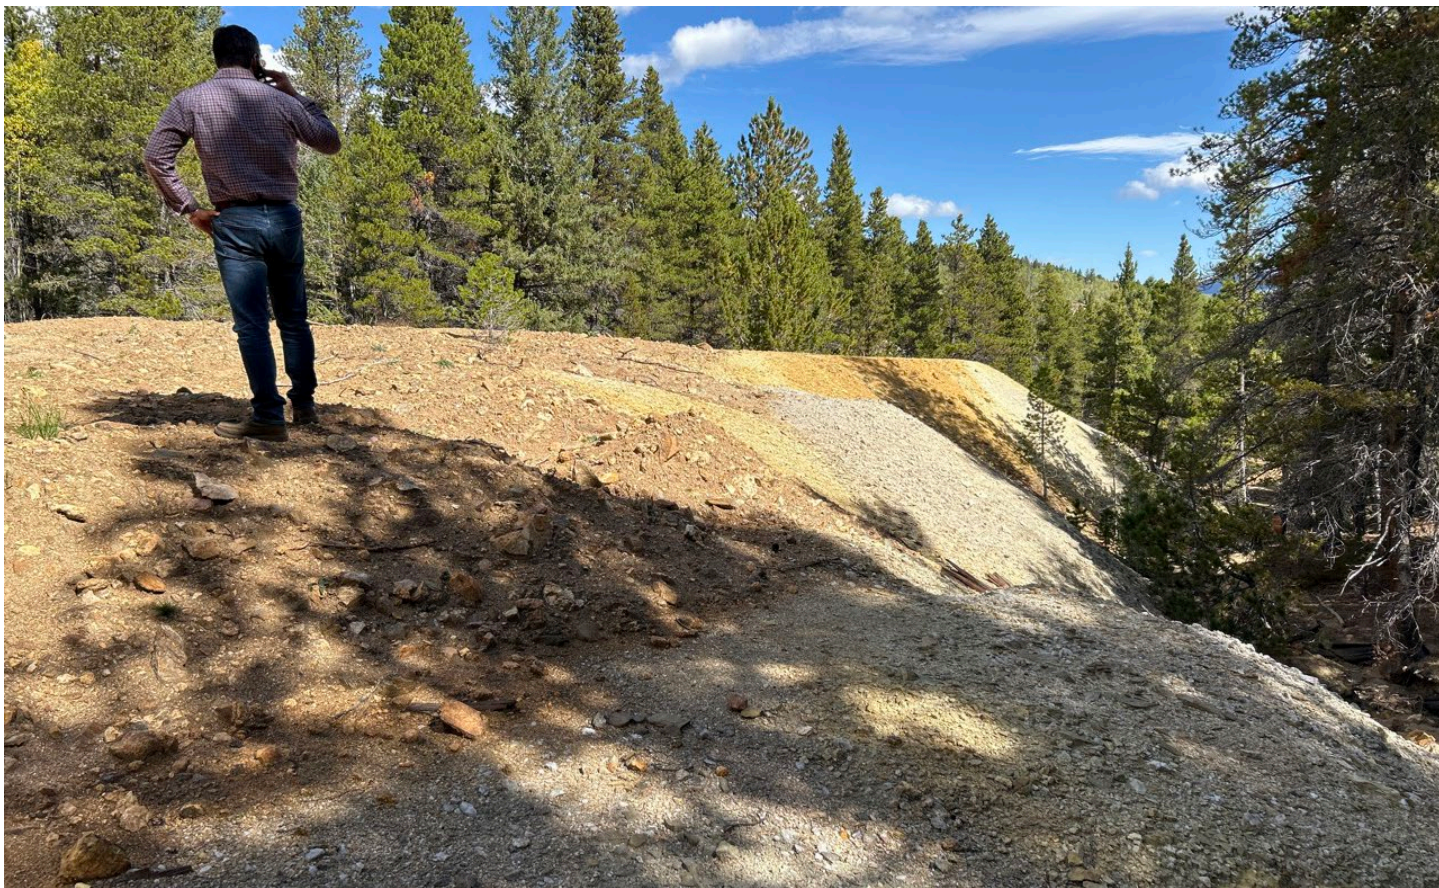
Possibly associated with the recent construction, some soil-containing material had been brought to the site and placed on top of the historic waste material. This activity was not described in the annual report. It's not clear where the material came from or what it contains, although it does appear to contain some organic matter and some plants had begun to grow in it. The new material did not appear to have been seeded or mulched, and there was no evidence to suppose that the historic mine waste beneath it had been broadcast with hydrated lime, as the reclamation plan calls for.

Figure 4: Southern edge of historic waste dump, showing soil brought to site, 364

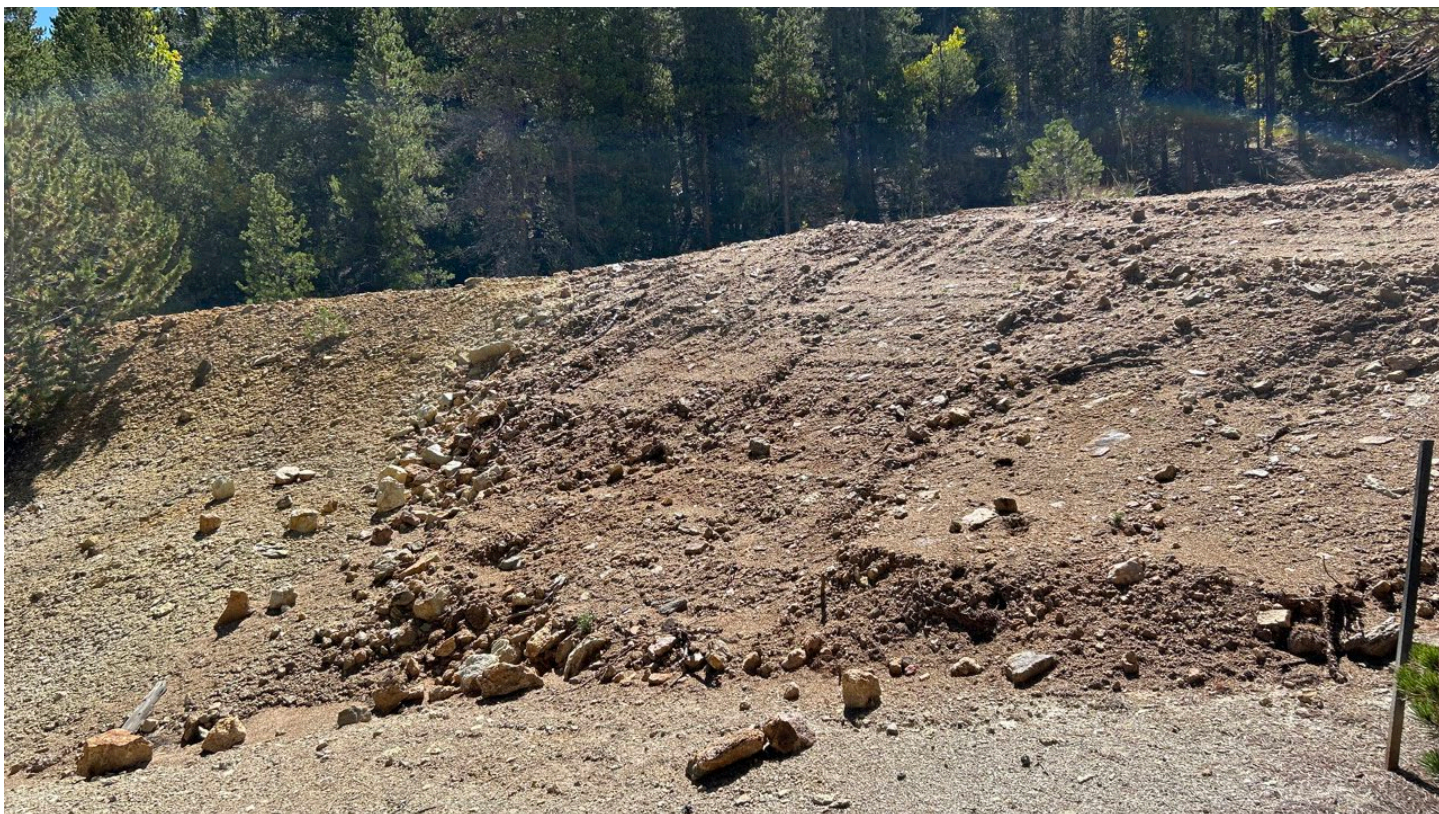
Figure 5: Northern edge of historic waste dump, showing soil brought to site, 365

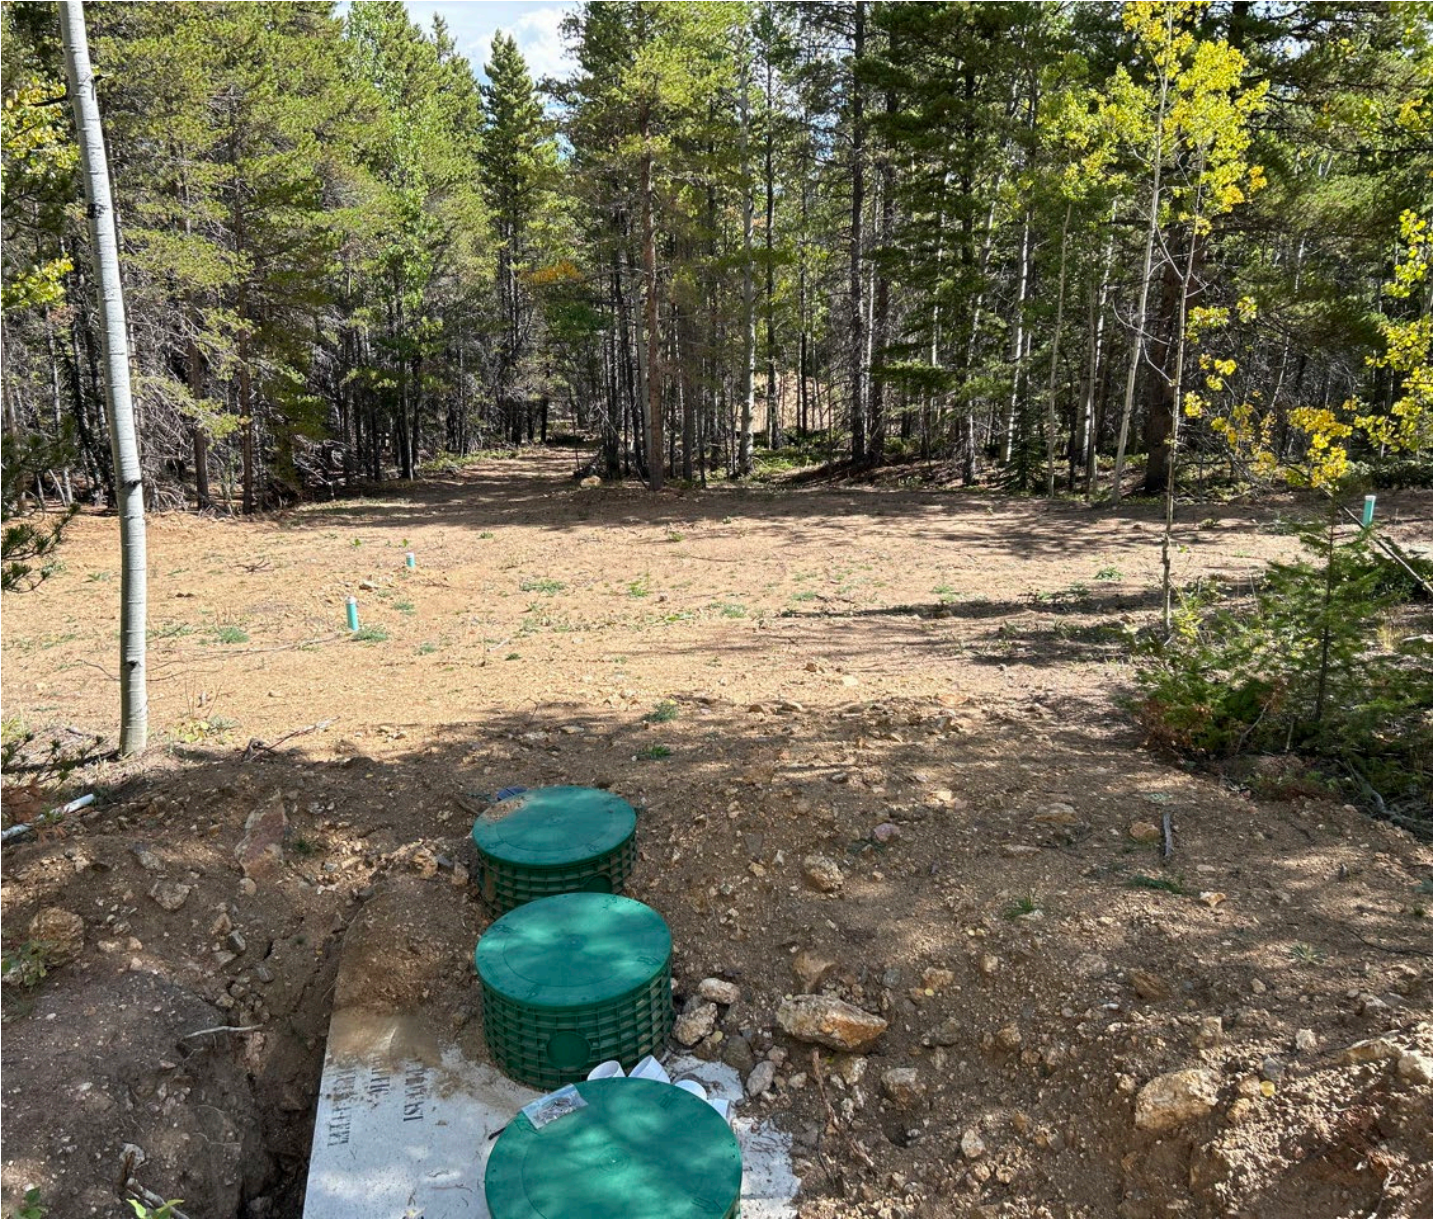
**PROBLEM/POSSIBLE VIOLATION:** Problem: The current mine plan (and possibly reclamation plan) needs to be updated and clarified pursuant to C.R.S. 34-32.5-112 (1)(c)(VI). The operator must provide sufficient information to describe or identify how the operator intends to conduct the operation.

A new septic tank and leach field had been installed, and survey stakes for a new structure had been laid out just west of the historic waste dump. Although the permit boundary was not clearly marked on the ground, these structures appear to be either inside or within 200 feet of the permit area. The structures are not described in either the mining or reclamation plans, or shown on any maps. A problem has been cited above.

**Figure 6: Recently installed septic tank and leach field, 366**

**CORRECTIVE ACTIONS:** The operator shall submit a Technical Revision, with the required \$216 revision fee, to update and clarify the current approved mine plan to reflect existing and proposed activities by the corrective action date. Please update Exhibit E - Mining Plan Map(s) to show the location and owner(s) of all structures within 200 feet of the permit boundary. Also, if any of the structures located within the permit area will remain following reclamation, please update Exhibit E - Reclamation Plan Map to show all structures/features proposed to remain. The Division will need to verify that the structures proposed to remain are consistent with the approved Post-Mining Land Use (PMLU) for the site. For example, if there is a plan to build a residence on site, please provide demonstration that this use is compliant with local land use and zoning laws, as well as the approved PMLU. Finally, please provide structure agreements per Rule 6.3.12 for any structures located on or within 200 feet of the permit area that are not owned by Venture Resources, Inc.

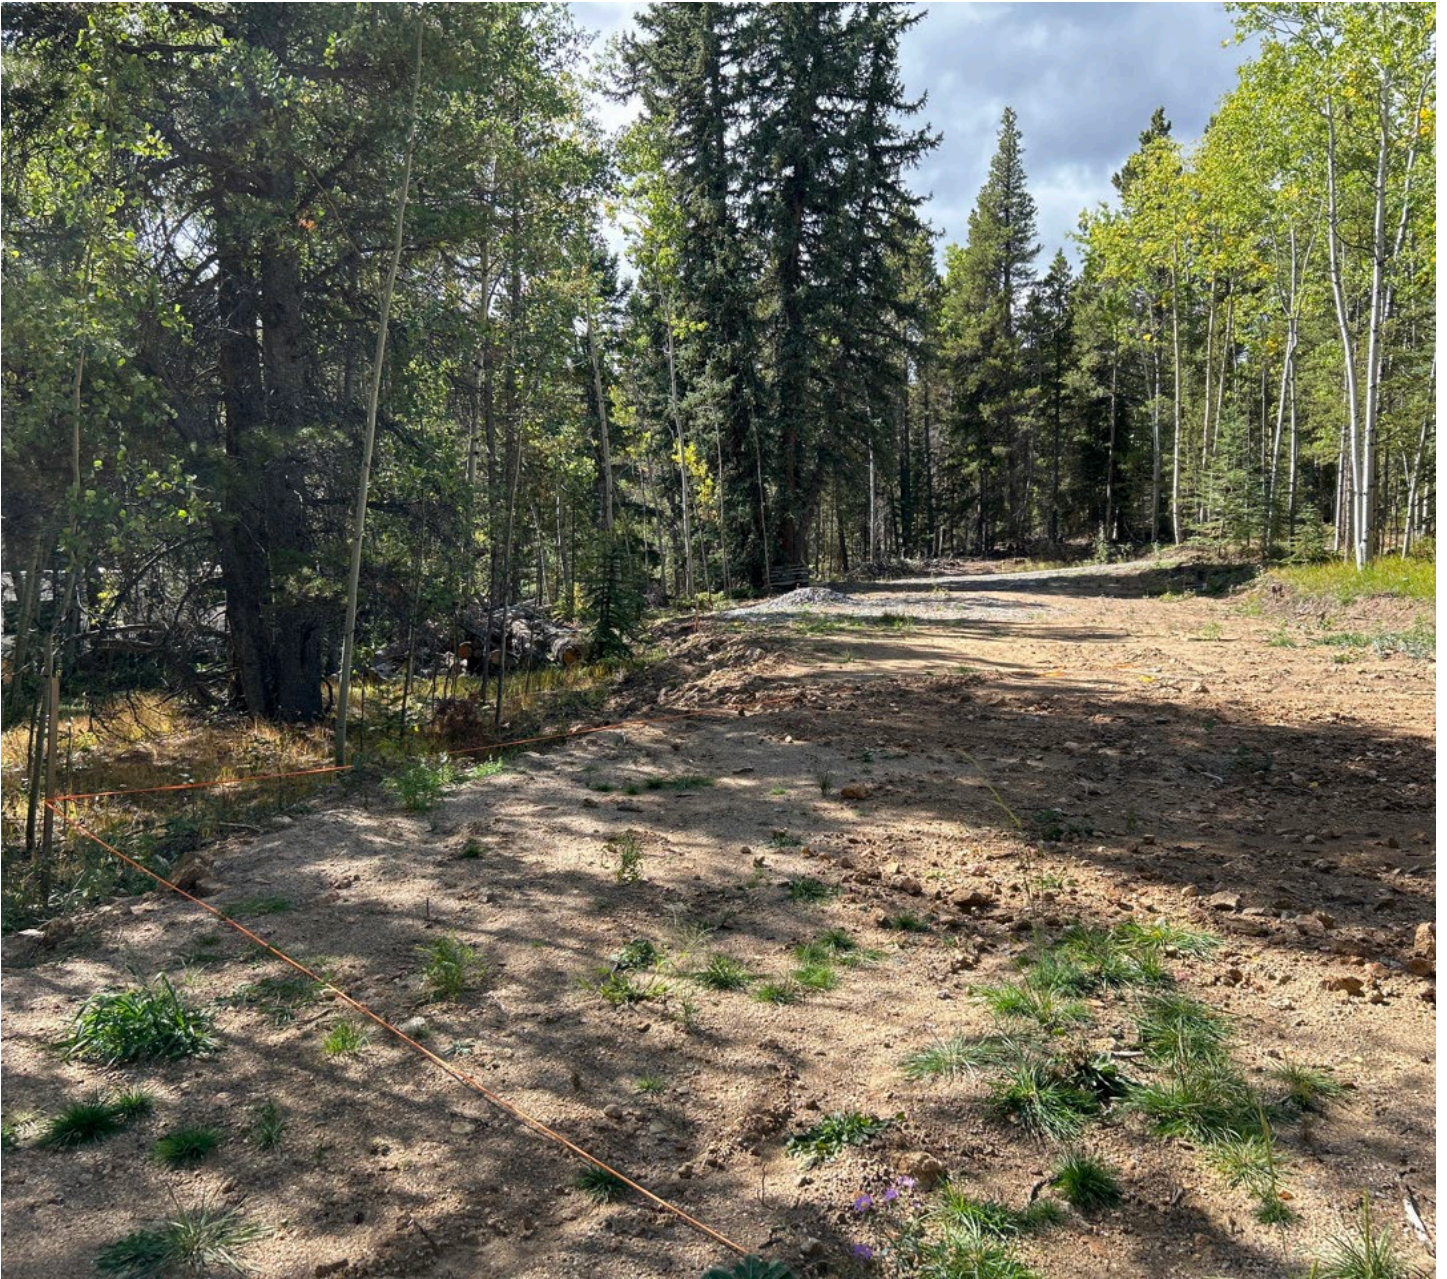
Figure 7: Staked construction site, 367
