MINERALS PROGRAM INSPECTION REPORT
PHONE: (303) 866-3567

MINE NAME: Climax Mine	MINE/PROSPECTING ID#: M-1977-493	MINERAL: Molybdenum	COUNTY: Lake, Summit
INSPECTION TYPE: Aerial Inspection	INSPECTOR(S): Dustin Czapla / Brock Bowles	INSP. DATE: September 11, 2024	INSP. TIME: 11:20
OPERATOR: Climax Molybdenum Company	OPERATOR REPRESENTATIVE: NA	TYPE OF OPERATION: 112d-3 - Designated Mining Operation	
REASON FOR INSPECTION: Normal I&E Program	BOND CALCULATION TYPE: None	BOND AMOUNT: \$91,011,850.00	
DATE OF COMPLAINT: NA	POST INSP. CONTACTS: None	JOINT INSP. AGENCY: None	
WEATHER: Clear	INSPECTOR'S SIGNATURE:

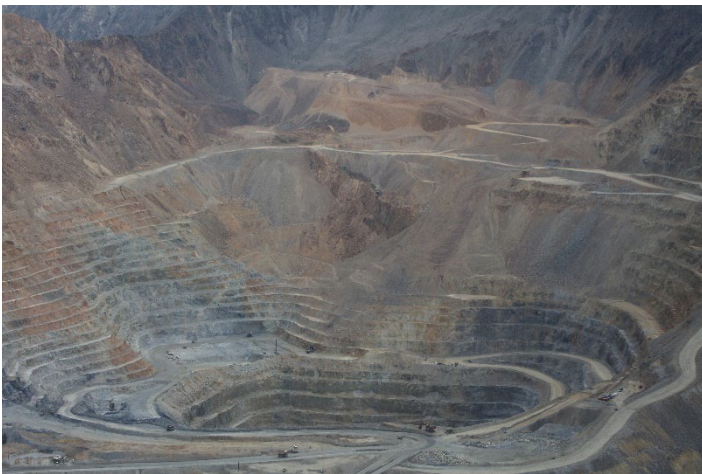
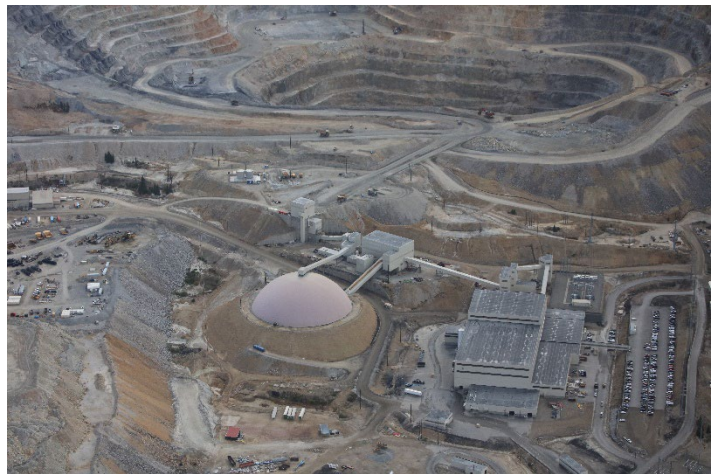
The Pit area was observed. Operations appear to be occurring according to approved plans. No problems were noted.

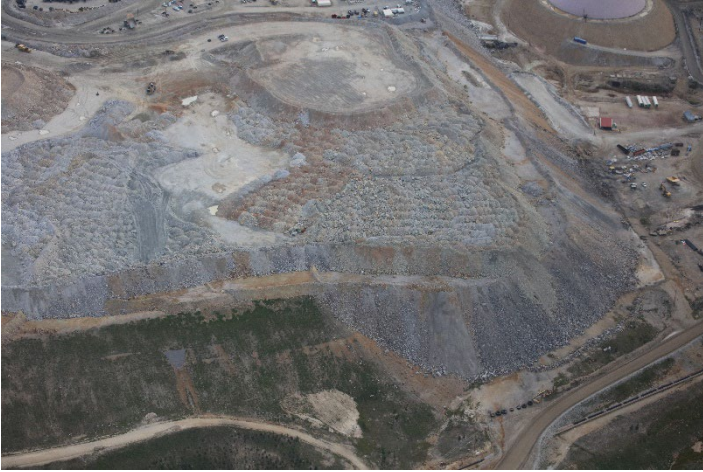
North 40 OSF

The North 40 and McNulty OSF's were observed. No abnormal conditions were noted. OSF's appear to be functioning within the established design criteria.

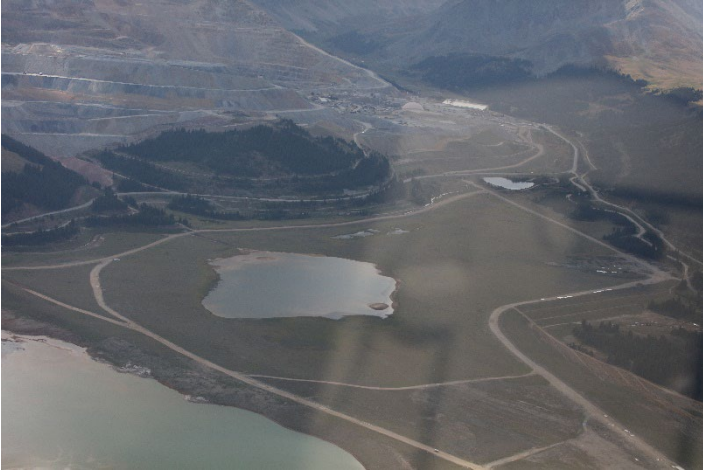
The Mayflower TSF and 5 Dam, Tenmile TSF and 3 Dam, Robinson TSF and 1 and 2 Dams, Robinson Lake, Eagle Park Reservoir and 4 Dam were observed. No abnormal conditions were noted. TSF's appear to be functioning within the established design criteria.
