**Citizen Complaint (CT1), Shannon Pit, M-1979-163 Follow-up**

## Inspection Report, Shannon Pit, M-1979-163, Citizen Complaint

**MINERALS PROGRAM INSPECTION REPORT**  
**PHONE: (303) 866-3567**

<b>MINE NAME:</b> Shannon Pit	<b>MINE/PROSPECTING ID#:</b> M-1979-163	<b>MINERAL:</b> Sand and gravel	<b>COUNTY:</b> Las Animas
<b>INSPECTION TYPE:</b> Monitoring	<b>WEATHER:</b> Clear	<b>INSP. DATE:</b> September 6, 2024	<b>INSP. TIME:</b> 09:20
<b>OPERATOR:</b> Las Animas County	<b>OPERATOR REPRESENTATIVE:</b> Keith Woodring and Brian Heguy	<b>TYPE OF OPERATION:</b> 112c - Construction Regular Operation

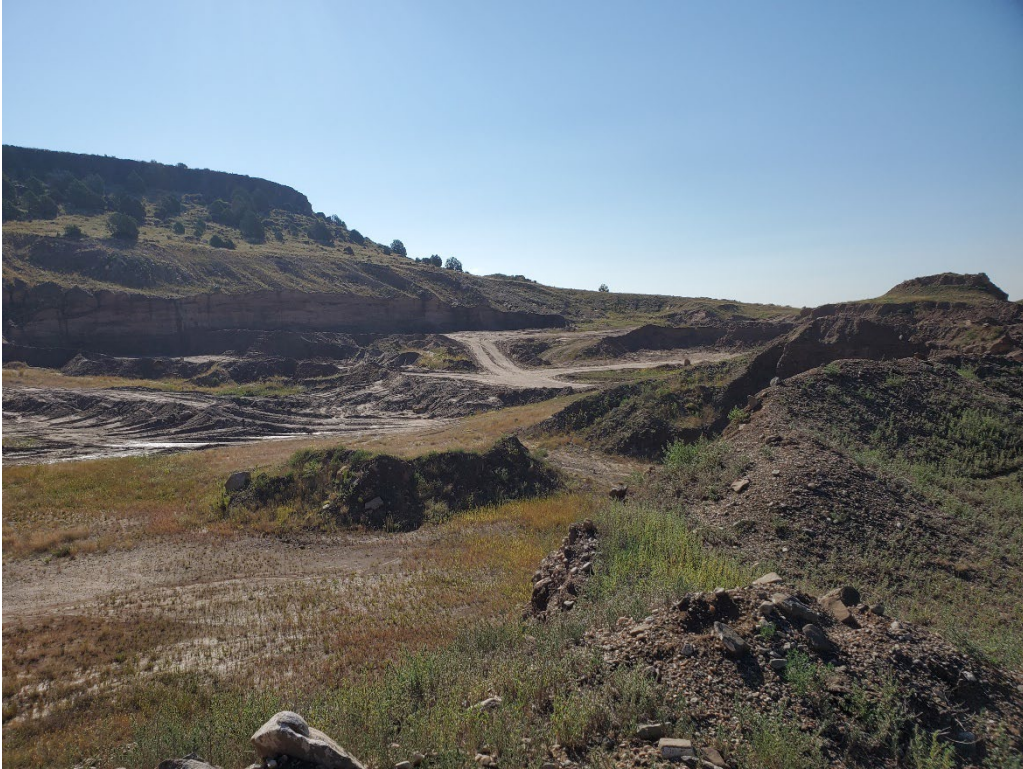
**Photo 1:** Looking southwest from the northern boundary.

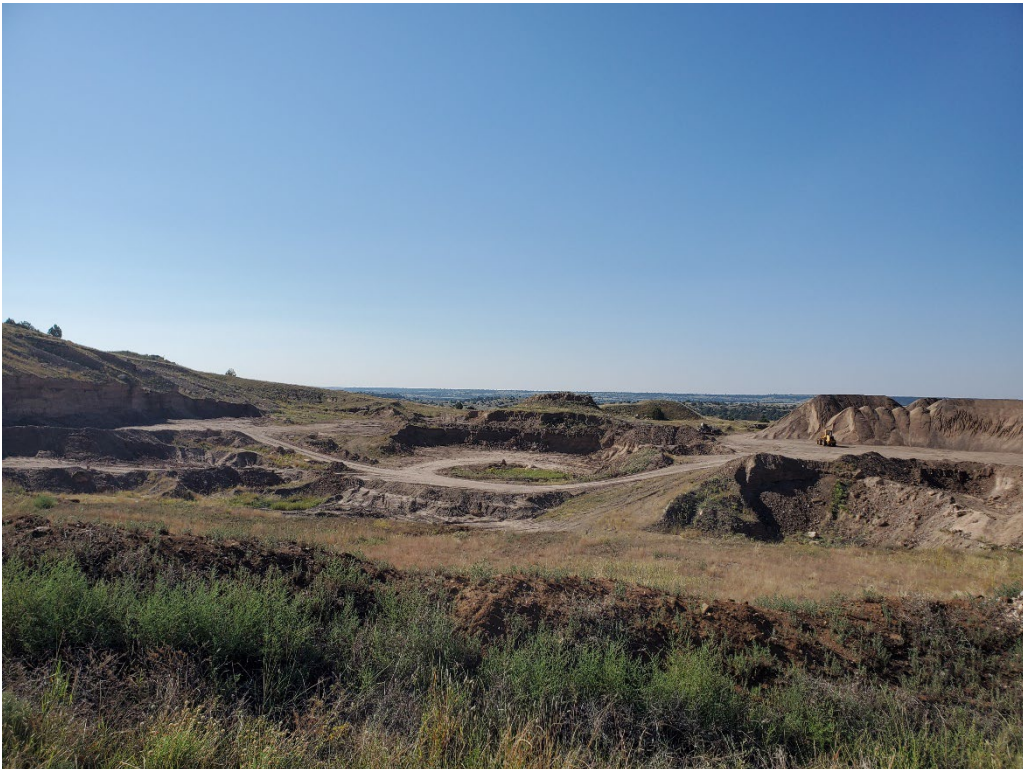
**Photo 2:** Looking southwest from the northeast boundary.

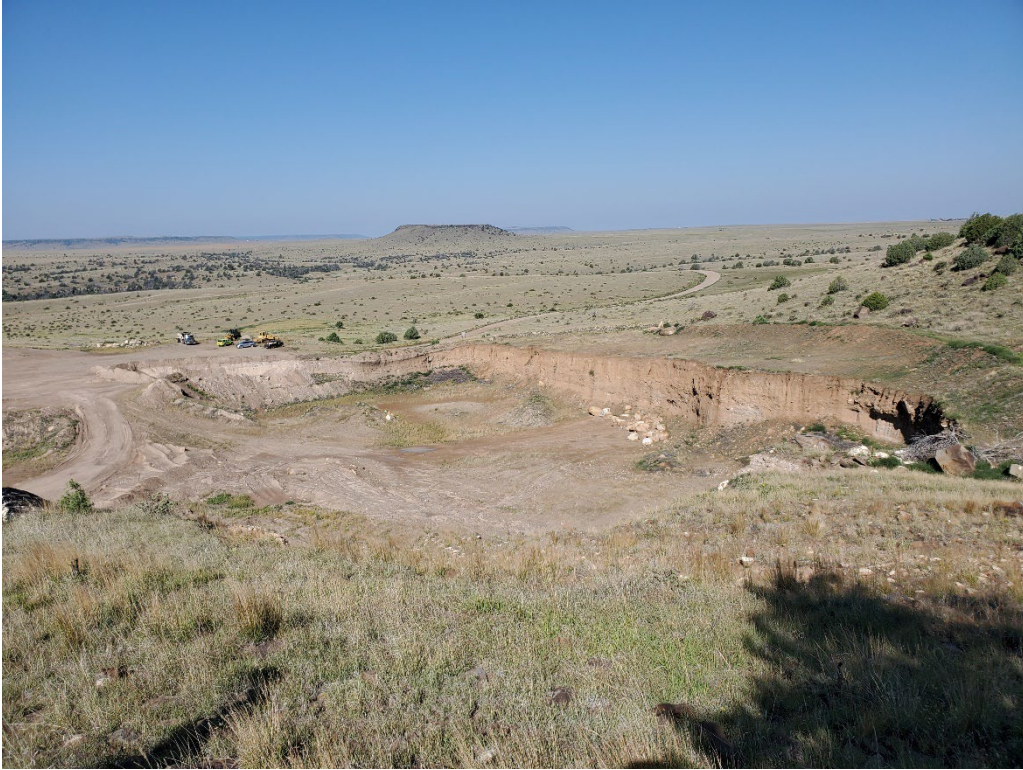
**Photo 3:** Looking northwest from the eastern boundary.

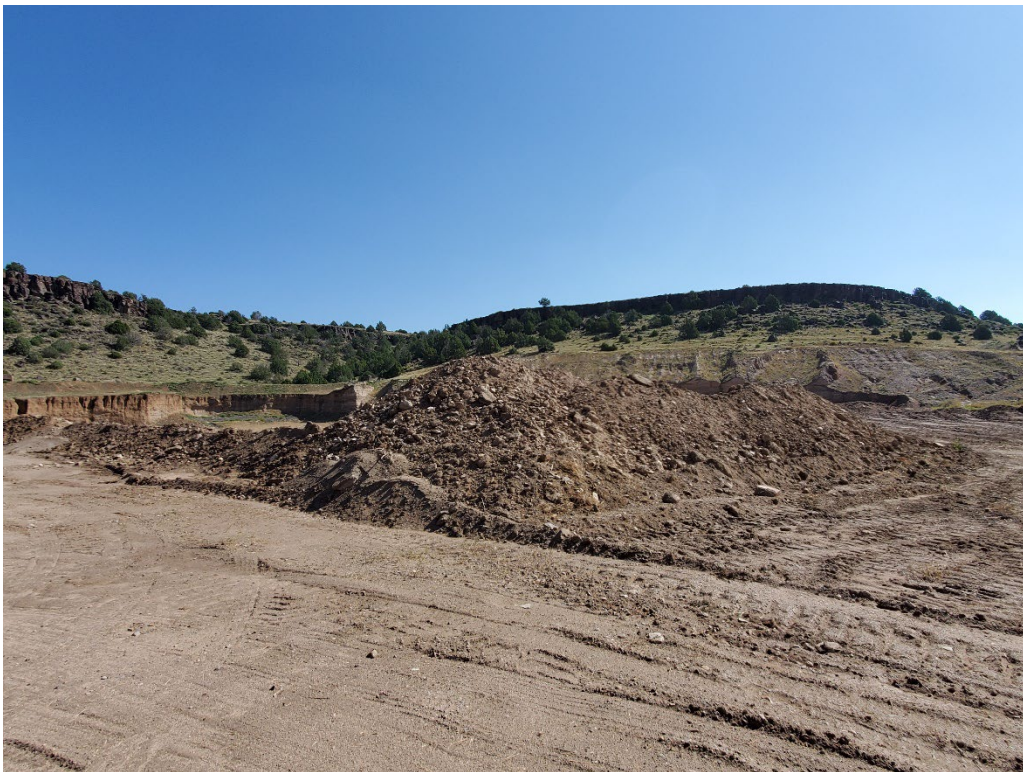
**Photo 4:** Looking east within the pit.

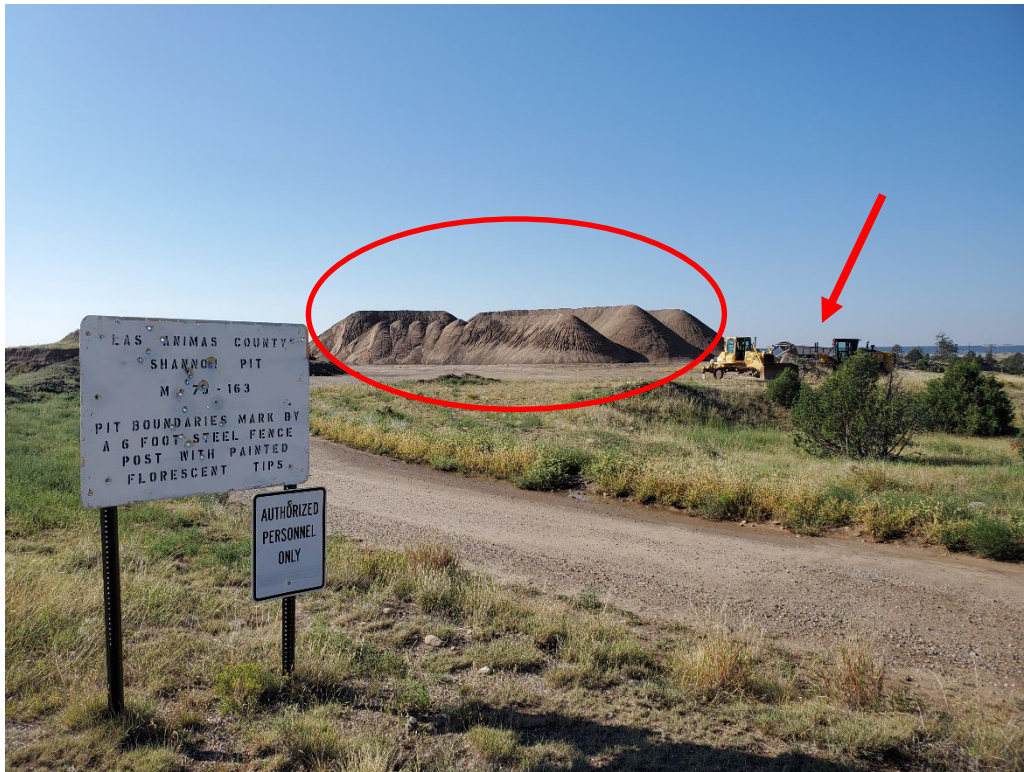
A few product stockpiles were observed towards the center of the permitted area as well as some excavation and portable processing equipment near the north-west side (Photo 5). Near vertical highwalls were observed along the north, northeast, and within some central portions of the pit. The highwall along the northeast side of the permit is approximately 25 feet high and near vertical (Photo 6). The approved mining plan states that overburden ranges from 6 inches to 5 feet throughout the permit, and that the depth of the deposit is up to 25 feet in some areas. Therefore, to address CT1 concern number 3, the depth of the excavation appears to be in compliance with the approved plan.

**Photo 5:** Permit sign located to the east of the entrance road along the northern permit boundary. Product stockpiles are circled and equipment and processing equipment is indicated by the arrow.

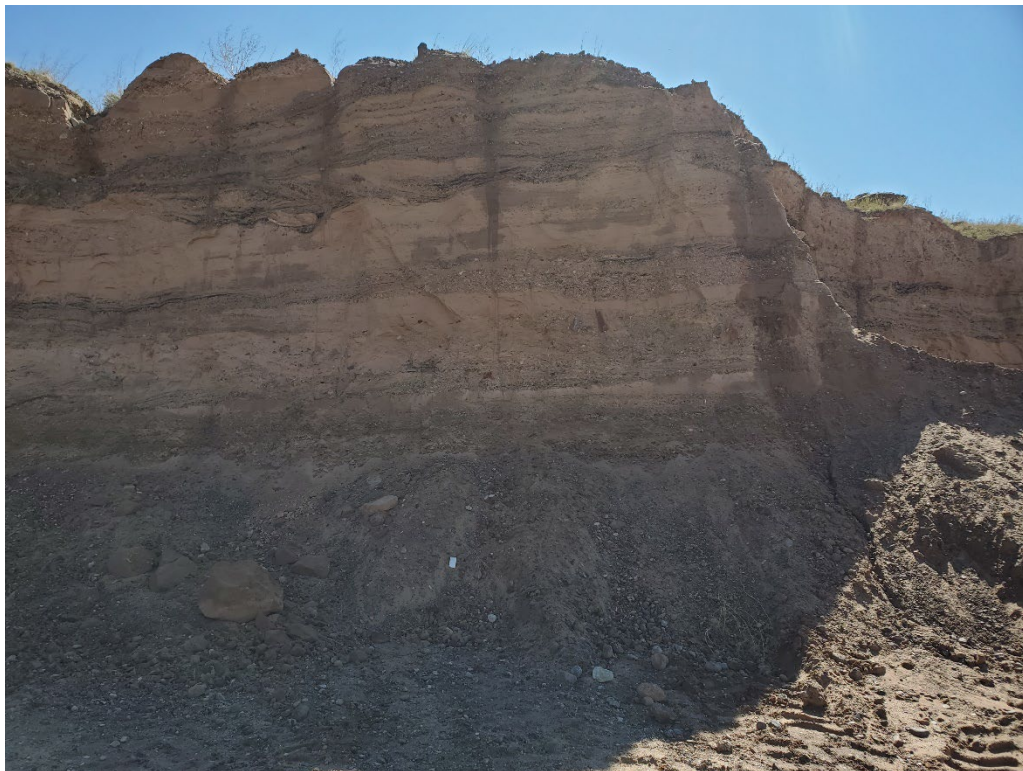
A permit sign is posted at the entrance to the permit in compliance with Rule 3.1.12(1) (Photo 6). During the inspection, the Division and the Operators walked around the perimeter of the permit boundary to locate the affected land boundary markers. The affected land boundary is marked with t-posts and the markers appear to be in compliance with Rule 3.12.1(2). The Division took coordinate points using the Esri Field Map application and synced the information with the Division's georeferenced permit boundary map using Esri ArcGIS Online. The Operator's *Map C-1 Aerial Photo* map included in revision CN1 (conversion application no. 1) was georeferenced and used to approximate the permit boundary location on the 2024 inspection map that has the boundary marker locations. Both Maps are enclosed at the end of this report.

**Photo 6:** Looking east at the highwall along the northeast side of the permit boundary. The notebook in the photo was used in combination with ImageJ to estimate the highwall height.

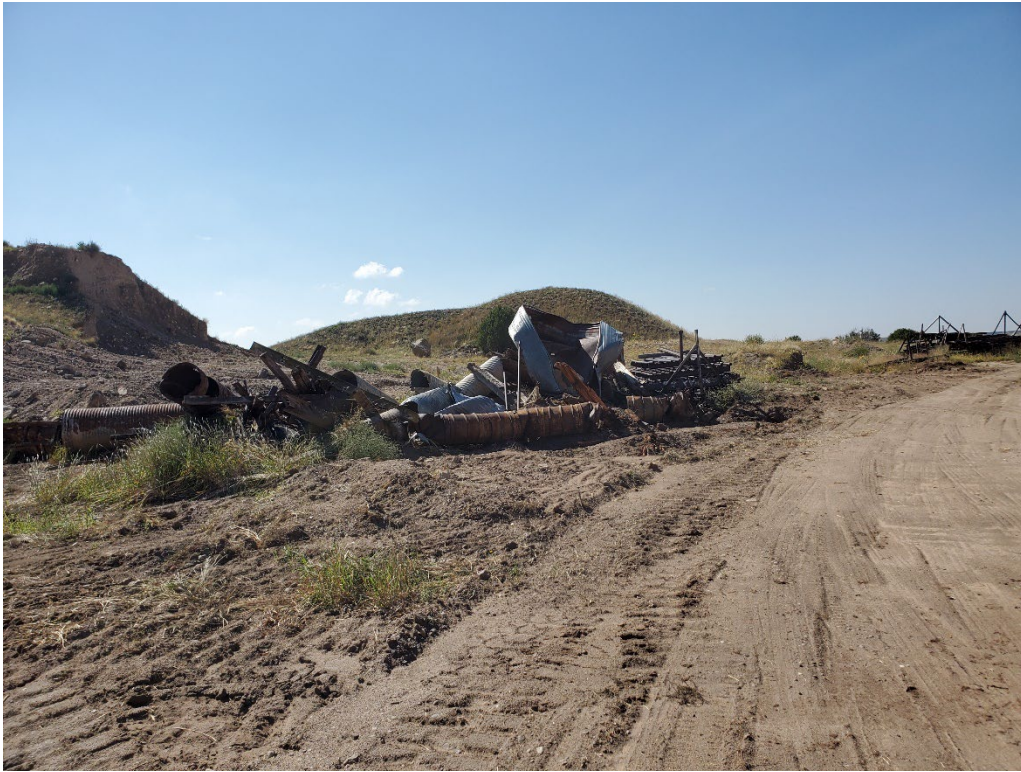
Addressing CT1 concern number 4, large amounts of scrap iron material was observed within the permit boundary (Photo 7). The Operators stated that they have collected some of the material, mostly consisting of old cattle grates, and that some of the material was brought onsite via other parties. The Operators have a plan to haul the material off-site and have begun to do so since the inspection was conducted. Storing scrap metal material on-site is not against the Division's regulations. However, it is against the Division's Rules and Regulations to backfill with any metal materials. The Division reminded the Operators that the material cannot be used for backfill and the Operators stated that it would not be used for that purpose.

**Photo 7:** Scrap metal stockpiled outside of the excavated area.

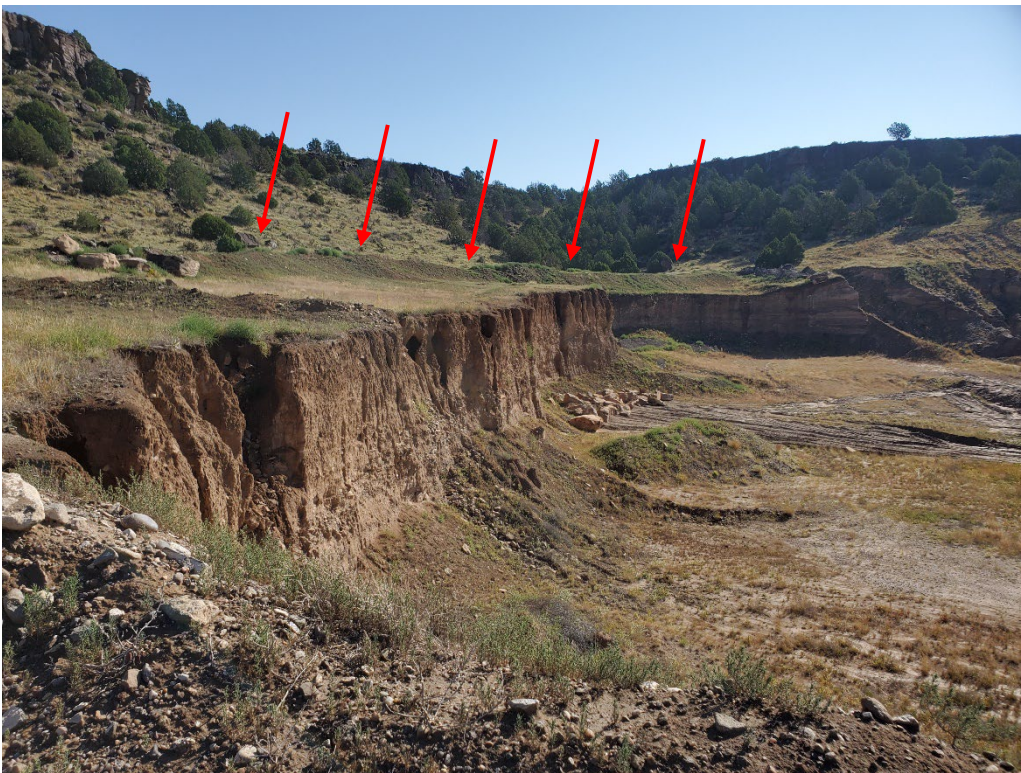
No reclamation work has yet been conducted at this site. The Operator stated that since they have finished mining in the north-east portion of the site, they plan to begin knocking down the highwalls in this area and backfilling the slopes. Overburden piles line the north-east side of the pit and will be used for backfilling and grading (Photo 8). The Division reminds the operator that the north-east portion of the disturbance is very close to the permitted boundary (see Map 2) and cautions the operator to maintain line of sight during reclamation to ensure that off-site disturbance is not created at that time.

**Photo 8:** Looking southeast along the north-eastern highwall. Arrows point to location of stockpiled overburden.

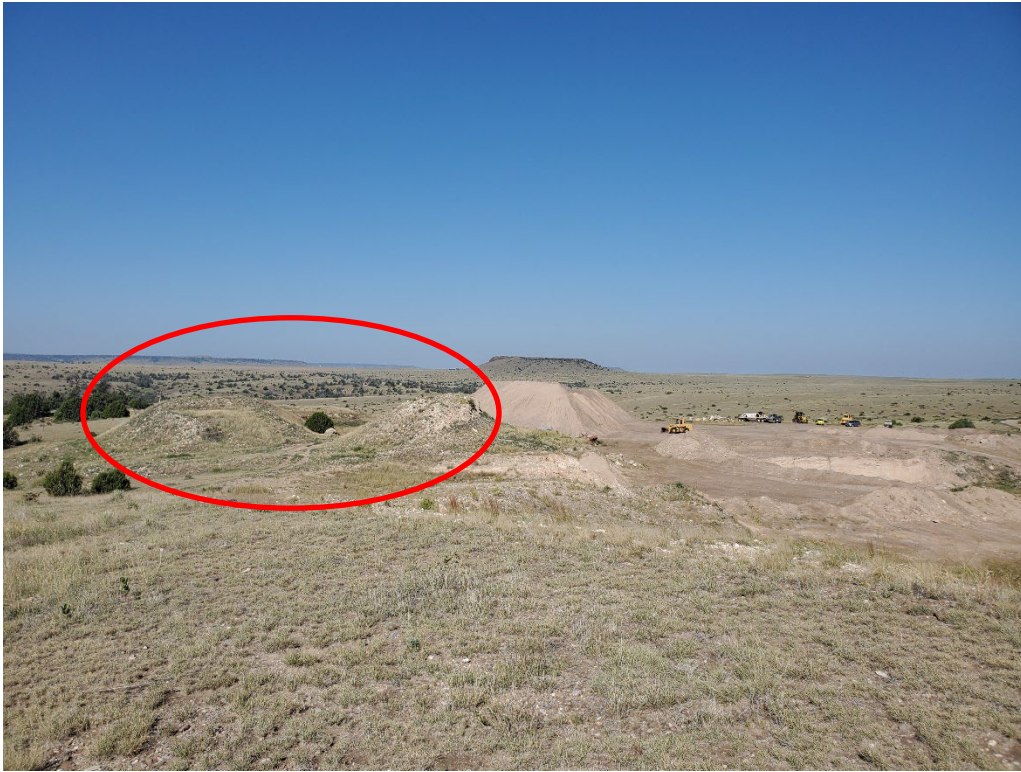
Topsoil stockpiles were observed along the southern sides of the permitted area (Photo 9). The piles were vegetated, out of the way of on-going mining activity, and appear to be stable.

**Photo 9:** Looking northwest from the southeastern boundary. Circled are the stockpiled topsoil piles along the southern side of the disturbance.

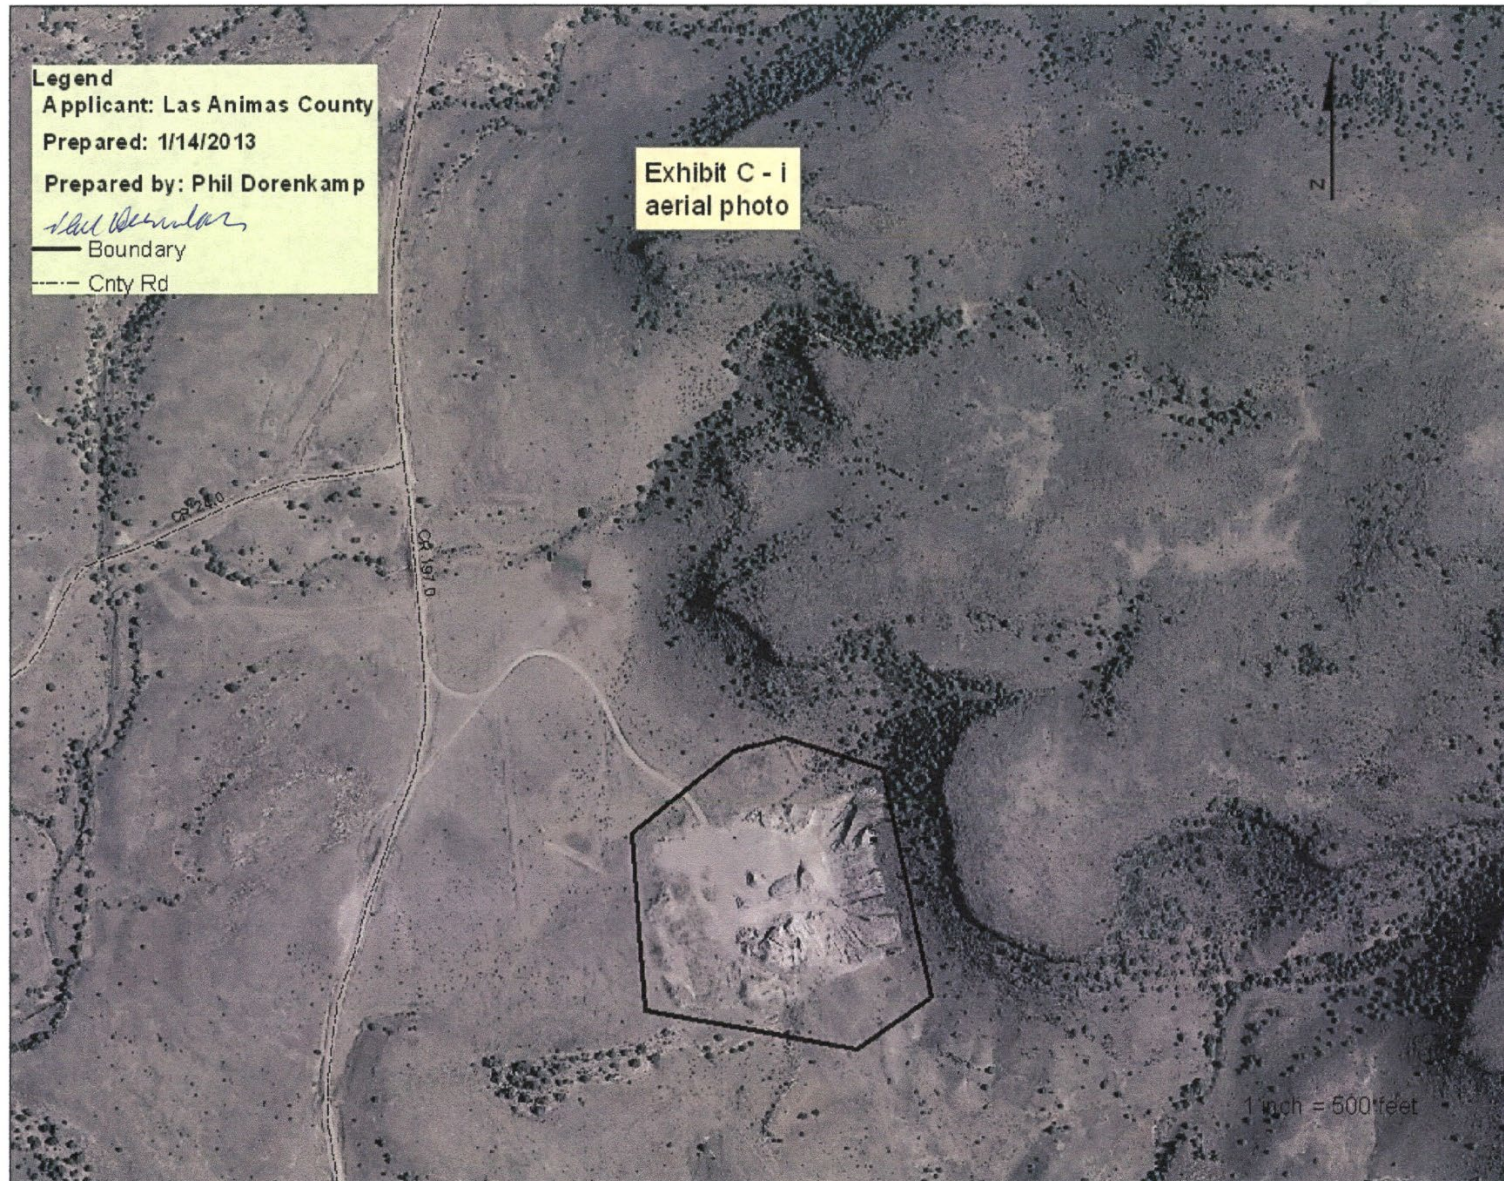
**Map 1:** *Map Exhibit C-i Aerial Photo* from the Operator's conversion (CN1) application package. This map shows the permitted boundary overlain onto an aerial photo.

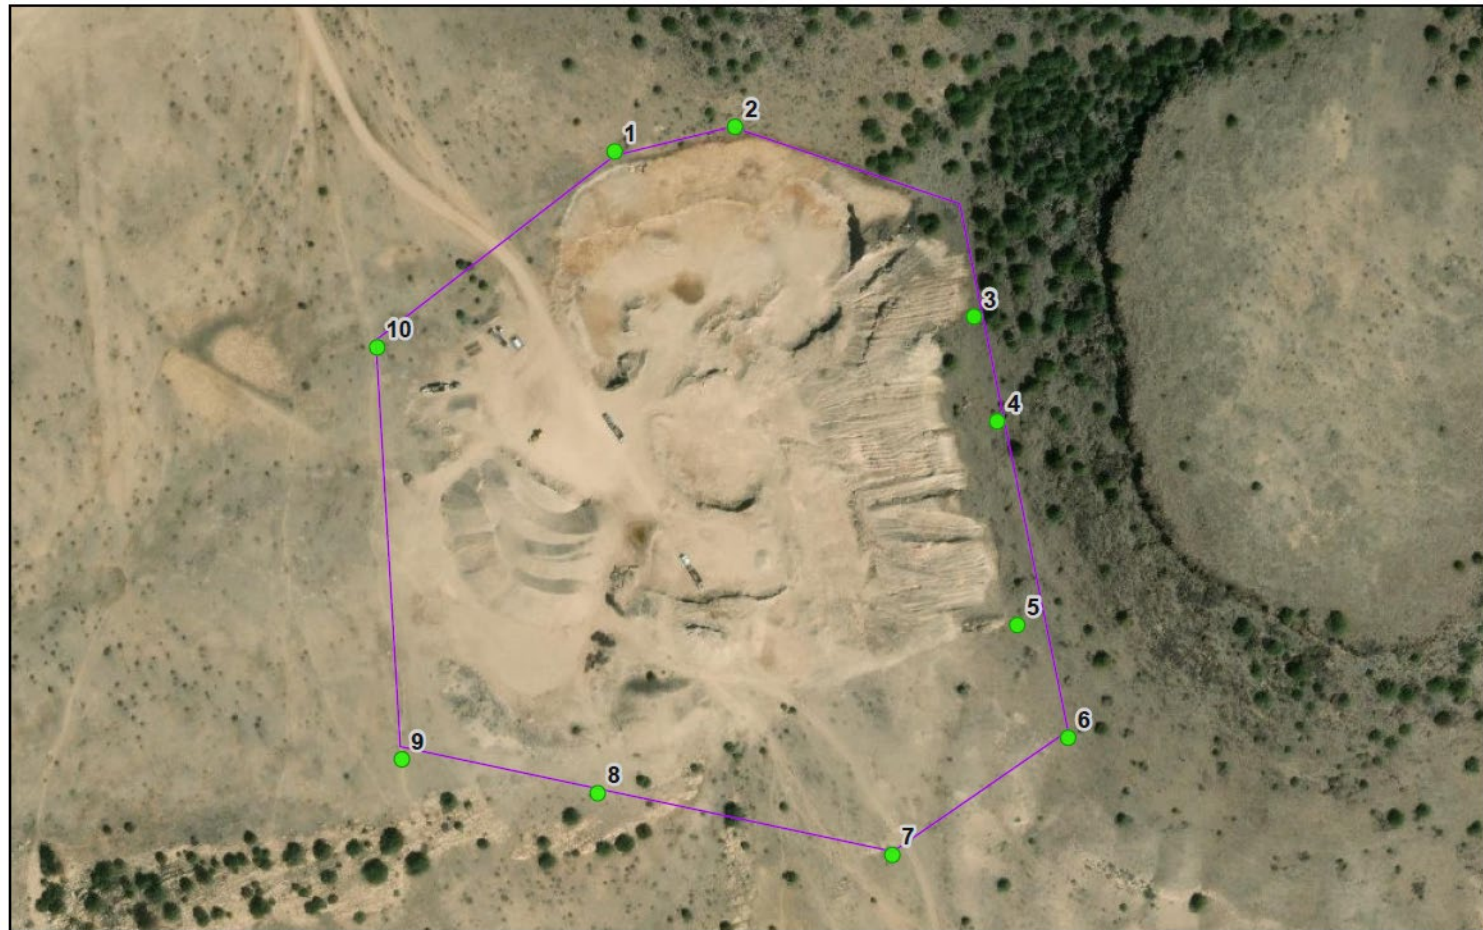
### Shannon Pit M-1979-163 Inspection Map

**Map 2:** Map generated using field data (collected in the Esri Field Maps application) in combination with a georeferenced boundary (purple line) in Esri ArcGIS Online. The green points indicate locations where t-posts were observed around the site. The posts appear to mostly agree with the permitted boundary. The Operator should be cautious when nearing the points that appear to possibly be located slightly past than the approved boundary.
