**MINERALS PROGRAM INSPECTION REPORT**  
**PHONE: (303) 866-3567**

<b>MINE NAME:</b> Debeque Sand and Gravel Resource	<b>MINE/PROSPECTING ID#:</b> M-2011-054	<b>MINERAL:</b> Gravel and sand	<b>COUNTY:</b> Mesa
<b>INSPECTION TYPE:</b> Monitoring	<b>WEATHER:</b> Clear	<b>INSP. DATE:</b> September 24, 2024	<b>INSP. TIME:</b> 09:00
<b>OPERATOR:</b> Oldcastle SW Group, Inc. dba United Companies	<b>OPERATOR REPRESENTATIVE:</b> Jesse Farmer	<b>TYPE OF OPERATION:</b> 112c - Construction Regular Operation	
<b>REASON FOR INSPECTION:</b> Normal I&E Program	<b>BOND CALCULATION TYPE:</b> Complete Bond	<b>BOND AMOUNT:</b> \$704,245.00	
<b>DATE OF COMPLAINT:</b> NA	<b>POST INSP. CONTACTS:</b> DRMS	<b>JOINT INSP. AGENCY:</b> None	
<b>INSPECTOR(S):</b> Amy Yeldell	<b>INSPECTOR'S SIGNATURE:</b>

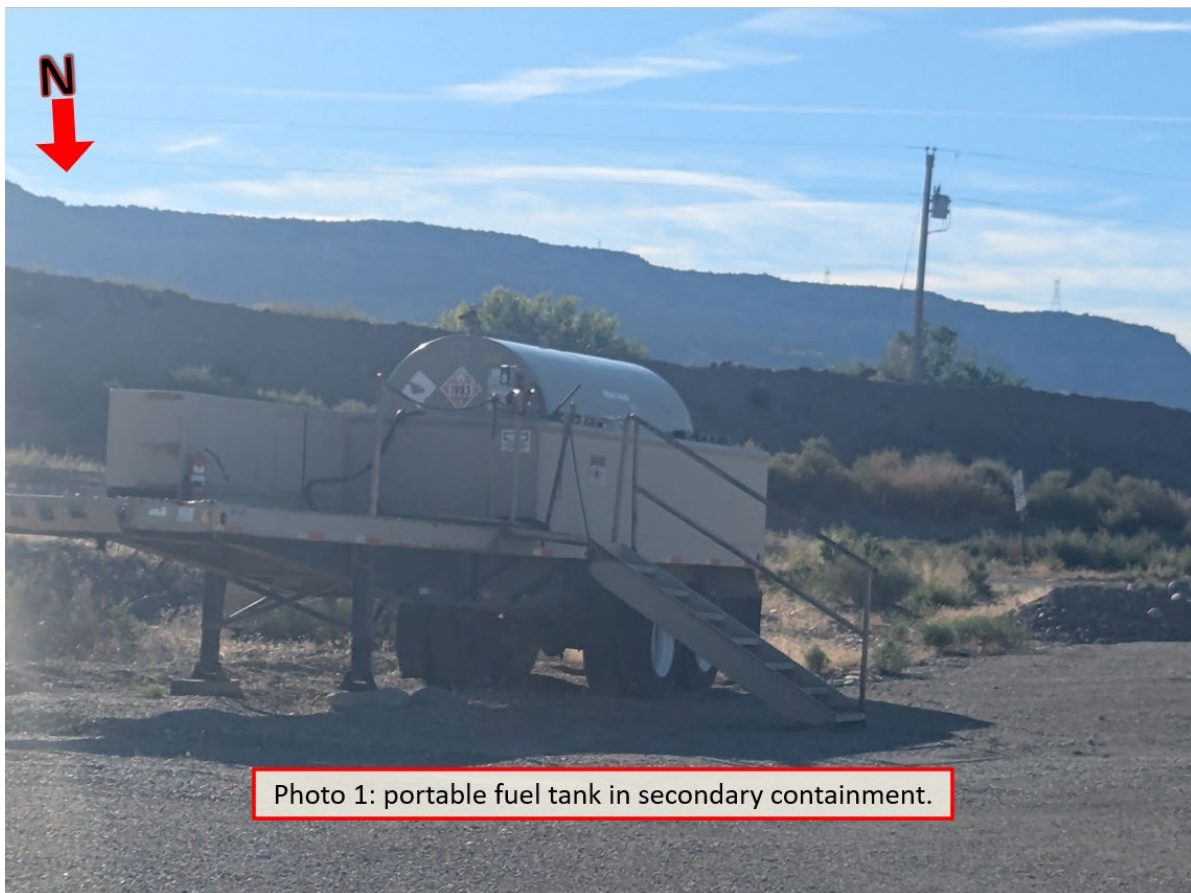
One large fuel tank is located adjacent to the scale and scale house (photo one). It was brought on site for the asphalt plant is anticipated to be removed. No other hazardous or toxic materials were observed on site.

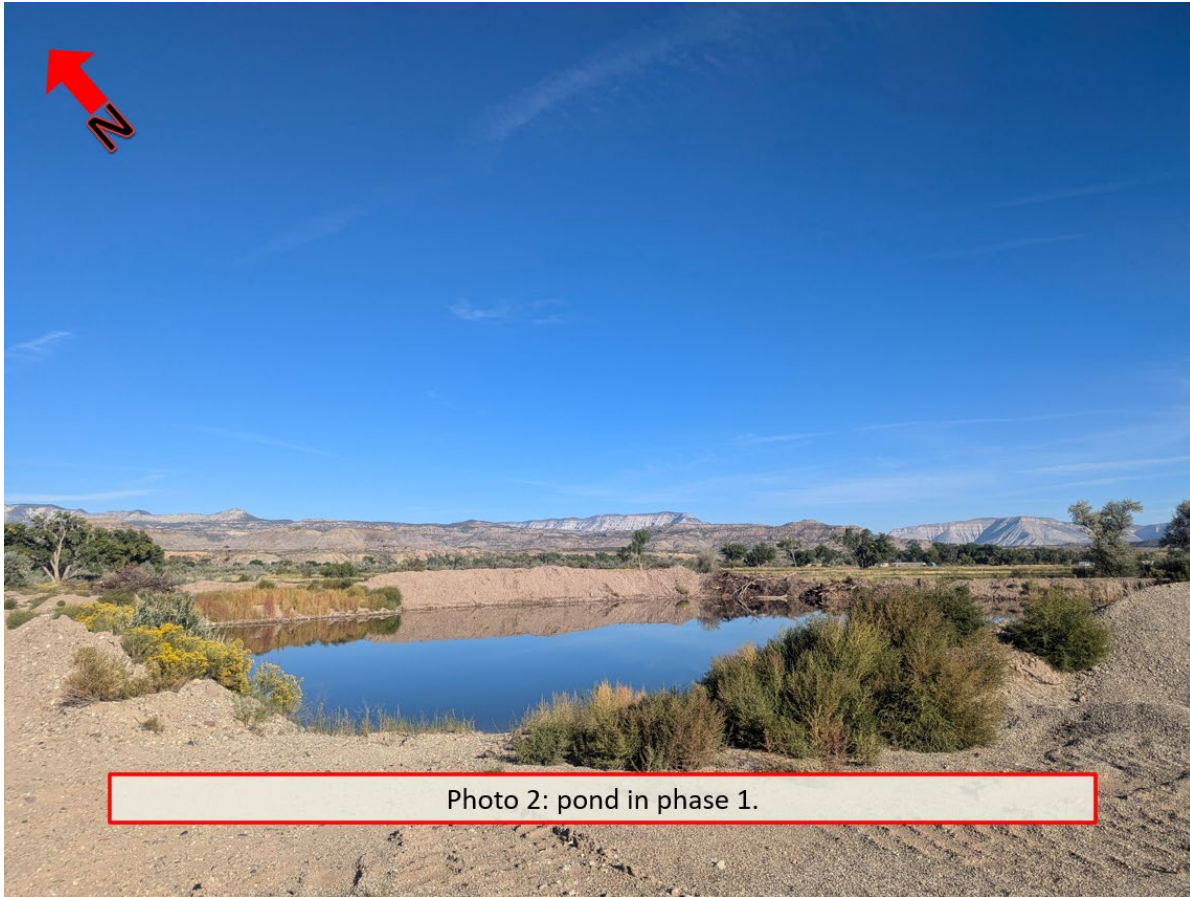
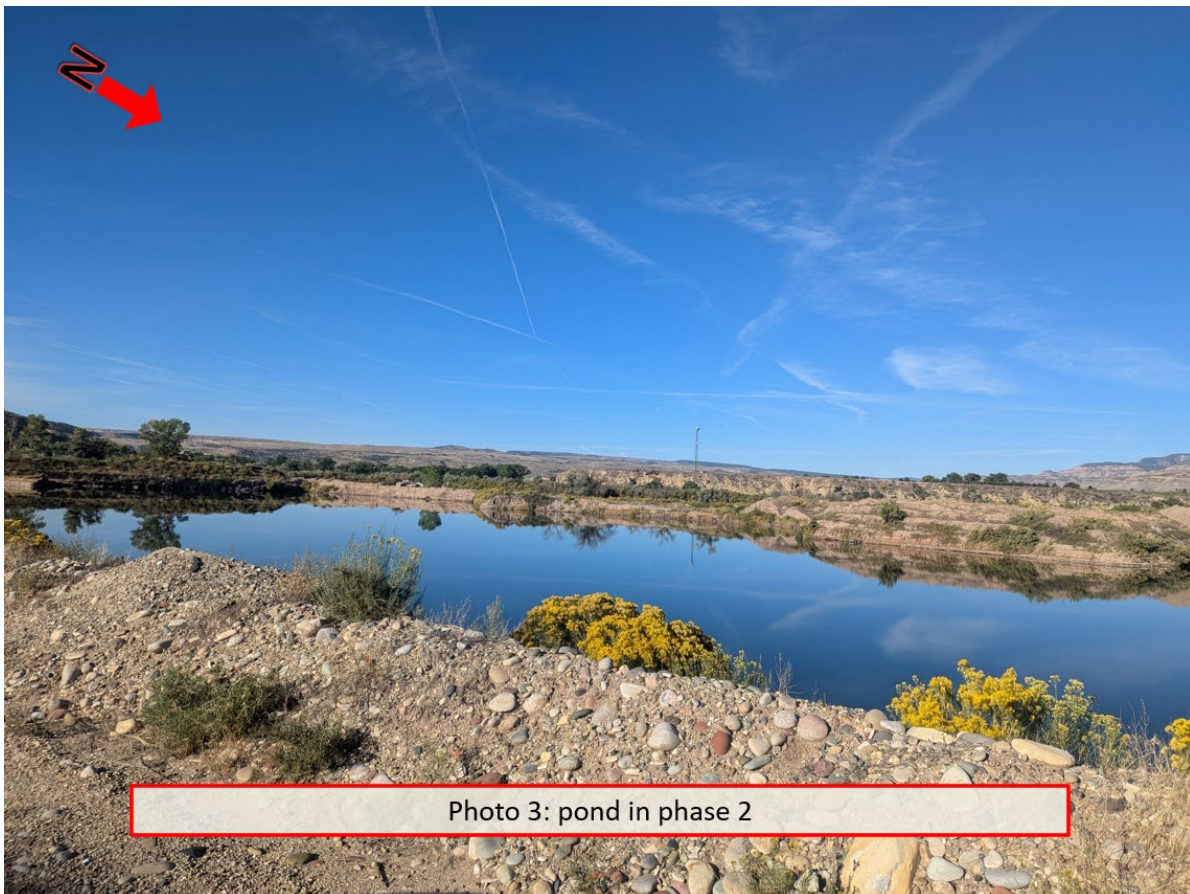
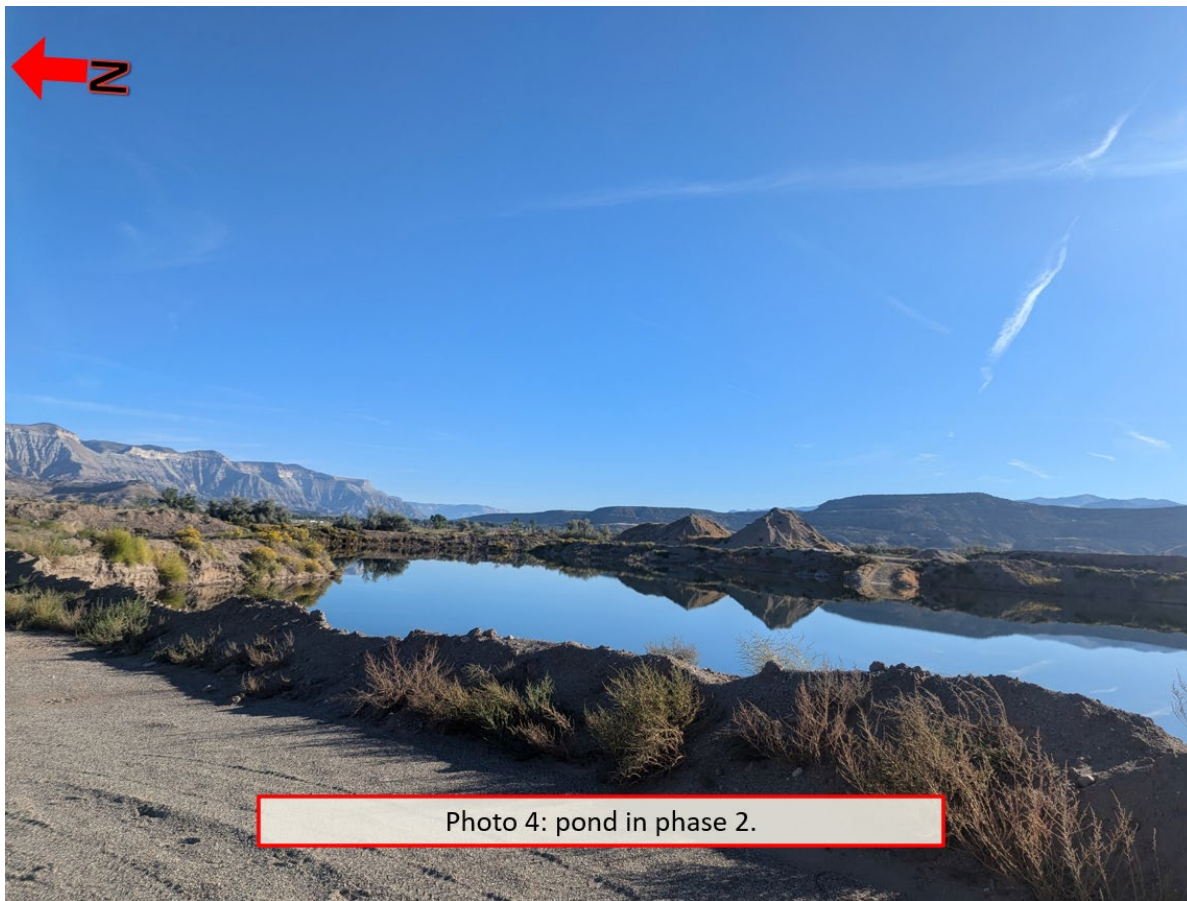
Two lakes are present (photos two – four). One in phase 1 and other on the western side of phase 2 and the northwest corner of phase 3. Both ponds have near vertical slopes around the entire length with a maximum depth of 25 feet. Until water rights are secured (future TR) all exposed groundwater will be backfilled.

The phase 2 and 3 pond is approximate 7.7 ac. The majority of process stockpiles are located on the east side of phase 2 (Photos five and six). Highwalls of the lakes appear to be near vertical. The ponds were inundated at the time of the inspection so slopes could not be verified. Between both lakes approximately 10 acres of water is exposed. Under TR-1 eventually only one lake in phase 3 will remain with a surface area of 10.6 acres.

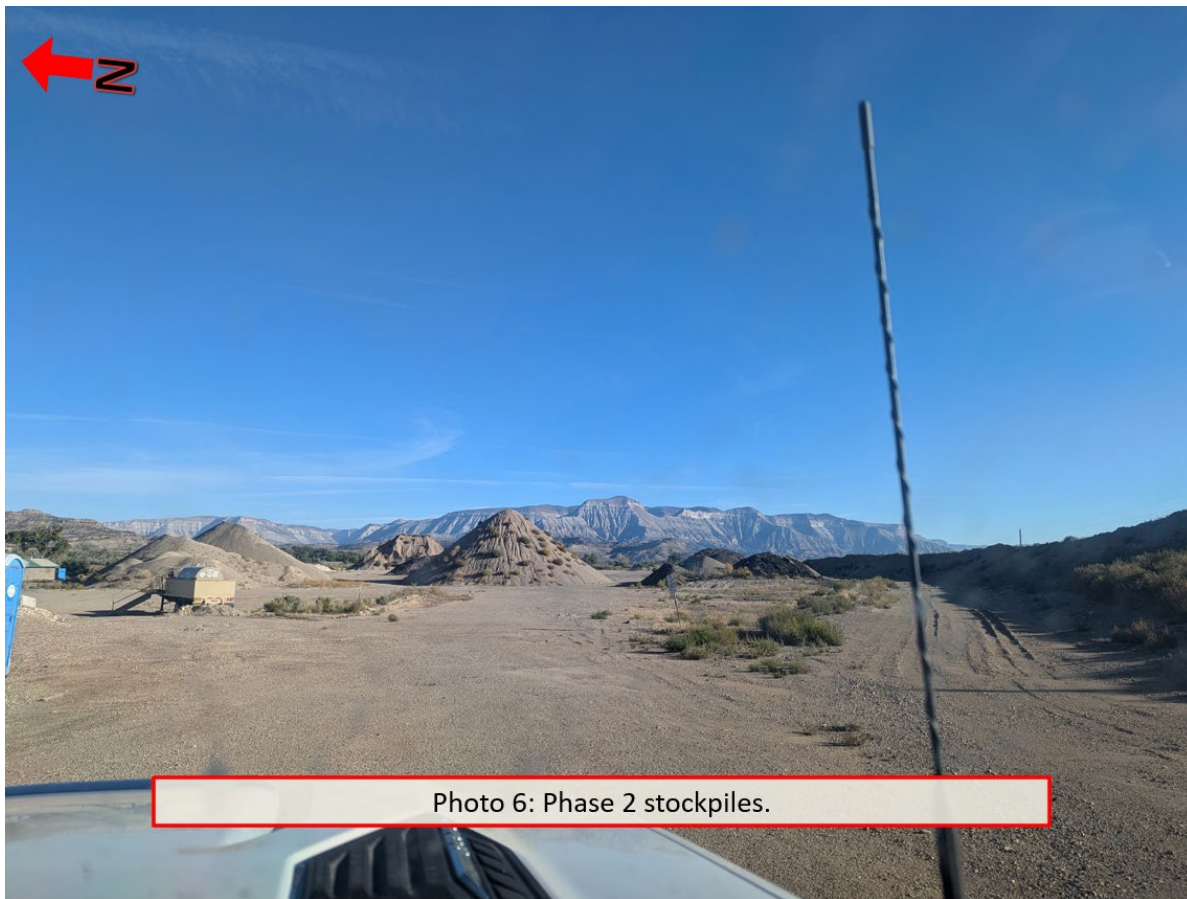
Photo 6: Phase 2 stockpiles.

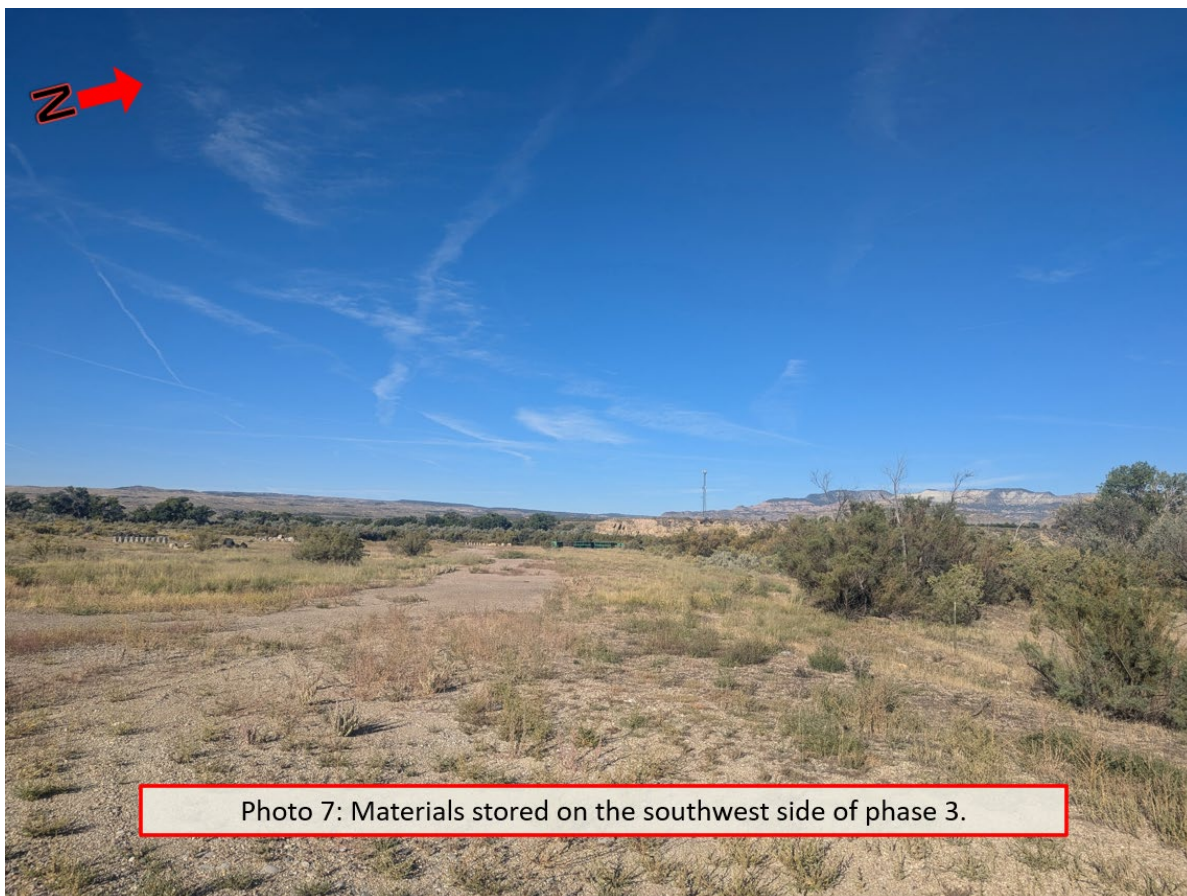
Currently both phases 1 and 2 are completely affected and the northwest portion of Phase 3 has also been affected by mining. The southwest corner of phase 3 continues to store jersey barriers but appears to not have been mined (photo seven). Phase 1 appears to be completely mined out. Currently there is approximate 2.4 acres of a pond that has yet to be backfilled in addition to the small sediment dewatering sump that will remain until the completion of mining.

Photo 7: Materials stored on the southwest side of phase 3.

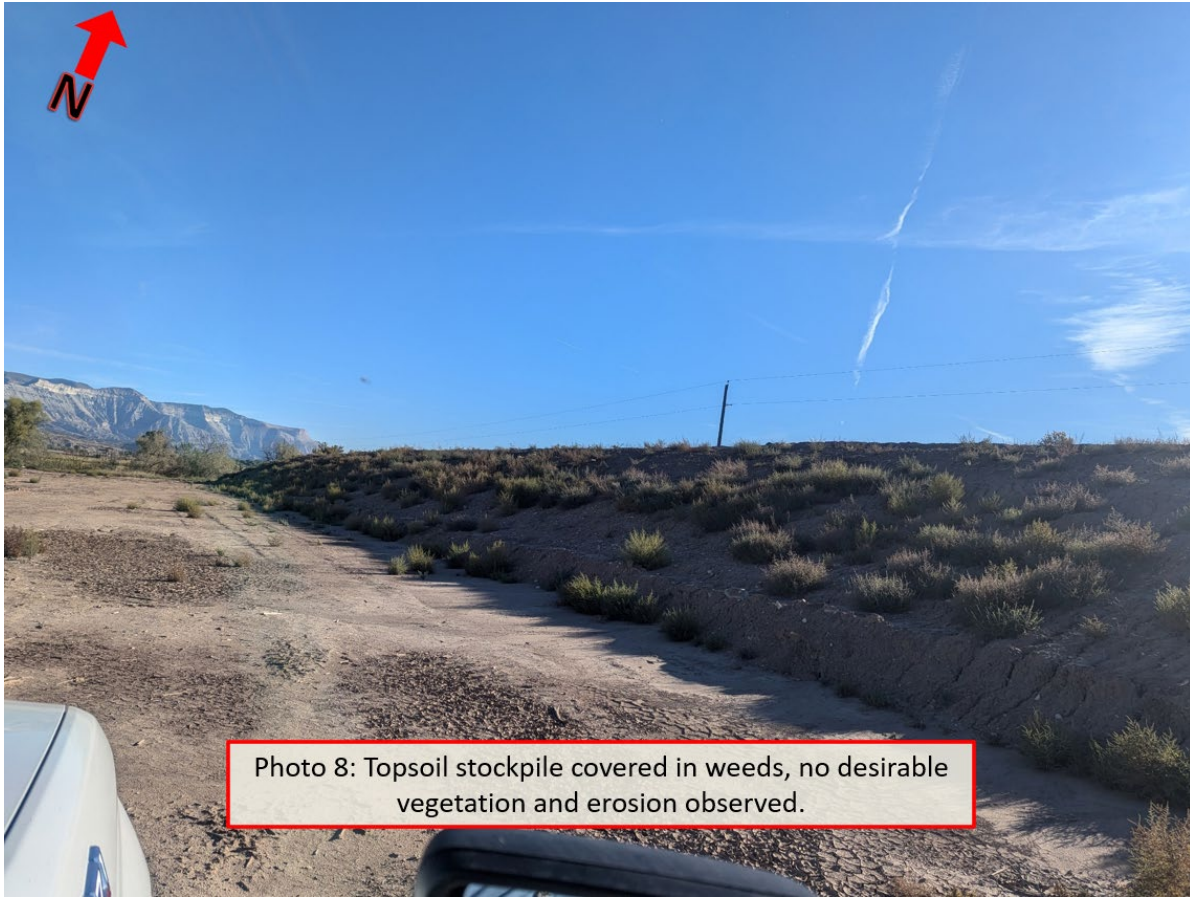
**PROBLEM/POSSIBLE VIOLATION:** Problem: The topsoil stockpiles do not have established vegetation on them and are therefore susceptible to erosion. Rule 3.1.9(1) states if topsoil is not replaced into the backfill area within a time short enough to avoid deterioration of the topsoil, vegetative cover or other means shall be employed so that the topsoil is protected from erosion.

The main topsoil stockpile remains void of a temporary cover and is bare or undesirable plants (photo eight). This is cited as a problem. Similar observations were noted in 2021, and the Division recommended additional seeding and vigilant noxious weed management of stockpiles. There appears to have been no further efforts to protect salvaged topsoil. The operator shall reseed the topsoil stockpiles this fall unless stockpiles will be reapplied in fall of 2024. Indicate to the Division which option was perused and provide photo documentation by the corrective action date

Photo 8: Topsoil stockpile covered in weeds, no desirable vegetation and erosion observed.

**CORRECTIVE ACTIONS:** The operator shall seed the stockpiles with the seed mix that was submitted as part of the approved Reclamation Plan. If no seed mix has been provided, the operator shall submit a seed mix for approval as a technical revision to the permit along with the appropriate \$216 revision fee to the Division by the corrective action date. The Operator shall demonstrate compliance by submitting seed tags, a bill of sale or photographs of seeding activities. The Operator may also request a follow up inspection.

**CORRECTIVE ACTION DUE DATE:** 12/31/24
