COLORADO
Division of Reclamation,
Mining and Safety
Department of Natural Resources

**RE: Response to Citizen Complaint; Abundant Resources Colorado, LLC;
Permit File No. M-2024-047**

MINERALS PROGRAM INSPECTION REPORT
PHONE: (303) 866-3567

MINE NAME: Abundant Resource Site	MINE/PROSPECTING ID#: M-2024-047	MINERAL: Unknown	COUNTY: Weld
INSPECTION TYPE: Possible Illegal, Unpermitted Operation	WEATHER: Clear	INSP. DATE: September 23, 2024	INSP. TIME: 09:30 a.m.
OPERATOR: Abundant Resources Colorado, LLC	OPERATOR REPRESENTATIVE: Louise Knowles	TYPE OF OPERATION: ILL – Illegal (Possible)	
REASON FOR INSPECTION: Citizen Complaint	BOND CALCULATION TYPE: None	BOND AMOUNT: N/A	
DATE OF COMPLAINT: 9/12/2024	POST INSP. CONTACTS: None	JOINT INSP. AGENCY: None	
INSPECTOR(S): Patrick Lennberg	INSPECTOR'S SIGNATURE:

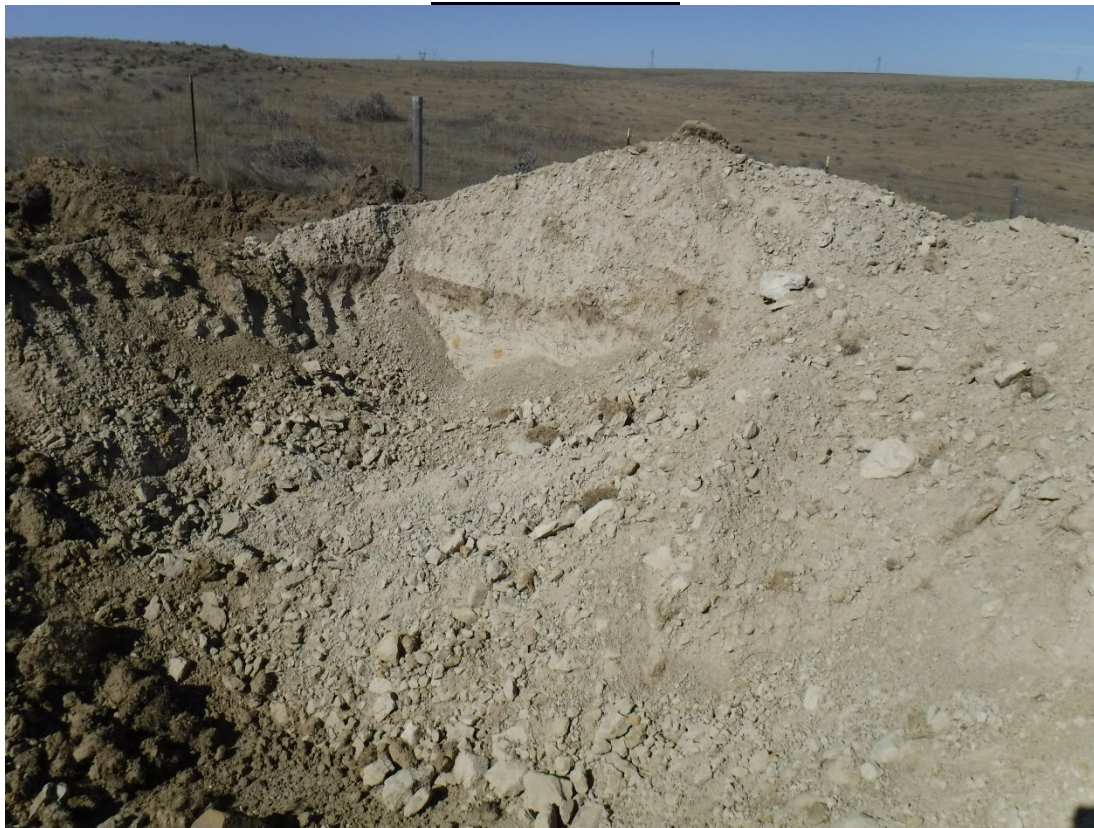
Photo 1: Typical pit dug at the site, clay with sandstone

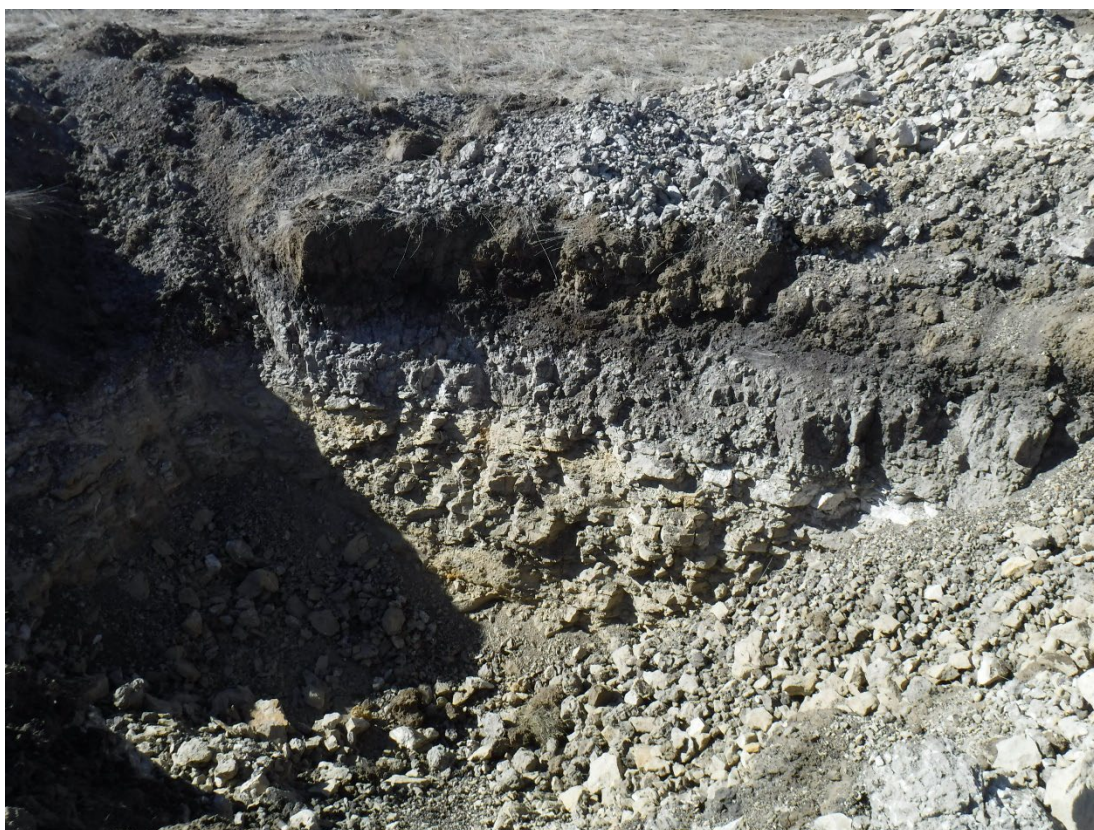
Photo 2: Another pit dug at the site, topsoil loam to weathered bedrock (sandstone)

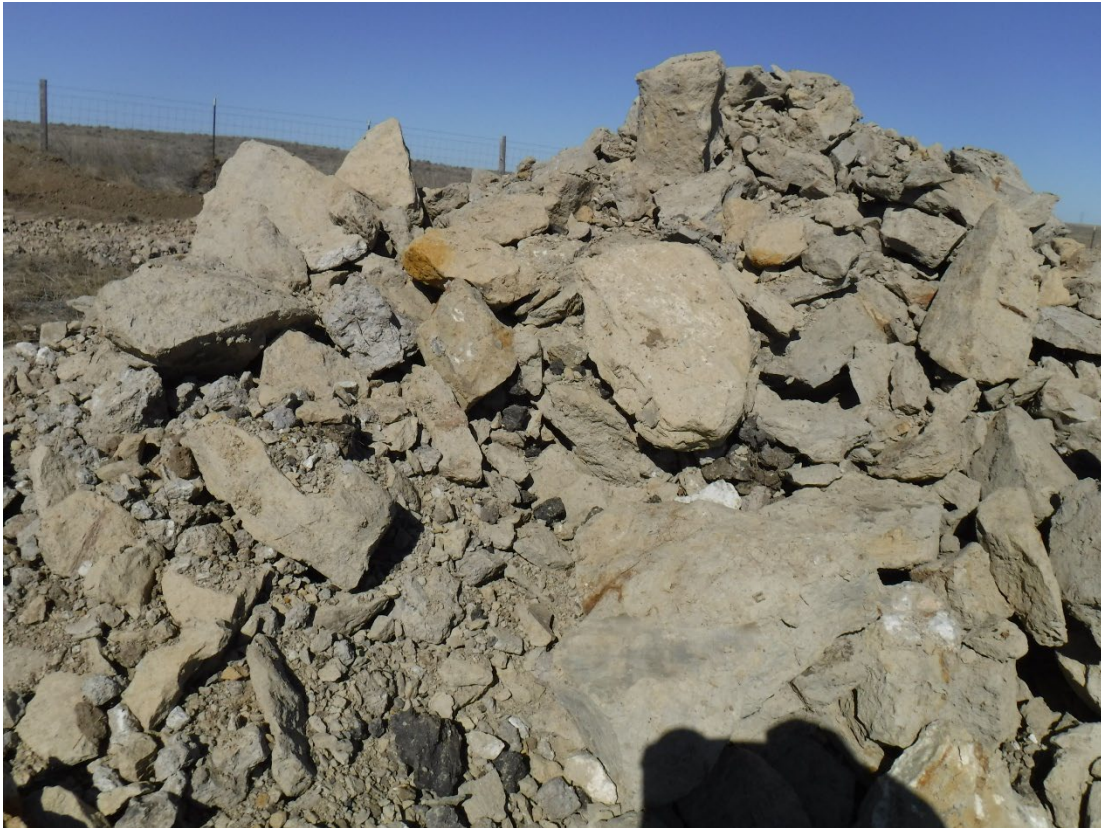
Photo 3: Typical weathered bedrock (sandstone)

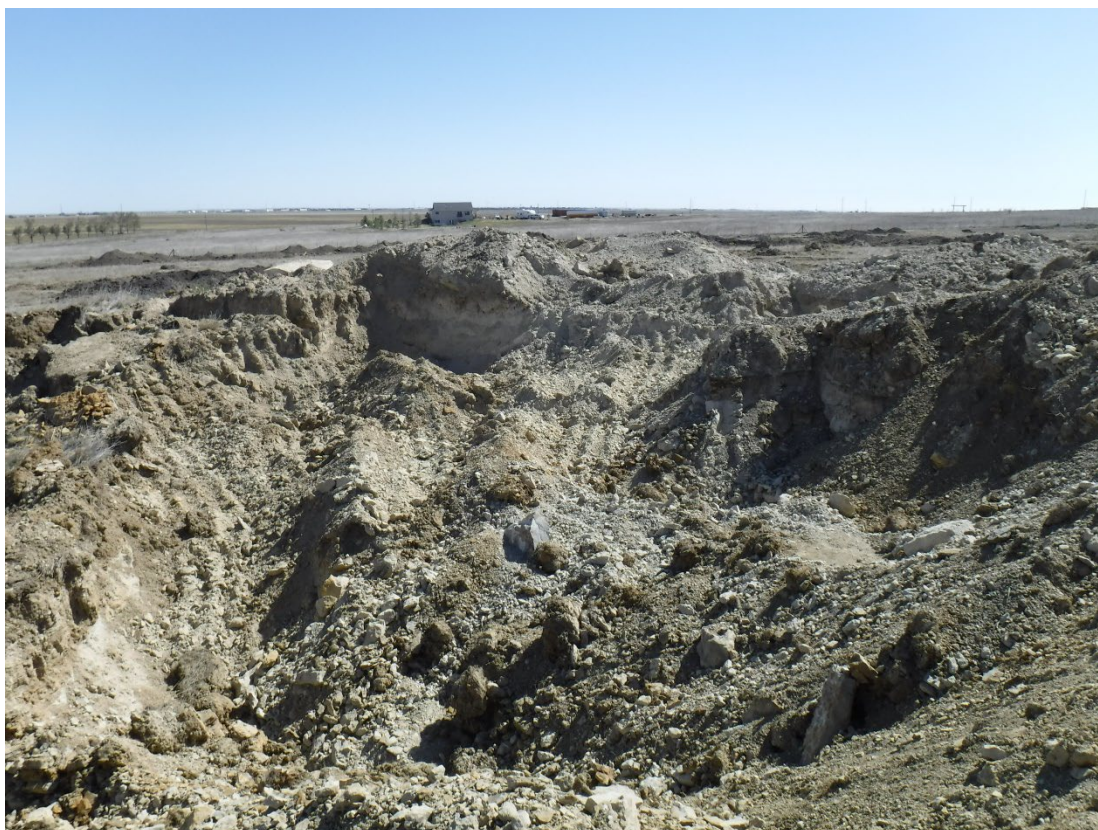
Photo 10: Pit near midpoint of the northeast quadrant of the property
