MINERALS PROGRAM INSPECTION REPORT
PHONE: (303) 866-3567

MINE NAME: Howe Pit	MINE/PROSPECTING ID#: M-1978-052	MINERAL: Sand and gravel	COUNTY: Adams
INSPECTION TYPE: Surety Release Inspection	WEATHER: Sunny and Clear	INSP. DATE: September 24, 2024	INSP. TIME: 07:30
OPERATOR: City & County of Denver, Board of Water Commissioners	OPERATOR REPRESENTATIVE: Brad Piede	TYPE OF OPERATION: 112c - Construction Regular Operation	
REASON FOR INSPECTION: Surety Release Requested	BOND CALCULATION TYPE: NA	BOND AMOUNT: NA	
DATE OF COMPLAINT: NA	POST INSP. CONTACTS: None	JOINT INSP. AGENCY: None	
INSPECTOR(S): Nikie Gagnon	INSPECTOR'S SIGNATURE:

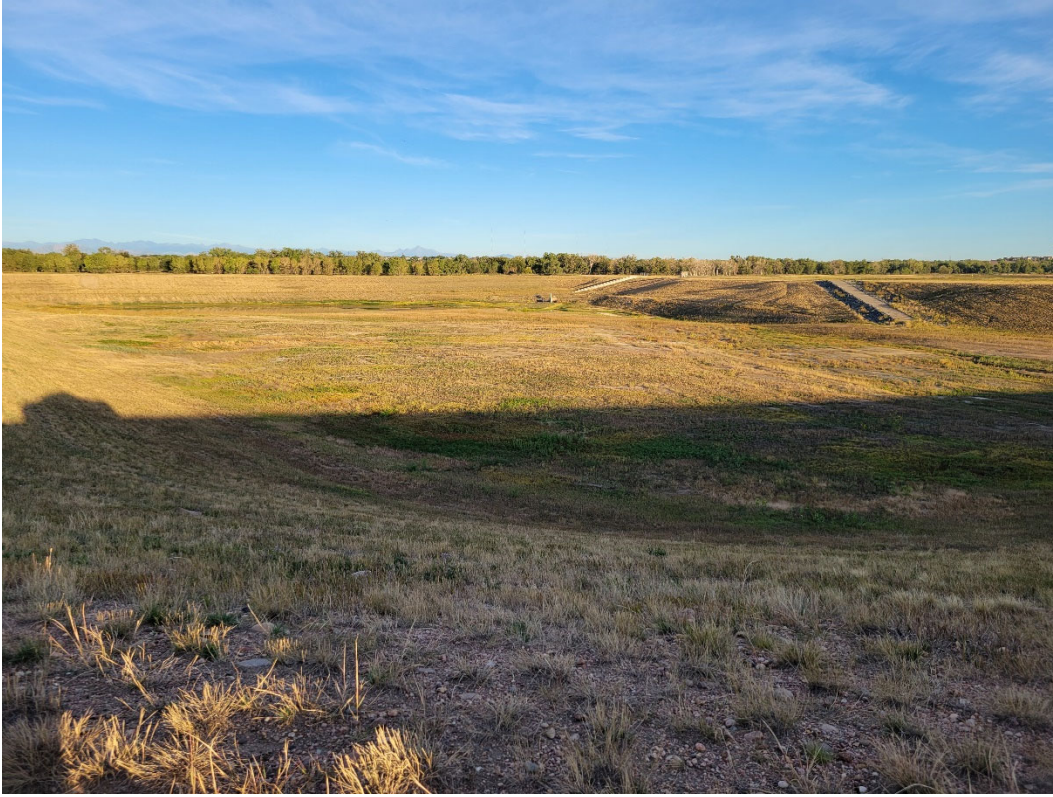
Photo 1: Looking west across Reservoir A from the southeast corner.

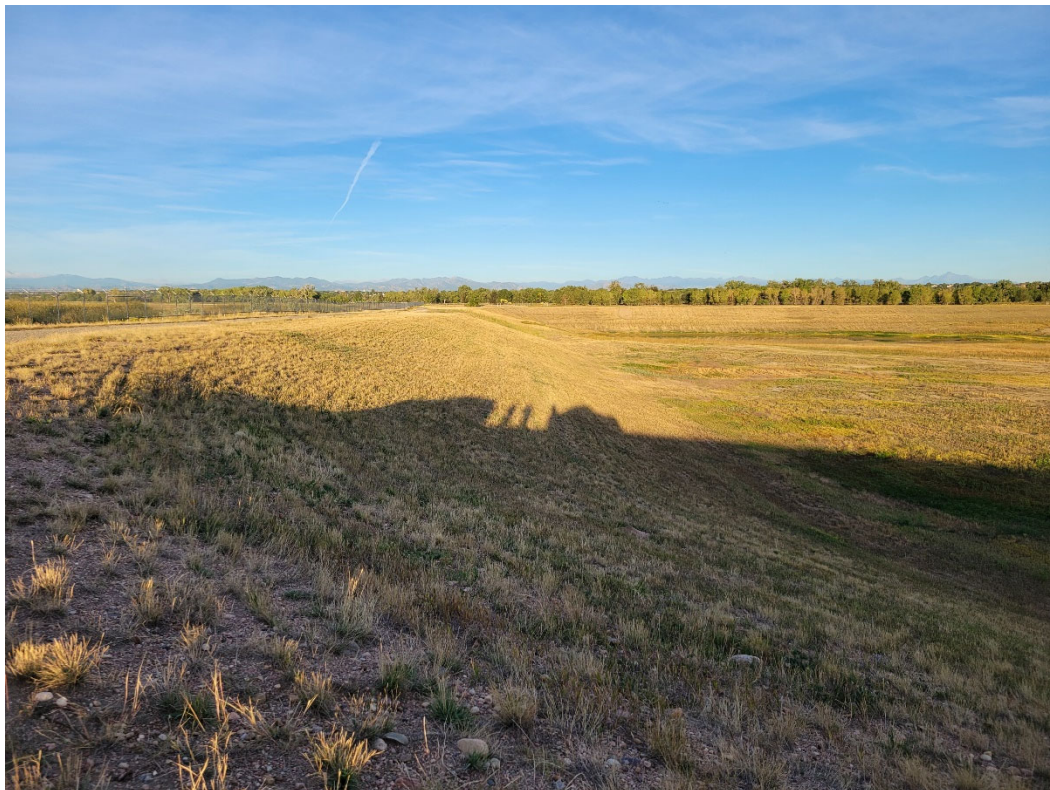
Photo 2: Looking west along the south slope of Reservoir A.

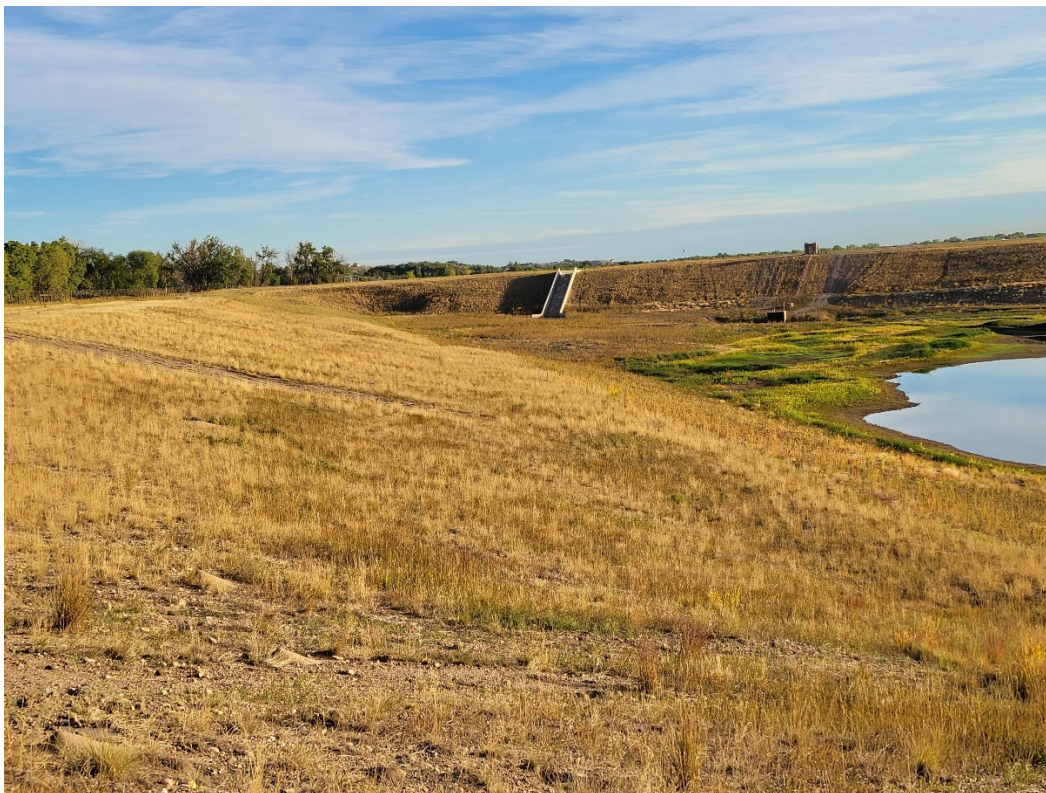
Photo 3: Looking north across the west slope of Reservoir A from the southwest corner.

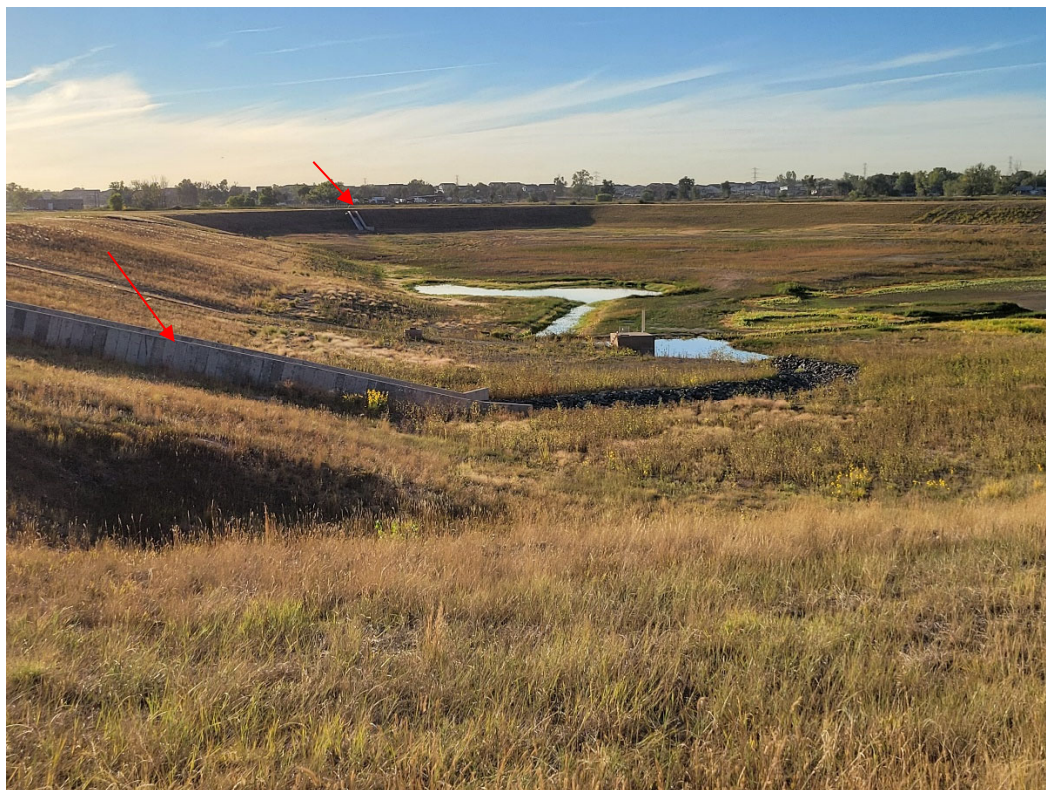
Photo 4: Looking east across Reservoir A from the northwest corner. Rundown structure on the left and intake structure on the far end.

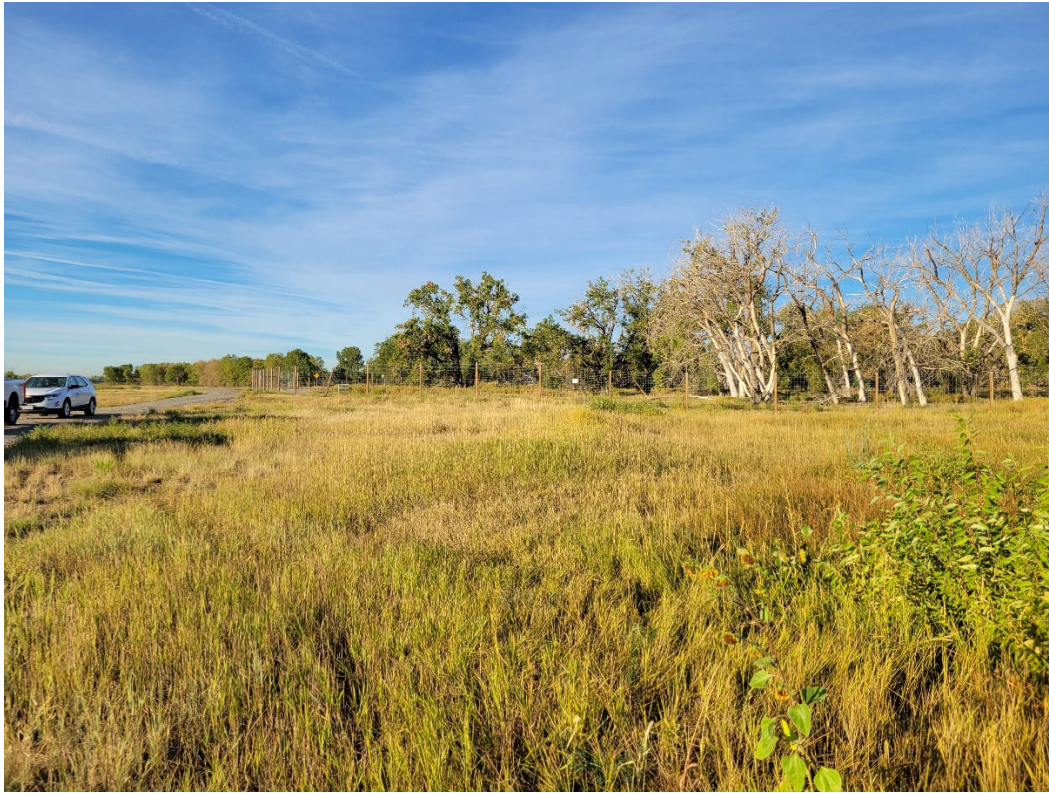
Photo 5: Looking south along the western permit boundary.

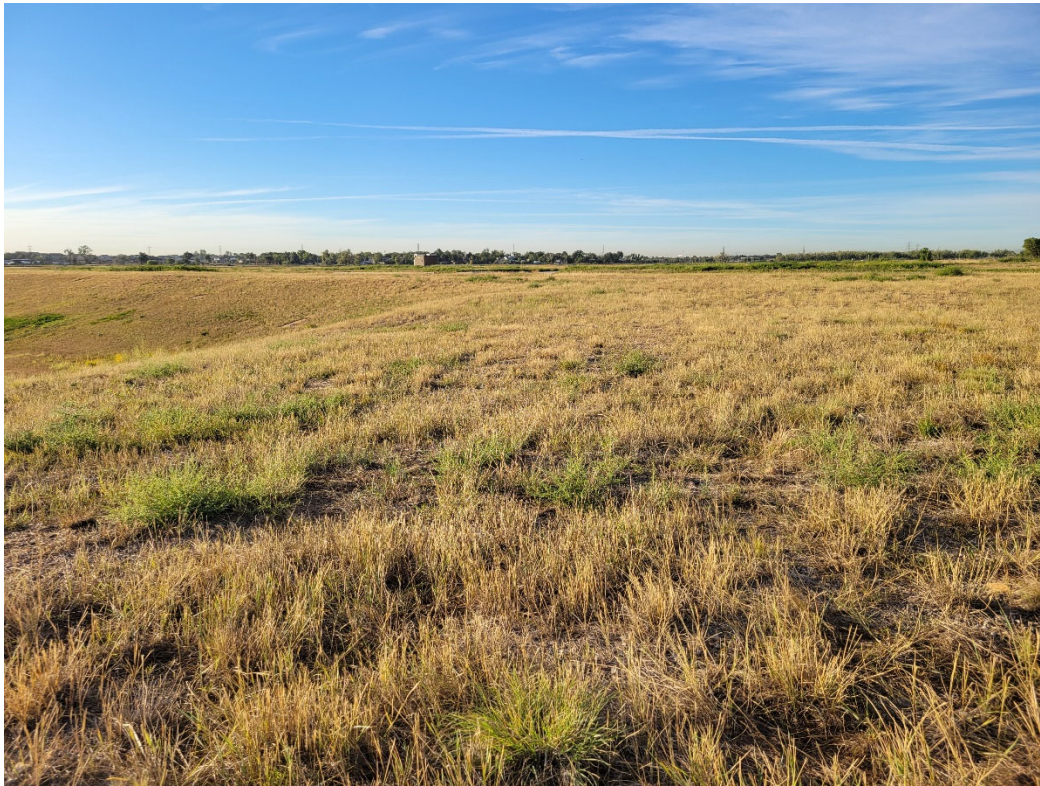
Photo 6: Looking at 2013 flood repair area.

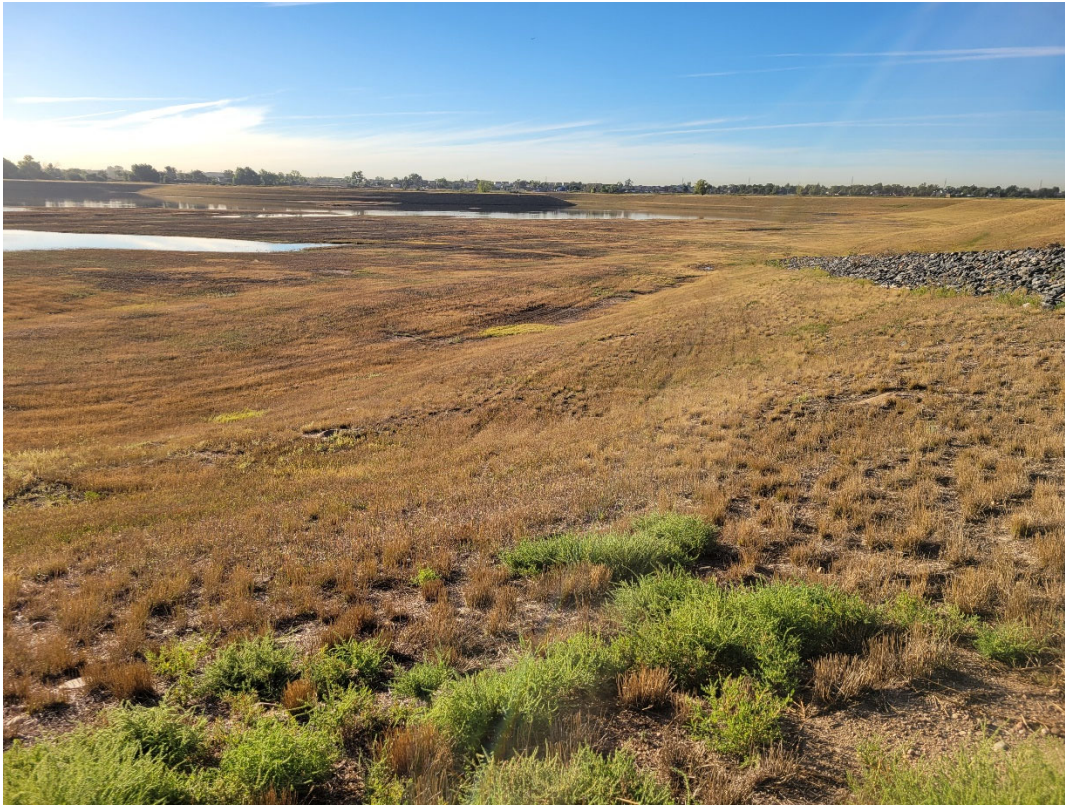
Photo 7: Looking east across Reservoir B from the northwest corner.

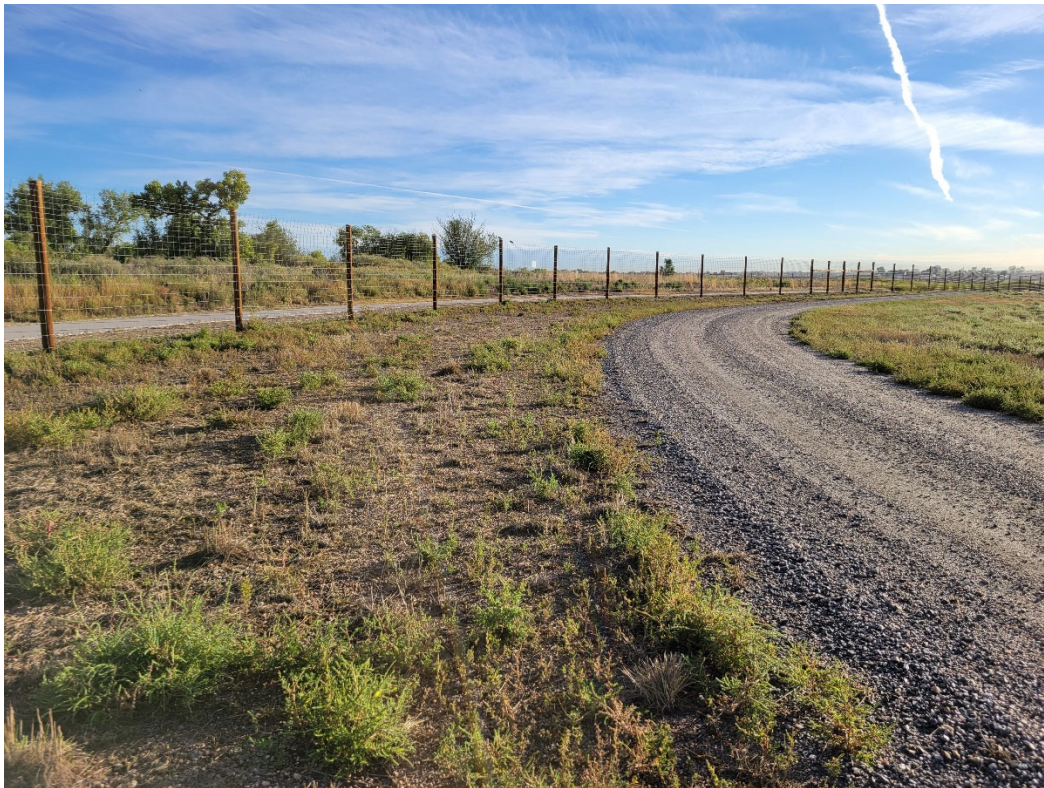
Photo 8: Looking bike path and access road on the west side of Reservoir A. Fence is installed along the bike path on the west side of the permit area.

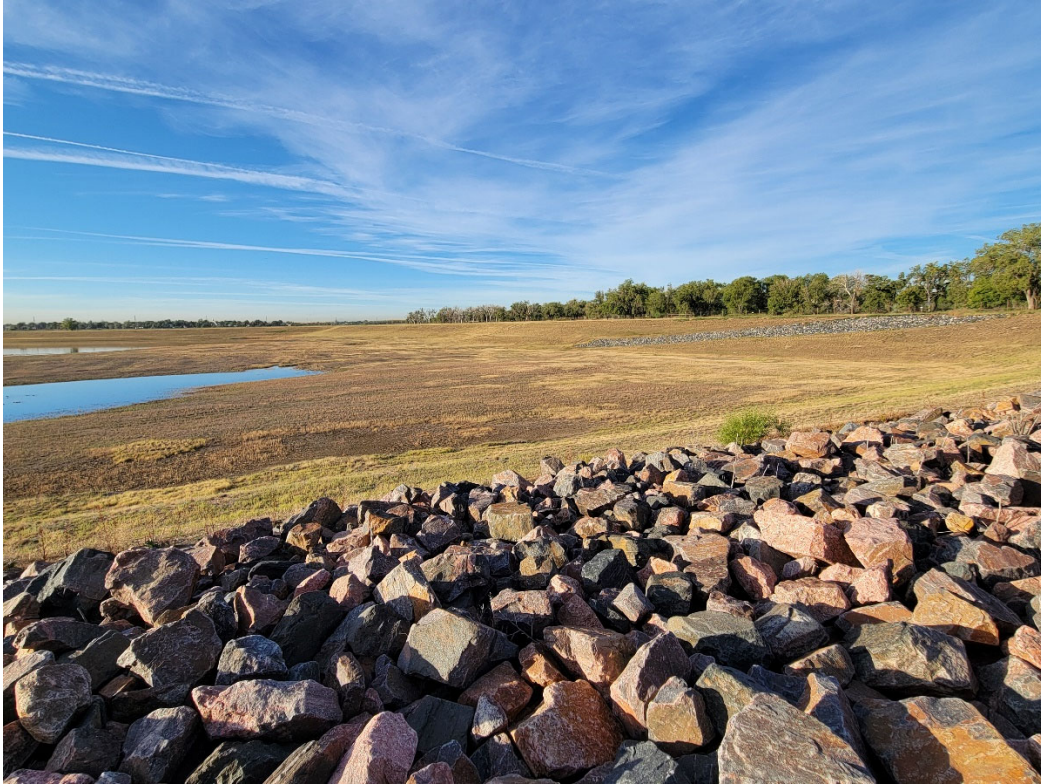
Photo 9: Looking southeast at the west end of Reservoir B. Rip rap rundown structure connects Reservoir B to future Hazeltine Reservoir (Permit No. M-1977-153).

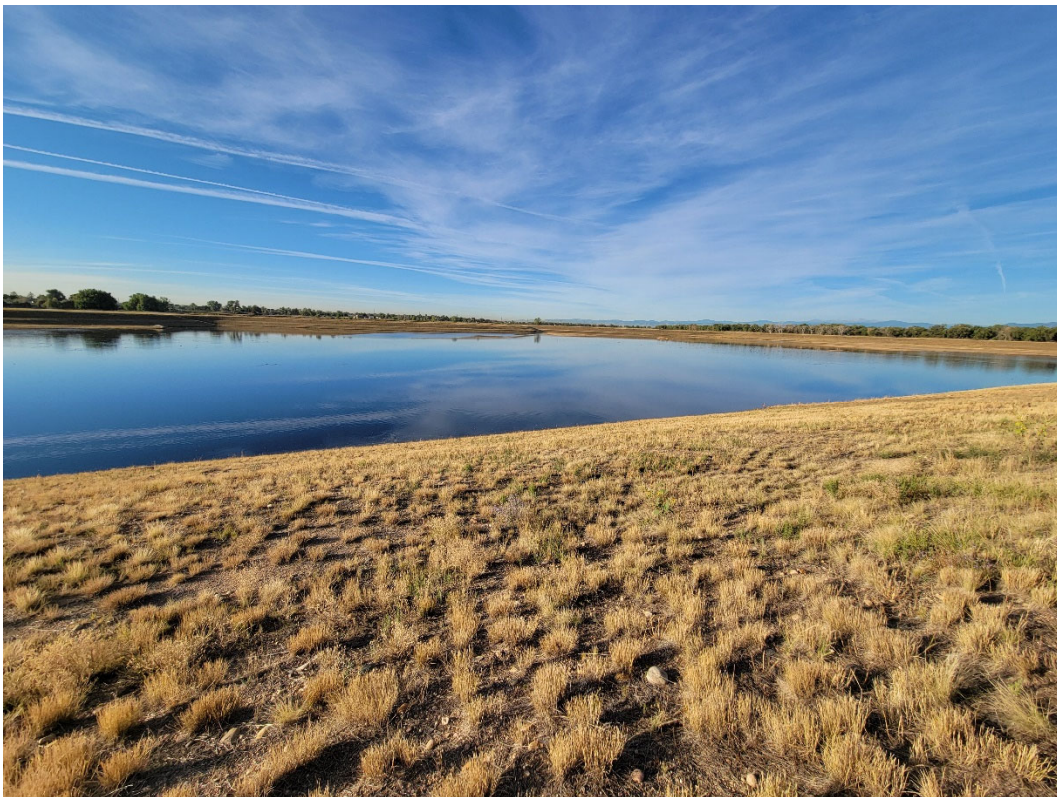
Photo 10: Looking southwest across Reservoir B from the north side.

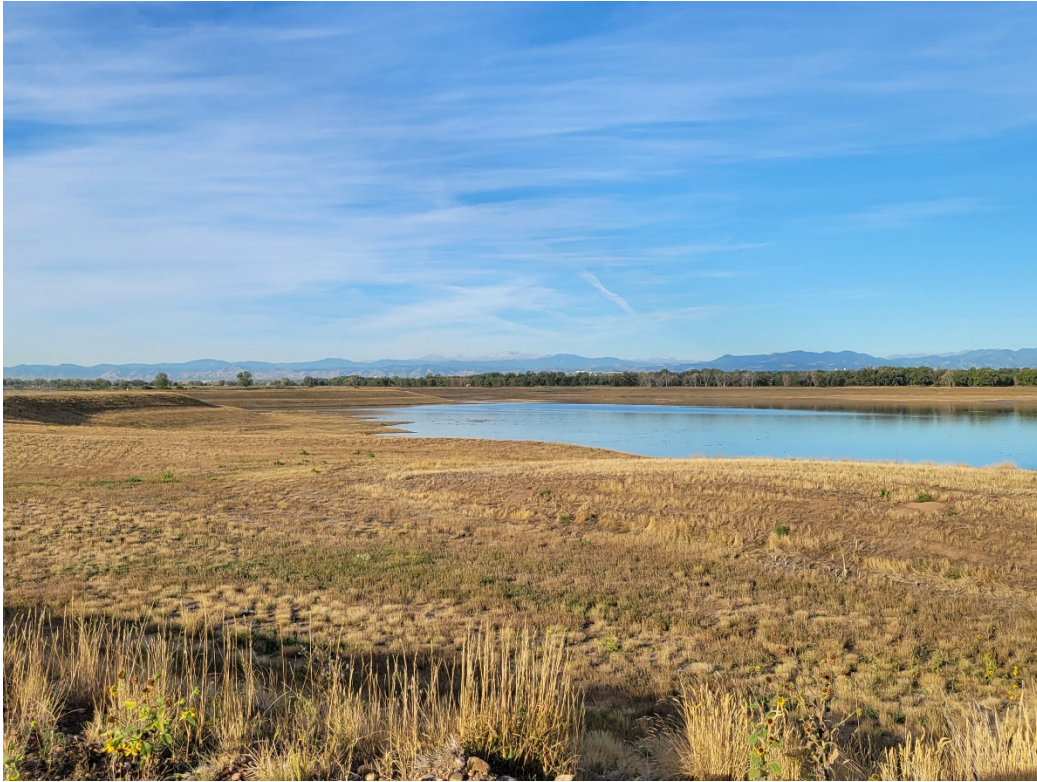
Photo 11: Looking west across Reservoir B from the northeast corner.

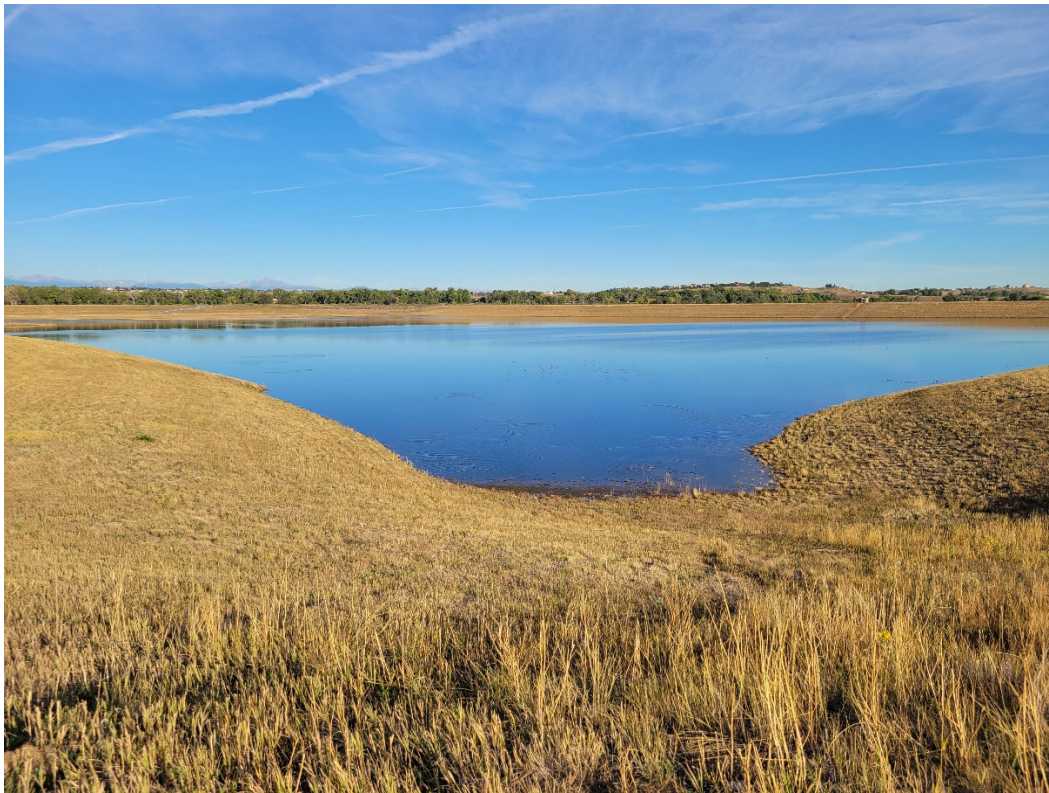
Photo 12: Looking west across Reservoir B from the southeast corner.

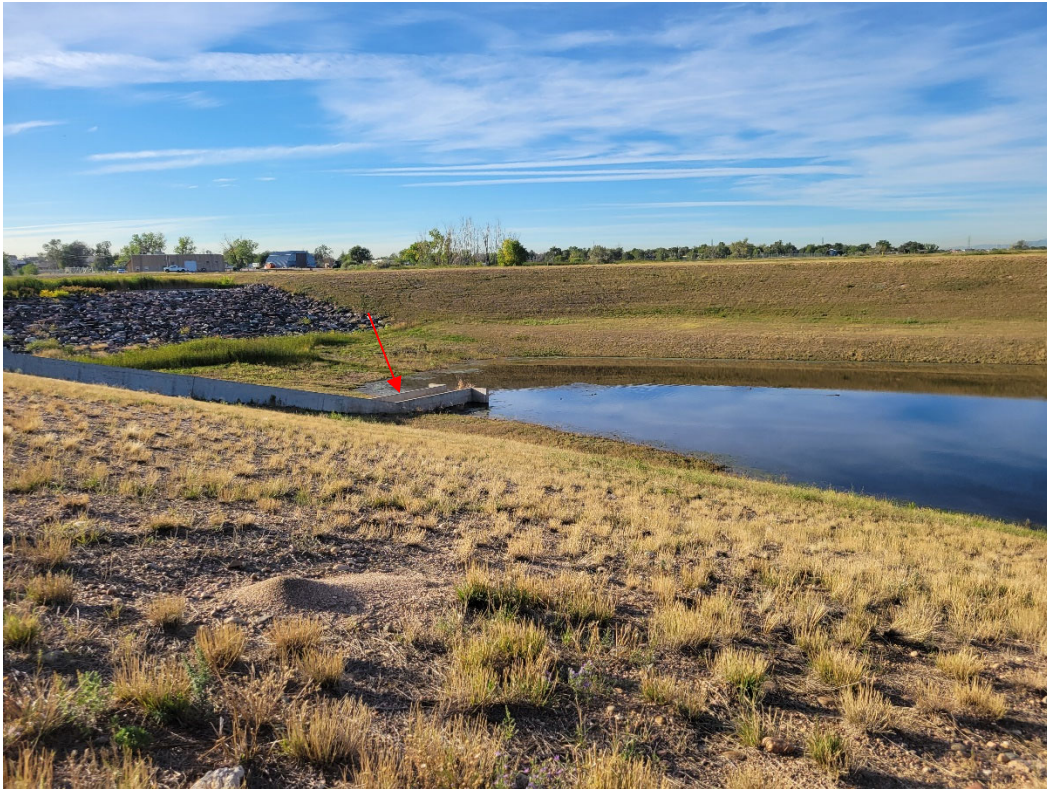
Photo 13: Looking at intake structure in the southeast corner of Reservoir B.

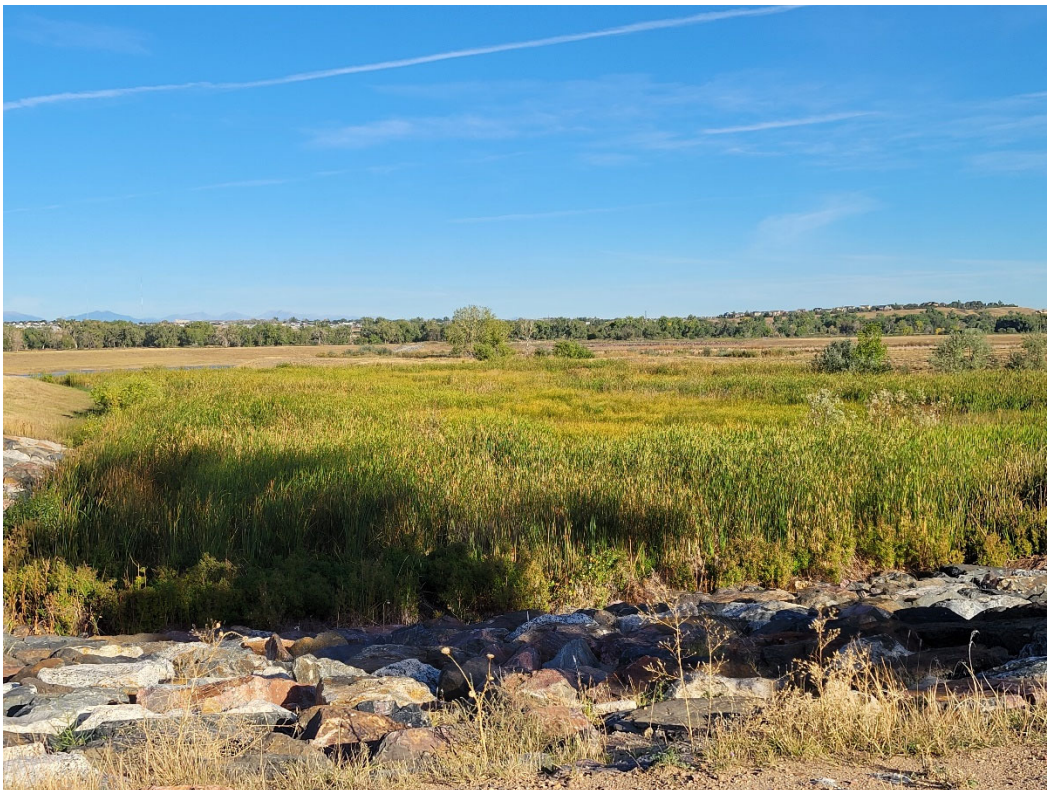
A public recreation path was installed on the west of the reservoirs along the South Platte. Denver water planted trees along this path. Cottonwoods, willows and wetland vegetation was observed on the east side of Reservoir B around the wetland pond. The pond was an existing feature on site due to mining that occurred at the site prior to 1981.

Photo 14: Wetland pond area adjacent to groundwater drain in Reservoir B.

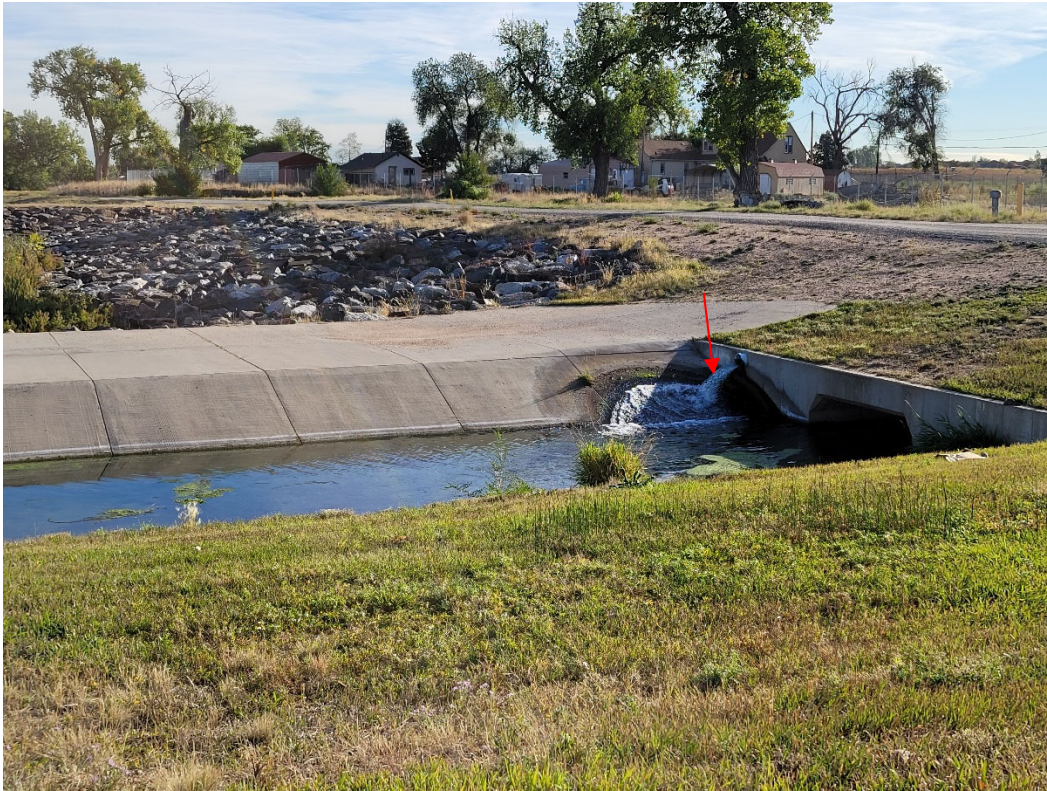
A groundwater mounding drain was installed west of Reservoir B to manage water during mining. The outlet to the drain is located adjacent to the site's main office. The mounding drain runs the length of the eastern side of the Howe-Haller A and B reservoirs. Water was flowing during the time of inspection through the discharge pipe into the First Creek channel that crosses the mine site to the South Platte River.

Photo 15: Water flowing from groundwater mounding drain.
