## Inspections: 2024 September Partial

**23 September 2024**

| <b>Permit Number:</b> C-1981-044<br><b>Mine Name:</b> Williams Fork Mines<br><b>Operator:</b> Moffat County Mining, LLC<br><br><b>Operator Address:</b><br>Ms. Miranda Kawcak<br>29515 Routt County Road #27<br>Oak Creek, CO 80467 | <b>County:</b> Moffat<br><b>Operation Type:</b> Underground<br><b>Permit Status:</b> Active<br><b>Ownership:</b> Private<br><br>Michael Howard |

INSPECTION INFORMATION

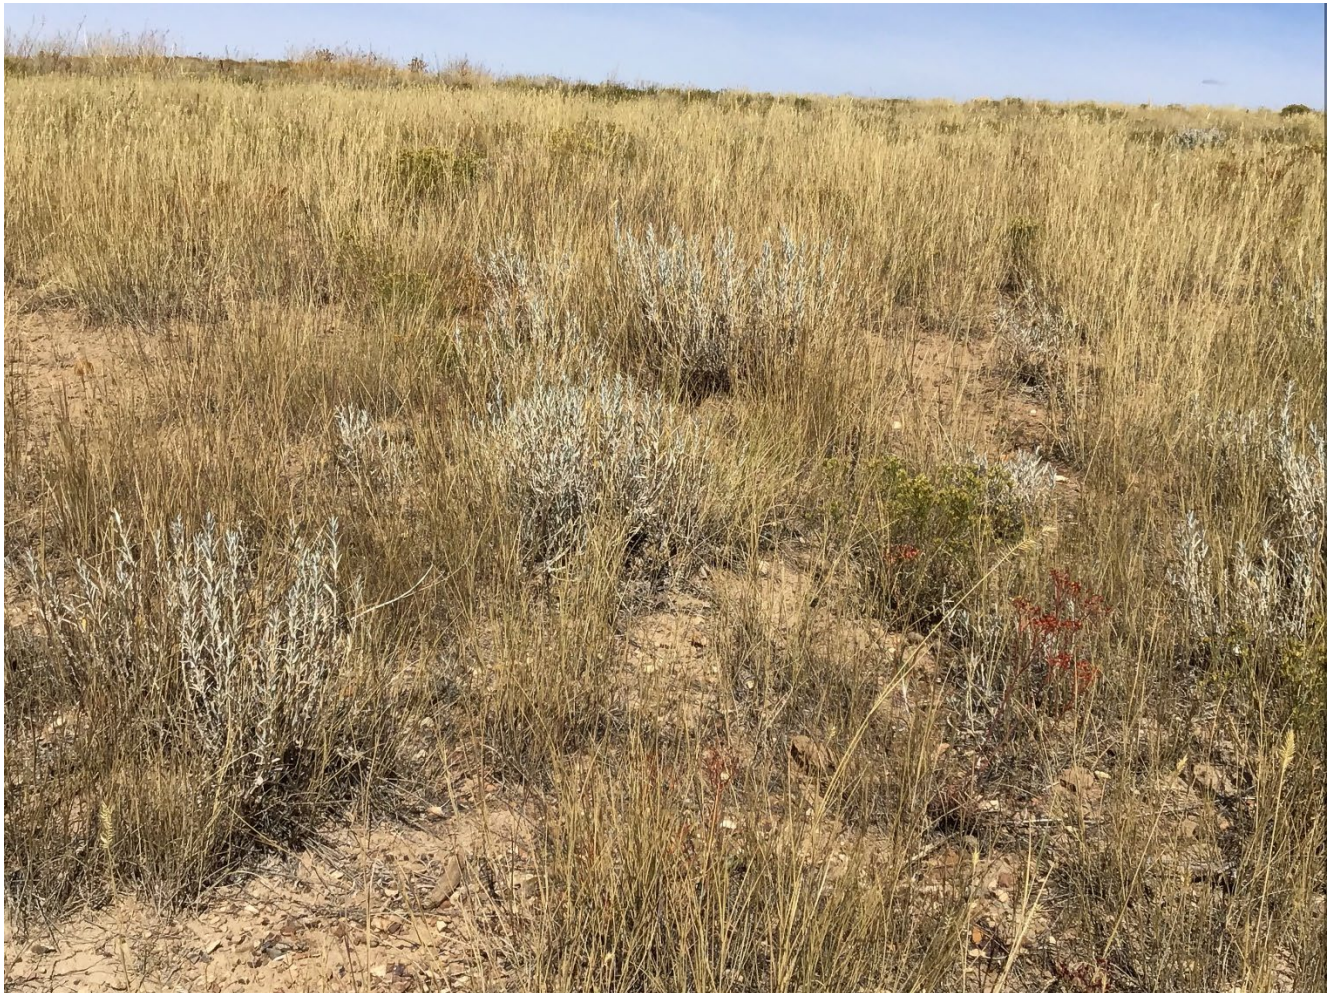
Photo one refuse, pile looking north, diverse, vegetation, shrubs, and grasses. South slope, north slope is more weedy

- Refuse pile was reclaimed, in 2020 and is capped, topsoiled and seeded.
- The refuse pile appears stable with no significant rills or gullies forming.
- The refuse pile tends to be weedier at the north end than at the south end.
- The south end of the refuse pile exhibits various species of grasses and some shrubs. The grasses appeared dormant at the time of inspection.

**Photo 1:** South end of the refuse pile exhibiting various dormant grasses and some artemisia shrubs, looking west.

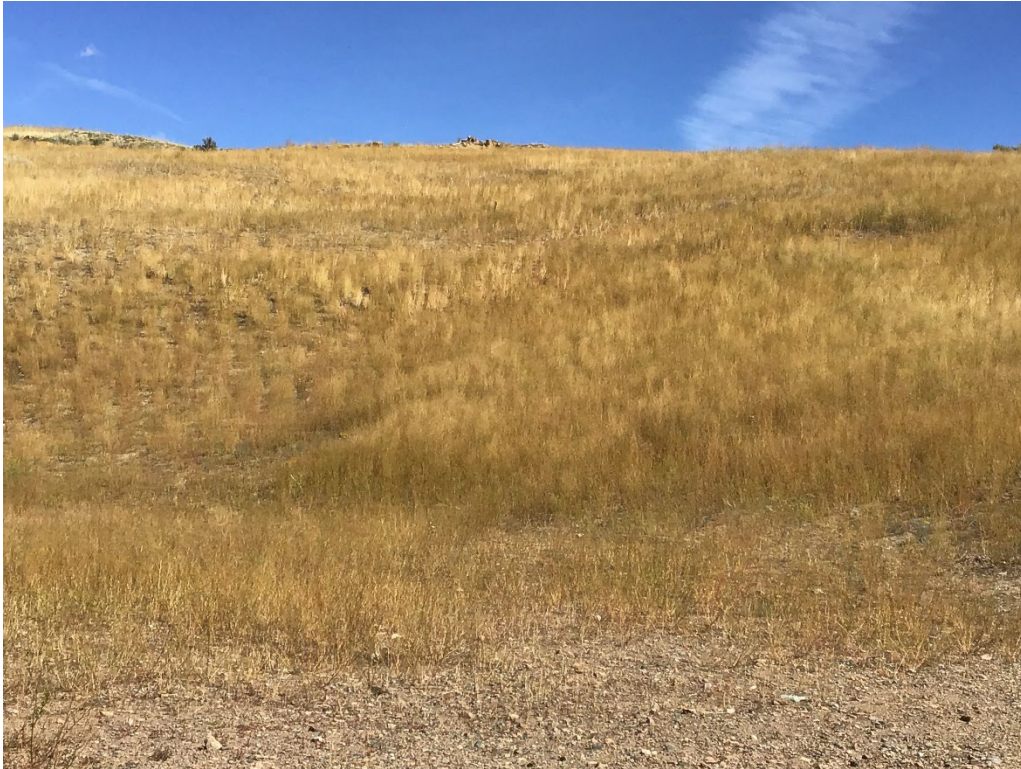
- Revegetated areas of reclamation appeared stable at the time of inspection.
- 5A Portal area exhibits grasses, and a dense stand of yellow sweet clover obscuring the small sage shrubs.
- The portal was treated with three different soil amendment scenarios, up until now any difference in the scenarios was difficult to detect. At this point there may be some indication that the south most treatment yielded a slightly more beneficial result as cover appears denser than the other two sections to the north.
- Vegetation throughout the site appeared dormant at the time of inspection.
- Croplands exhibited dormant vegetation with the exception of some alfalfa with dry hay stubble throughout having been harvested in early August.
- Vegetation appeared sparse and patchy in some areas at the south end of the hay field.

***Photo 2.*** Slope at the south end of the 5A portal, looking east at dormant vegetation predominated by yellow sweet clover.

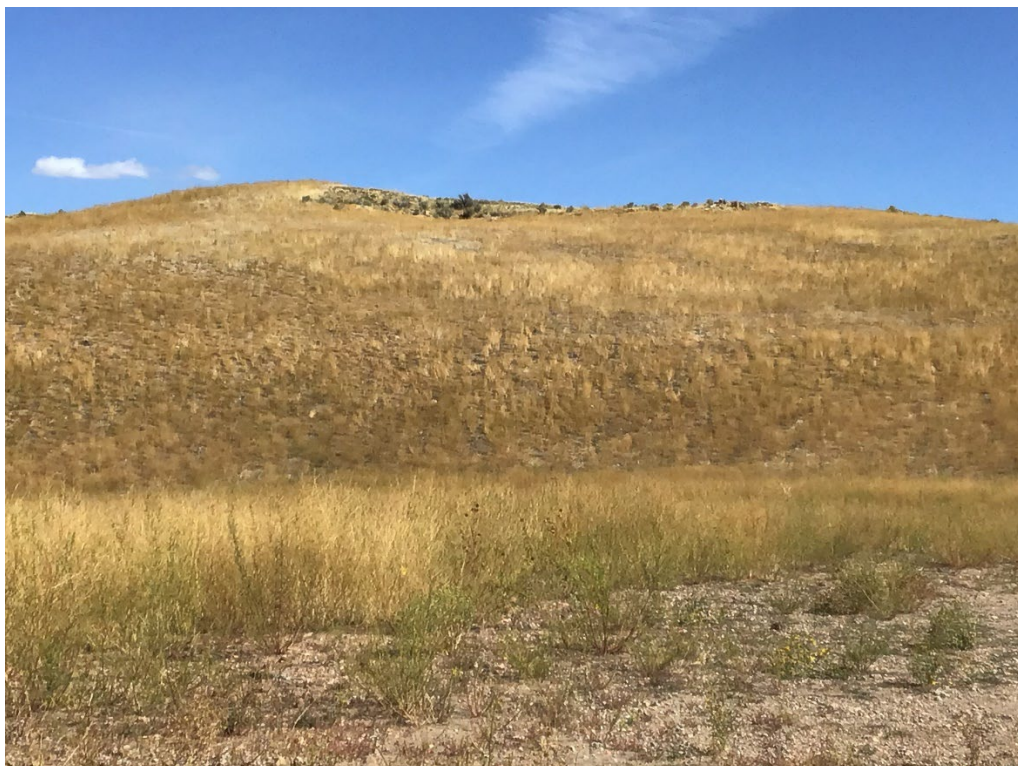
***Photo 3.*** Slopes at the north end of the 5A portal, looking northeast at dormant vegetation.

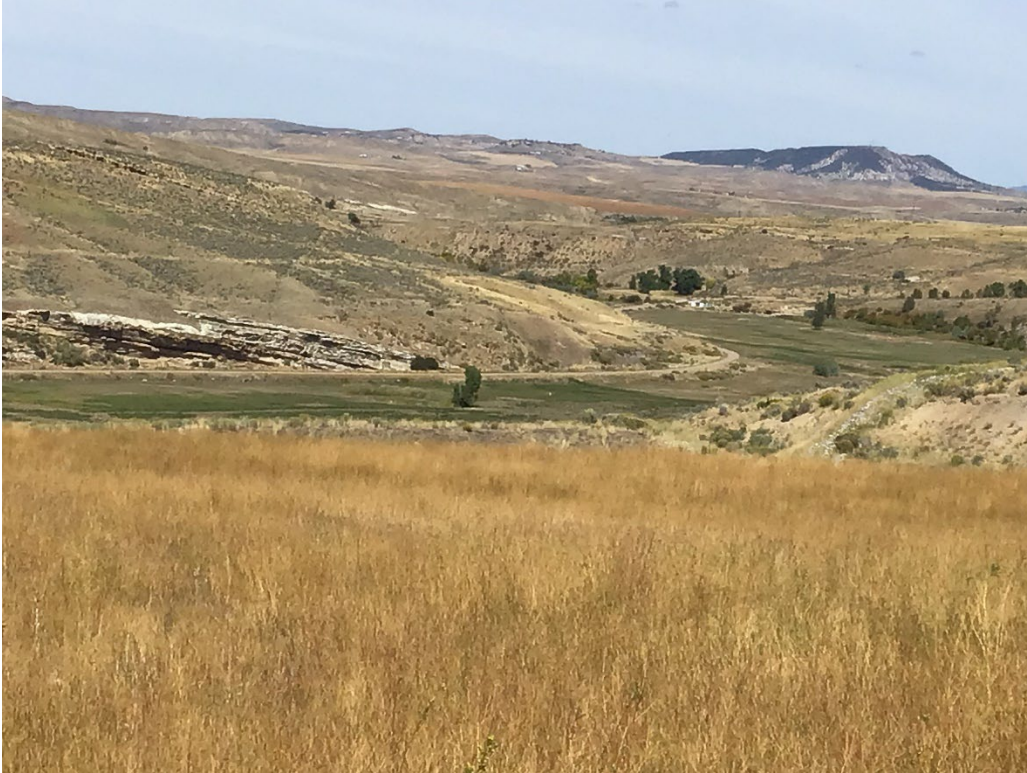
**Photo 4:** Overview of the northern section of the cropland area adjacent to the Williams Fork River, looking north west from the 5A portal.

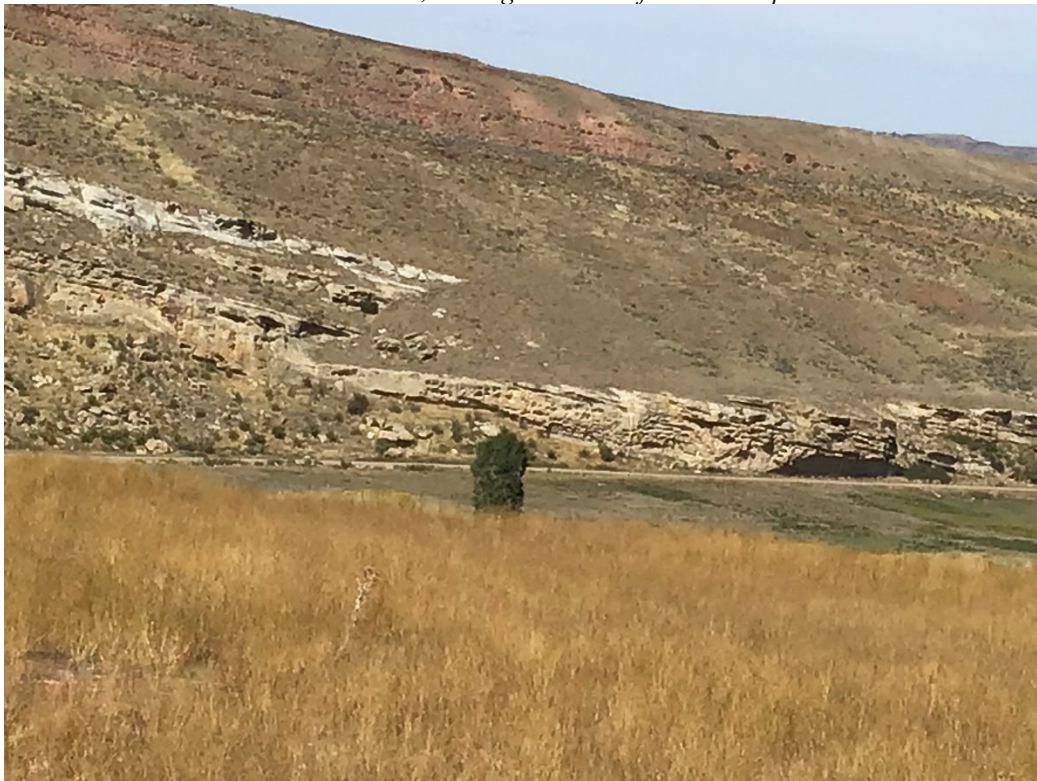
**Photo 5:** Overview of the central section of the cropland area adjacent to the Williams Fork River, looking north west from the 5A portal.

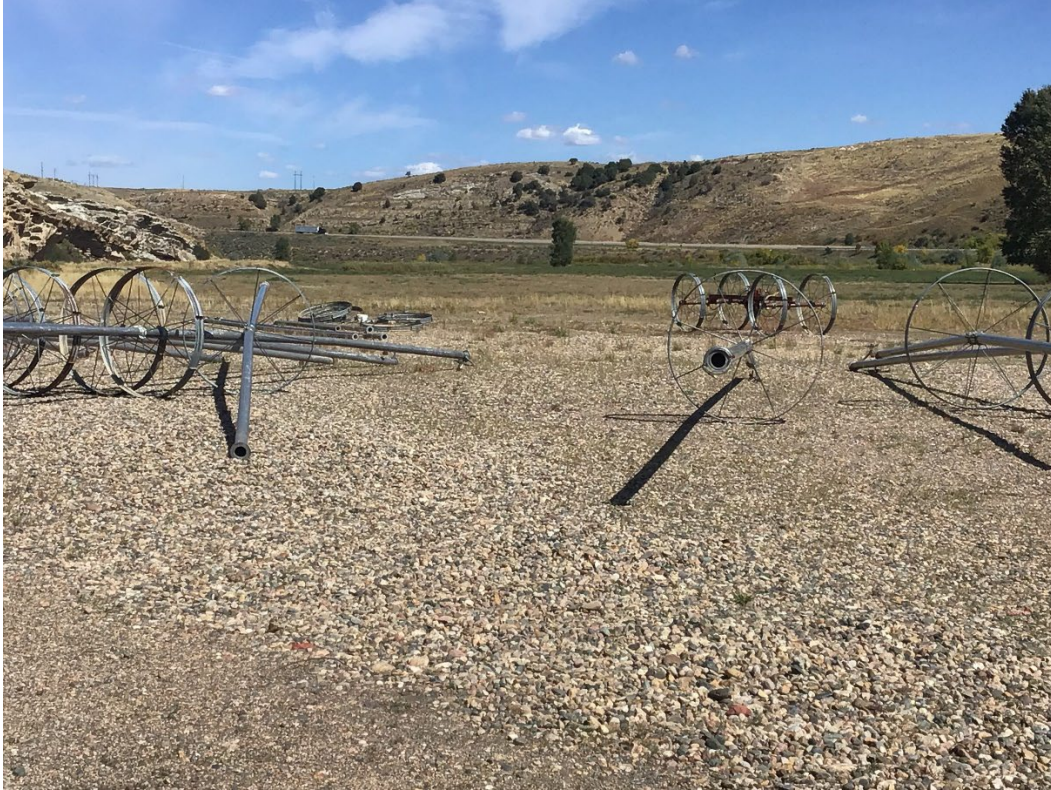
**Photo 6:** *Irrigation infrastructure ready for assembly in the cropland area adjacent to the Williams Fork River, looking north.*

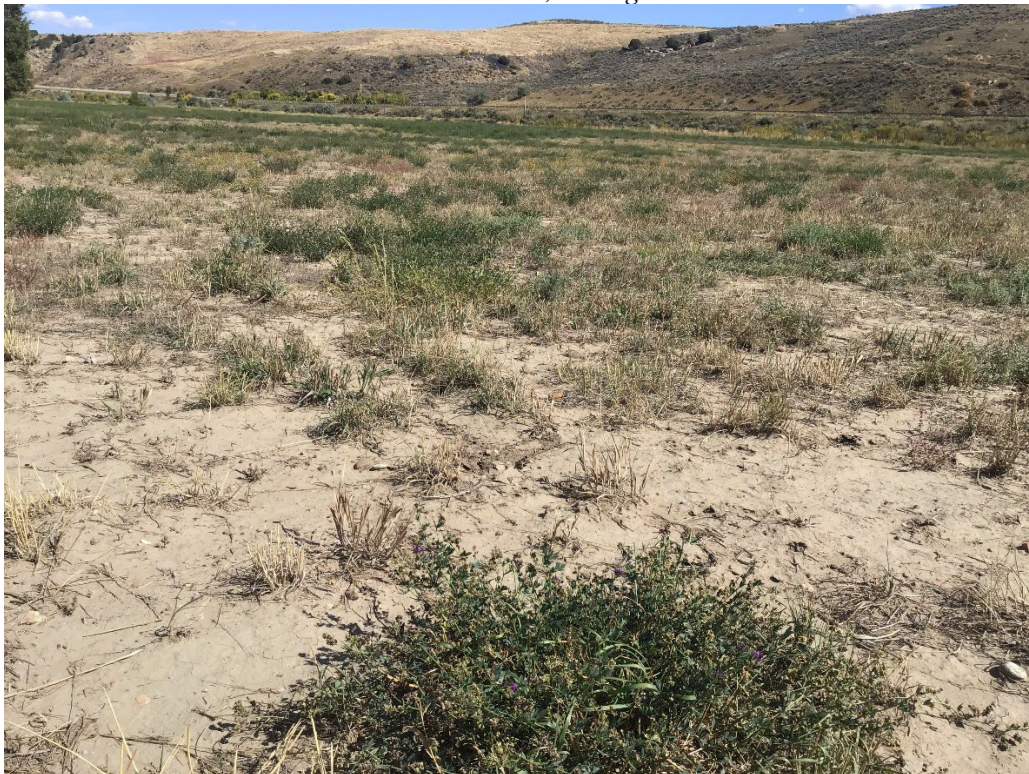
**Photo 7:** *Area of sparse vegetation, comprised of alfalfa at the south end of the cropland area.*

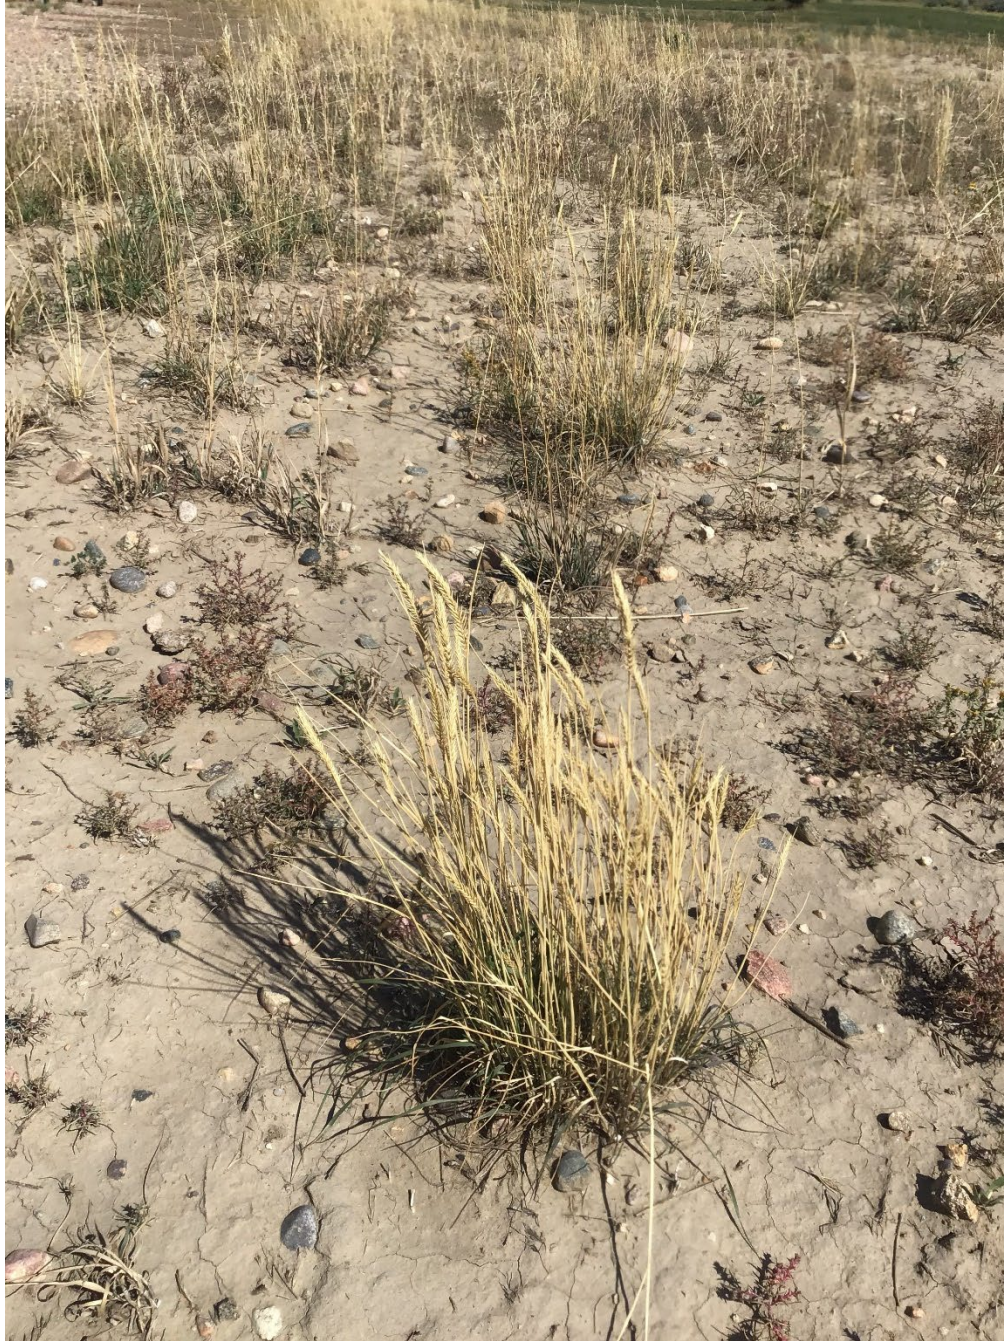
***Photo 8:*** Backfilled Vegetation comprised of various wheat grasses and some weeds in the cropland area.
