MINERALS PROGRAM INSPECTION REPORT
PHONE: (303) 866-3567

MINE NAME: Lykins Gulch	MINE/PROSPECTING ID#: M-2000-090	MINERAL: Dolomite and sandstone stone, quartzite)	COUNTY: Boulder
INSPECTION TYPE: Monitoring	WEATHER: Clear	INSP. DATE: September 19, 2024	INSP. TIME: 11:00
OPERATOR: Loukonen Bros. Stone Company	OPERATOR REPRESENTATIVE: Michael Loukonen	TYPE OF OPERATION: 110c - Construction Limited Impact	
REASON FOR INSPECTION: Normal I&E Program	BOND CALCULATION TYPE: Complete Bond	BOND AMOUNT: \$21,000.00	
DATE OF COMPLAINT: NA	POST INSP. CONTACTS: None	JOINT INSP. AGENCY: None	
INSPECTOR(S): Patrick Lennberg	INSPECTOR'S SIGNATURE:

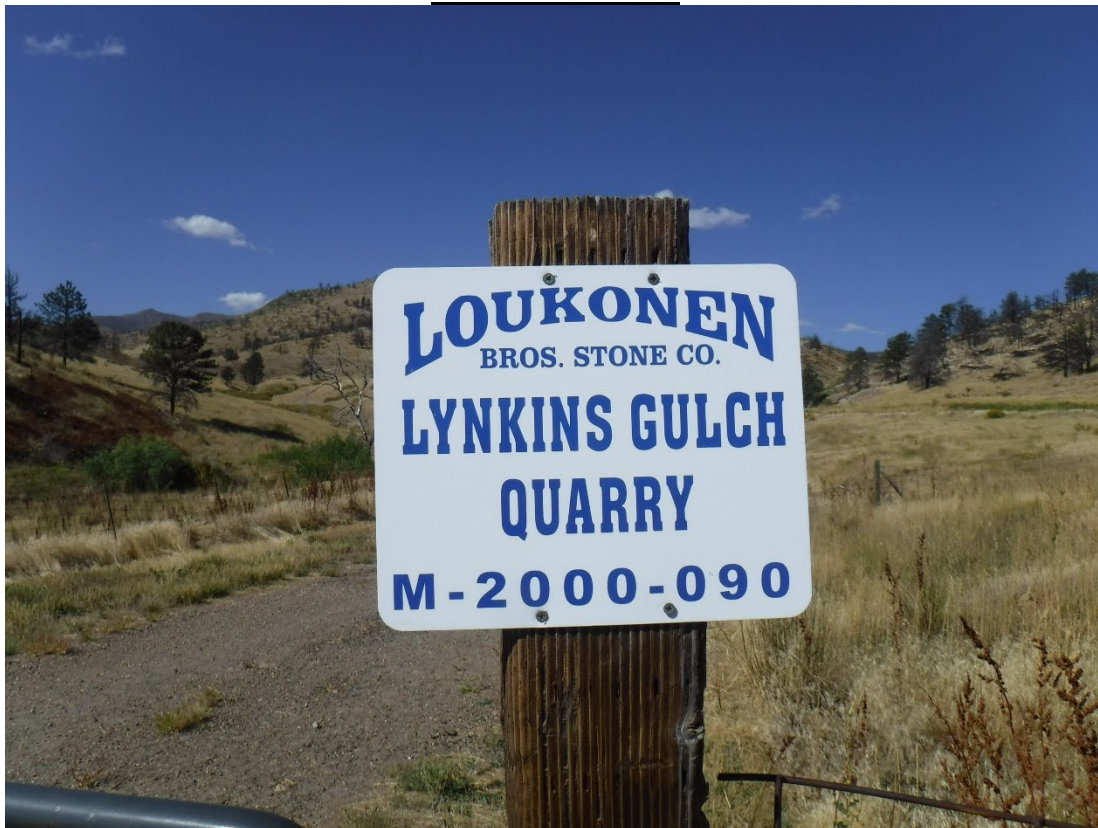
The site is 110c Construction Materials permit for 9.9 acres to mine sandstone. The mine is located in Boulder County, approximately 6 miles southwest of Lyons, CO. The site is accessed from off Hwy 36 to the west. The post-mining land use for this site is rangeland. The affected lands are owned by Loukonen G-4, LLC whose registered agent is L. Dean Loukonen. A mine sign was posted at the primary mine entrance as required by Rule 3.1.12. The weather was clear and mild.

Photo 1: Mine sign at primary mine entrance

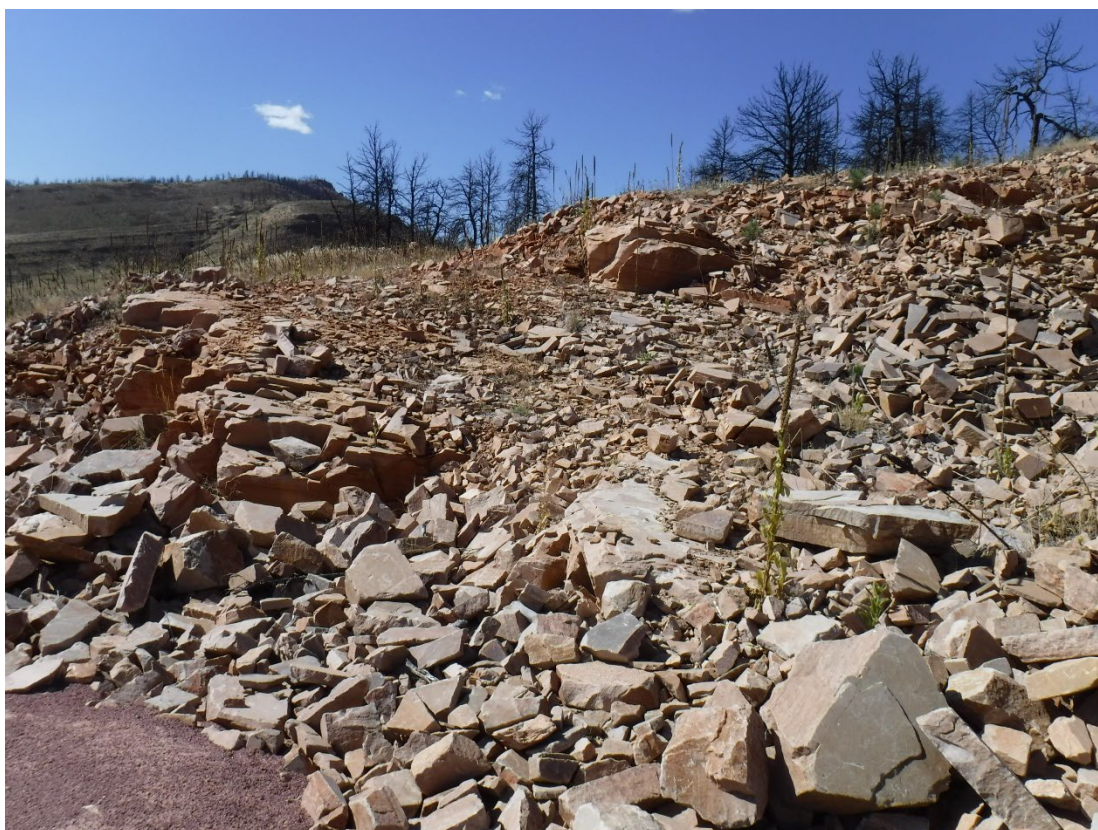
Photo 2: Typical mining area in the North Quarry looking south

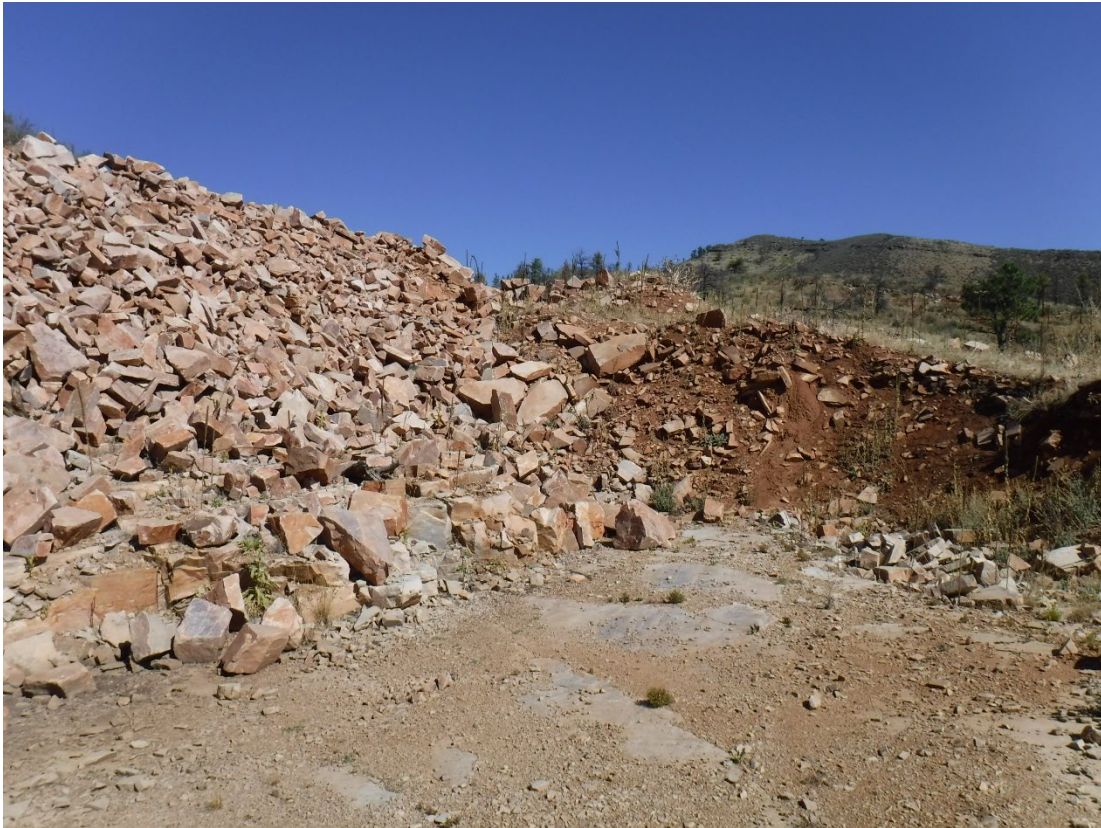
Photo 3: Mining face in the North Quarry looking north

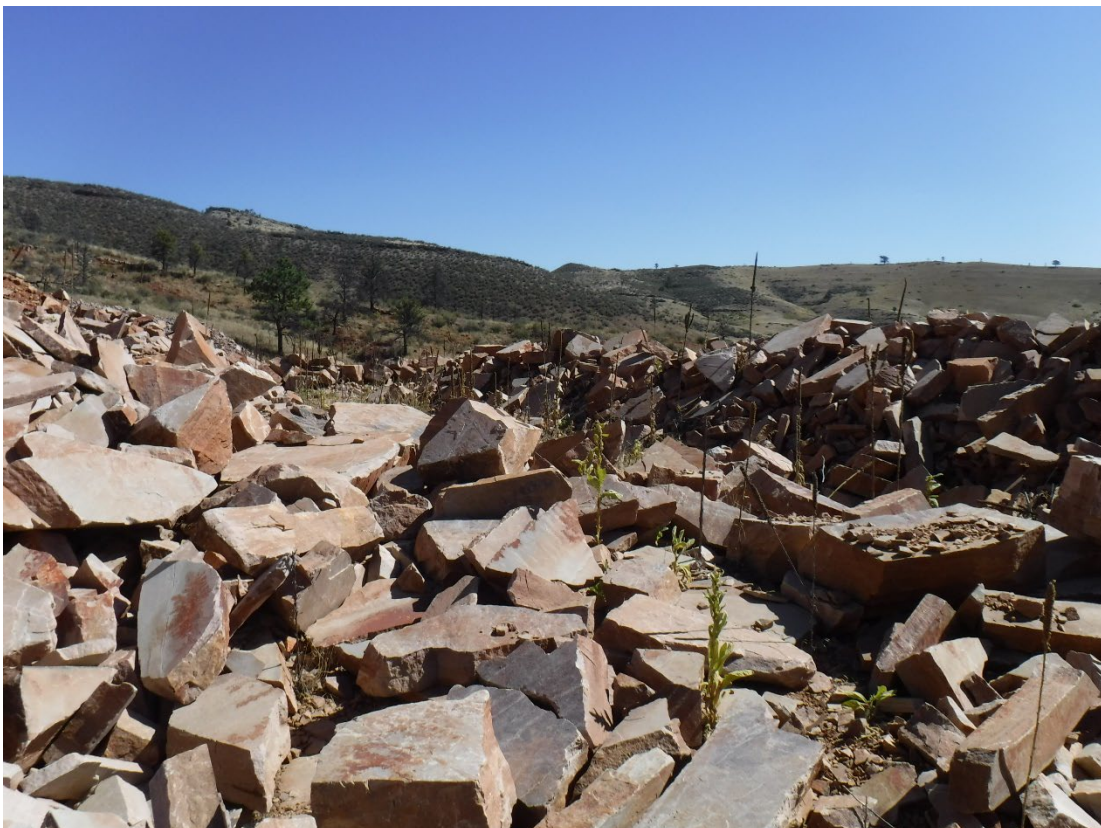
quarry, which includes three primary working benches and various stockpiles of overburden and waste rock at the toe of the excavations. The operator appears to be mining the north quarry generally westward and northward. The permitted acreage for the north quarry is 5.5 acres. The Division estimates the operation has disturbed approximately 2.5 acres in the north quarry area. The Division estimates the operation has disturbed a total of 4.7 acres at the site, including both quarries and the one-acre storage area. The storage area has largely been reclaimed and only a couple of pallets of material need to be removed. The site is mined every year but at a very slow rate.

Photo 4: Overburden/waste rock pile North Quarry area

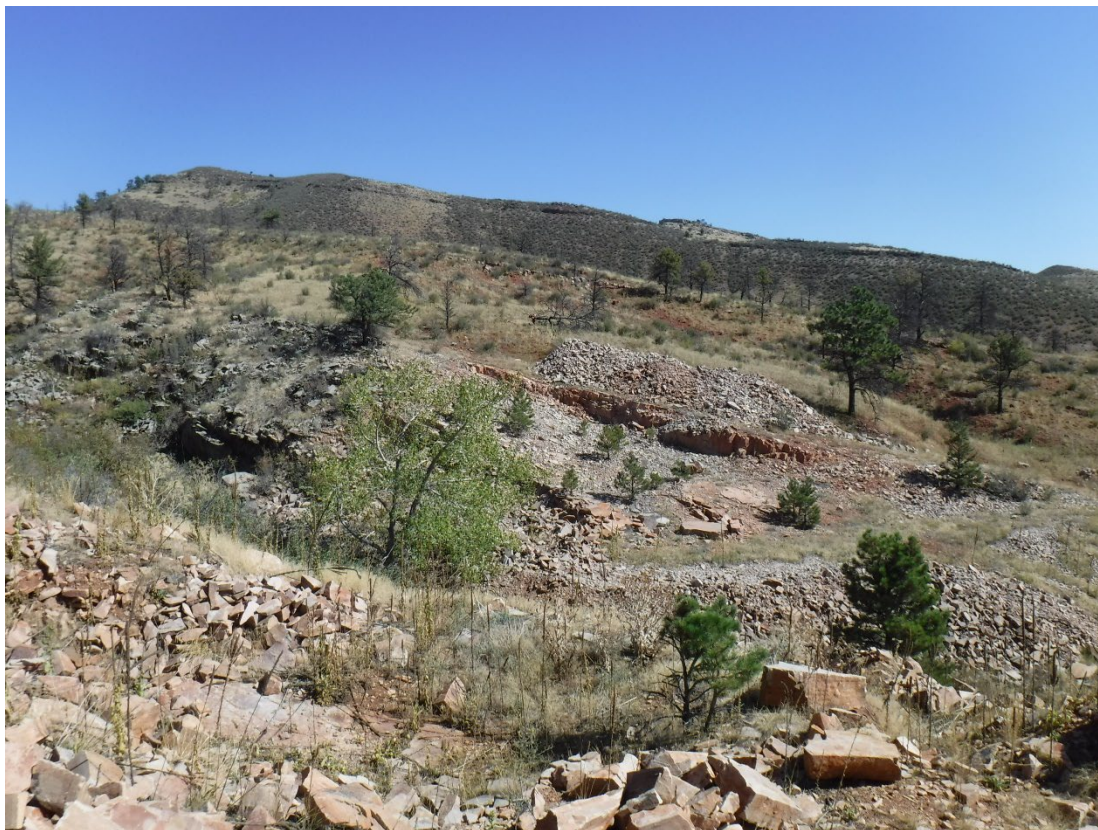
Photo 5: Looking at the northern most quarry site in the North Quarry area

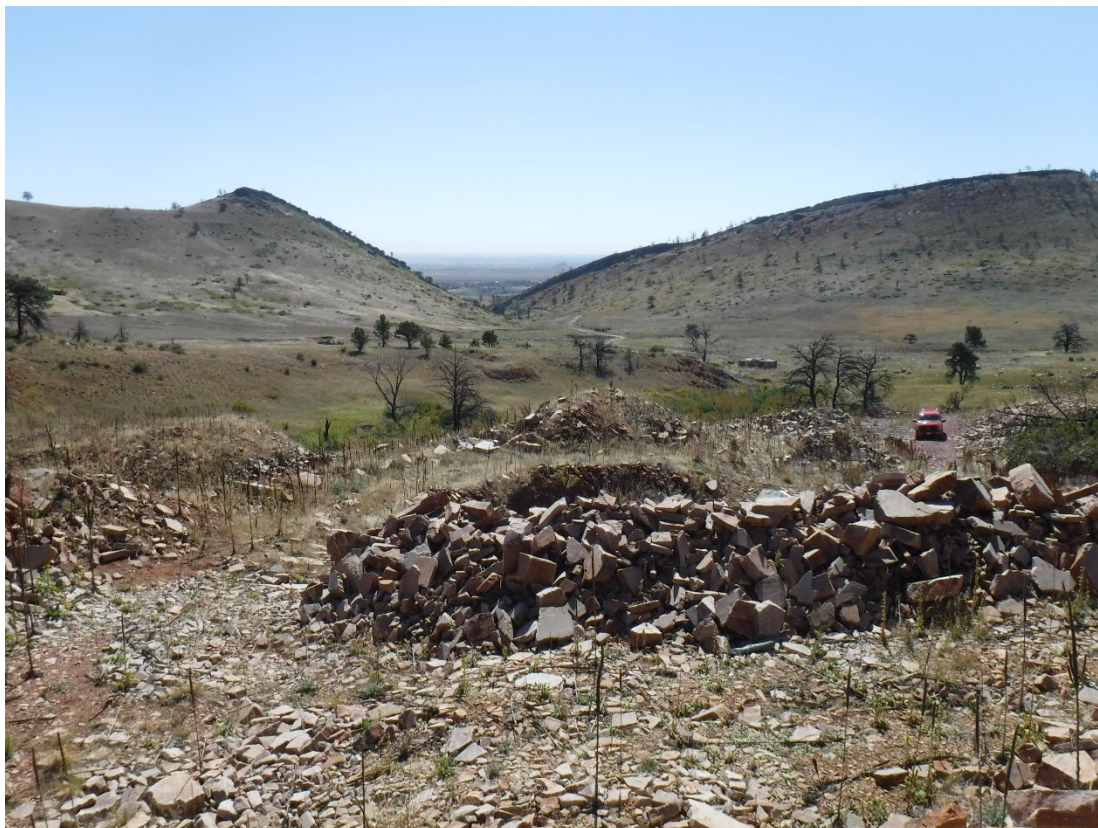
Photo 6: Looking east from the southernmost quarry site in the North Quarry area

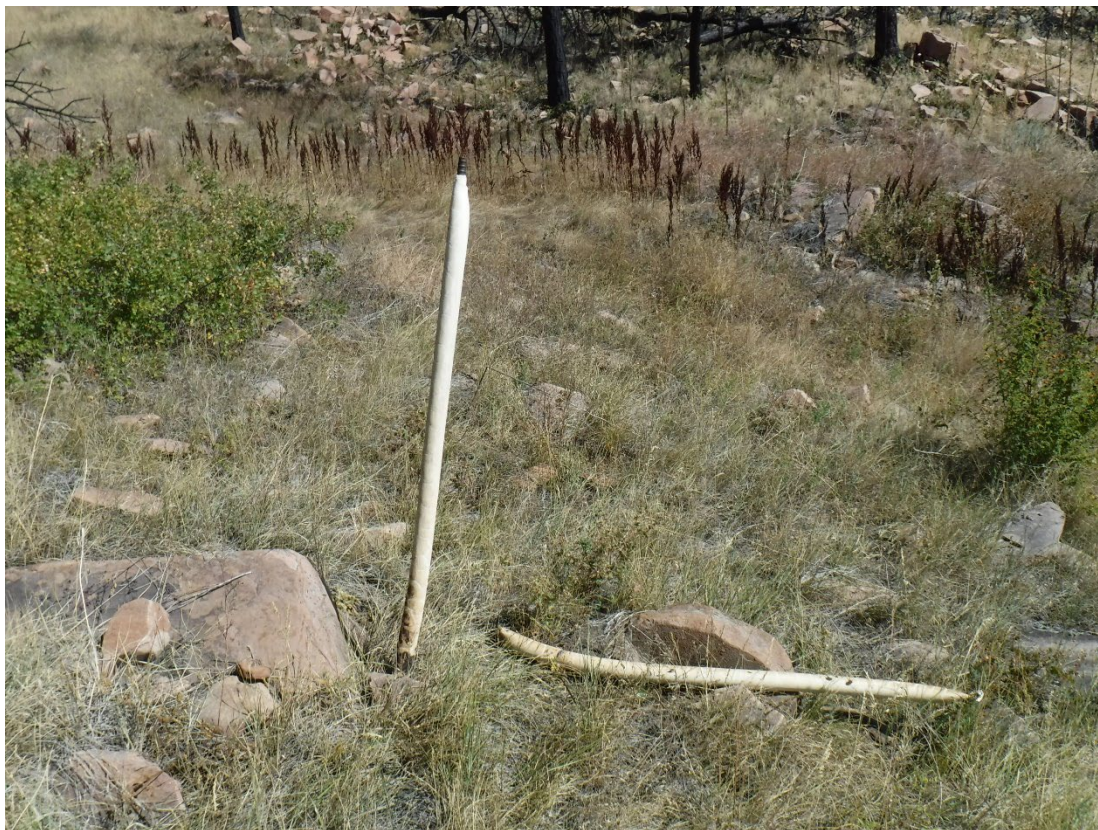
The site burned during the fast moving Cal-Wood Fire that burned ~8,600 acres beginning in October 2020. As a result of the fire several of the permit boundary markers were melted or destroyed. However, most of the markers were found in the field.

Photo 7: Typical permit boundary marker, melted during fire

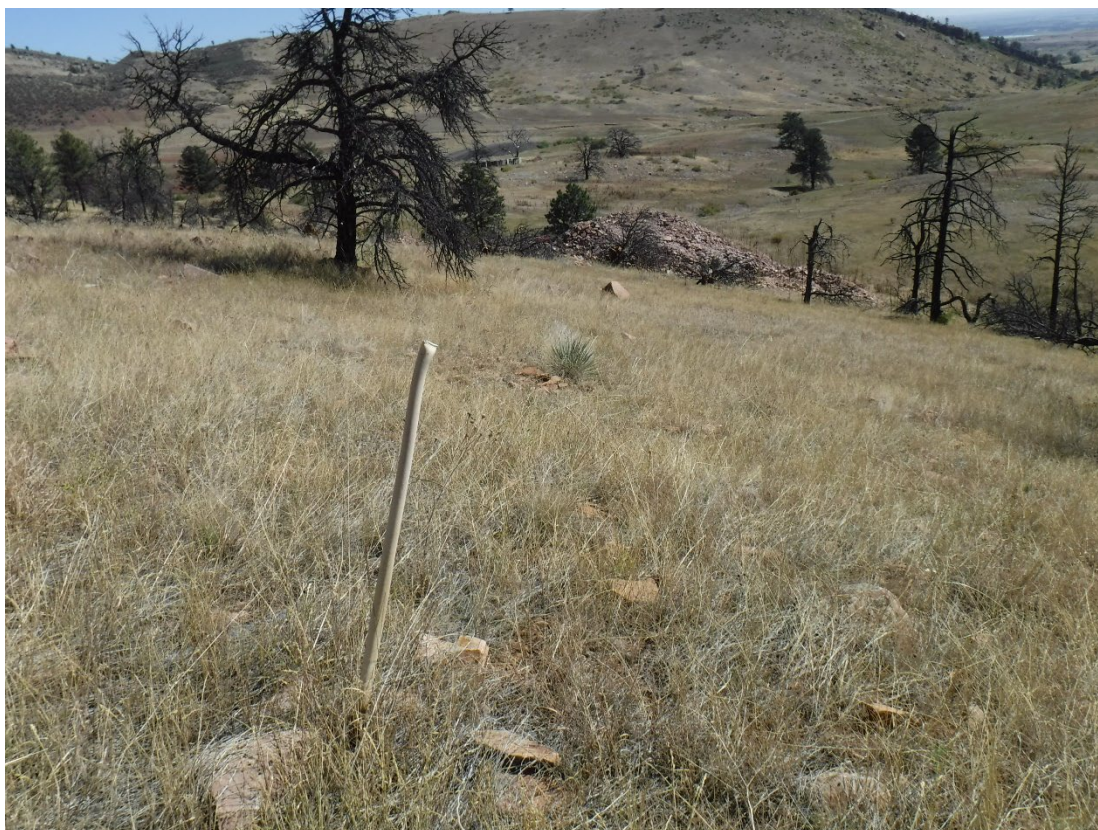
Photo 8: Typical permit boundary marker south quarry area

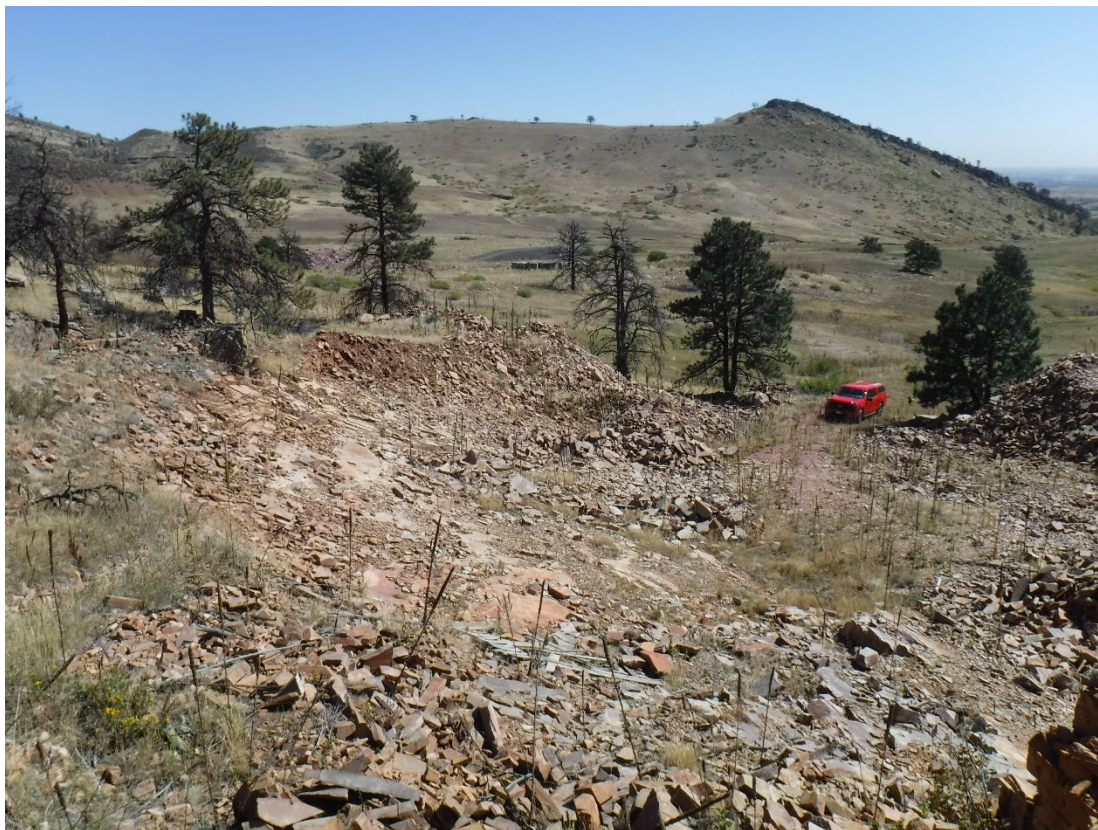
The Division observed the south quarry, which includes two primary working benches and various stockpiles of overburden and waste rock at the toe of the excavations. The operator appears to be mining the south quarry generally westward. The permitted acreage for the south quarry is 2.5 acres. The Division estimates the operation has disturbed approximately 1.2 acres in the south quarry area. The Division observed the north

Photo 9: South quarry area

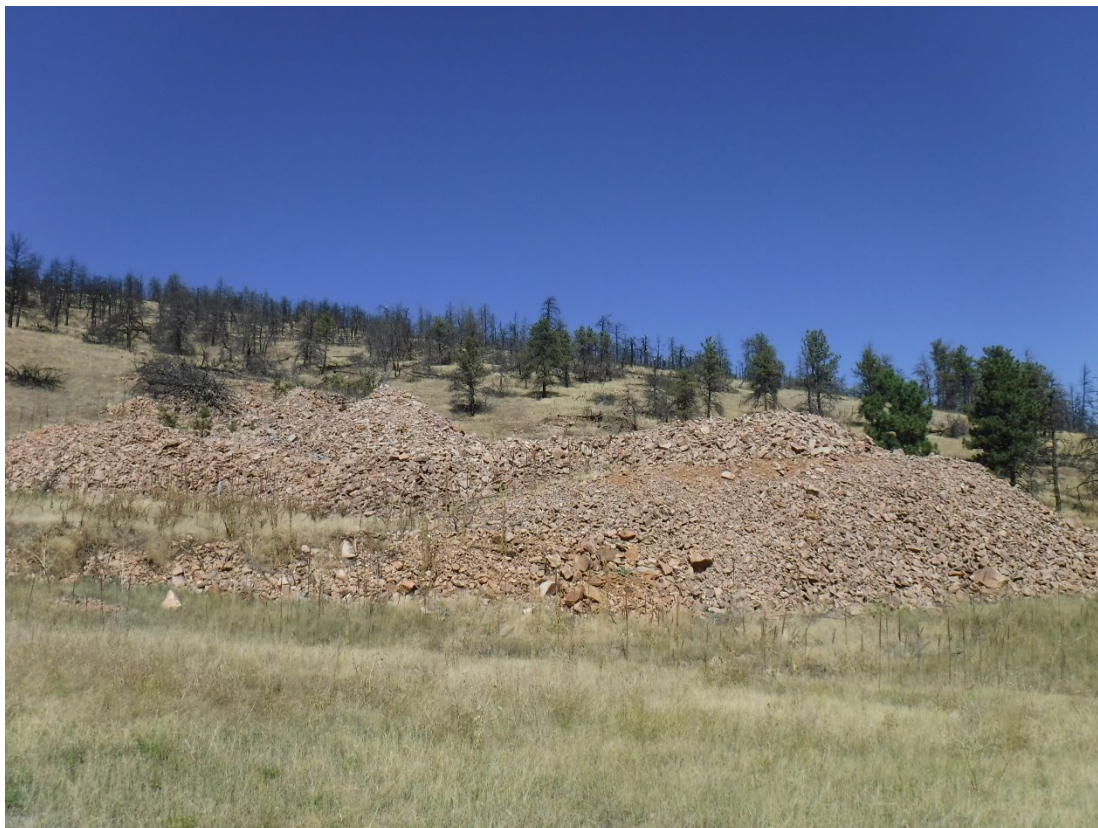
Photo 10: South quarry area looking uphill to the west
