Keenesburg Mine inspection report

Permit Number: C-1981-028 Mine Name: Keenesburg Strip Mine Operator: Coors Energy Company Operator Address: Mr. Ben Moline P.O. Box 4030 Golden, CO 80402	County: Weld Operation Type: Surface Permit Status: Permanent Cessation Ownership: Private
	Operator Representative Present: None
Operator Representative Signature: (Field Issuance Only)

Inspection Start Date: September 30, 2024 Inspection Start Time: 09:00 Inspection End Date: September 30, 2024 Inspection End Time: 10:15		Inspection Type: Coal Partial Inspection Inspection Reason: Normal I&E Program Weather: Clear	
Joint Inspection Agency: None		Joint Inspection Contacts: 	
Post Inspection Agency: None		Post Inspection Contacts: 	
Inspector(s): Robert Zuber, P.E.	Inspector's Signature:

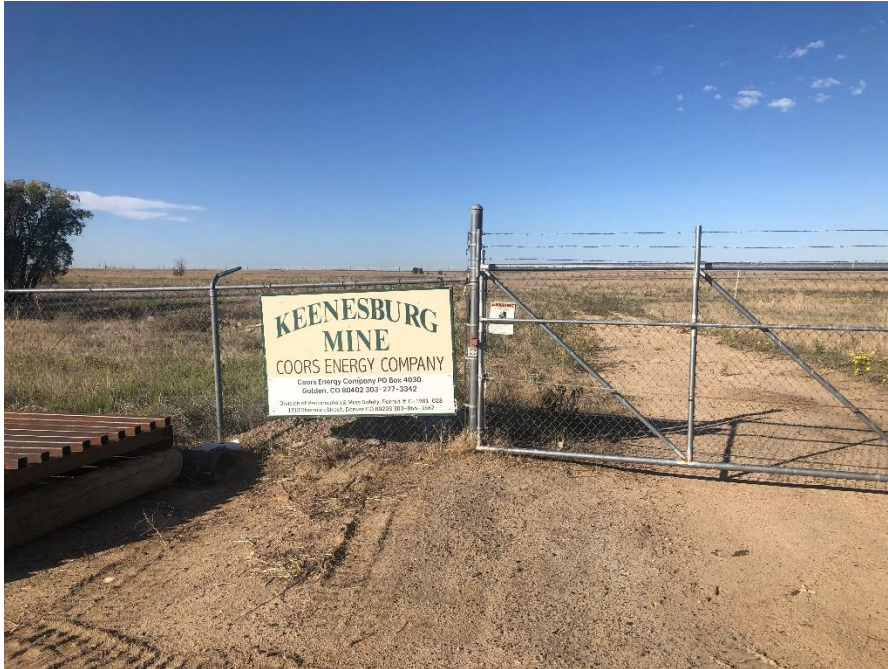
The entrance sign remains in place and contains the required information.

Entrance sign

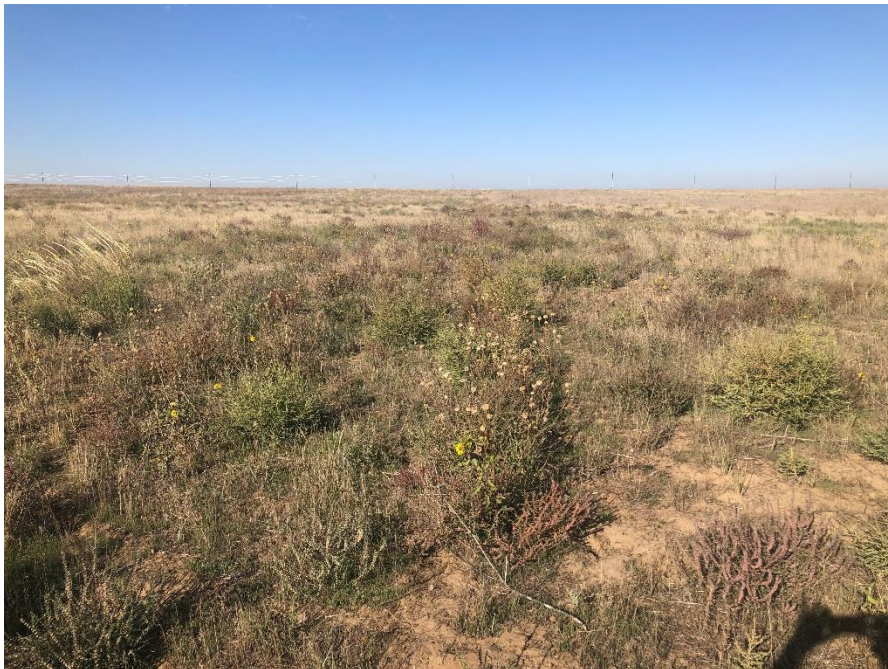
Area 44 - Vegetation cover is good, but many Russian thistle plants and cheat grass were seen.

West side of Area 44, with Russian thistle

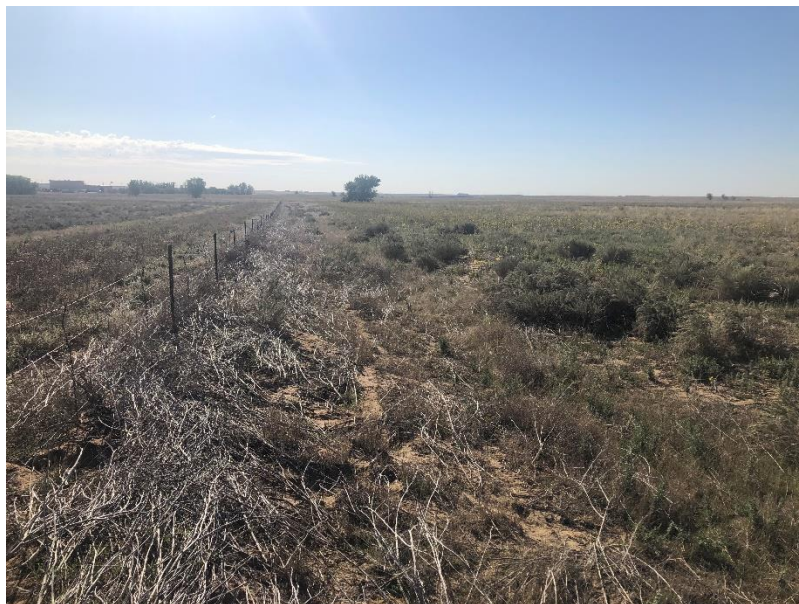
The northern boundary of the site (the down gradient side) was observed, and no signs of pollutant loading from the mine site, or any other problems, were seen.

North boundary, looking southeast from halfway point between east and west sides

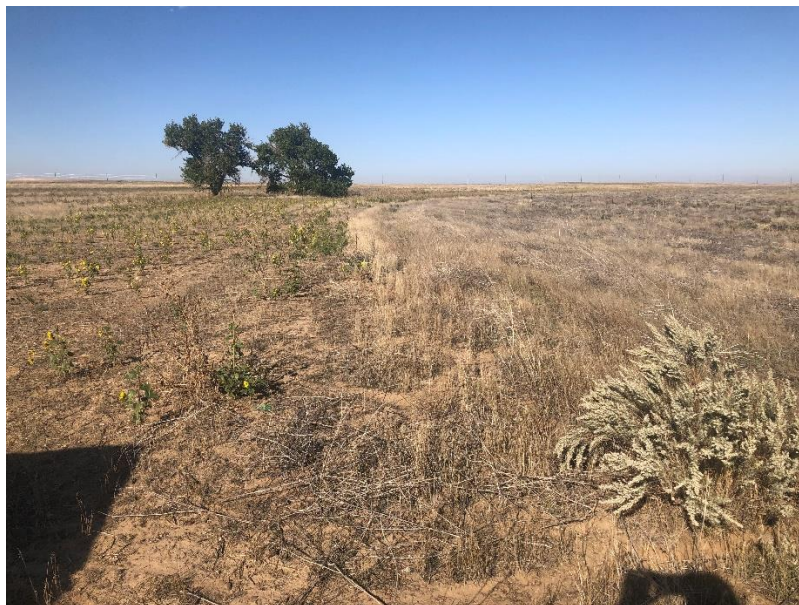
Area 42 (near Sediment Pond 2) – The vegetation cover is mediocre. Many sunflowers were seen.

The vegetation around the site compares favorably to the surrounding undisturbed area.

Area 42 (near Sediment Pond 2) on left and undisturbed on right, looking west

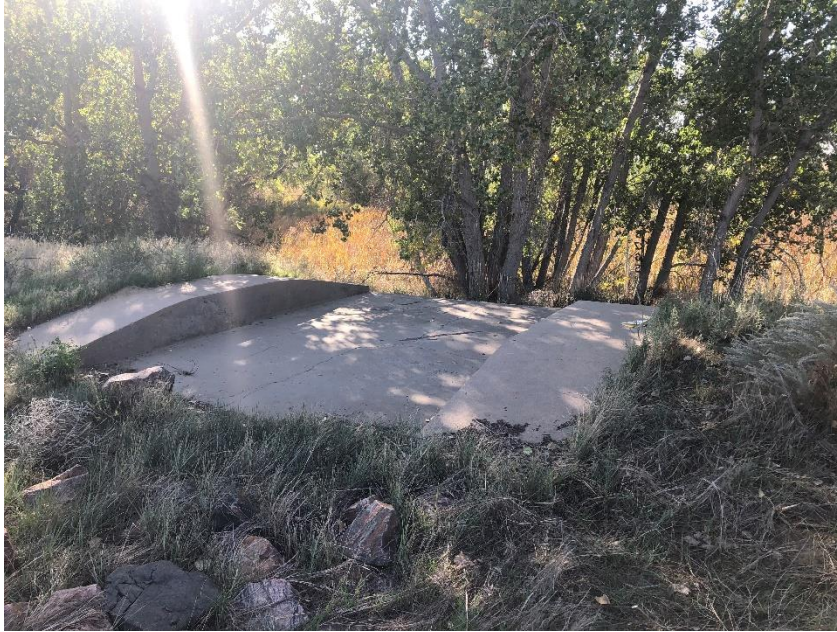
Sediment Pond 2 and the Dugout Pond contained no visible water. In both ponds the bottom is obscured by heavy vegetation. They were not discharging during the inspection. There were no signs that either pond had discharged recently. No problems were observed.

Sediment Pond 2 spillway

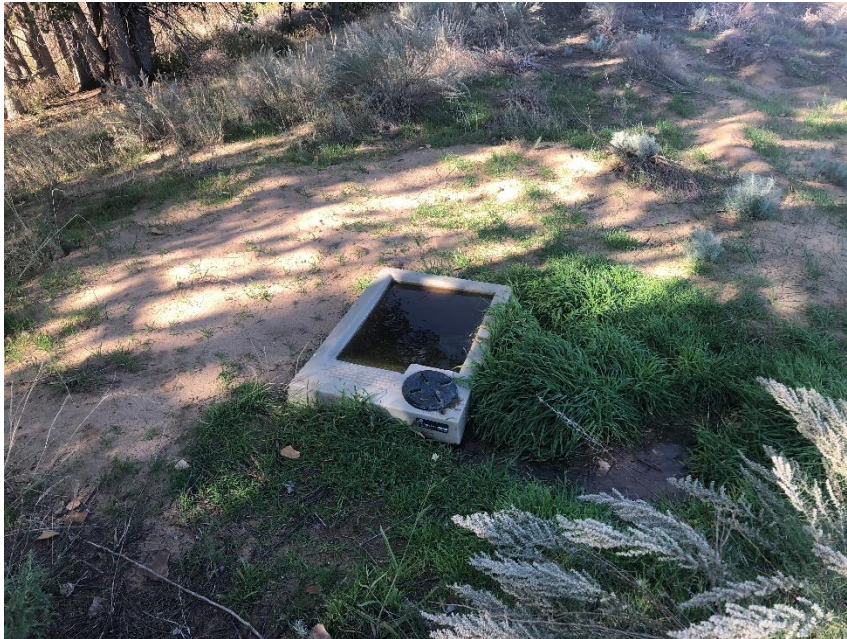
A wildlife watering device (label indicates it was manufactured by Rainmaker) was seen on Sediment Pond 2. Given the fact that the device is fairly small (approximately 2' x 3'), the pond is a "dugout" pond," and the fact that the pond has never been close to full (per past DRMS inspections), this device does not appear to be a problem.

Wildlife watering device on embankment of Sediment Pond 2
