**MINERALS PROGRAM INSPECTION REPORT**  
**PHONE: (303) 866-3567**

<b>MINE NAME:</b> Ghost River Gravel Pit	<b>MINE/PROSPECTING ID#:</b> M-2024-029	<b>MINERAL:</b> Aggregate	<b>COUNTY:</b> Huerfano
<b>INSPECTION TYPE:</b> Preoperation Inspection	<b>WEATHER:</b> Clear	<b>INSP. DATE:</b> September 4, 2024	<b>INSP. TIME:</b> 11:36
<b>OPERATOR:</b> P B & S Sand and Gravel LLC	<b>OPERATOR REPRESENTATIVE:</b> Jodi Schreiber, Patrick Steele & Jordan Power	<b>TYPE OF OPERATION:</b> 112c - Construction Regular Operation	
<b>REASON FOR INSPECTION:</b> Pre-operation Inspection	<b>BOND CALCULATION TYPE:</b> None	<b>BOND AMOUNT:</b>	
<b>DATE OF COMPLAINT:</b> NA	<b>POST INSP. CONTACTS:</b> None	<b>JOINT INSP. AGENCY:</b> None	
<b>INSPECTOR(S):</b> Amber M. Gibson	<b>INSPECTOR'S SIGNATURE:</b>

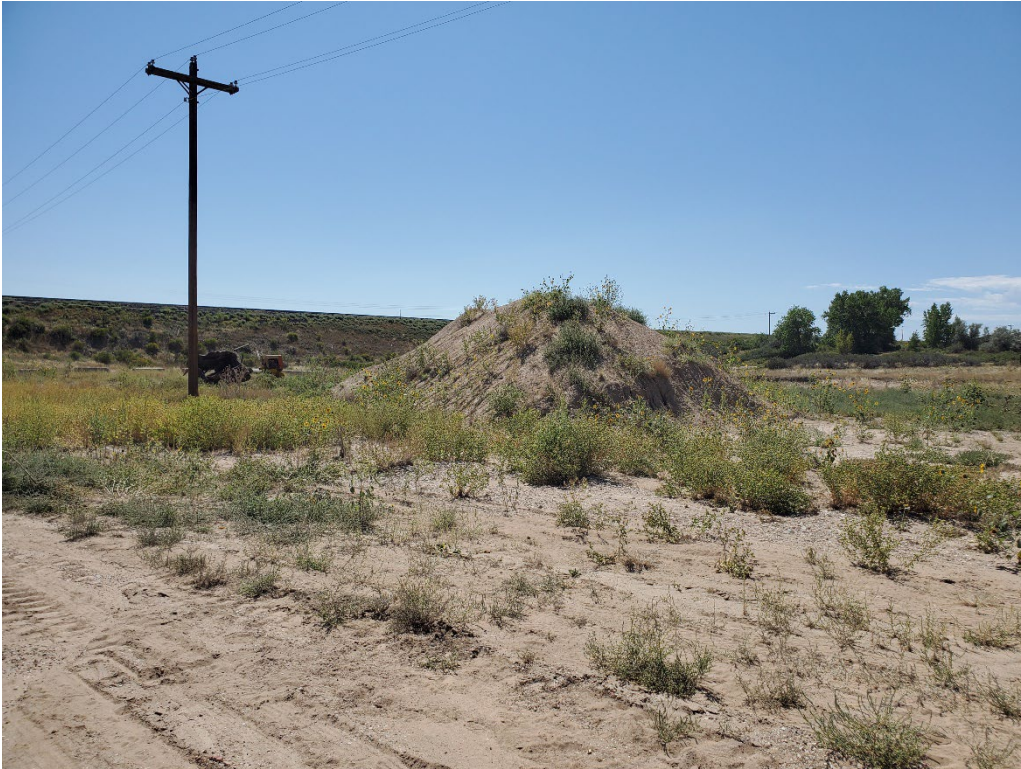
**Photo 1:** Looking southeast at a pre-existing stockpile.

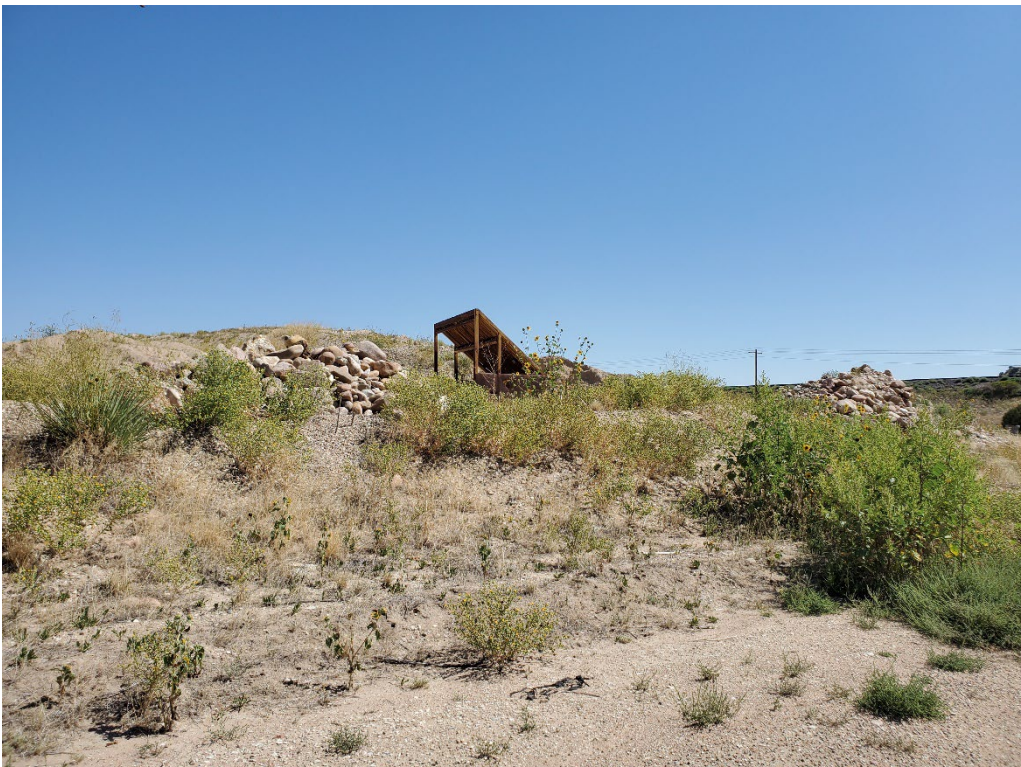
**Photo 2:** Looking northeast from the southern portion of the proposed permit area at leftover product and a remaining grizzly screener.

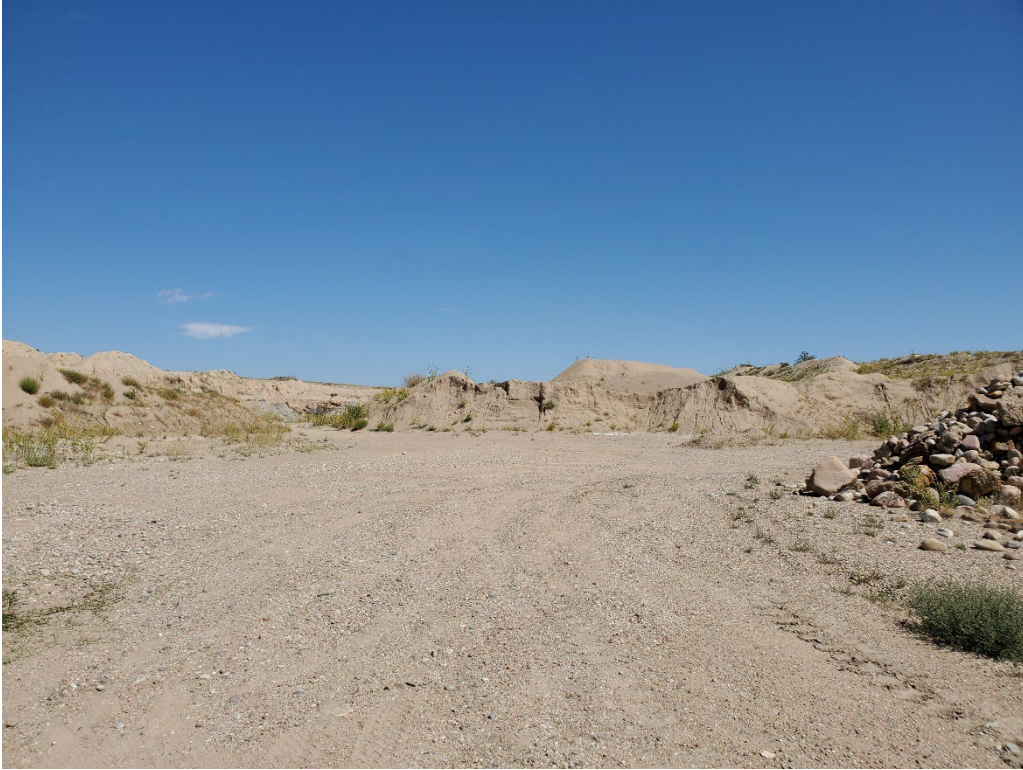
**Photo 3:** Looking north into the pre-existing pit area from the southern portion of the proposed permit boundary.

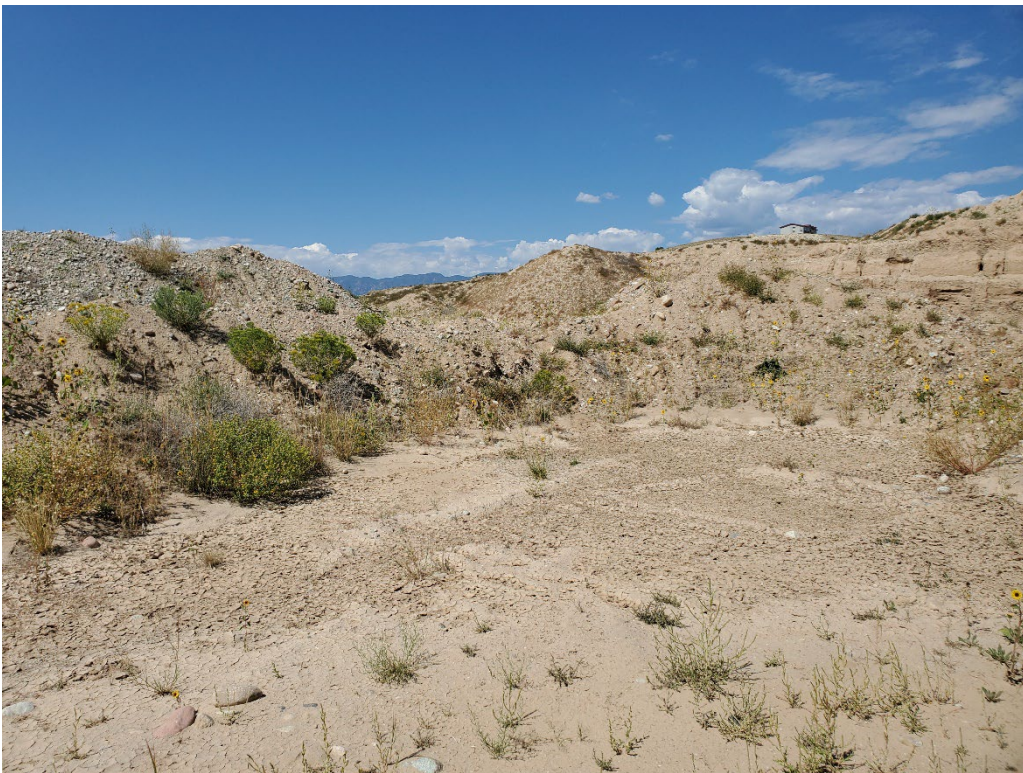
**Photo 4:** Looking west from within the pre-existing pit.

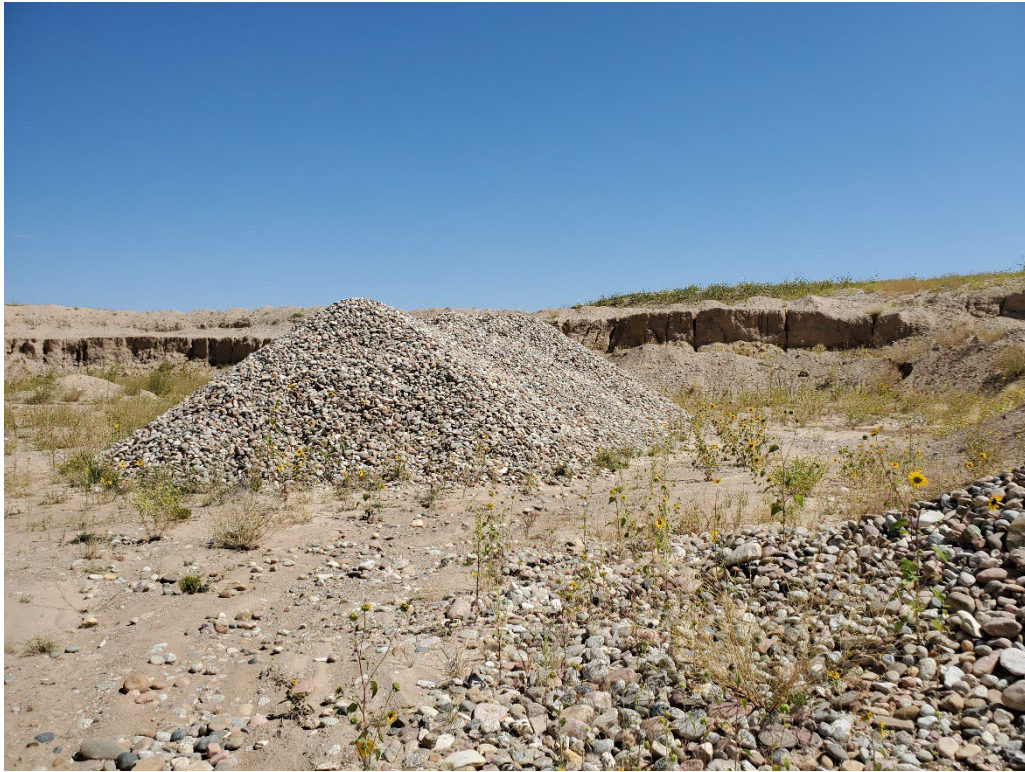
**Photo 5:** Looking east from within the pre-existing pit.

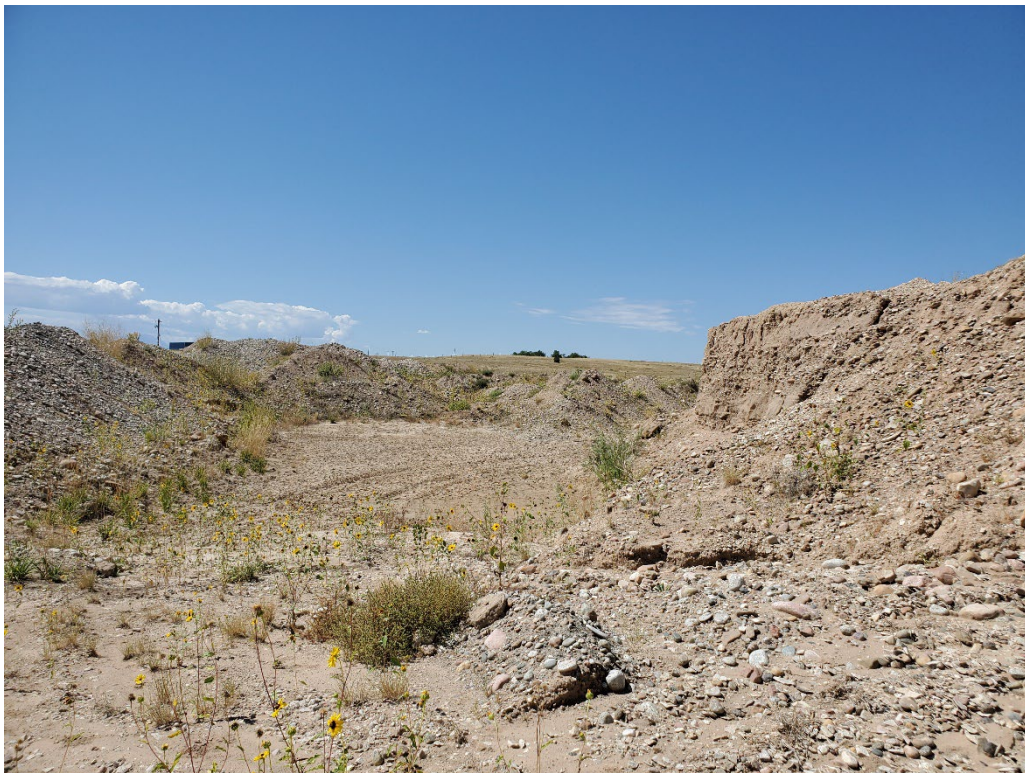
**Photo 6:** Looking south along the base of the western highwall within the pre-existing pit.

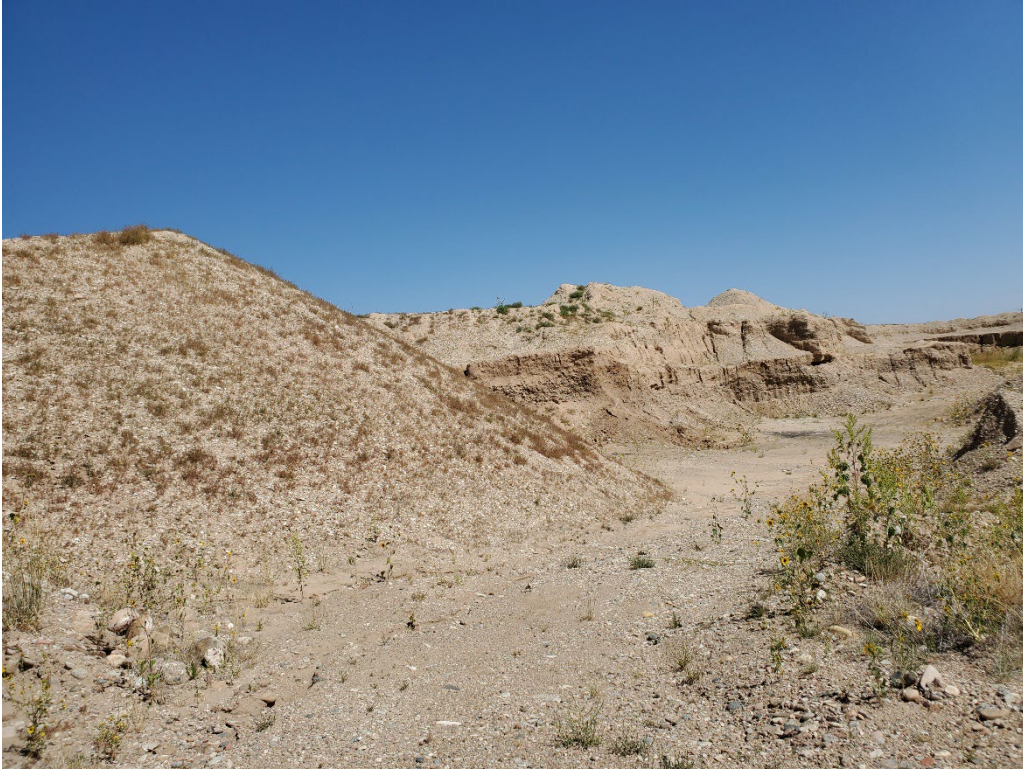
**Photo 7:** Looking north along the western portion of the pre-existing pit.

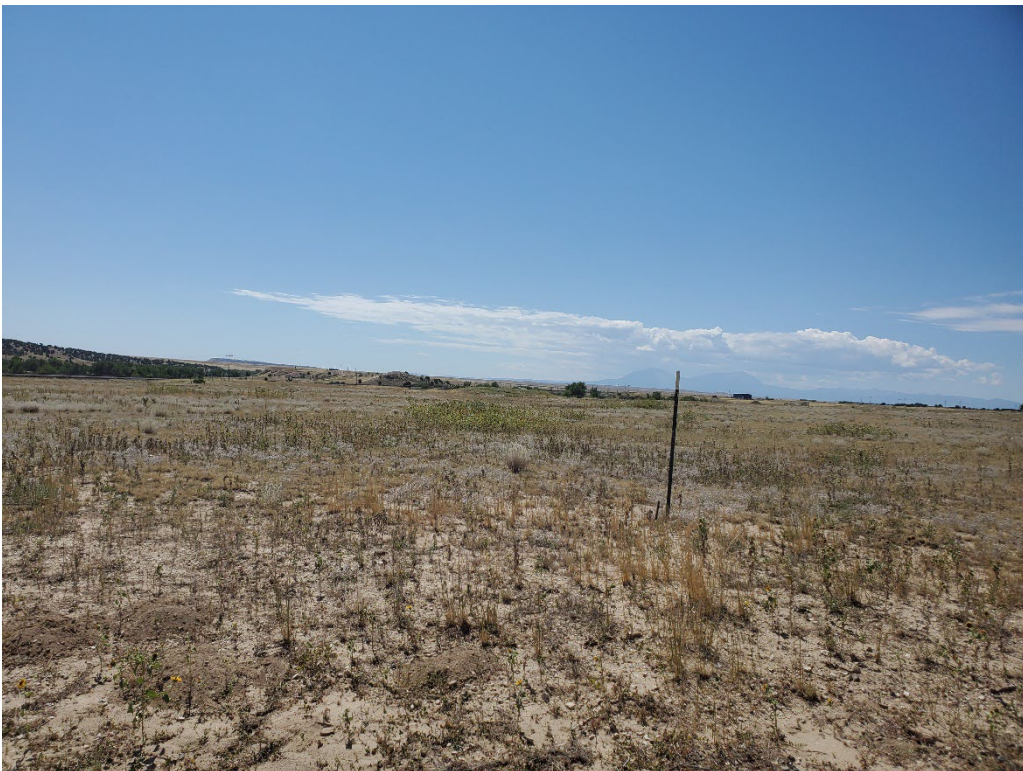
**Photo 8:** Looking south at undisturbed lands to be included in the proposed permit boundary.

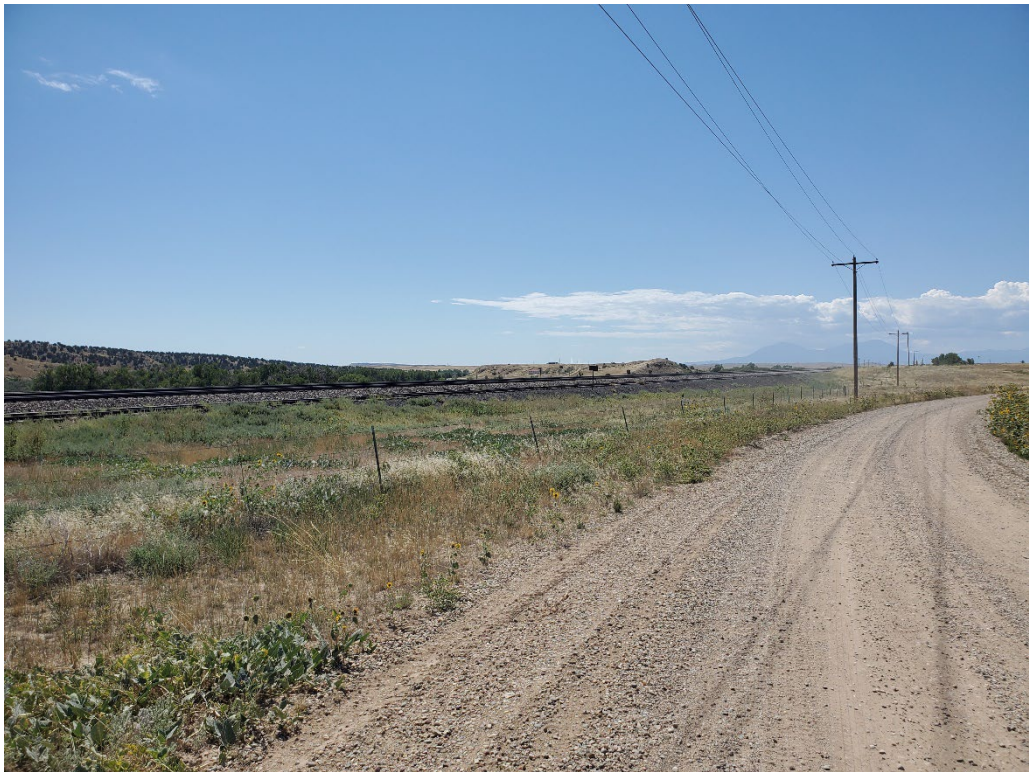
The Division conducted an adequacy review of the permit application and sent it to the Applicant's on August 26, 2024 and have not yet received adequacy responses. During the inspection, the Applicant and the Division observed that the fences depicted on the application maps that follow the east and north sides of the proposed permit boundary do not exist (see Map 1). T-posts were observed in a few spots, suggesting that the fence may have existed at one time, but the Applicant's stated that there has not been a fence in these locations since they purchased the land. However, there does appear to be a fence that the Applicant believes belongs to the railroad, located on the east side of County Rd. 110 (Photo 9). The Applicant stated that the updated fence information will be included on the maps submitted with the adequacy response.

**Photo 9:** Looking southeast at the fence located on the east side of CR 110.

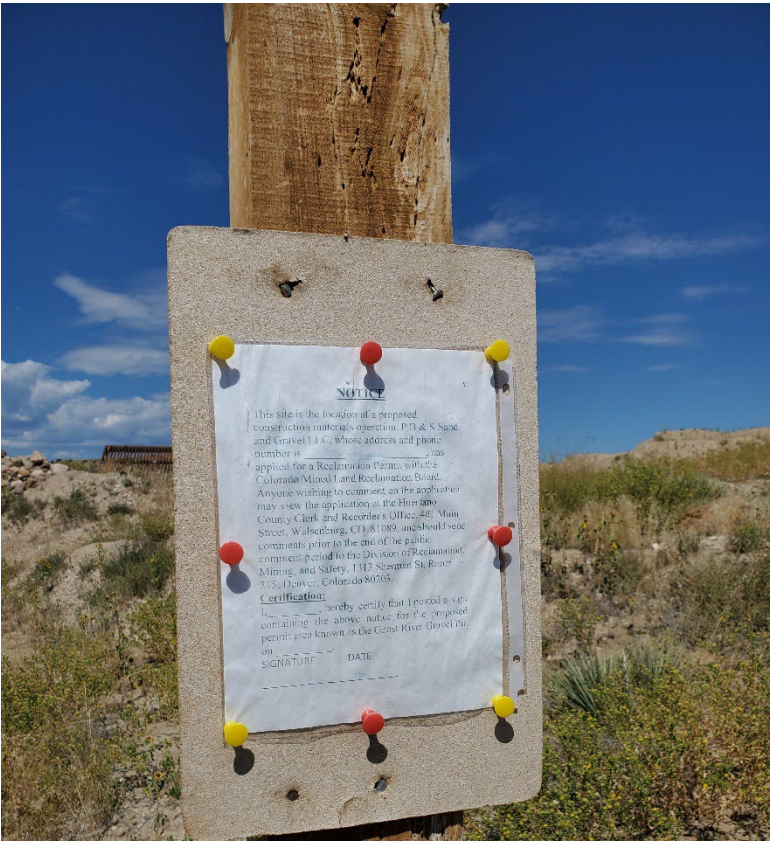
A notice sign was posted near the entrance to the site in compliance with Rule 1.6.2(1)(b) (Photo 10).

**Photo 10:** Notice sign posted at the entrance to the site. Written/signed information was faded from exposure to the elements.

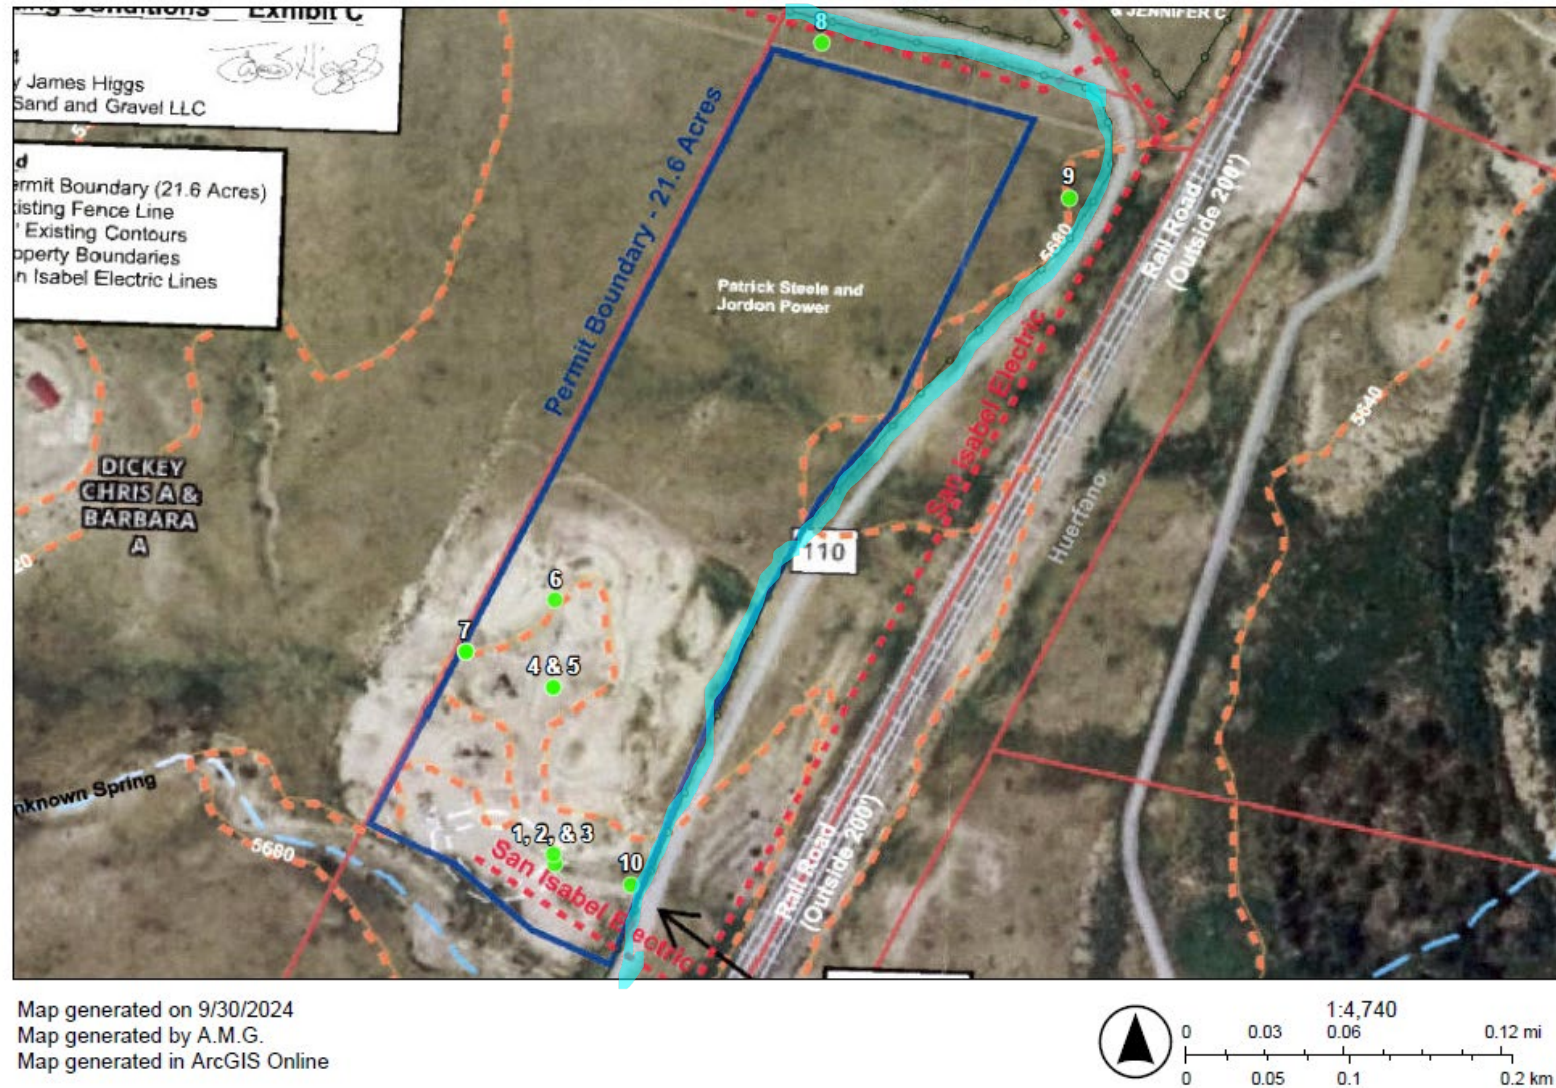
**Map 1:** Map generated in ArcGIS Online in combination with the Applicant's proposed mining plan map. The Division georeferenced the mining plan map into ArcGIS Online and overlaid the inspection photo locations onto the image (green numbered dots). The numbers next to the green dots correspond with the inspection photos. The fence line highlighted in light blue does not exist. A fence line does exist on the east side of CR 110 that will need to be added to the map (see Photo 9).
