MINERALS PROGRAM INSPECTION REPORT
PHONE: (303) 866-3567

MINE NAME: Specification Aggregates Quarry	MINE/PROSPECTING ID#: M-1974-004	MINERAL: Granite, granite gneiss	COUNTY: Jefferson
INSPECTION TYPE: Monitoring	WEATHER: Clear	INSP. DATE: September 17, 2024	INSP. TIME: 11:00
OPERATOR: Martin Marietta Materials, Inc.	OPERATOR REPRESENTATIVE:	TYPE OF OPERATION: 112c - Construction Regular Operation	
REASON FOR INSPECTION: Normal I&E Program	BOND CALCULATION TYPE: Complete Bond	BOND AMOUNT: \$7,240,331.00	
DATE OF COMPLAINT: NA	POST INSP. CONTACTS: None	JOINT INSP. AGENCY: None	
INSPECTOR(S): Ben Hammar Zach Trujillo	INSPECTOR'S SIGNATURE:

OBSERVATIONS

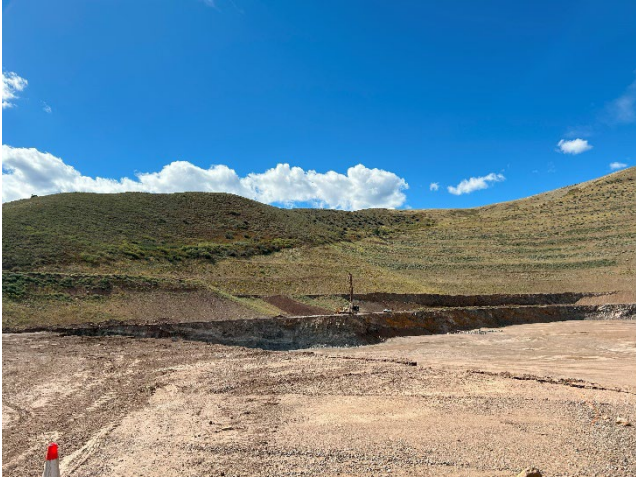
Concurrent reclamation present on-site is generally excellent. Previously reclaimed slopes are in accordance with the reclamation plan, and seeding appears to be well established. The operator has done well to re-establish slopes following benched quarrying operations.

Photo 1: Reclaimed slopes facing south. The unaffected near the top of the slope is the undisturbed AM4 addition.

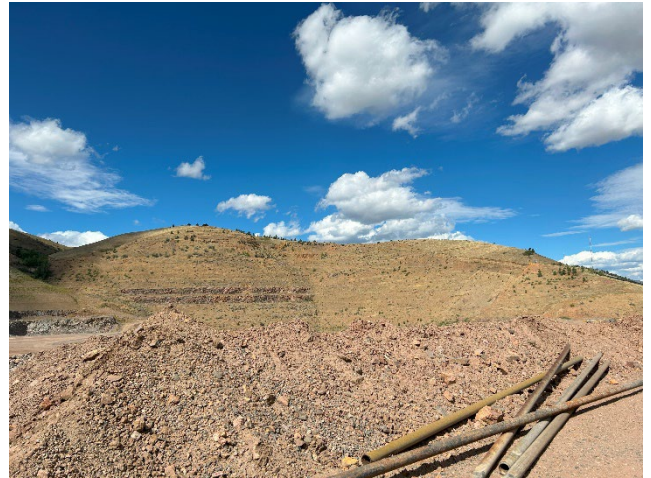
The proposed post mining land use for the site is "developed water resource", and currently the State Engineer's Office has determined the water collection pond within the northern portion of the permit meets the standards for a lined reservoir. As mining continues the operator plans to expand the pond area as reclamation occurs. As mining progresses the operator has stated that the water level within the pond is expected to fluctuate significantly. Final reclamation is currently planned to create a lined reservoir that encompasses most of the current permit area.

Photo 2: Reclaimed slopes facing north overlooking the quarry pit pond.

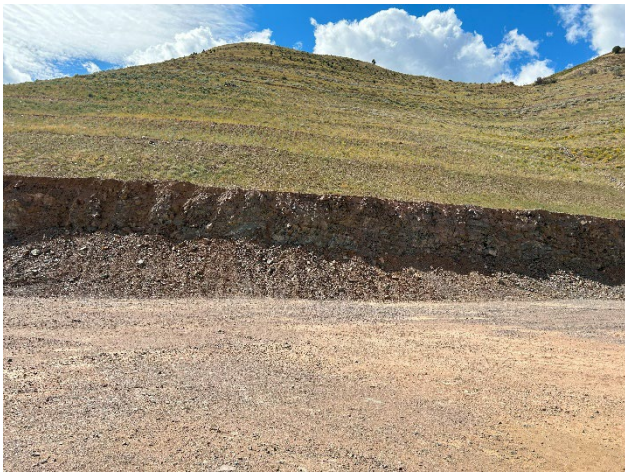
Photo 3: Current highwall reclamation in progress.

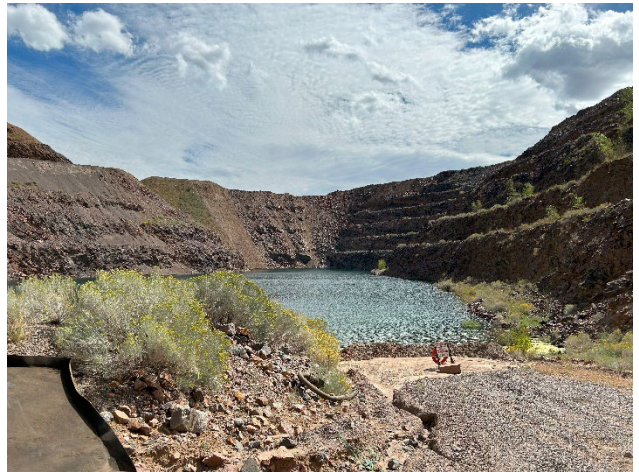
Photo 4: Image from the access ramp of the Spec Agg quarry pit.

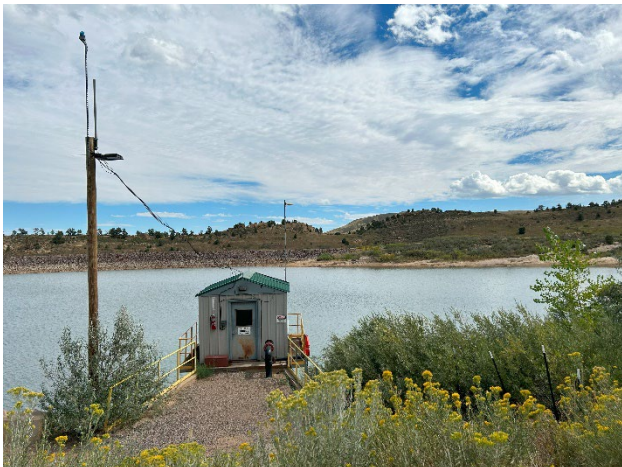
No problems were found during this inspection. No off-site impacts were observed as a consequence of operations and no impacts to the surrounding hydrologic balance were found. Drainage from the site appears to be very well maintained, primarily flowing into the previously mentioned pond on the northern portion of the permit and into Magic Mountain reservoir to the east.

Photo 5: Pumphouse and shoreline of Magic Mountain reservoir.

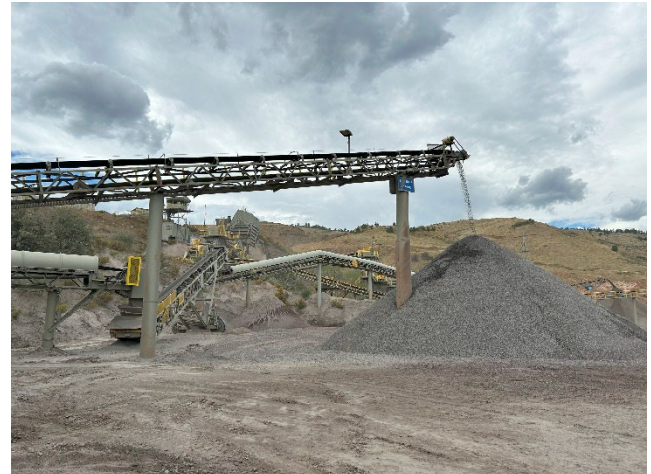
Photo 6: Representative photo of operation stockpiles and processing facilities.
