MINERALS PROGRAM INSPECTION REPORT
PHONE: (303) 866-3567

MINE NAME: Chieftain South Mine	MINE/PROSPECTING ID#: M-1981-148	MINERAL: Clay (general)	COUNTY: Jefferson
INSPECTION TYPE: Monitoring	WEATHER: Cloudy	INSP. DATE: September 16, 2024	INSP. TIME: 11:00
OPERATOR: General Shale Brick, Inc.	OPERATOR REPRESENTATIVE: Jason McGraw	TYPE OF OPERATION: 112c - Construction Regular Operation	
REASON FOR INSPECTION: Normal I&E Program	BOND CALCULATION TYPE: Complete Bond	BOND AMOUNT: \$397,830.00	
DATE OF COMPLAINT: NA	POST INSP. CONTACTS: None	JOINT INSP. AGENCY: None	
INSPECTOR(S): Ben Hammar Zach Trujillo	INSPECTOR'S SIGNATURE:

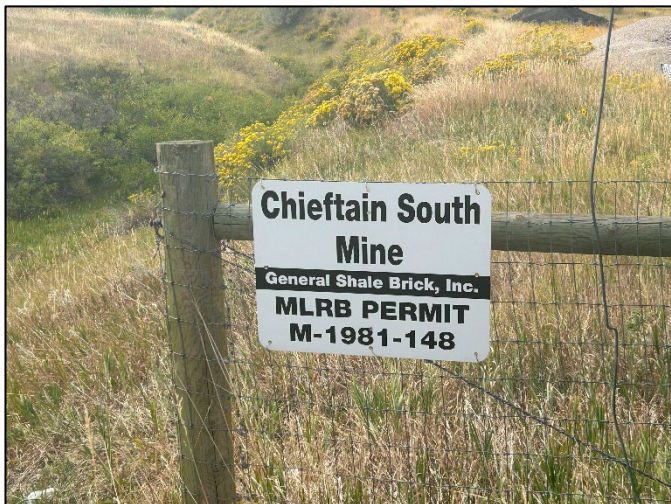
Photo 1: Permit sign.

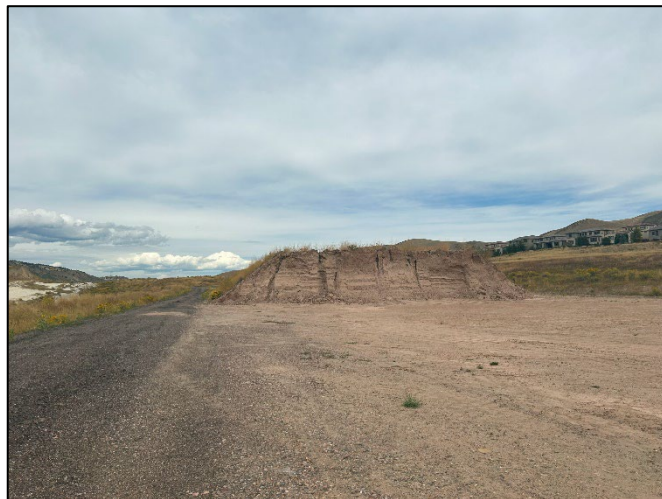
Stockpiles of topsoil, overburden, and product are present on-site and are well vegetated and stable. Dust control issues have been cited in past inspections, with complaints being filed by citizens of the bordering housing development. Currently there appears to be no risk of further issues.

Photo 2: Representative stockpile, with established vegetation.

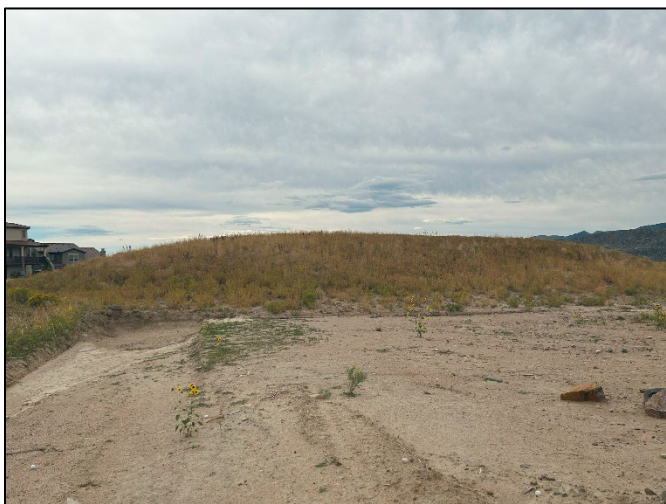
Photo 3: Stockpile that had been a source of complaints. Currently well stabilized.

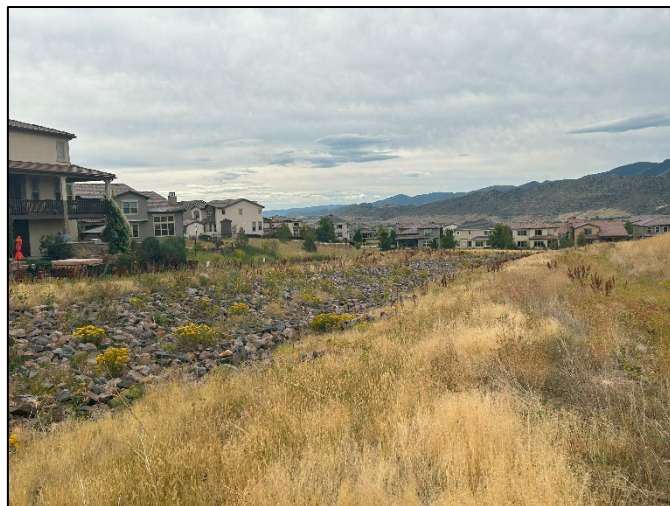
No problems were found during this inspection. No off-site impacts were observed and no impacts to the surrounding hydrologic balance were found. The operator has constructed large rip-rap lined drainage channels following an agreement with a local developer. As such, drainage from the site appears to be very well maintained. Active mining has not taken place on-site since 2006, however material from existing stockpiles is regularly removed for sale.

Photo 4: Drainage channel and southern site boundary.

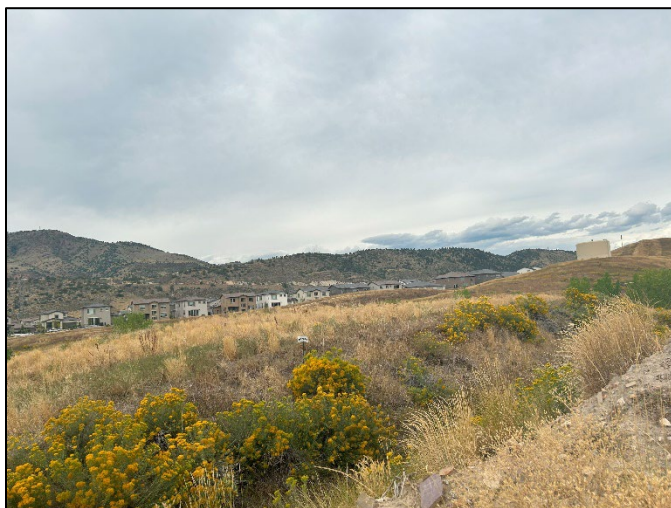
Photo 5: Seeded topsoil stockpile.

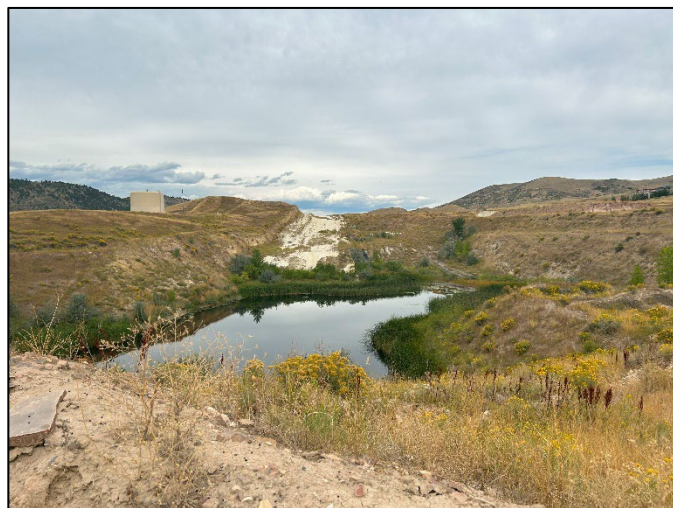
Photo 6: Previous mined area and drainage pond.
