**MINERALS PROGRAM INSPECTION REPORT**  
**PHONE: (303) 866-3567**

<b>MINE NAME:</b> Arapaho Pit	<b>MINE/PROSPECTING ID#:</b> M-2024-043	<b>MINERAL:</b> Sand and gravel	<b>COUNTY:</b> Jackson
<b>INSPECTION TYPE:</b> Preoperation Inspection	<b>WEATHER:</b> Clear	<b>INSP. DATE:</b> September 25, 2024	<b>INSP. TIME:</b> 10:00
<b>OPERATOR:</b> Harry Corkle Construction	<b>OPERATOR REPRESENTATIVE:</b> Harry Corkle	<b>TYPE OF OPERATION:</b> 112c - Construction Regular Operation	
<b>REASON FOR INSPECTION:</b> Preoperation Inspection	<b>BOND CALCULATION TYPE:</b> Complete Bond	<b>BOND AMOUNT:</b> TBD	
<b>DATE OF COMPLAINT:</b> NA	<b>POST INSP. CONTACTS:</b> None	<b>JOINT INSP. AGENCY:</b> None	
<b>INSPECTOR(S):</b> Ben Hammar Hunter Ridley	<b>INSPECTOR'S SIGNATURE:</b>

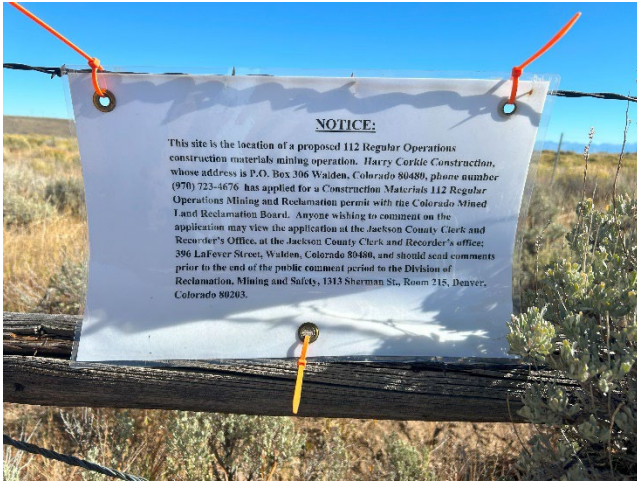
Photo 1: Posted notice of the permit application, located at the gate leading to the permit.

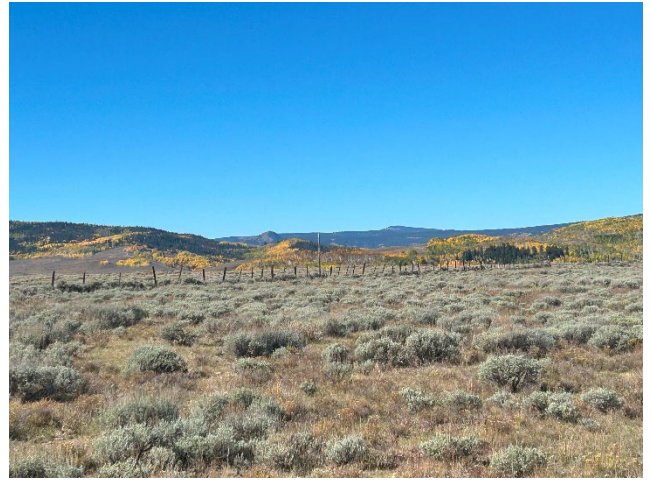
Photo 2: Pre existing fence line and larger post marking southern point of the east permit boundary.

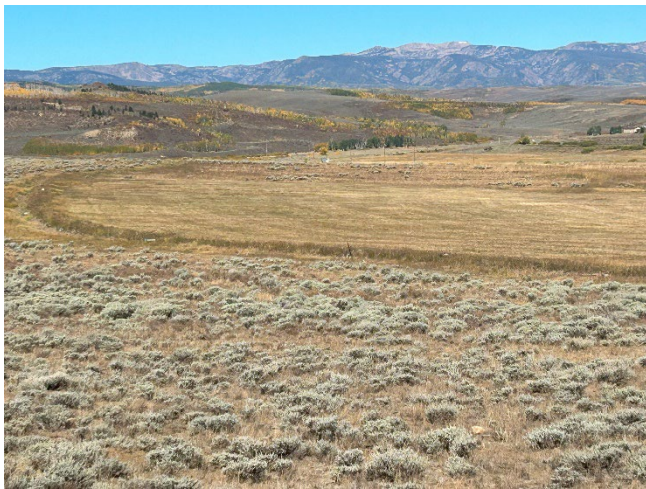
Photo 3: Nearby Arapaho Ditch and northern boundary marker for the eastern site boundary.

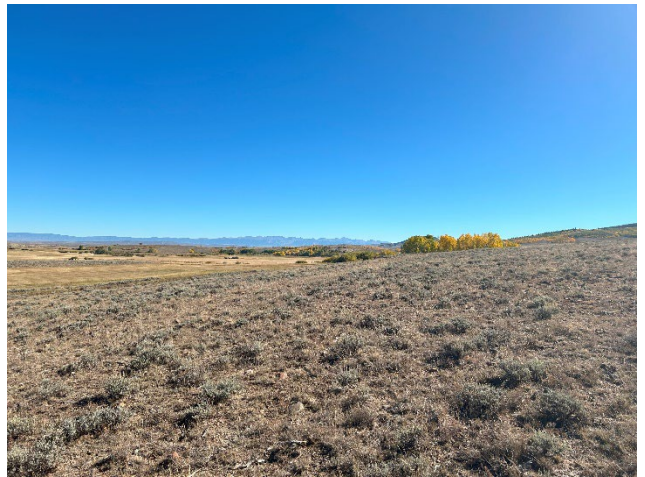
Photo 4: Ditch heading east.

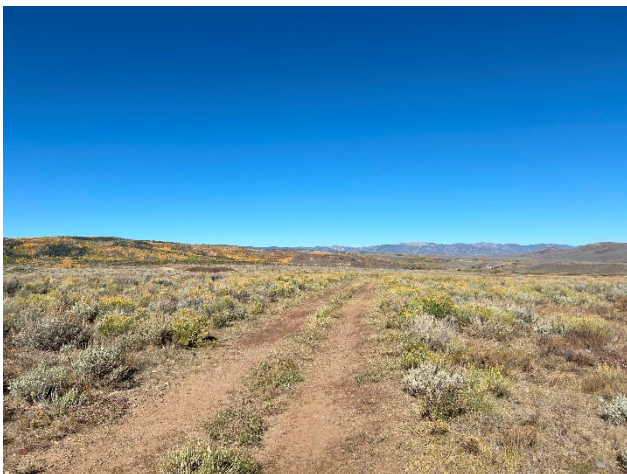
Three structures were visible within 200 feet of the permit boundary during the inspection. An existing fence line, ranch road, and ditch were observed. The operator has stated that all structures were present prior to submitting their permit, and no improvements are currently planned to the existing road.

Photo 5: Pre-existing road. The operator has stated that no improvements are planned as part of this permit.

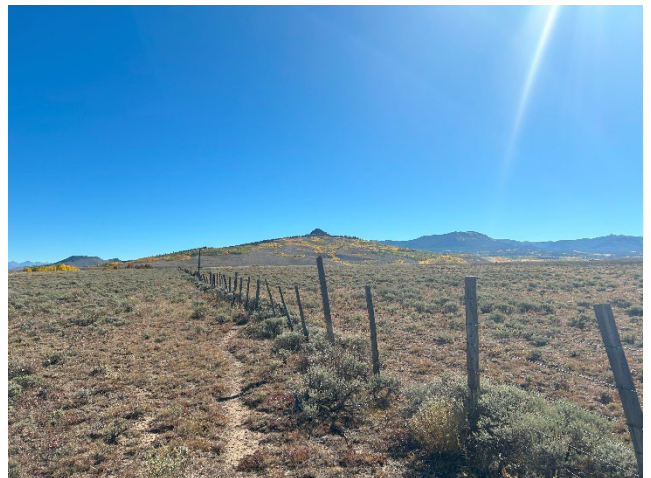
Photo 6: Fenceline near the southern permit boundary.
