Re: Follow-Up Action Plan from 6-3-24 TDL Leak – Climax Mine Permit No. M-1977-493

The purpose of this letter is to provide a written plan of the work performed/to be performed to address the drainage and stability issues in the area near the Tailing Delivery Line (TDL) leak just up-gradient from the Clinton Cutout near Drop Tower 13 that occurred June 3, 2024.

Profile View of Alignment - TDL Ditch

SEEPAGE CONVEYANCE BENCH
TYPICAL DETAIL (N.T.S.)

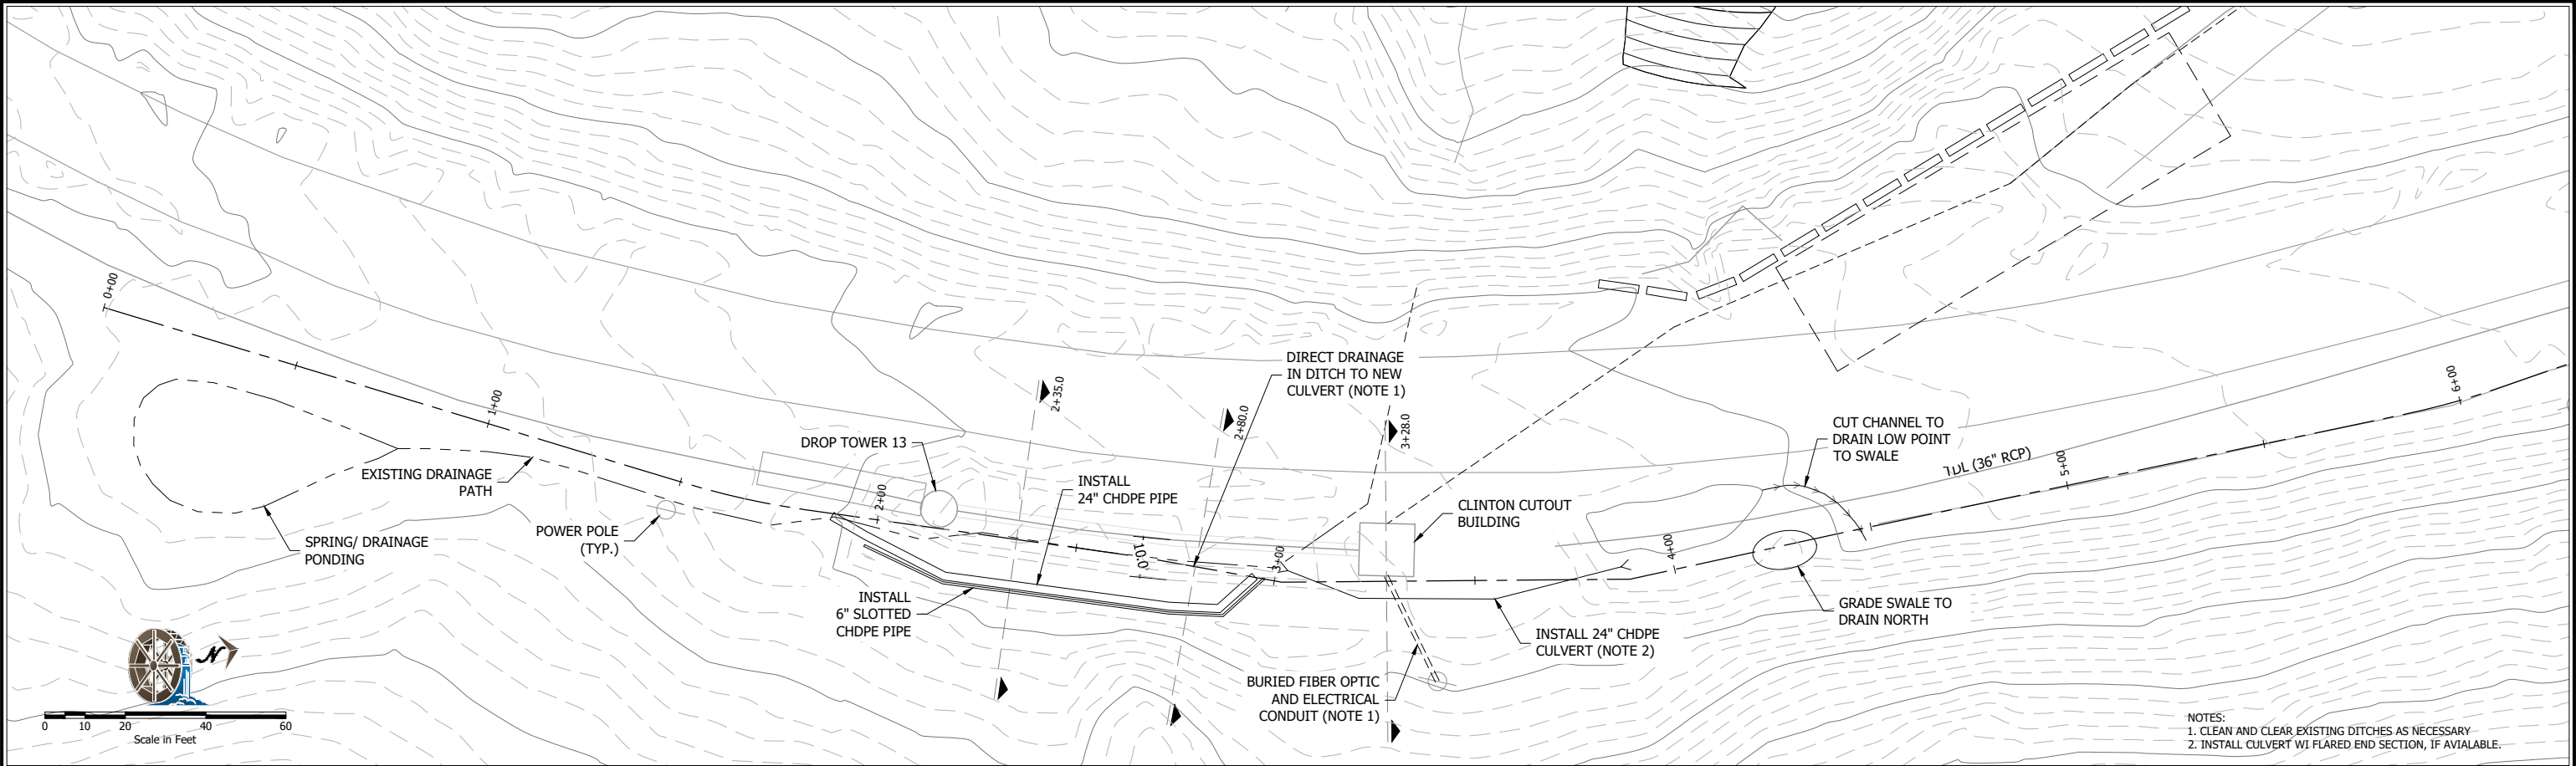
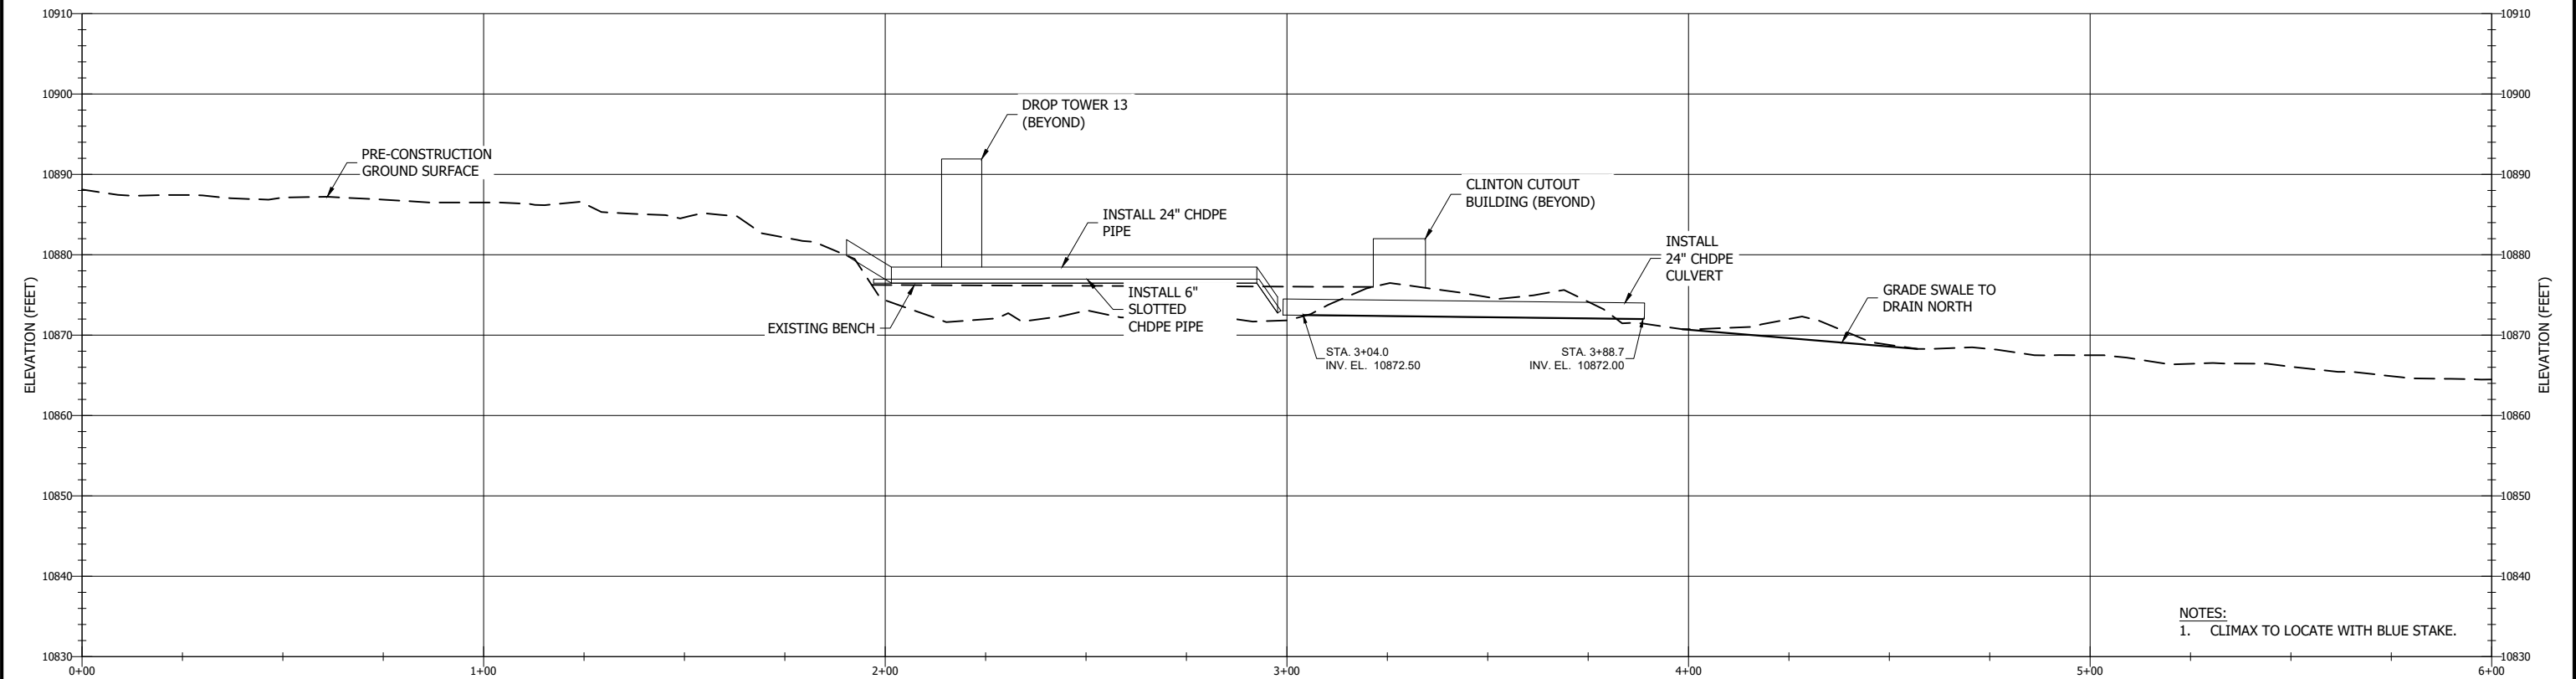
NOTES:
1. CLEAN AND CLEAR EXISTING DITCHES AS NECESSARY
2. INSTALL CULVERT W/ FLARED END SECTION, IF AVAILABLE.

NOTES:
1. CLIMAX TO LOCATE WITH BLUE STAKE.

4. Install approximately 100' of 24"-diameter CHDPE or HDPE culvert on the east side of the Clinton Cutout Building. Bend the pipe as necessary around the building without fittings.

6. Regrade the bench to match uphill slope and reestablish ditch on the east side of TDL between Drop Tower 13 and the Clinton Cutout grade ditch to flow north to new 24"-diameter culvert.
