MINERALS PROGRAM INSPECTION REPORT
PHONE: (303) 866-3567

MINE NAME: Rocky Flats Pit	MINE/PROSPECTING ID#: M-1987-113	MINERAL: Clay (general) and sand gravel	COUNTY: Jefferson
INSPECTION TYPE: Monitoring	WEATHER: Clear	INSP. DATE: September 16, 2024	INSP. TIME: 08:30
OPERATOR: BURNCO Colorado, LLC	OPERATOR REPRESENTATIVE: Chris Oestreich	TYPE OF OPERATION: 112c - Construction Regular Operation

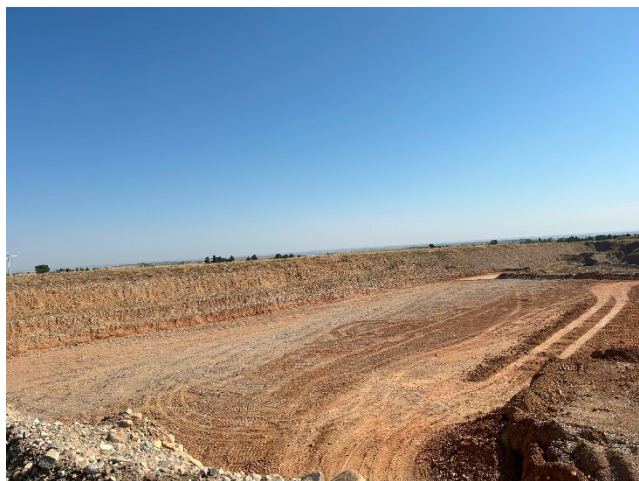
Photo 1: Pit floor and active mining area.

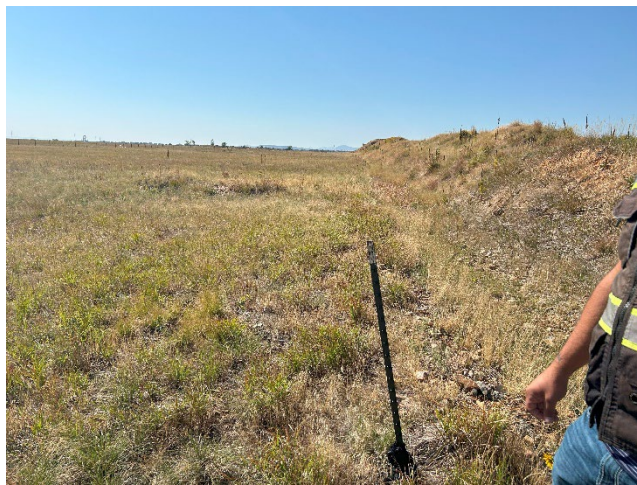
Photo 2: East visual berm and function eastern boundary.

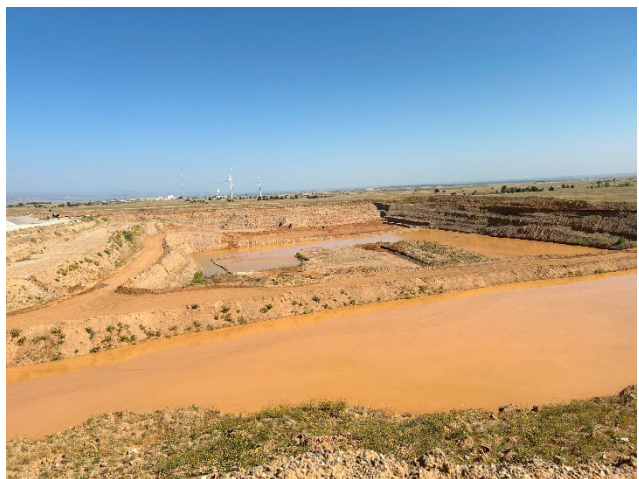
Photo 3: Water storage for on-site wash plant, filtered on-site per operator.

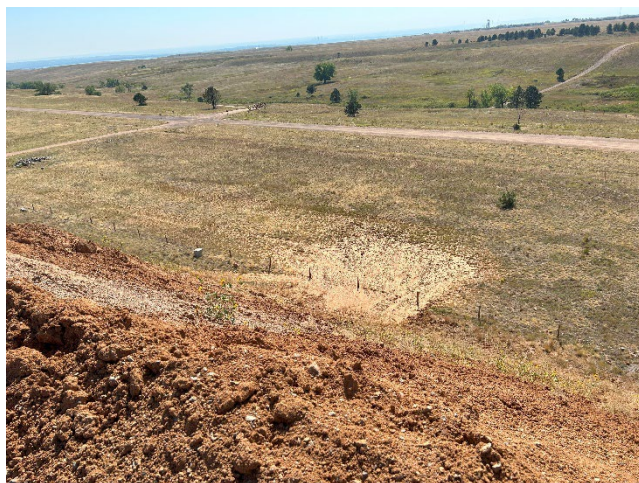
PROBLEM/POSSIBLE VIOLATION: Problem: A washout due to recent rainfall was noticed on the southwest portion of the large overburden stockpile located on the southern border of the permit boundary. Pursuant to C.R.S 34-32.5-116(4)(j), all surface areas of affected land, including spoil piles, shall be stabilized and protected so as to effectively control erosion.

As mentioned previously, at the time of the inspection, recent rainfall appears to have cause excessive erosion on the southern end of the south soil stockpile, which led to a washout of material. DRMS is requiring the operator to submit proof of repair of the washed-out section of the stockpile, as well as placement of silt fencing or another adequate best management practice along the fence line boundary near the failure.

Photo 4: Erosion as mentioned in report.

CORRECTIVE ACTIONS: The operator shall provide photo documentation to the Division verifying stockpile erosion has been repaired, and that the site has have been reconstructed and stabilized to prevent erosion damage by the corrective action date. Please also provide verification that silt fencing or other adequate best management practices have been placed around the erosion as discussed during the inspection.

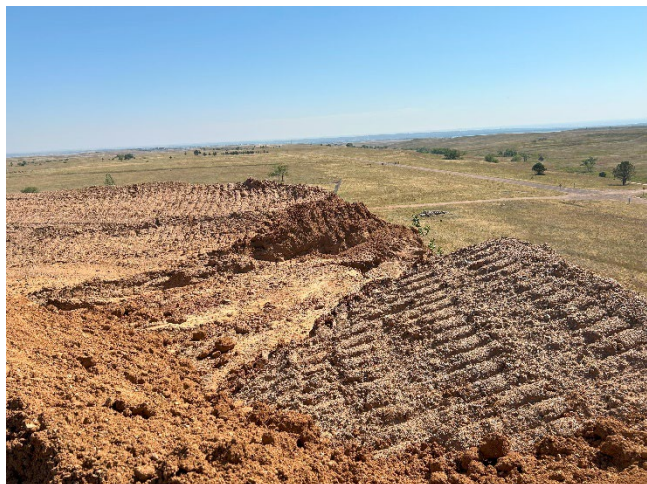
Photo 5: Erosion from top of overburden pile.

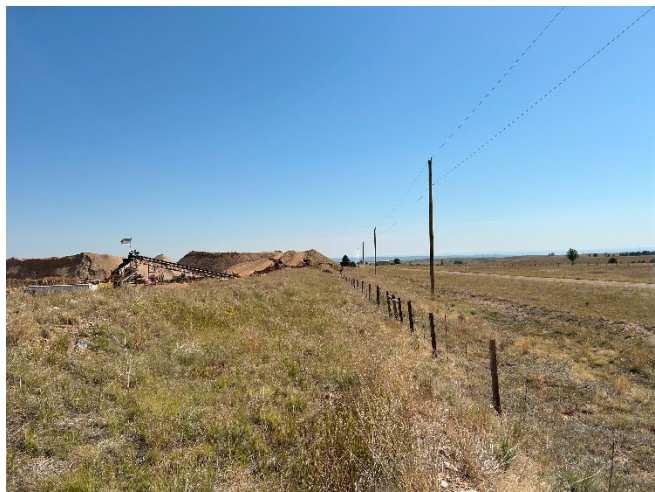
Photo 6: Southern fenceline and permit boundary.
