McClane Canyon Mine, C-1980-004, September Complete Inspection Report1 message

PERMIT INFORMATION

Permit Number: C-1980-004 Mine Name: McClane Canyon Mine Operator: ARC McClane Canyon, LLC Operator Address: Joe Brinton 652 Peony Dr Grand Junction, CO 81507	County: Garfield Operation Type: Underground Permit Status: Temporary Cessation Ownership: Private
	Operator Representative Present: Chuck Silengo
Operator Representative Signature: (Field Issuance Only)

Inspection Start Date: September 19, 2024 Inspection Start Time: 09:35 Inspection End Date: September 19, 2024 Inspection End Time: 11:05		Inspection Type: Coal Complete Inspection Inspection Reason: Normal I&E Program Weather: Clear	
Joint Inspection Agency: None		Joint Inspection Contacts: None	
Post Inspection Agency: None		Post Inspection Contacts: None	
Inspector(s): Clayton Wein	Inspector's Signature: <i>Clayton Wein</i>		
	Signature Date: 10/2/2024

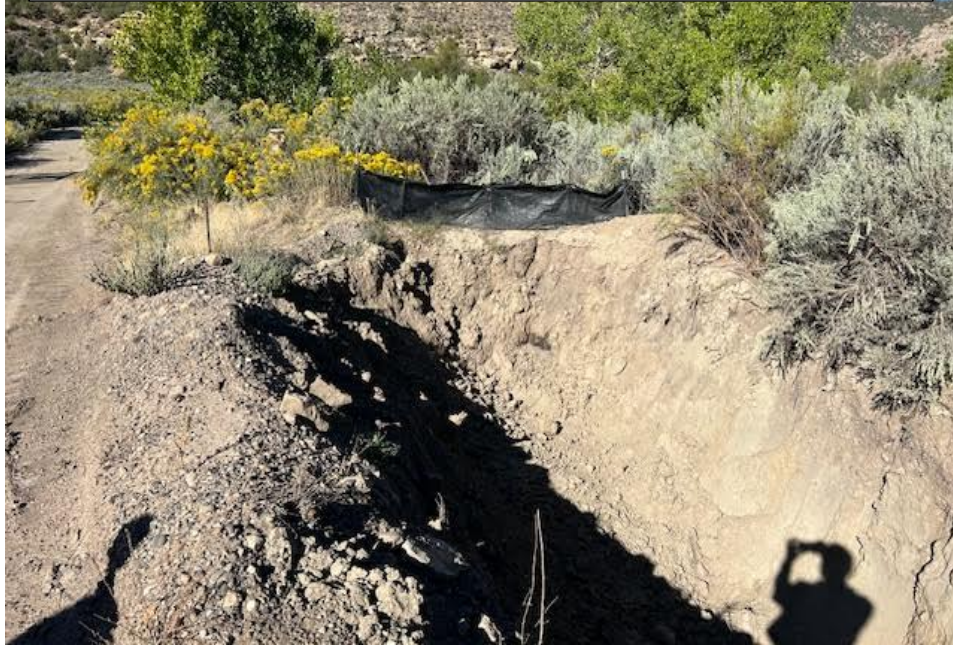
Two sumps are located on the western side of the mine office pad. One sump is located on the north side of the haul road not too far from the bridge over East Salt Creek (Photo 1). The sump was dry and recently had been cleaned. The silt fence at the sump's discharge outlet was clean and stable. There were no observed signs of offsite impacts. The second sump is located on the south side of the haul road at the corner of the haul road and the mine office pad (Photo 2). The sump was muddy and stable. The silt fence at the sump's outlet was in good repair and clean. The operator had recently cleaned the sump. There were no indications of off-site impacts.

Photo 1: The north office pad sump.

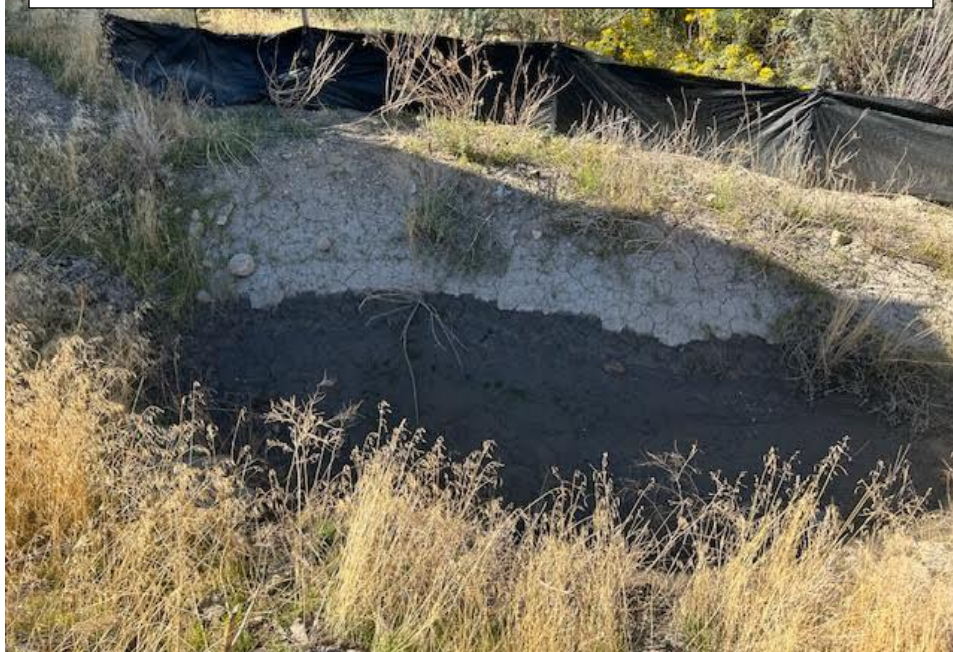
Photo 2: The south office pad sump.

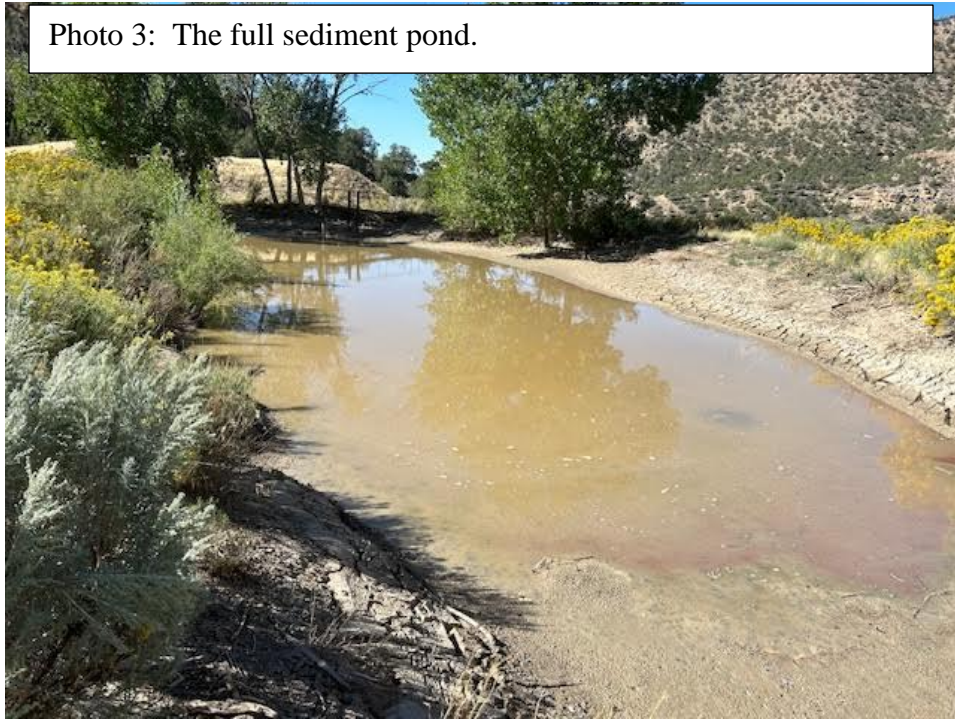
The Sediment pond is located to the east of Sump P on the south side of the haul road. The pond was holding water during the inspection (Photo 3). There was no discharge through the primary discharge outlet. Due to recent precipitation events, the sediment level in the pond had reached maximum capacity. Discussions with the operator's representatives, Chuck Silengo and Joe Brinton, and the Division during the inspection and the day after the inspection occurred about the urgency to clean the sediment pond. The operator's representatives started cleaning operations on the pond would start right after the discussions. The operator will use a front end loader to remove as much sediment as possible from the pond as the conditions in the pond allow. As material is removed, the bottom of the pond becomes muddy and soft. Equipment must wait for the material to dry before more cleaning operations can occur, or they risk getting the loader stuck. The operator will continue this method until the sediment pond has been restored to the designed capacity. Due to the recent large scale precipitation events, water impounded in the pond had reached the level of the primary and emergency spillways. Evidence of flow through both spillways was observed during the inspection. At the time of the inspection the primary discharge outlet and the emergency spillway were observed to be unobstructed.

Photo 3: The full sediment pond.

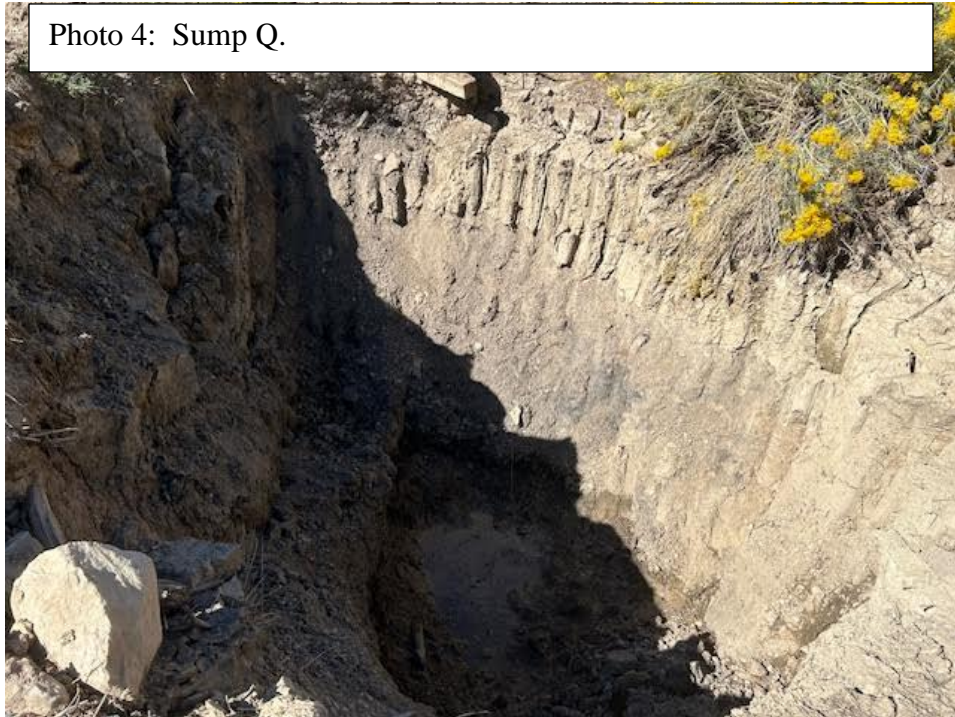
Sump Q is located on the north side of the haul road, across from the sediment pond (Photo 4). The sump had recently been cleaned. The sump was not holding any water during the inspection. The culvert outlet for Sump Q was unobstructed. The sump was stable with no indications of erosional features.

Photo 4: Sump Q.

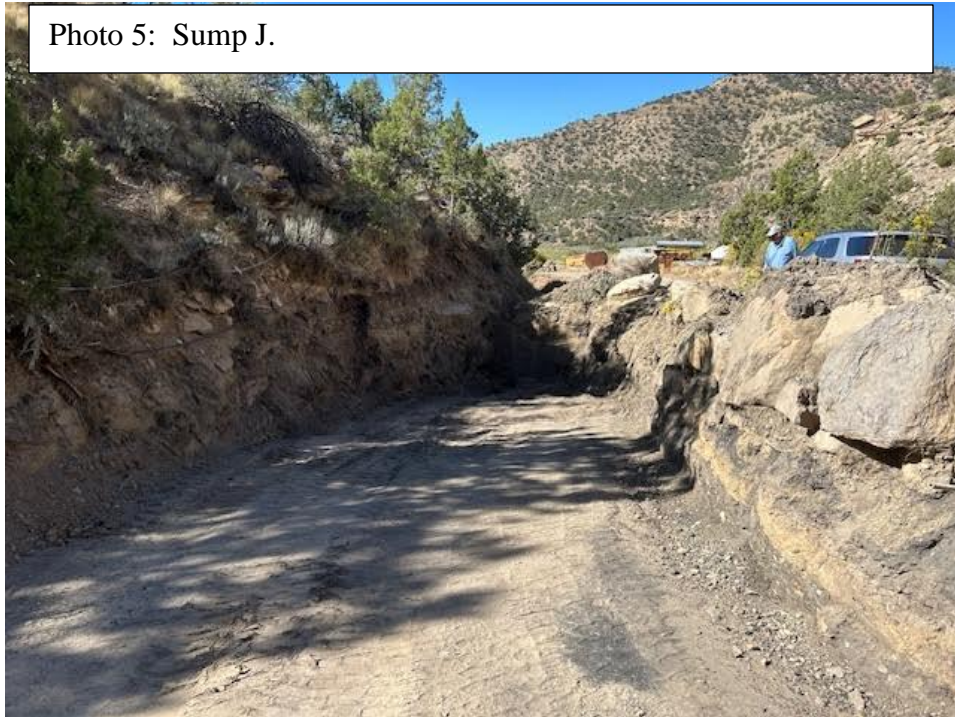
Sump J is located on the south side of the haul road and east of the sediment pond. The sump had recently been cleaned (Photo 5). No water was impounded in the sump during the inspection. The sump was stable with no erosional concerns. The outlet for the sump is a surface discharge into the D-6 Ditch. The D-6 ditch was stable and observed to be unobstructed. The D-6 ditch terminates into the sediment pond. The junction between the D-6 Ditch and the sediment pond was clear of debris.

Photo 5: Sump J.

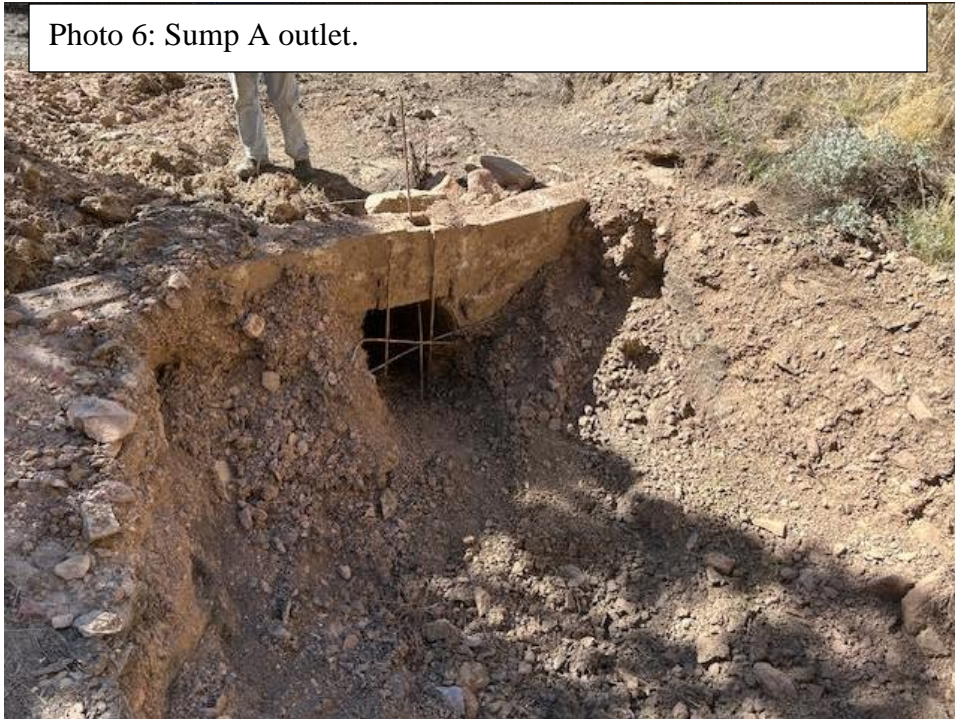
Sump A is located on the northwestern side of the portals facilities area. The sump was dry and stable. The outlet for the sump was clear of debris (Photo 6). Sump A had also been cleaned recently. There were no indications of erosion.

Photo 6: Sump A outlet.

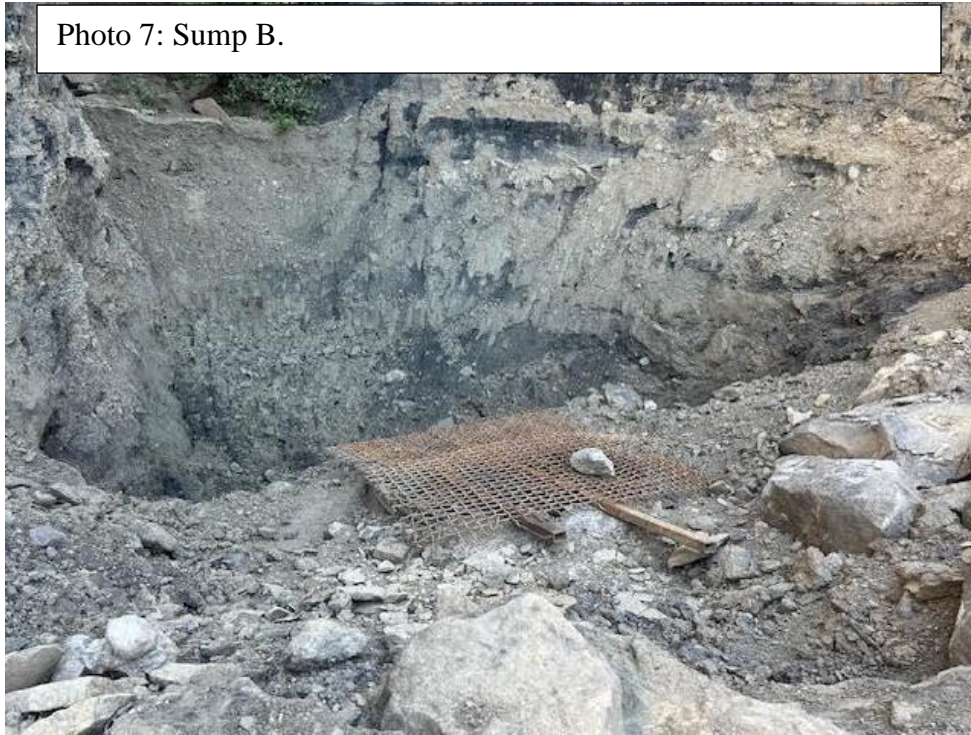
Sump B is located on the northeastern side of the portals facilities area. Sump B was dry and had been cleaned since the previous Division inspection (Photo 7). The trash rack covering the discharge outlet was clear of blockages. No erosional features were observed.

Photo 7: Sump B.

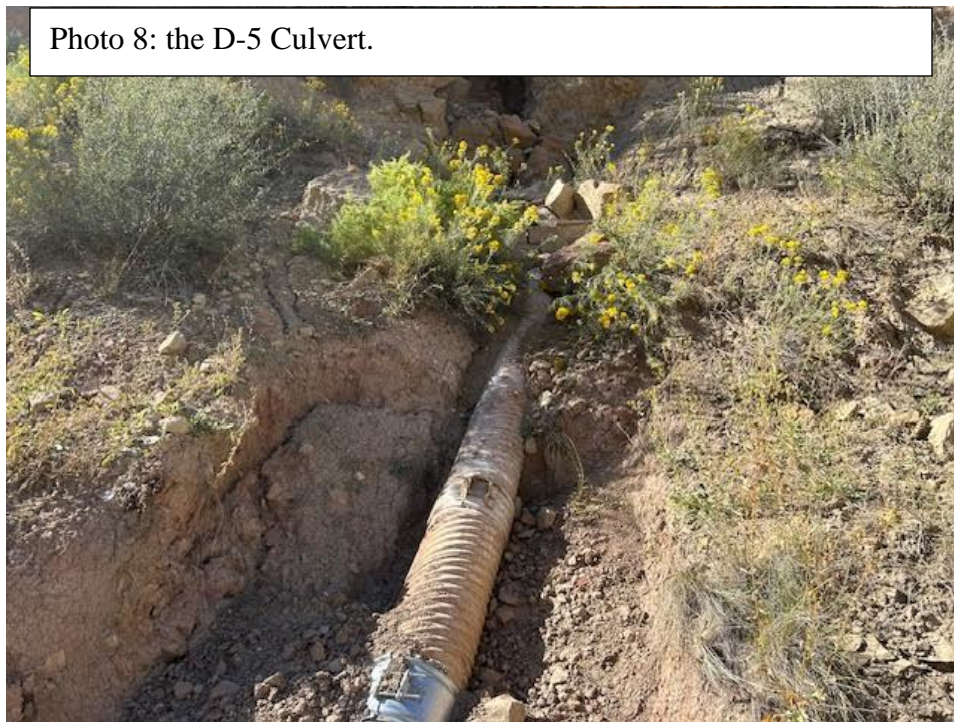
The culvert for D-5 is located on the southern side of the portals facilities area. The culvert was stable and in good condition (Photo 8). No erosional features were observed.

Photo 8: the D-5 Culvert.

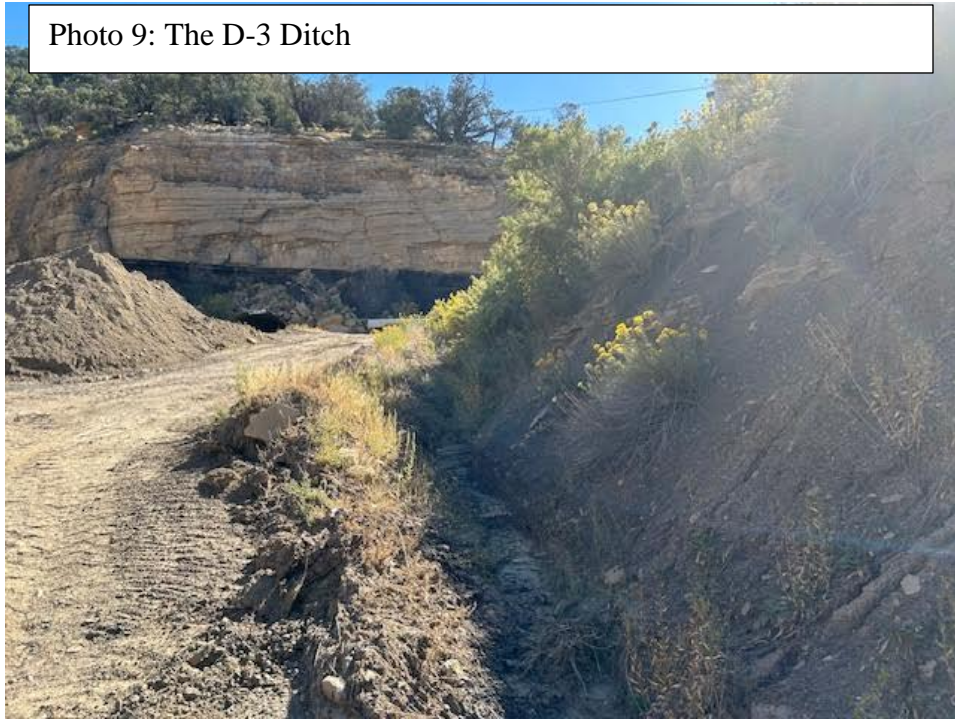
The D-3 Ditch is located along the southwest side of the portals facilities pad. The ditch was clear of debris and stable (Photo 9). No erosional concerns were identified.

Photo 9: The D-3 Ditch

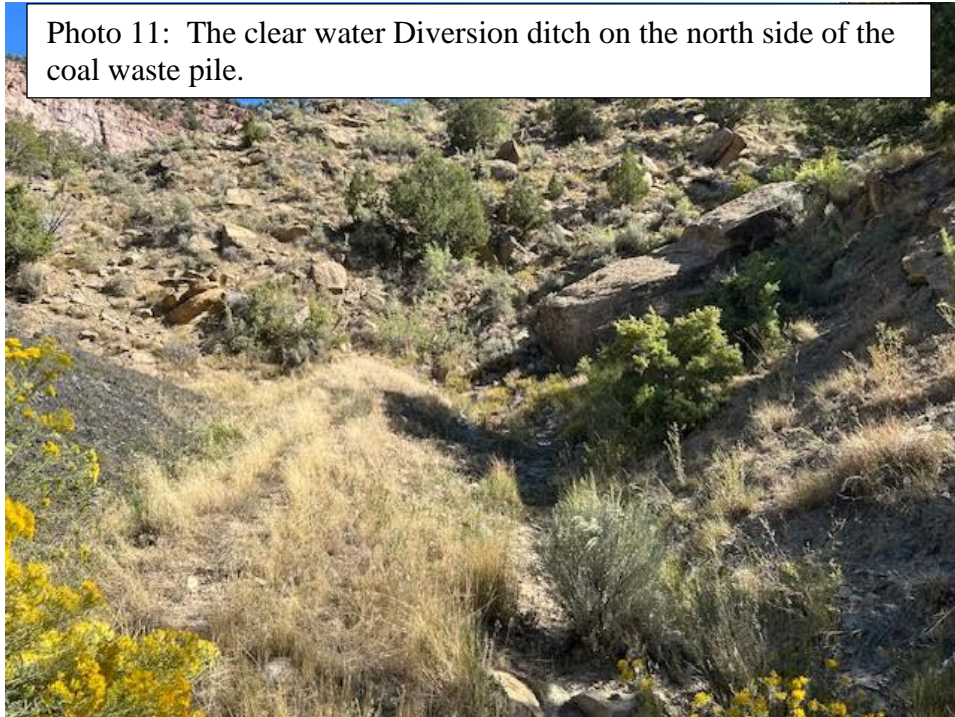
During the inspection the coal waste pile was stable with no erosional concerns identified. The clear water diversion ditch located on the north side of the pile was stable and clear of obstructions (Photo 10). The drainage from the coal waste pile is routed to the sediment pond.

Photo 11: The clear water Diversion ditch on the north side of the coal waste pile.

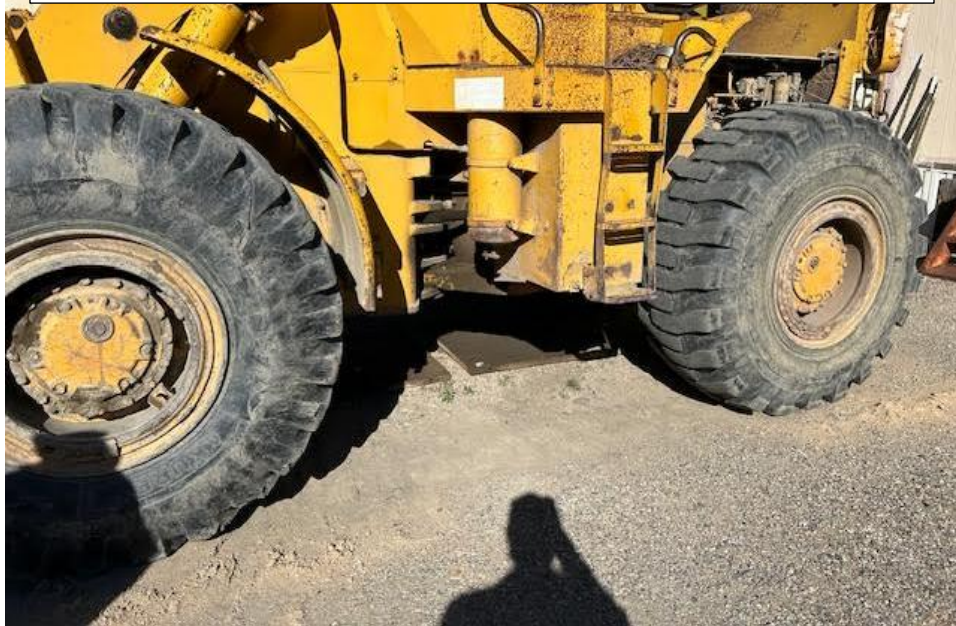
The mine office pad was stable with no erosional concerns. The equipment stored on the pad had catch pans placed beneath them (Photo 11). All liquids were stored in a secondary containment structure (Photo 12). The berm for the pad was vegetated and stable. No off-site impacts were observed. Materials stored on the pad were well kept and organized.

Photo 12: The loader parked on the mine office pad with catch pan underneath.

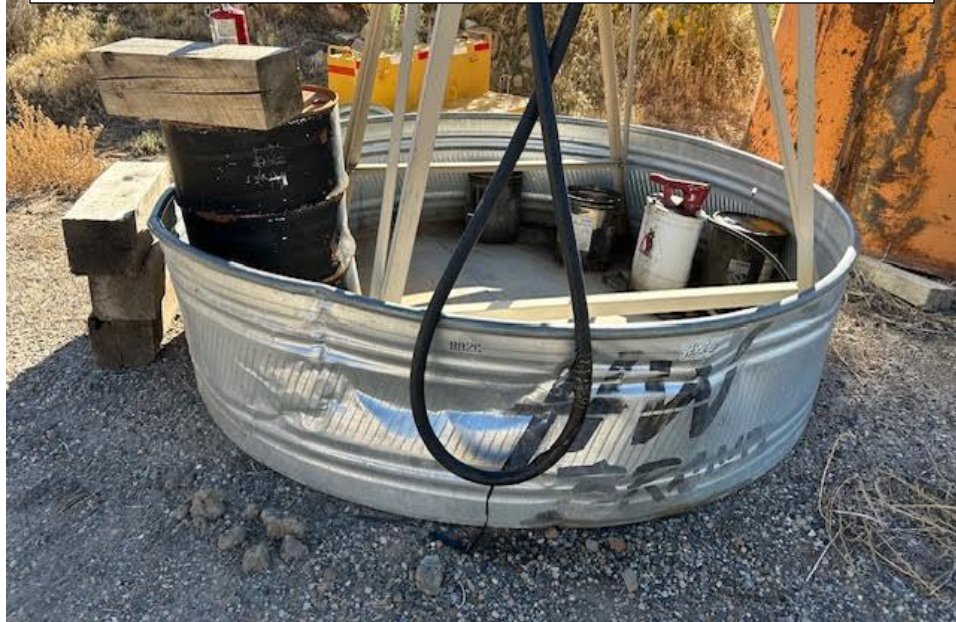
Photo 13: The secondary containment structure on the mine office pad.

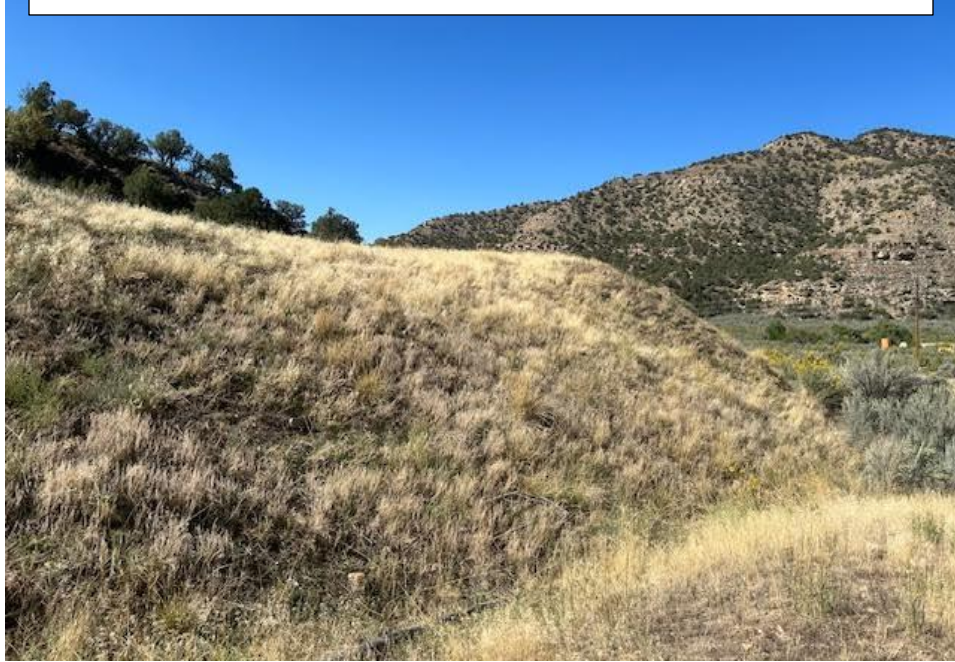
The topsoil pile is located to the southwest of the sediment pond. The pile was observed to be stable with vegetative cover (Photo 13). There were no erosional features noted. The topsoil pile marker was in place on top of the pile. The perimeter ditch was stable with no obstructions identified. There was no loss of topsoil resource observed.

Photo 14: The topsoil pile.
