C1980007, West Elk Mine, September Inspection Report

PERMIT INFORMATION

Permit Number: C-1980-007 Mine Name: West Elk Mine Operator: Mountain Coal Company, LLC Operator Address: Jessica Wilczek 5174 Highway 133 Somerset, CO 81434	County: Delta, Gunnison Operation Type: Underground Permit Status: Active Ownership: Private
	Operator Representative Present: Chase Hiatt
Operator Representative Signature: (Field Issuance Only)

Inspection Start Date: September 26, 2024 Inspection Start Time: 09:30 Inspection End Date: Inspection End Time:		Inspection Type: Coal Complete Inspection Inspection Reason: Normal I&E Program Weather: Clear	
Joint Inspection Agency: None		Joint Inspection Contacts:	
Post Inspection Agency: None		Post Inspection Contacts:	
Inspector(s): Leigh Simmons	Inspector's Signature:

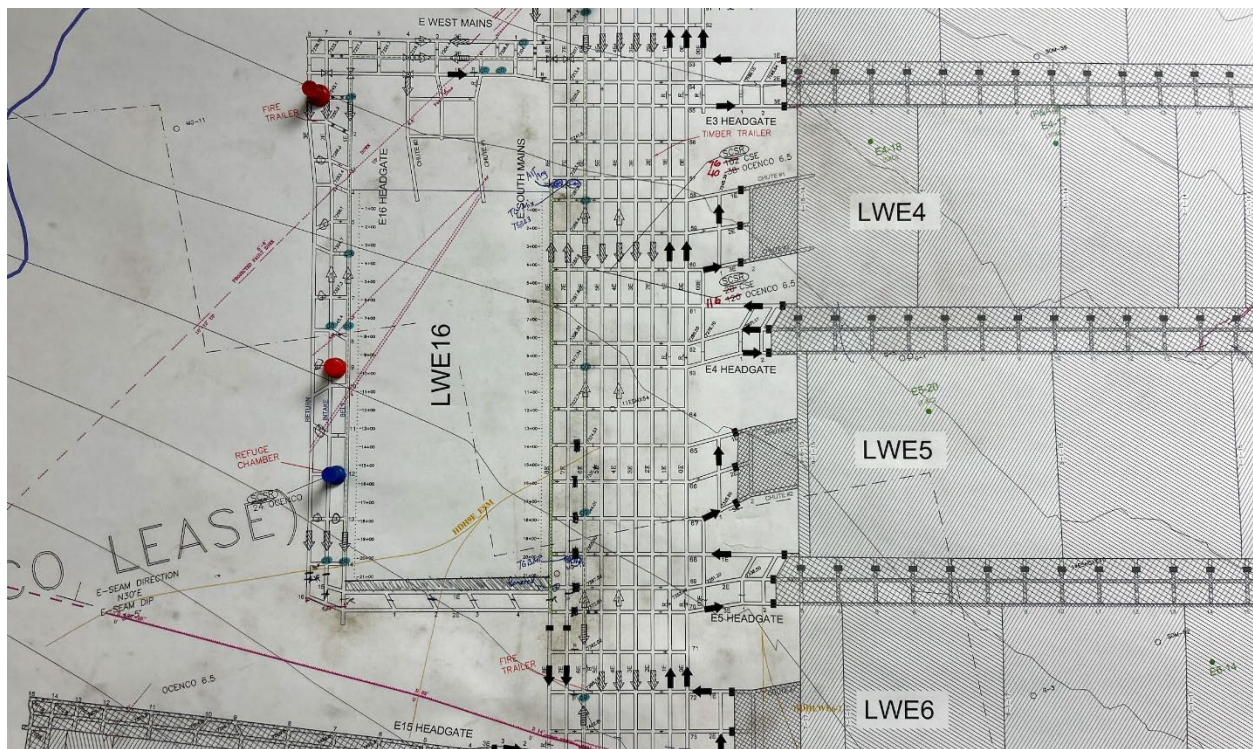
The longwall move to the LWE16 panel was complete and mining of the panel had begun.

Figure 1: Mine map showing longwall progress in LWE16

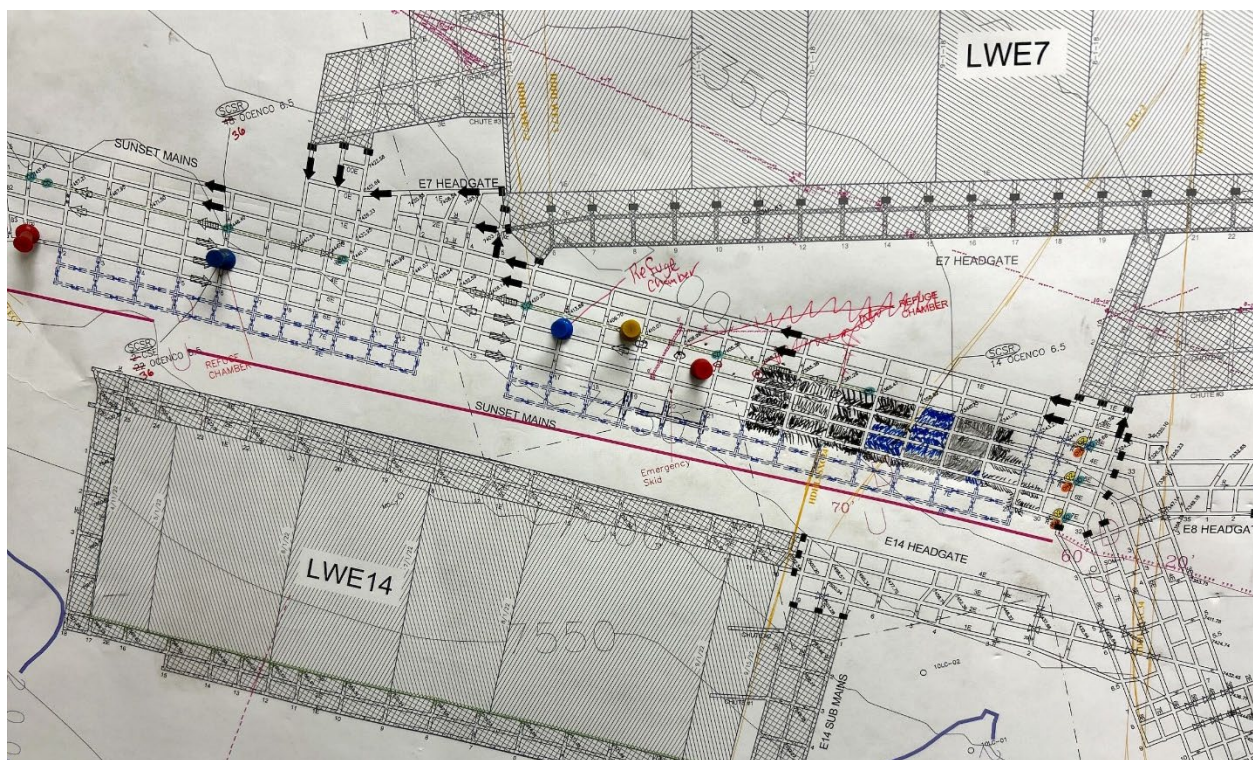
Contractors with Phoenix Mining continued to work on pillaring of the Sunset Mains, the job was expected to be completed by March 2025.

Figure 2: Mine map showing pillaring progress

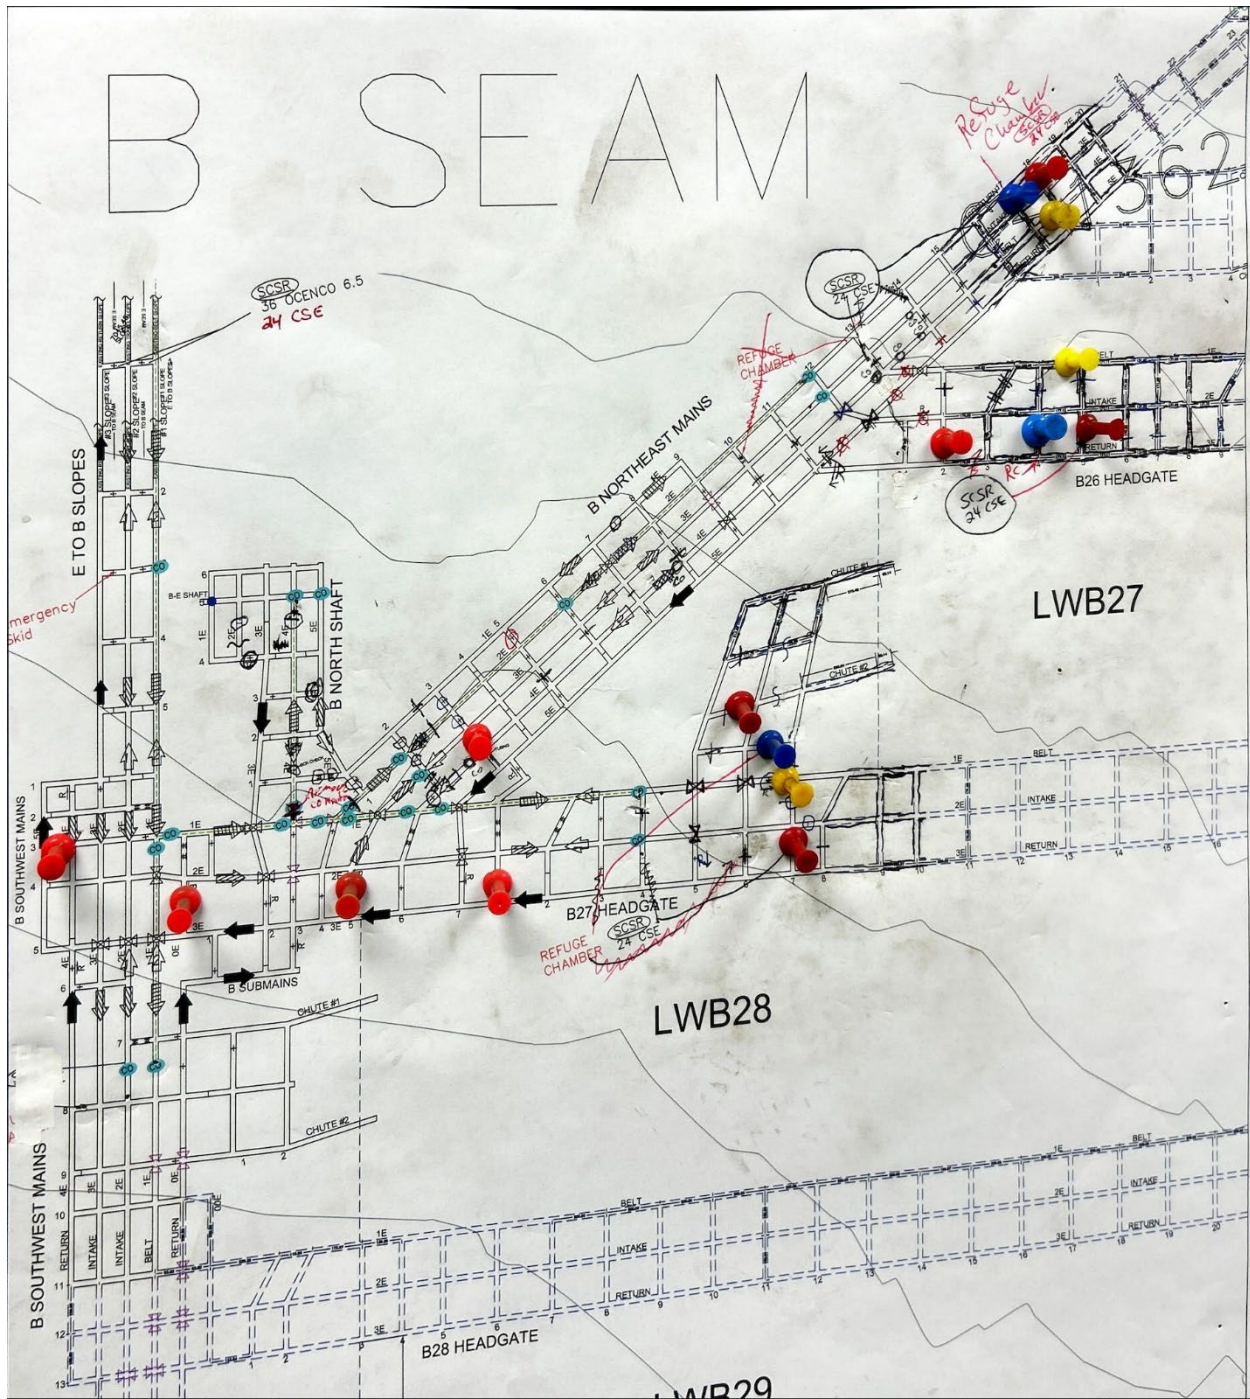
Three development crews were working: in the B-seam NE Mains (contractors with Phoenix Mining), in the B26 head gate, and in the B27 head gate.

Figure 3: Mine map showing B seam development progress

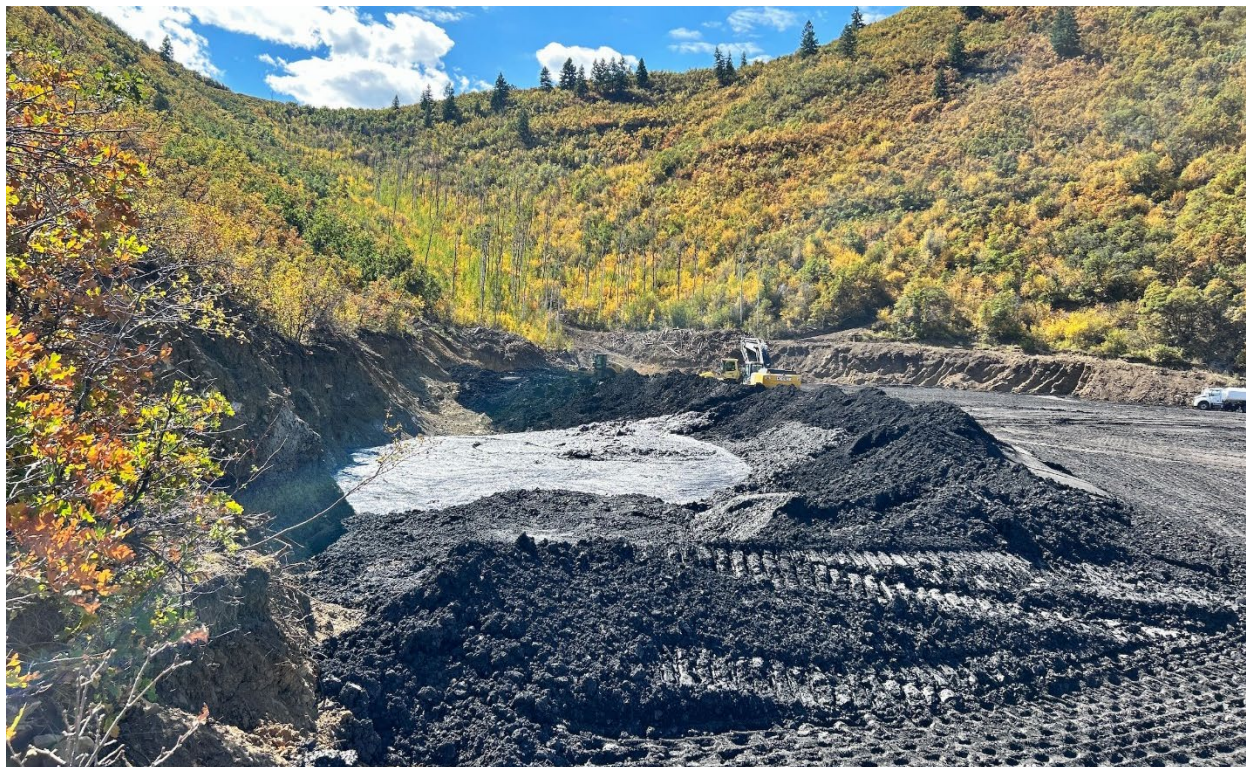
Waste cleaned from sediment ponds was being transported to the RPEE and placed on the eastern edge of the pile to dry out. Work was in progress to compact the surface of the pile, which had been graded to drain to the north-west corner. A berm had been built up at the edge of the working surface of the pile, and a dozer was working on the outslope to finish grade the slope and spread topsoil.

Figure 4: Pond cleanings on RPEE

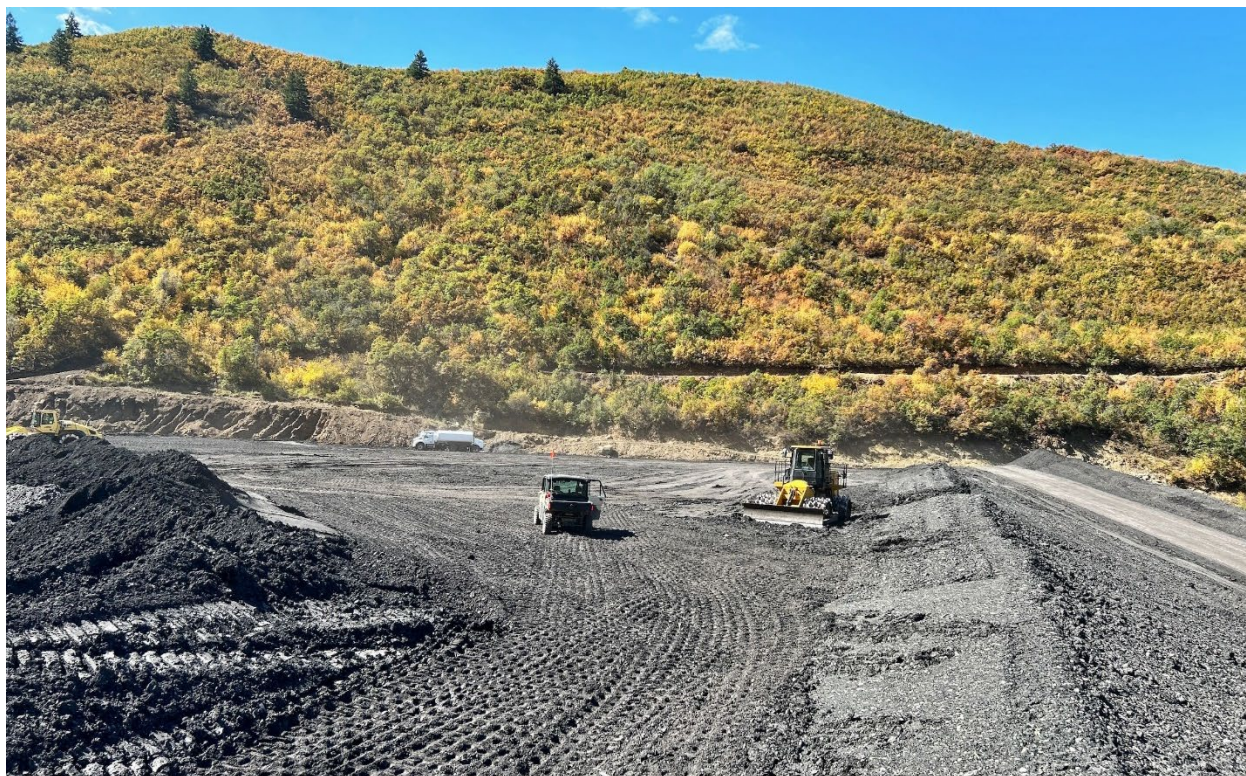
Figure 5: Compaction of RPEE in progress

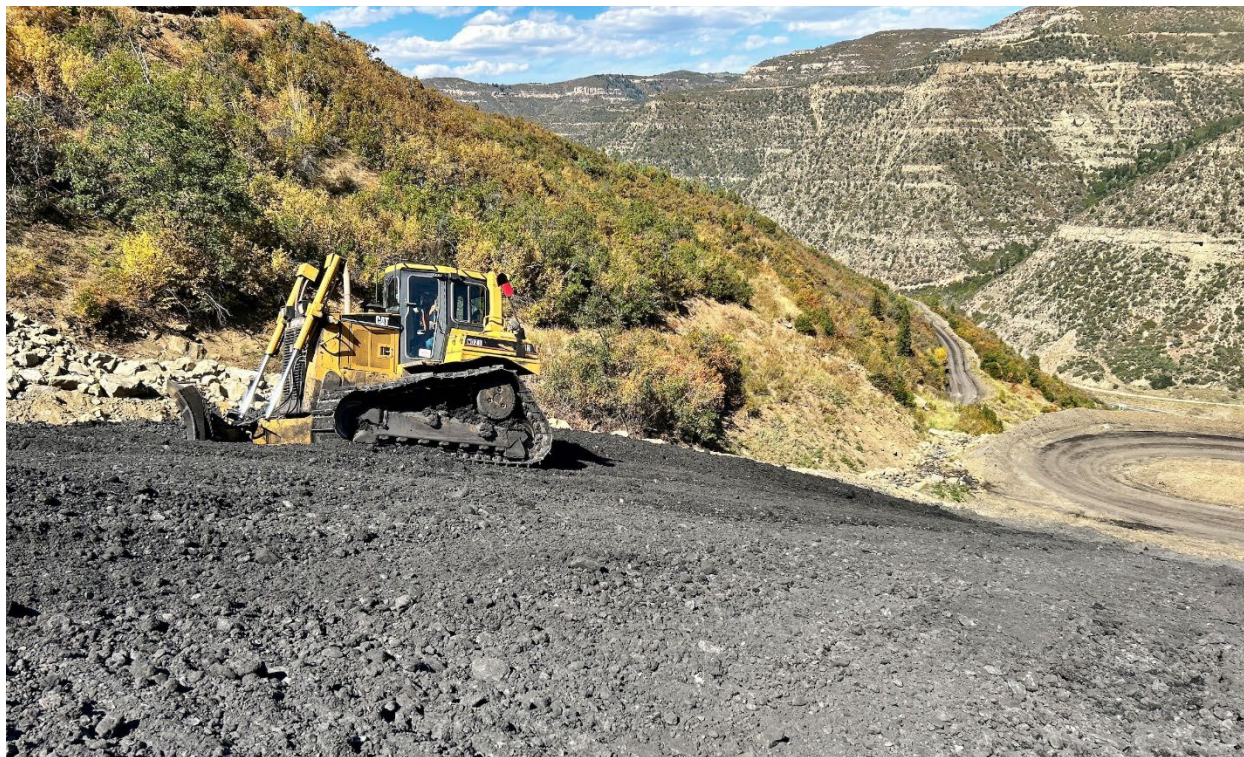
Figure 6: Grading of RPEE outslope in progress

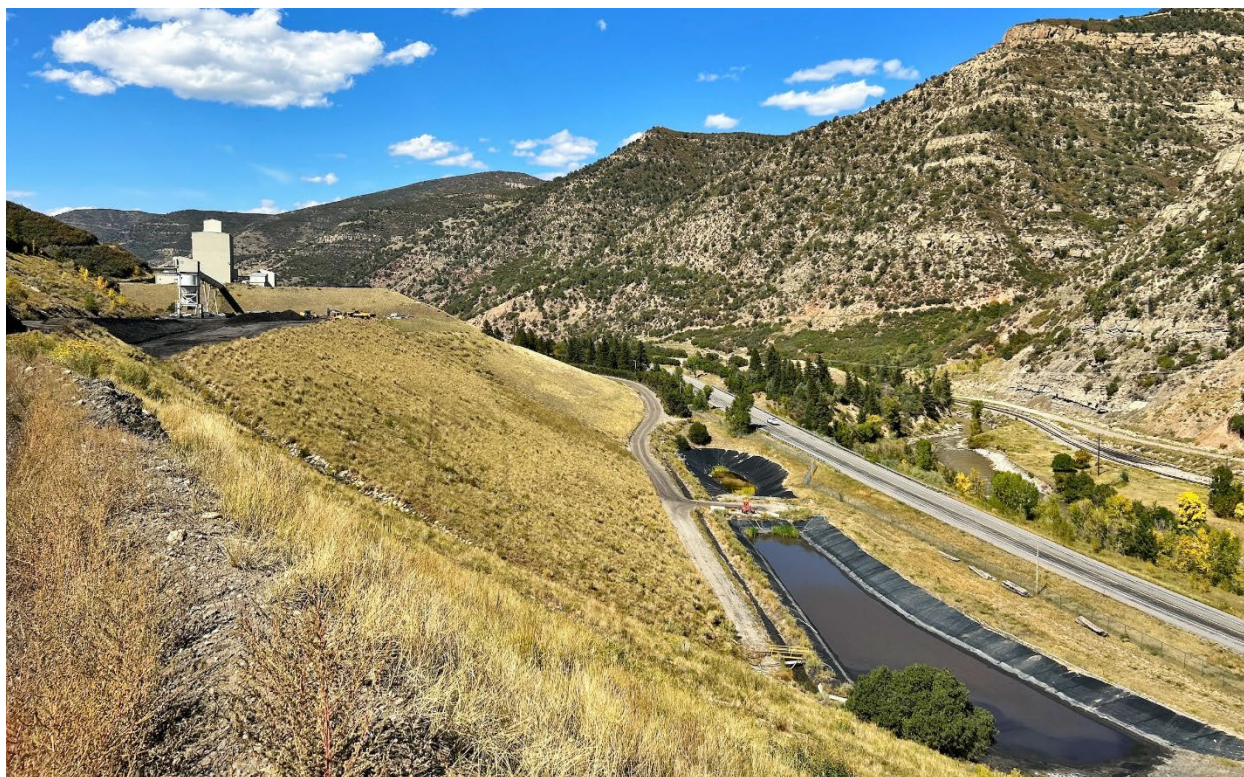
The RPE had been cleared of temporarily stockpiled processing waste.

Figure 7: RPE and RPE pond

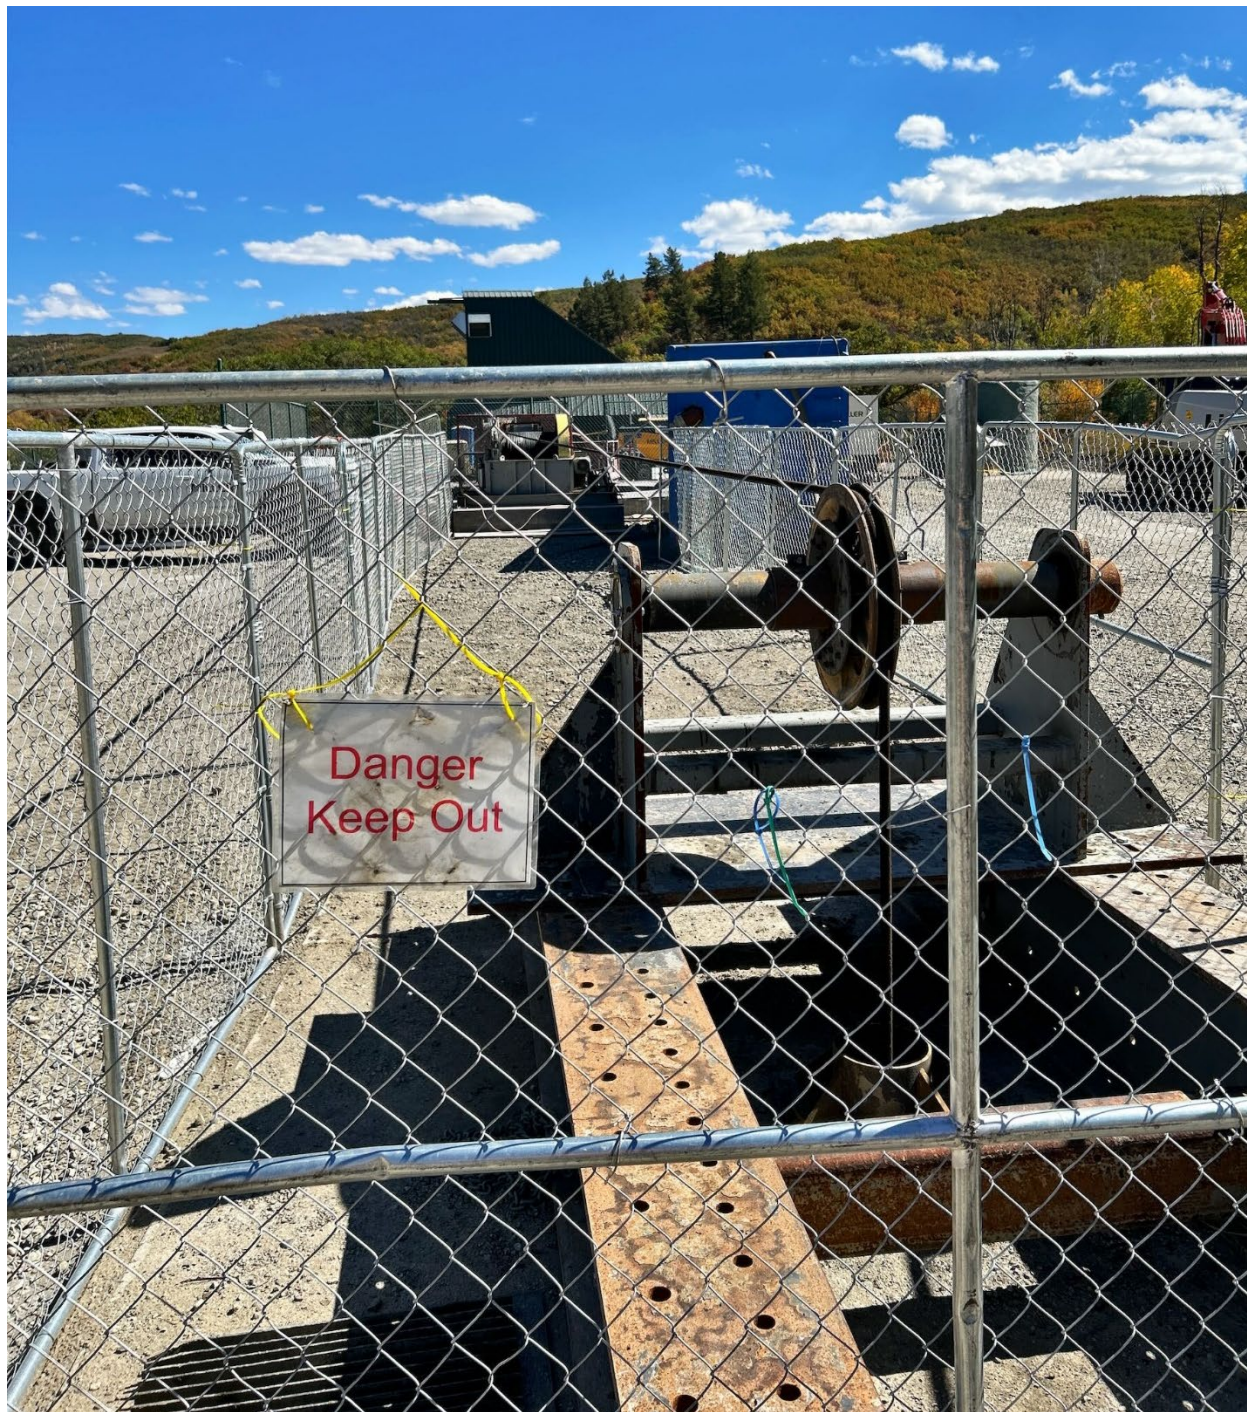
At the Deer Creek Vent Shaft site work was in progress to line the shaft between the E and B seams. Although most of the work was taking place underground, a winch to control the level of the form was operated from the surface via the cased utility hole above the in-seam shaft, and concrete trucks (operated by United Companies) were used to pump concrete through a pipe running down the Deer Creek Vent Shaft, horizontally through the E seam workings, and down the in-seam shaft. Work to line the shaft was progressing at the rate of ~15 feet per day.

Figure 8: Winch cable down utility hole at Deer Creek Vent Shaft pad

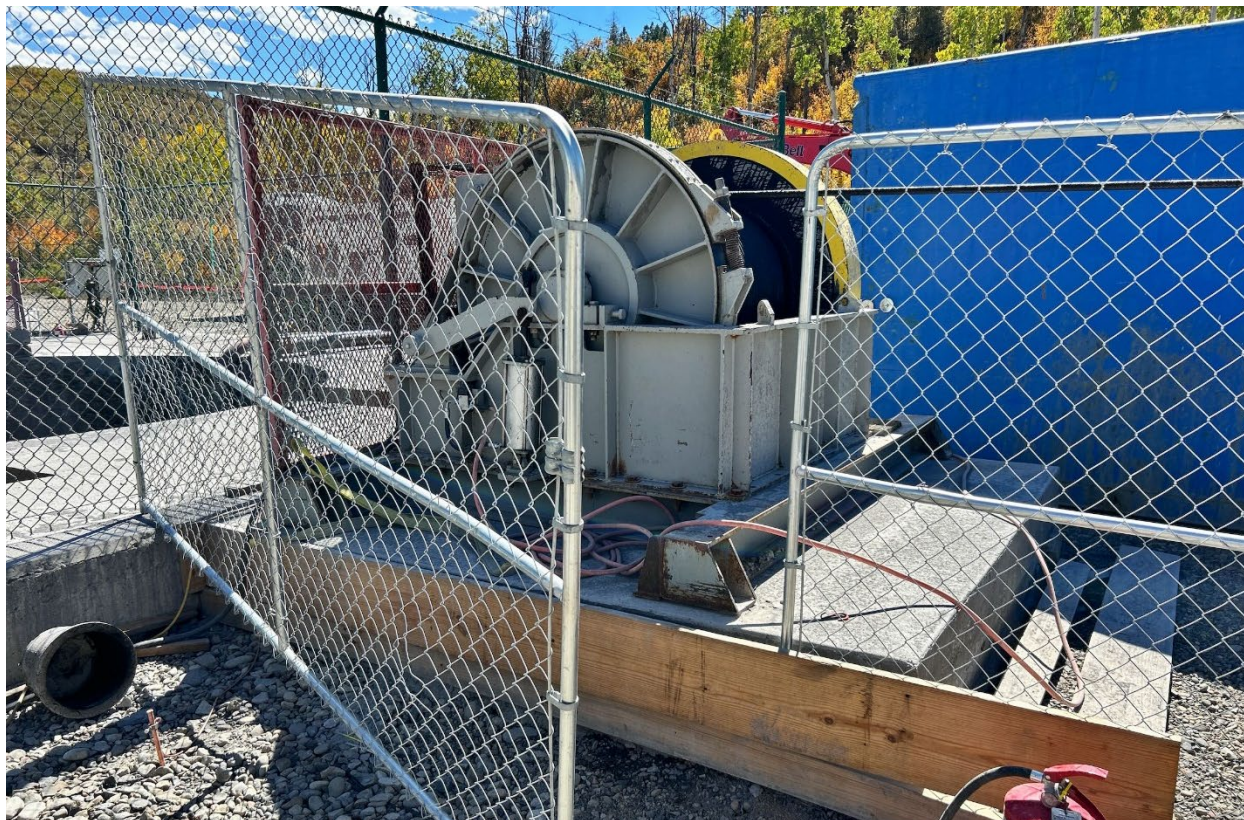
Figure 9: Winch at Deer Creek Vent Shaft pad

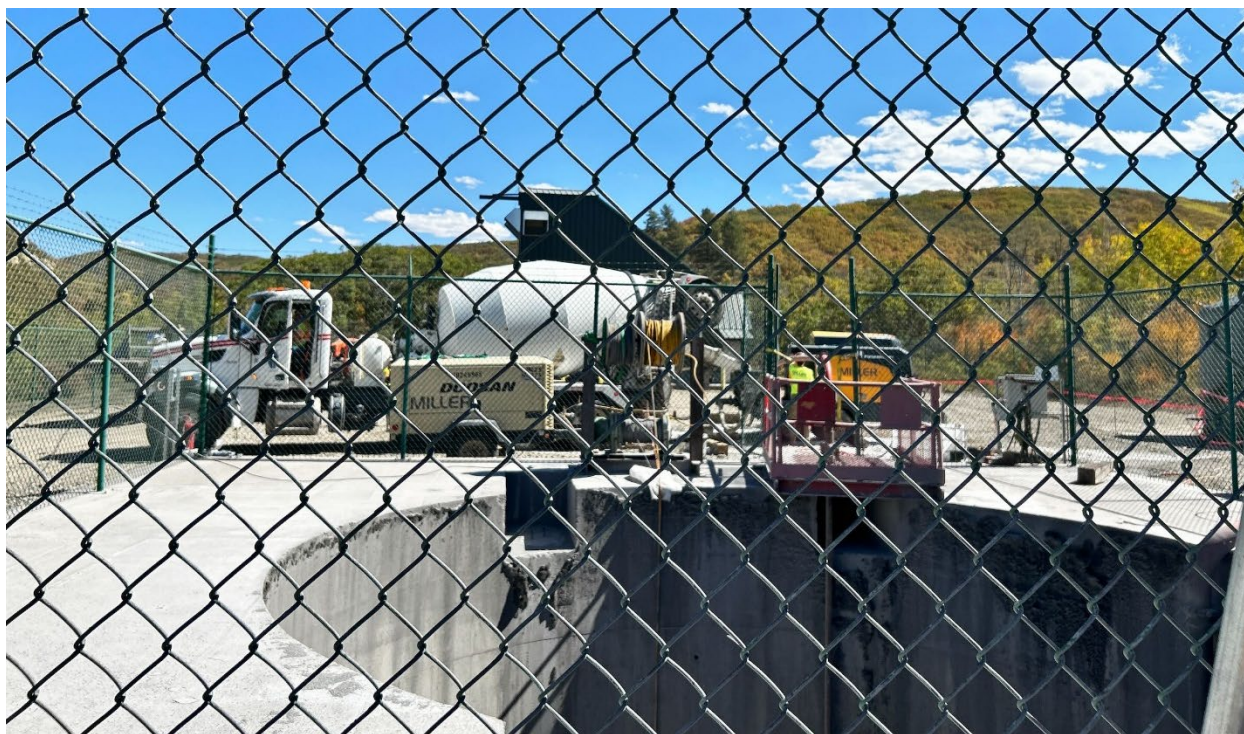
Figure 10: Concrete delivery at Deer Creek Vent Shaft

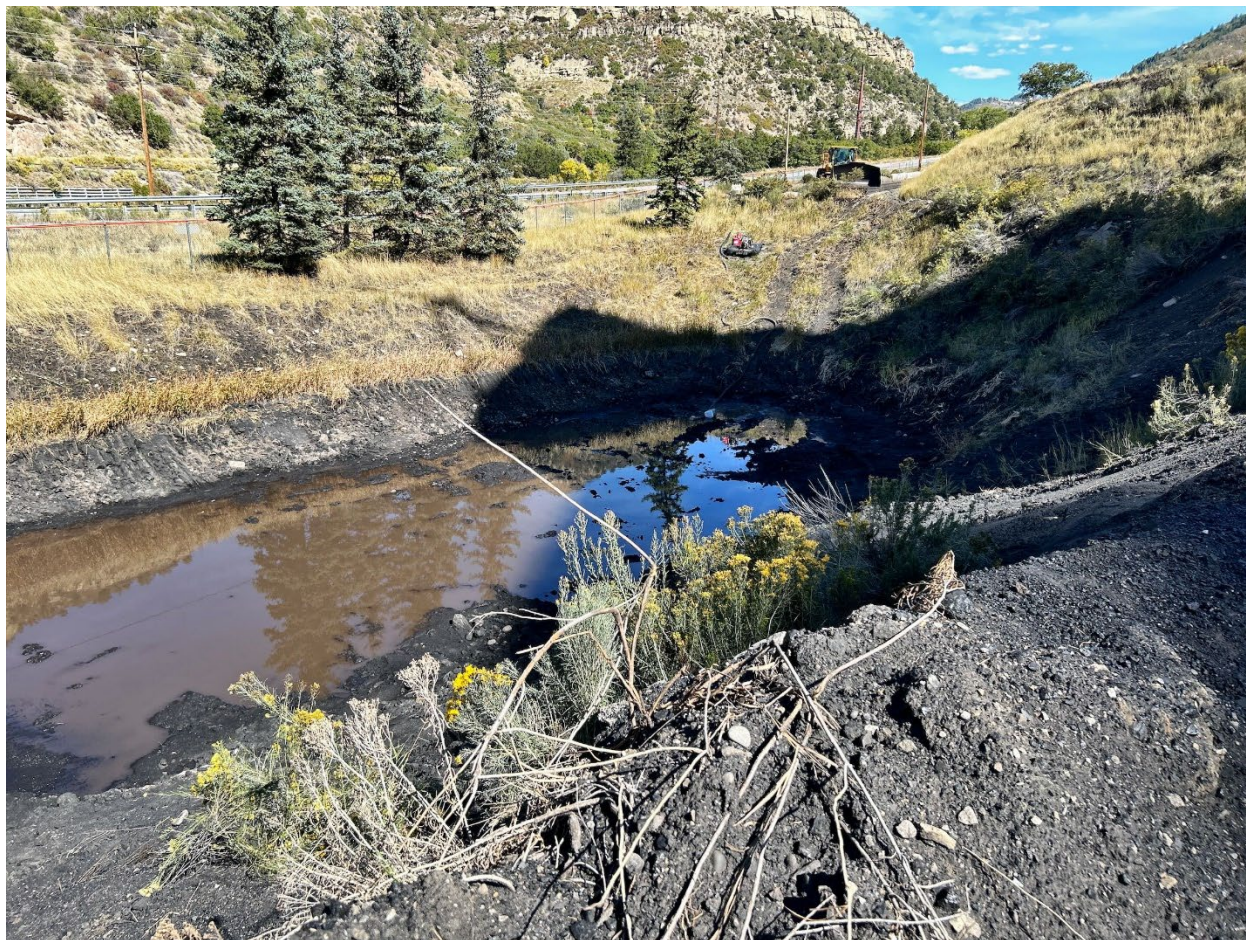
Work to clean the MB3 pond had been completed, and work to clean the MB5E pond was in progress. Material removed from the ponds was being transported by haul truck to the RPEE. A survey of the cleaned ponds was planned.

Figure 11: MB3 pond, cleaned

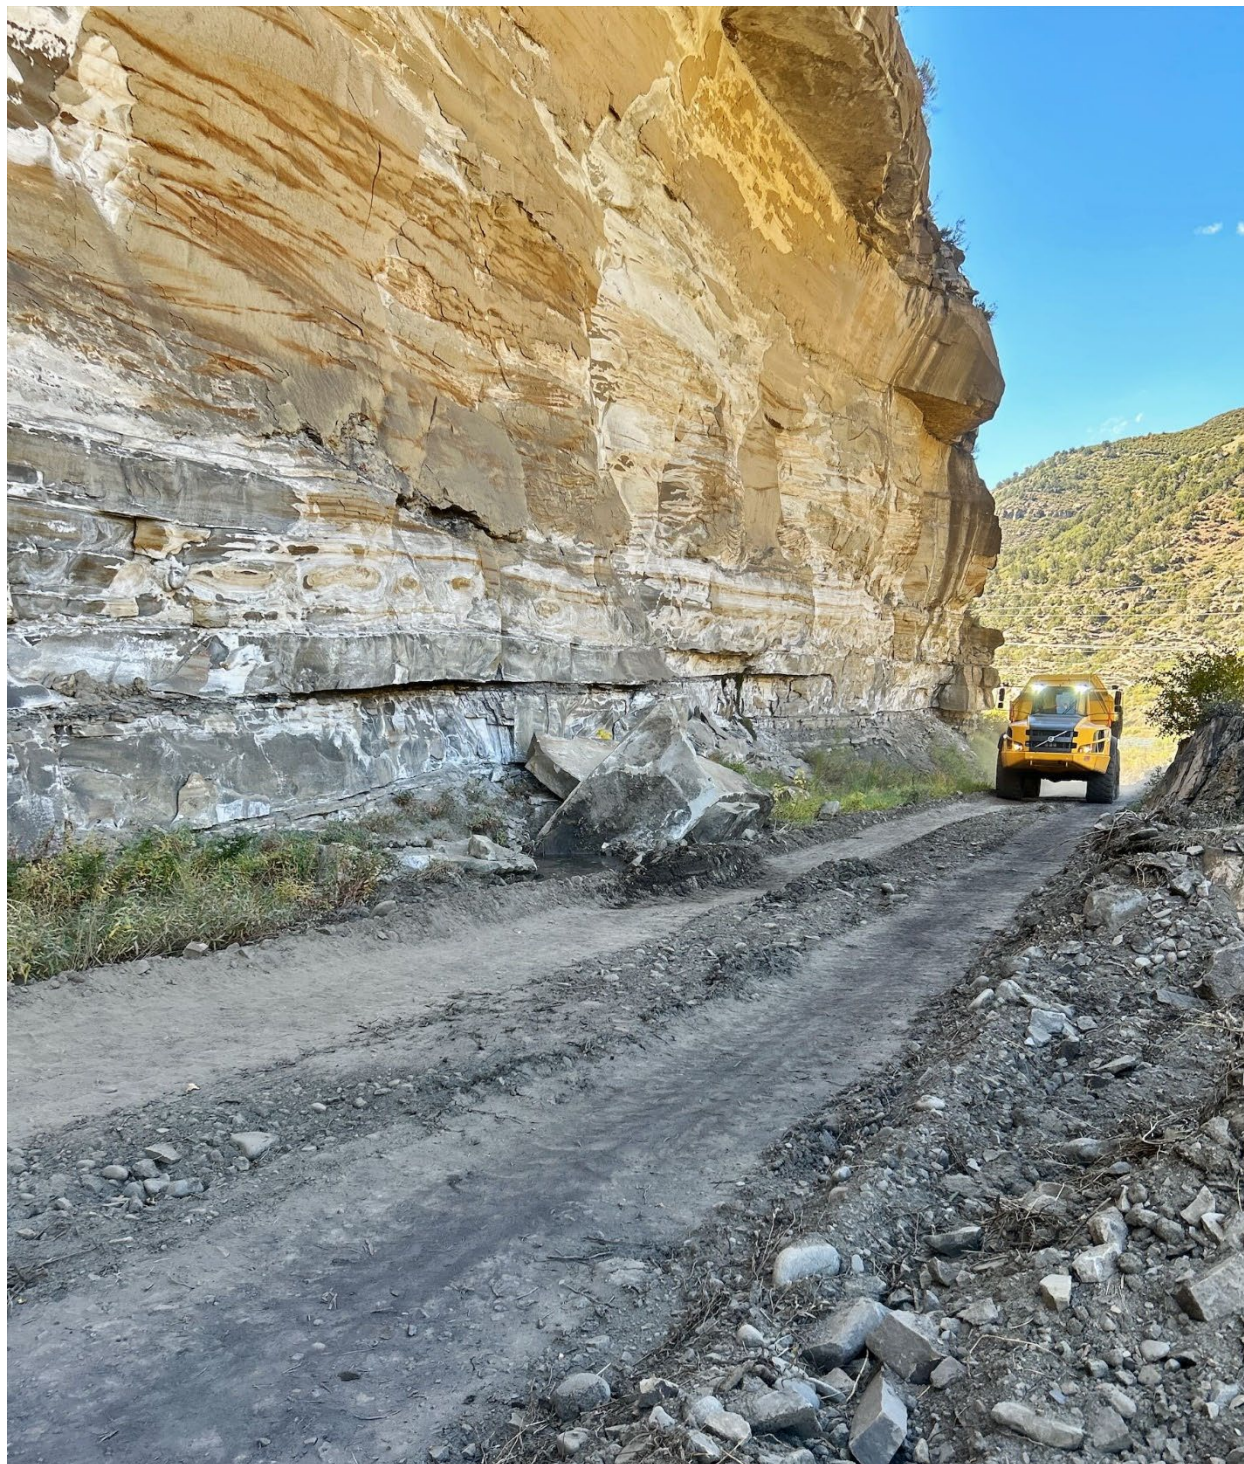
Figure 12: Pond cleanings from MB5E being transported to RPEE

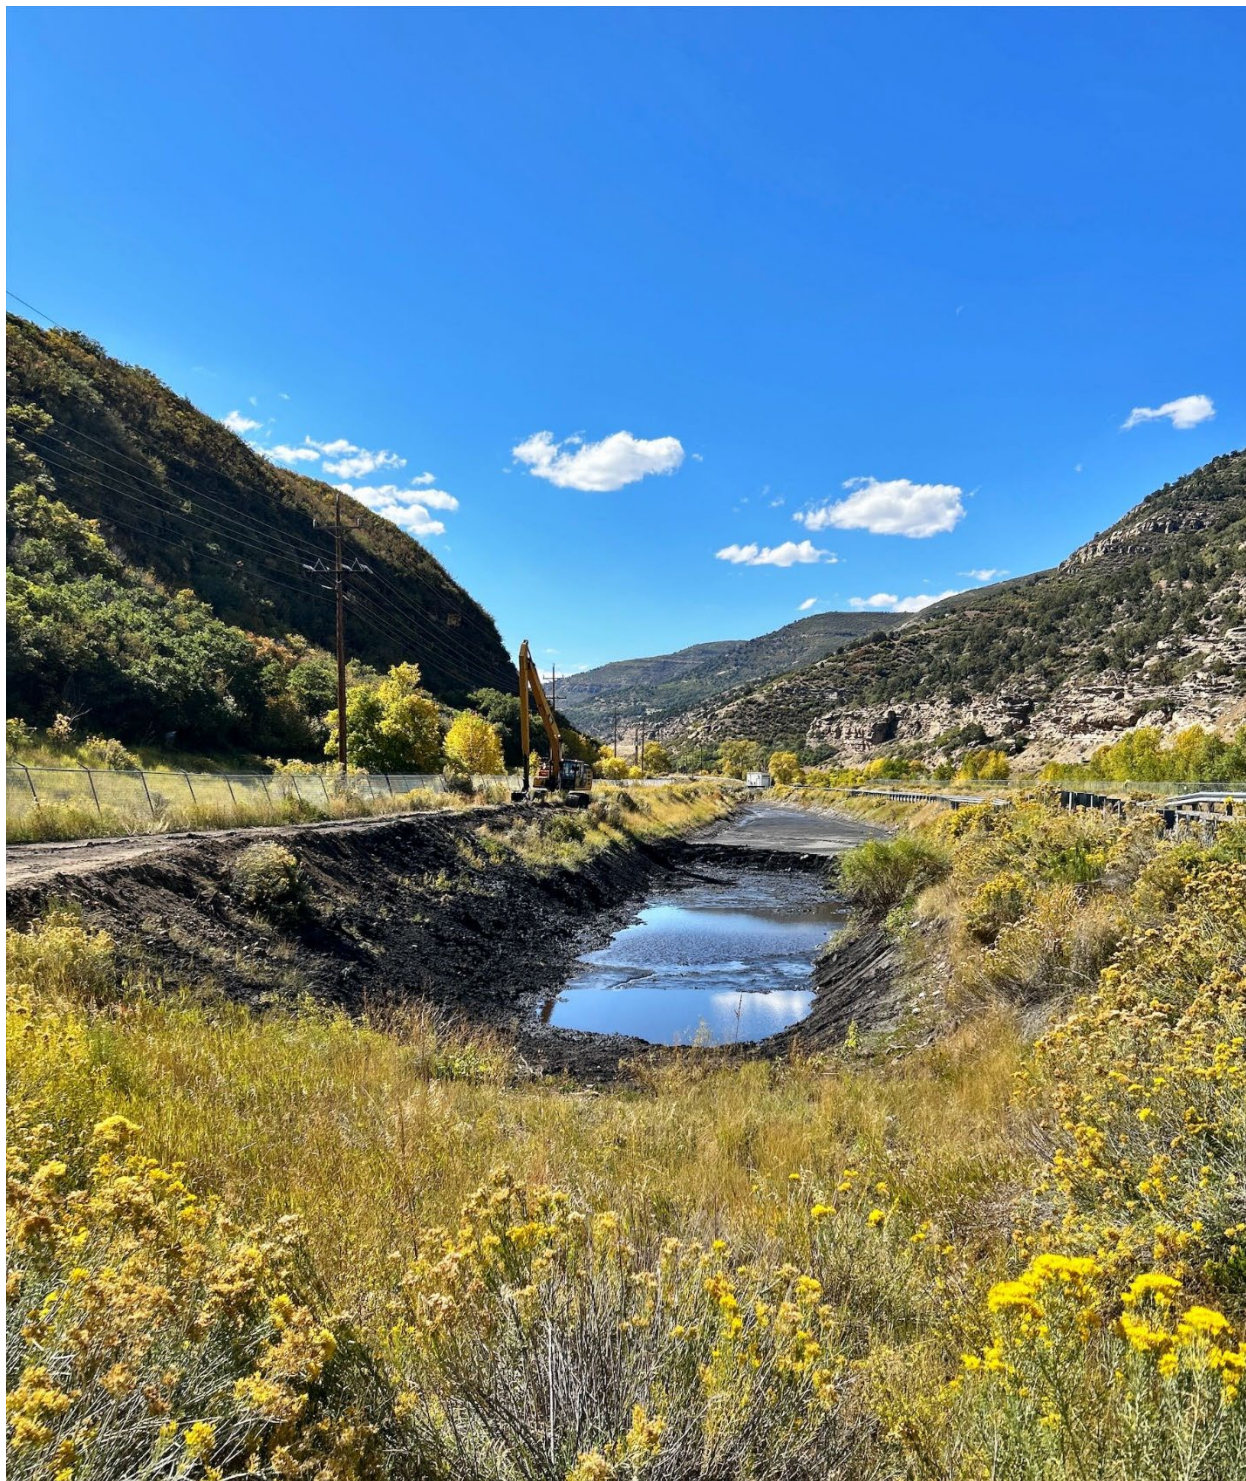
Figure 13: MB5E pond, south cell cleaning in progress

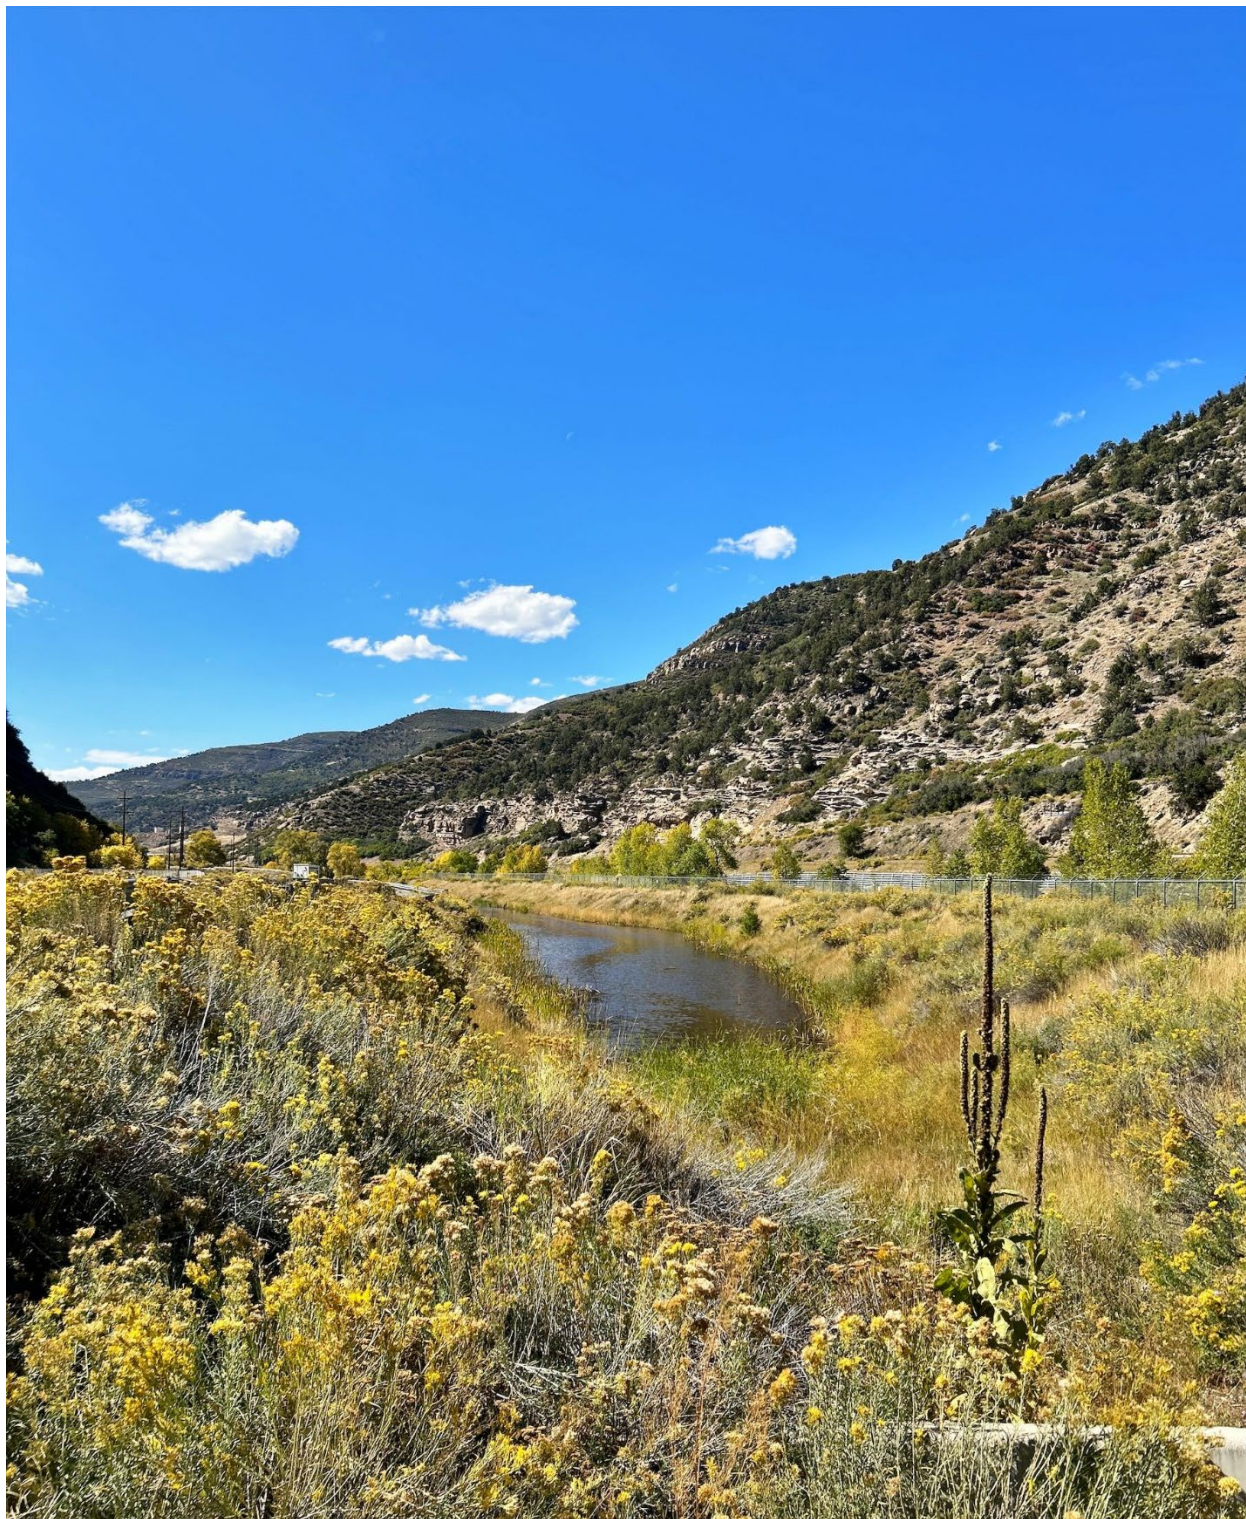
Figure 14: MB5E pond, north cell cleaning not yet begun
