MINERALS PROGRAM INSPECTION REPORT
PHONE: (303) 866-3567

MINE NAME: Henderson Mine	MINE/PROSPECTING ID#: M-1977-342	MINERAL: Molybdenum	COUNTY: Clear Creek, Grand
INSPECTION TYPE: Aerial Inspection	WEATHER: Clear	INSP. DATE: September 11, 2024	INSP. TIME: 09:00
OPERATOR: Climax Molybdenum Company	OPERATOR REPRESENTATIVE: N/A	TYPE OF OPERATION: 112d-3 - Designated Mining Operation	
REASON FOR INSPECTION: Normal I&E Program	BOND CALCULATION TYPE: None	BOND AMOUNT: \$143,264,468.00	
DATE OF COMPLAINT: NA	POST INSP. CONTACTS: None	JOINT INSP. AGENCY: None	
INSPECTOR(S): Amber M. Gibson Brock Bowles	INSPECTOR'S SIGNATURE:

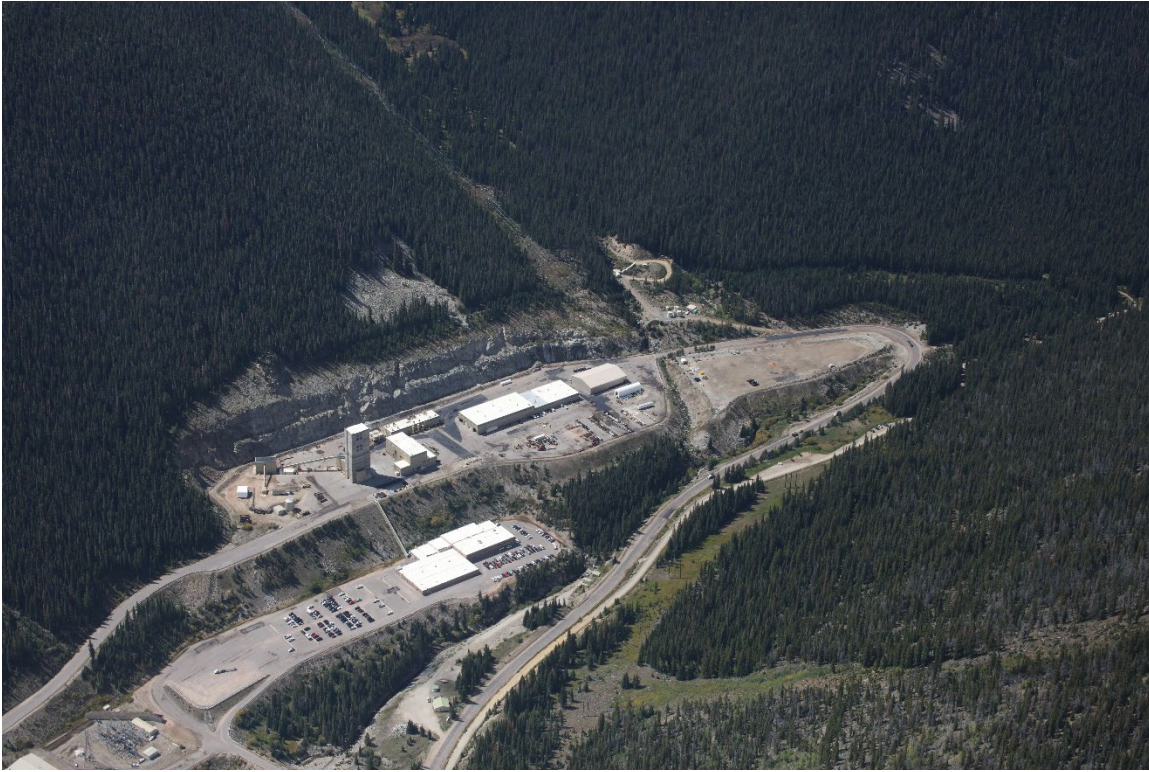
Photo 1: Looking southwest at the surface facilities at the mine.

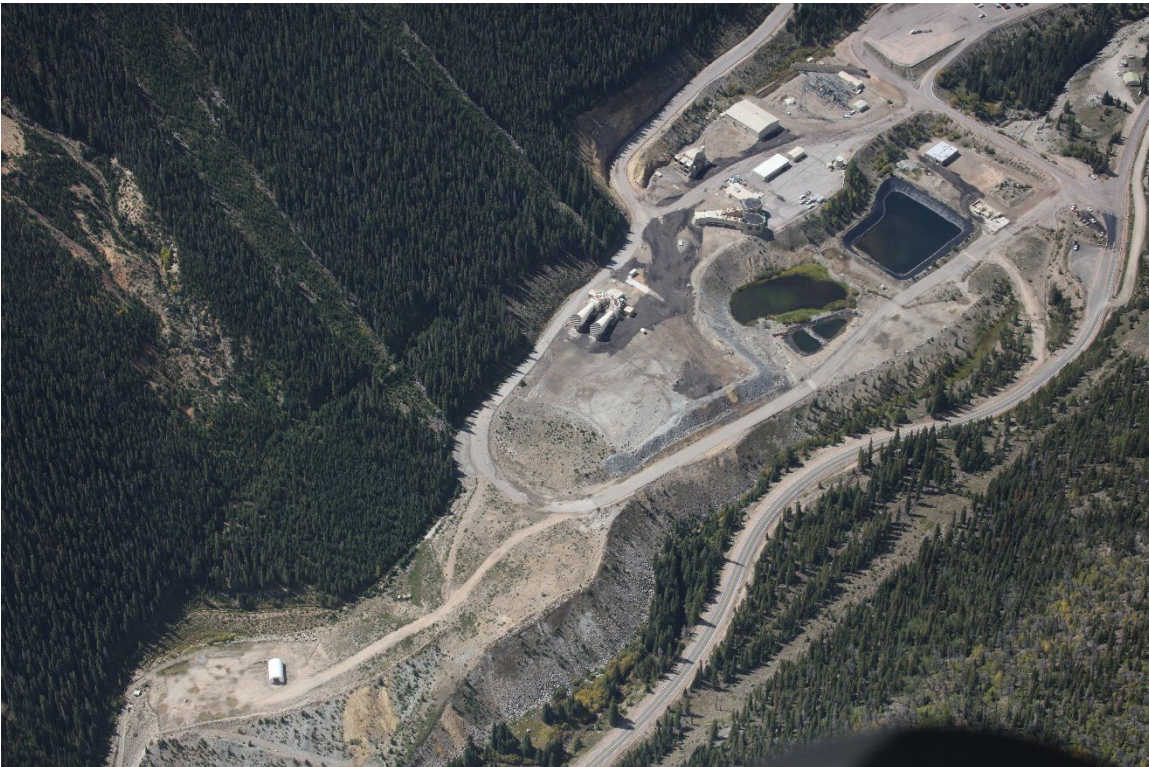
Photo 2: Looking at the eastern side of the surface facilities at the mine.

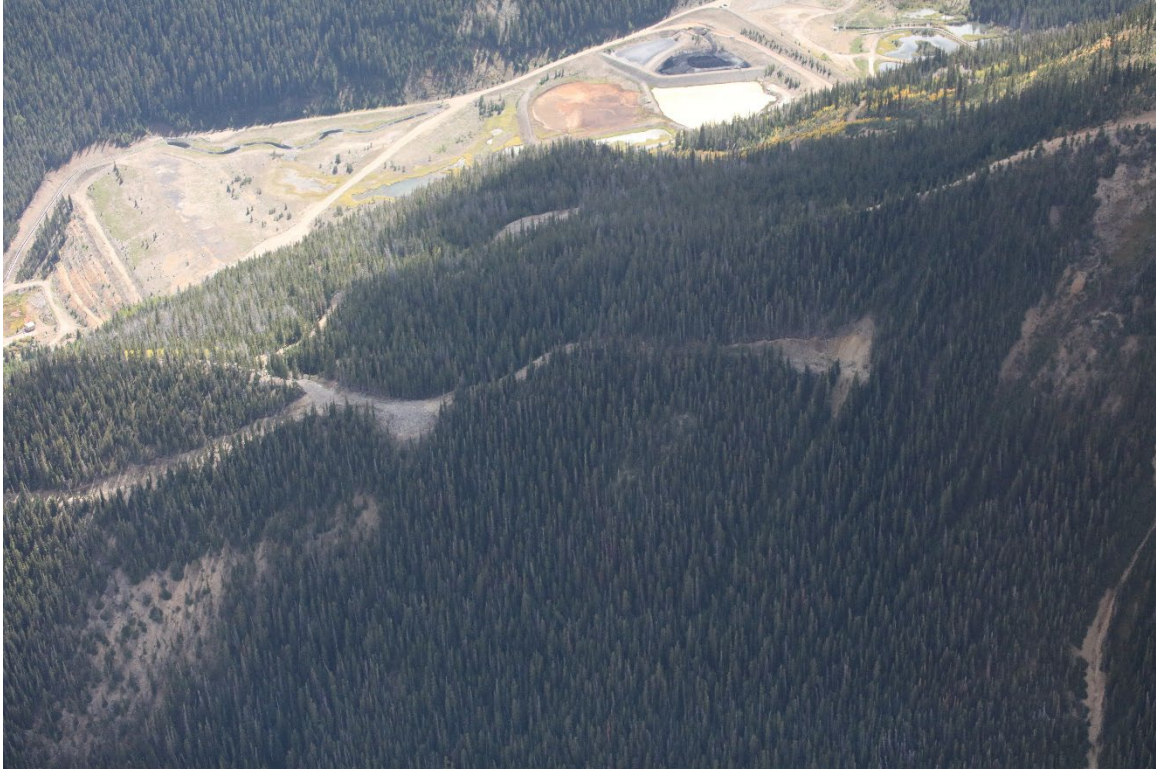
Photo 3: Looking south at the URAD water treatment facility ponds.

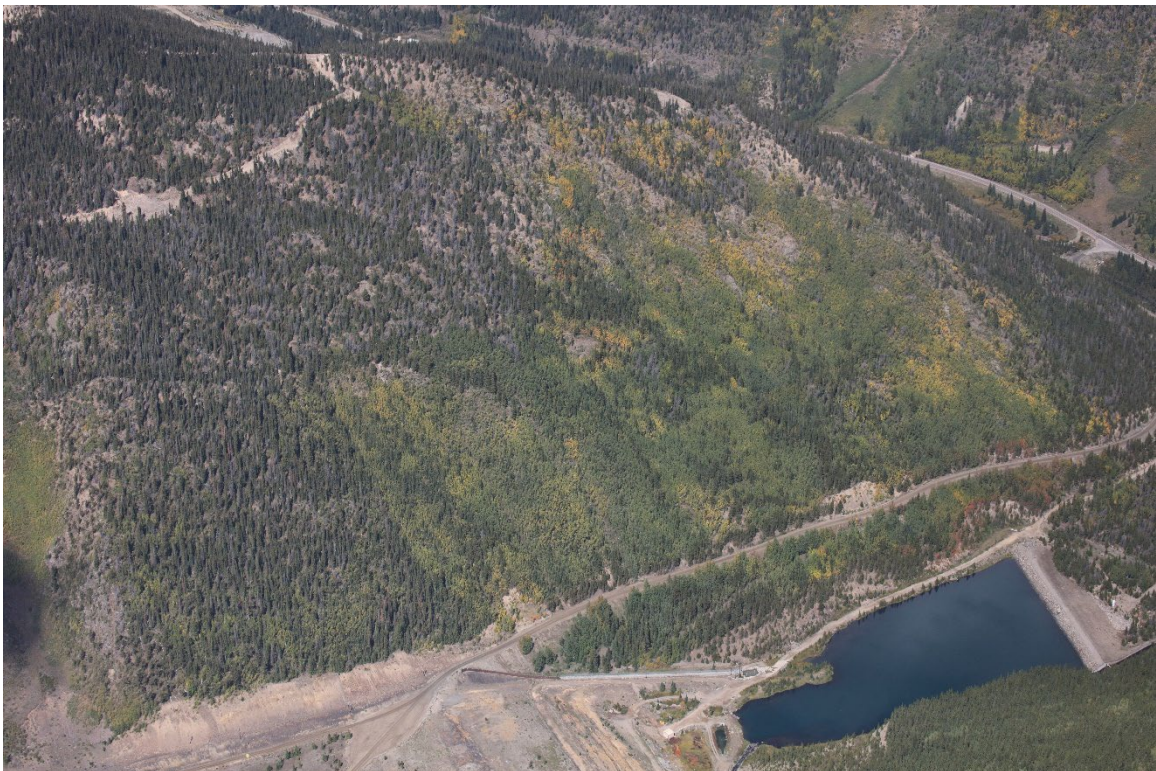
Photo 4: Looking northeast at the Lower URAD reservoir at the base of the URAD water treatment area.

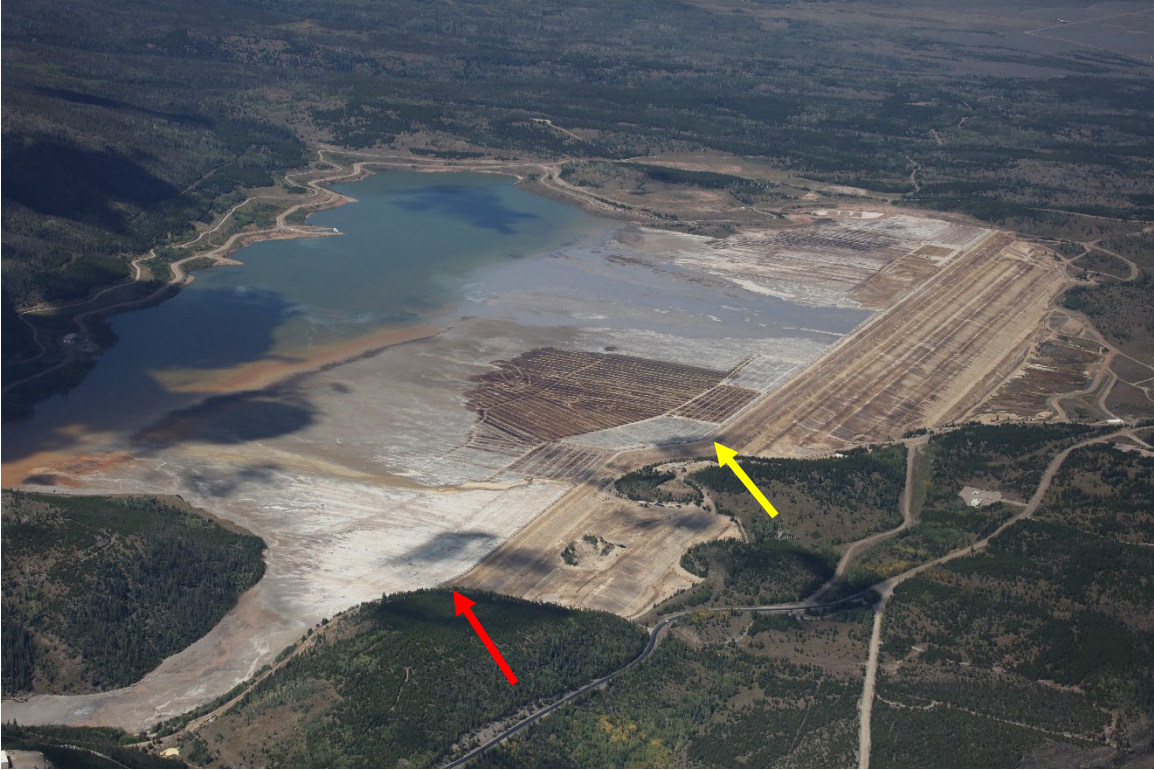
Photo 5: Looking northwest at the Tailings Impoundment at the Mill. The red arrow points to 3-Dam and the yellow arrow points to 1-Dam.

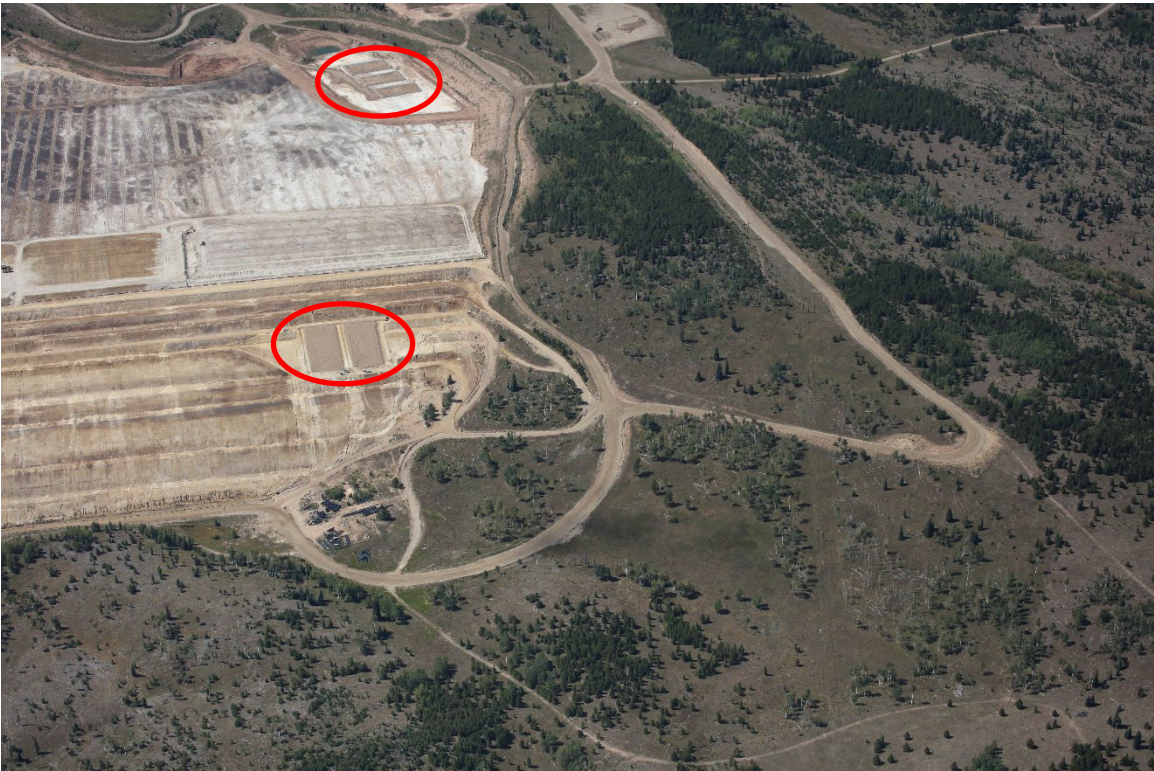
Photo 6: Looking west across the northern border of the deposition cells in the Tailings Impoundment. Circled are test plot areas where the Operator is testing revegetation methods for future use in reclamation efforts on the Tailings Impoundment.

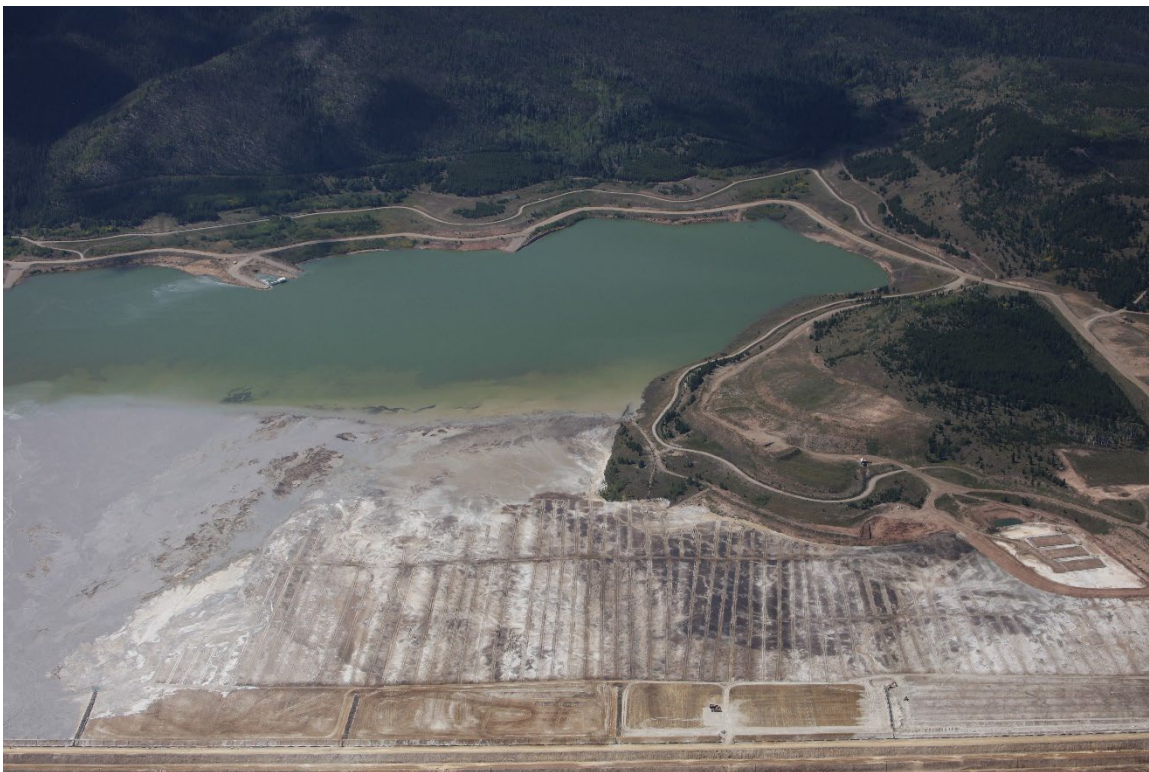
Photo 7: Looking west at the northern portion of the Tailings Pond.

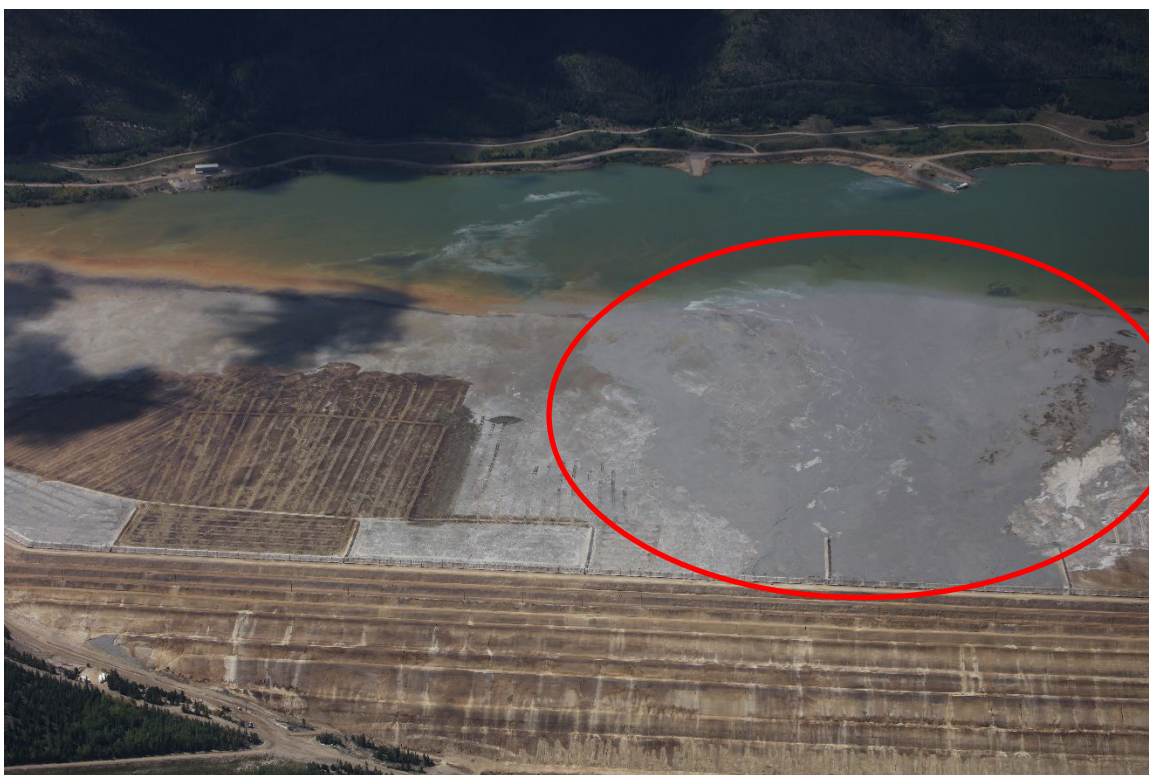
Photo 8: Looking west across the Tailings Impoundment. The area circled in red shows some recent tailings deposition on the Tailings Impoundment.

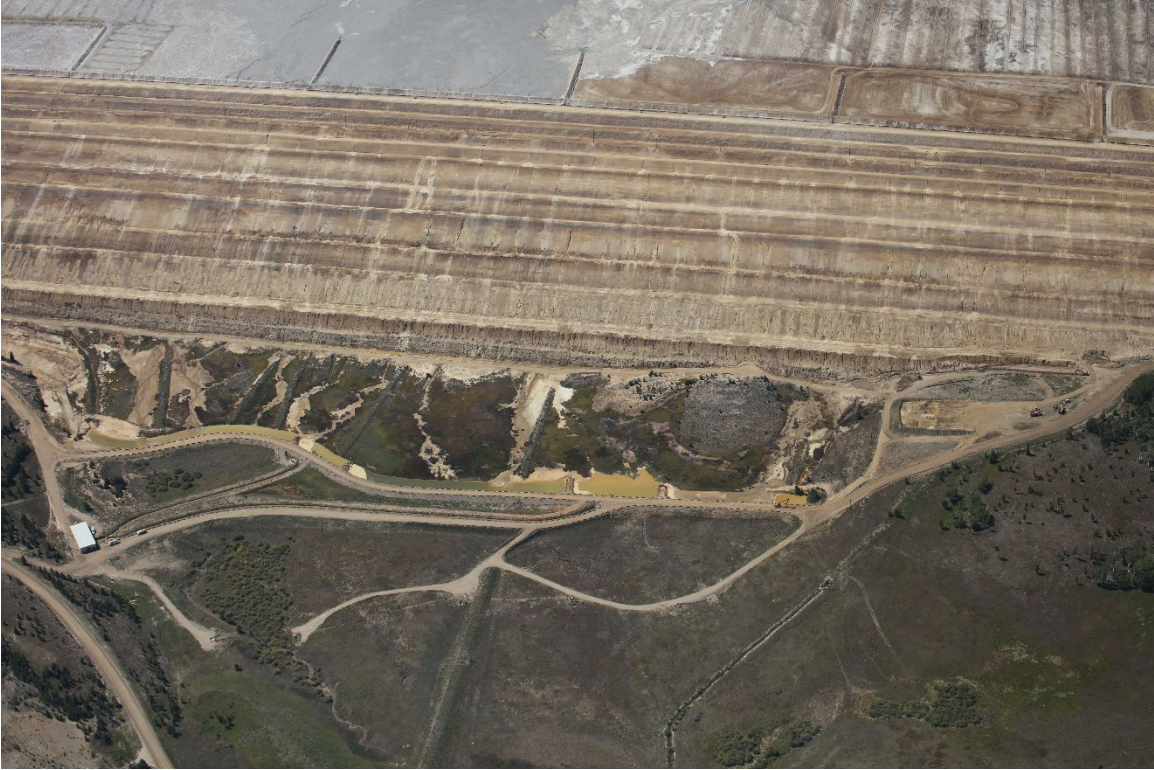
Photo 9: Looking southwest at the seepage collection trenches along the toe of the slope behind 1-Dam.

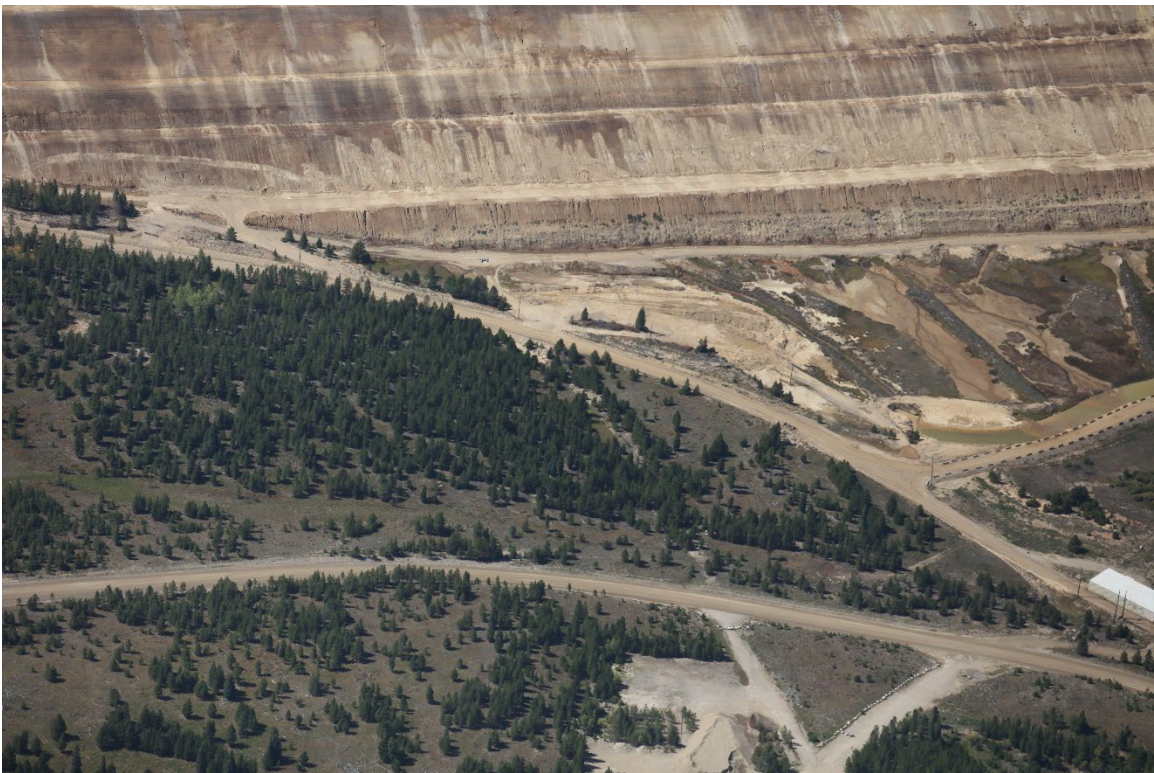
Photo 10: Looking northwest at the southern portion of the seepage collection canals on 1-Dam and the 1-Dam abutment area.

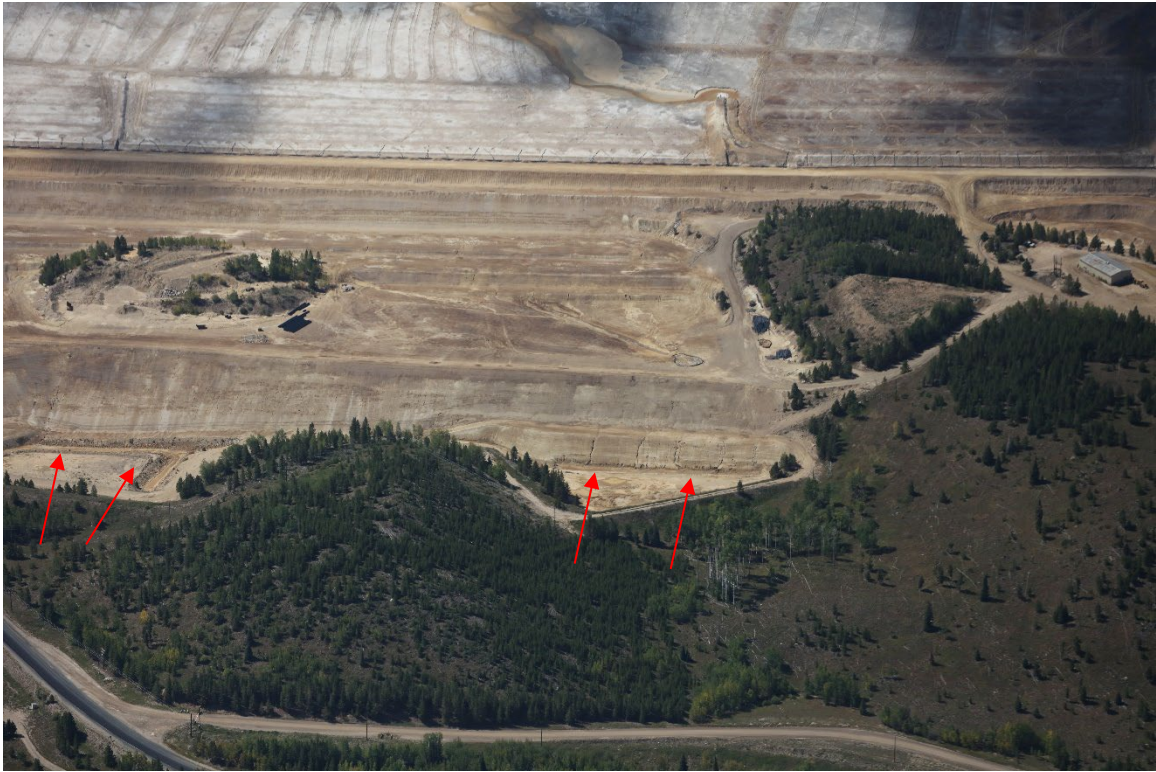
Both the mine and the mill appear to be in compliance with the approved mining plans. No unidentified disturbance areas, or offsite disturbance was observed. Some deep erosion gullies can be seen on the northern toe of the slope at 3-Dam. The Operator is aware of this erosion and has plans to repair it. No other cause for concern was identified from the aerial photographs.

Photo 11: Looking west at the north side of 3-Dam. The arrows indicate the seepage collection trenches. Some erosion gullies are present along the north toe of the slope on the backside of 3-Dam.

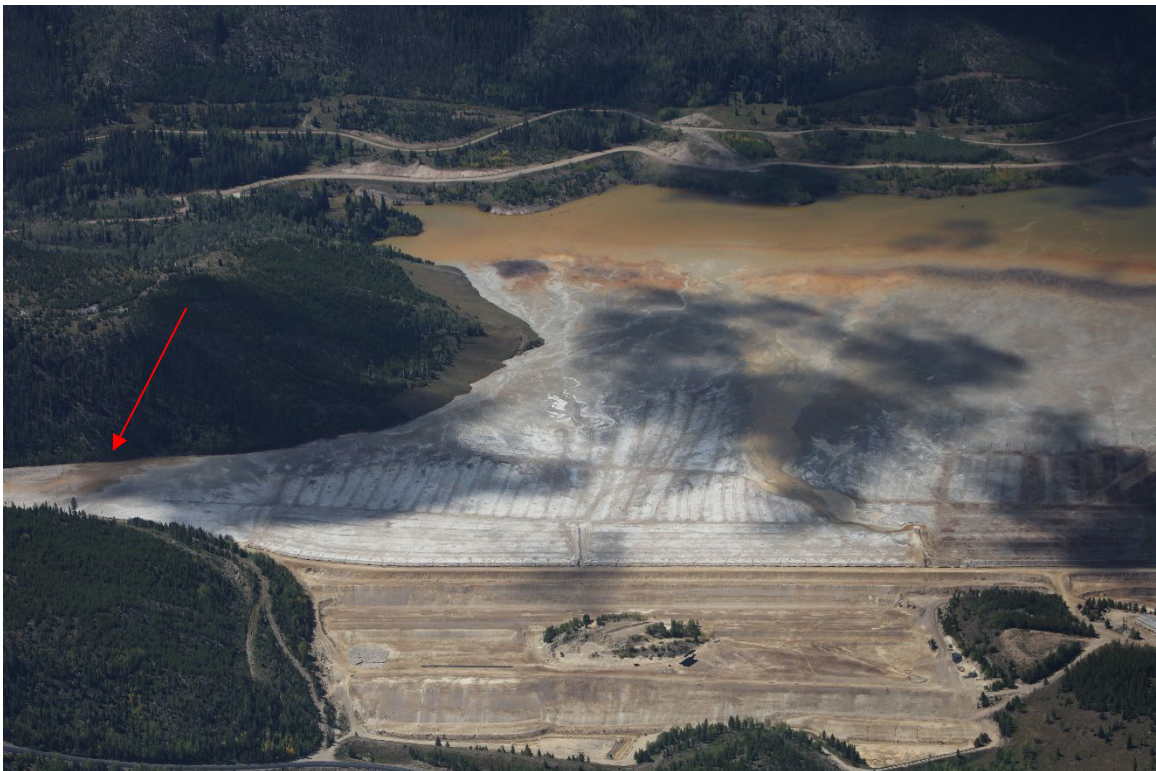
Photo 12: Looking west at an overview of 3-Dam and the start of the east branch of Ute Creek leading from 3-Dam (red arrow).

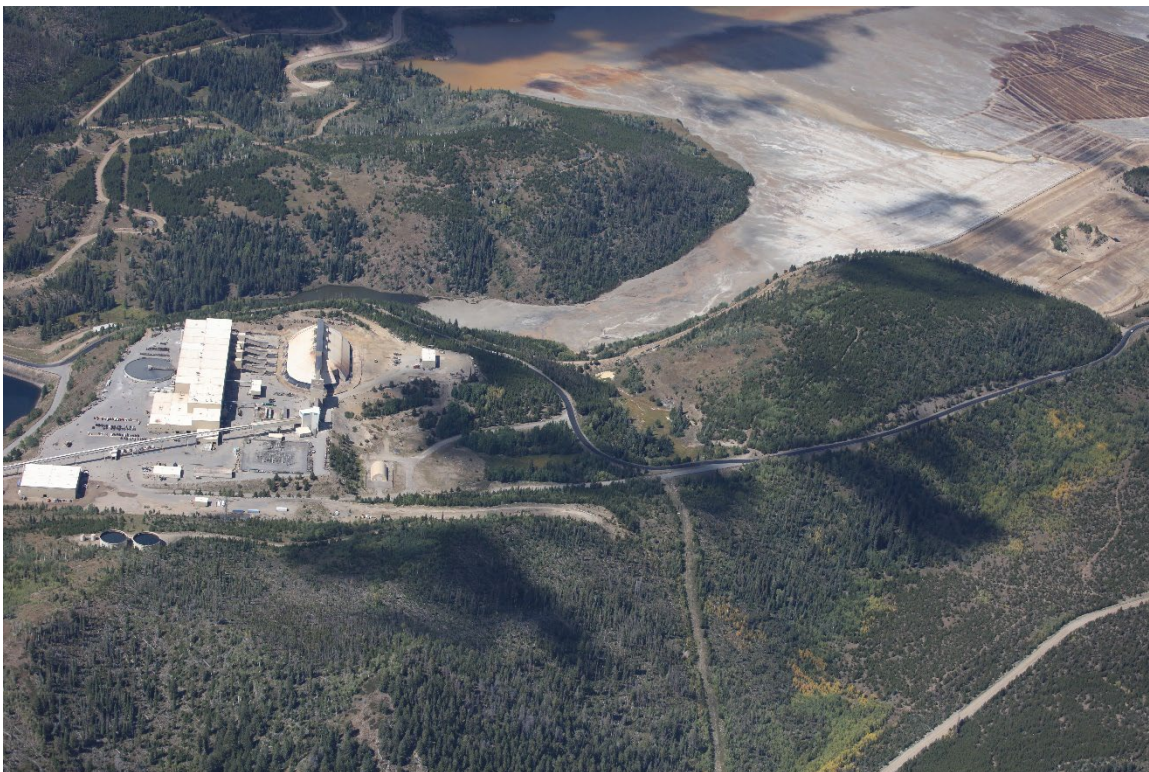
Photo 13: Looking northwest at the East Branch of Ute Creek and the Mill facilities.

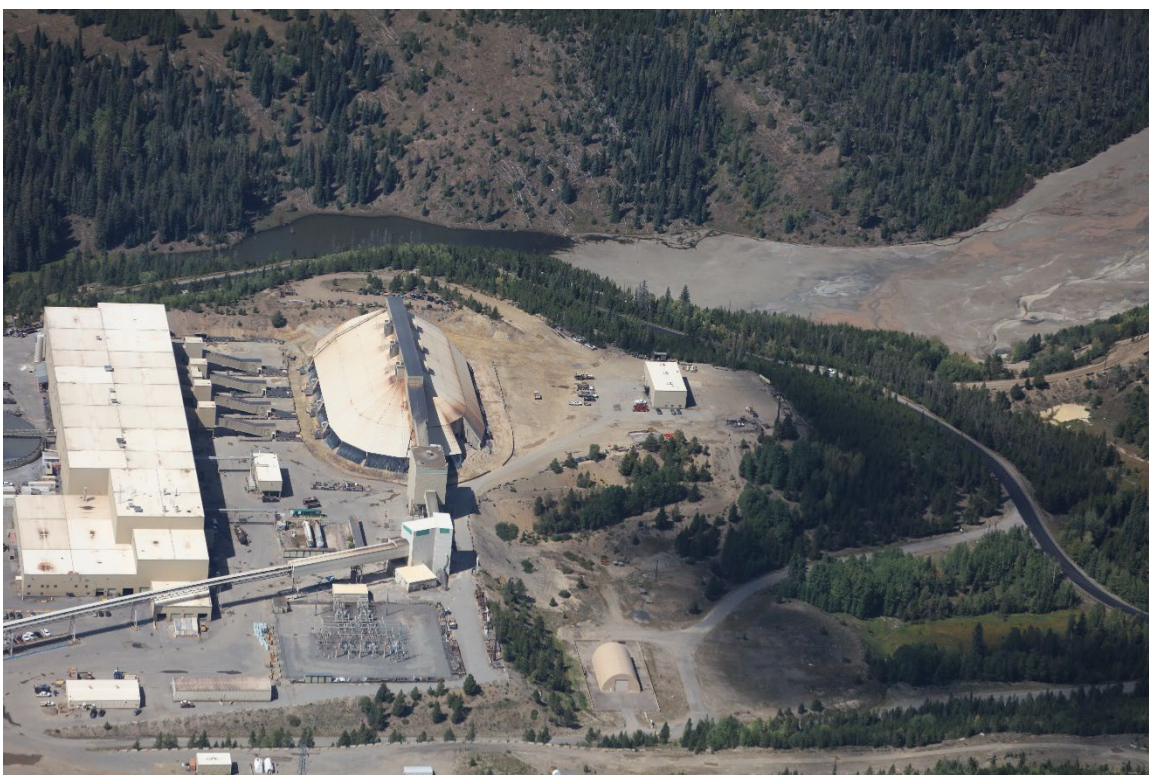
Photo 14: Looking at the tailings deposition within the East Branch of Ute Creek and the northwest side of the Mill facilities.

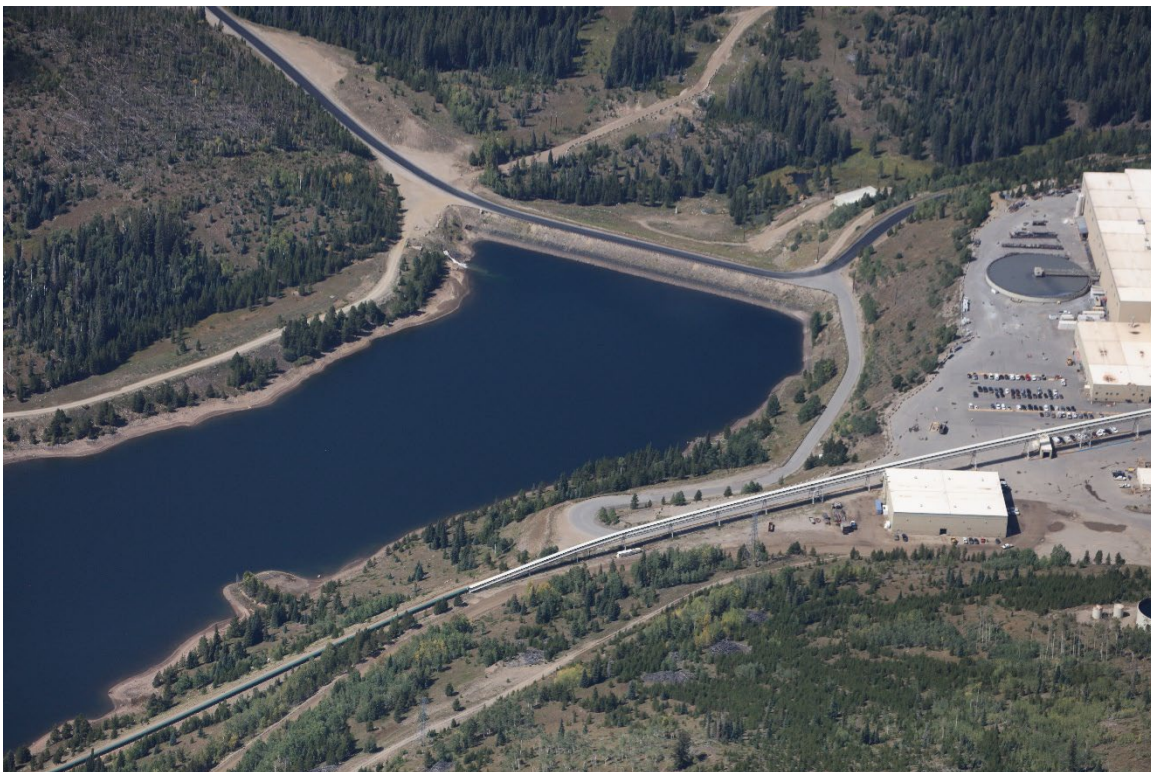
Photo 15: Looking at the north side of the East Branch Reservoir.

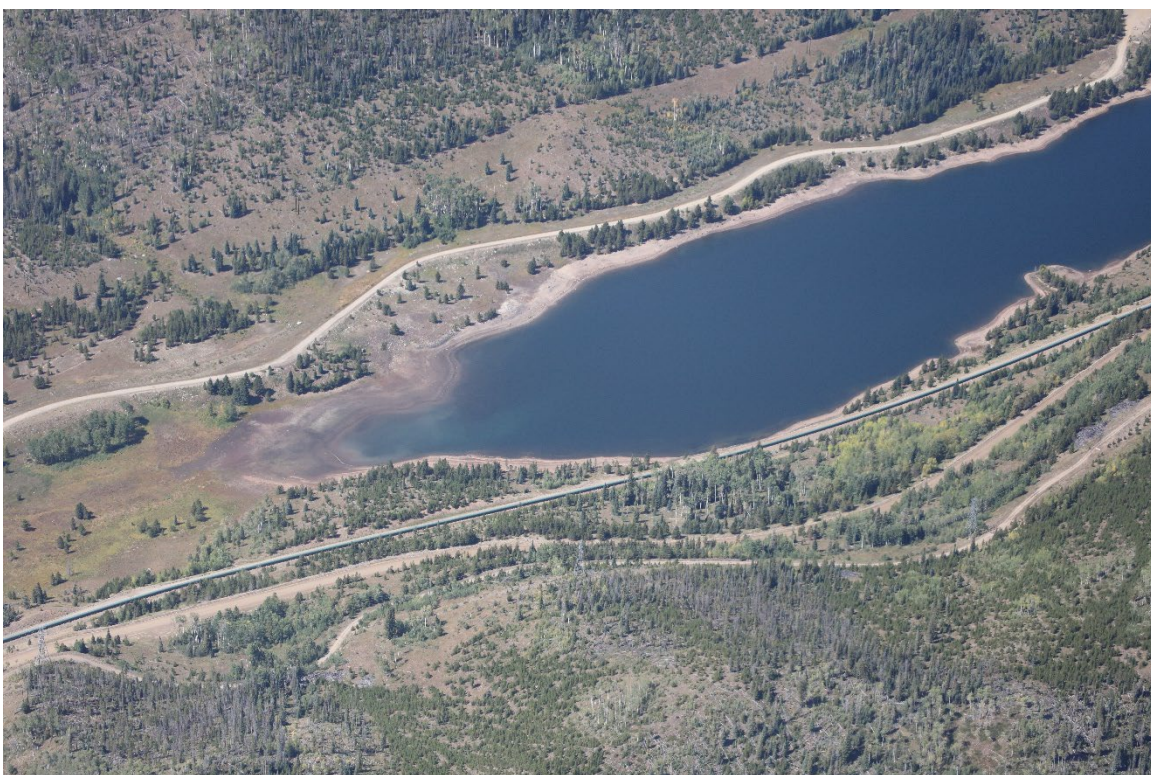
Photo 16: Looking at the south side of the East Branch Reservoir.

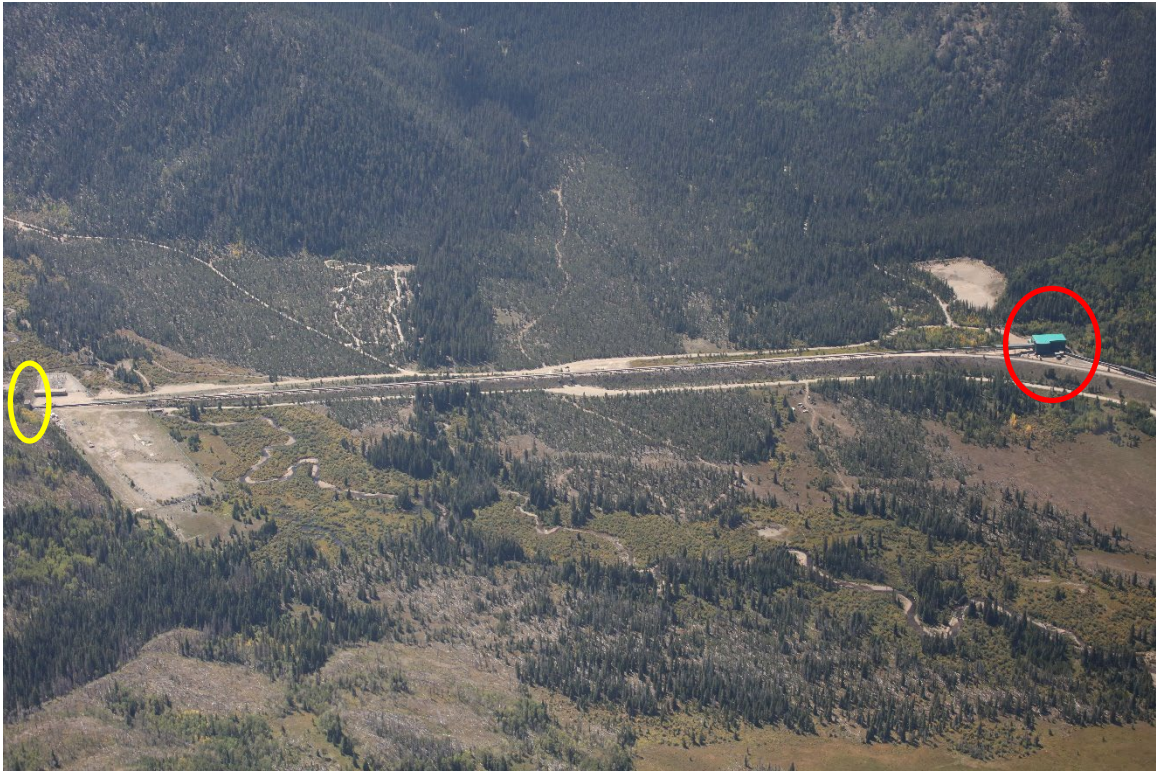
Photo 17: Looking southwest at the transfer station for the conveyor system (red circle). Looking southeast at the portal (yellow circle).
