QUARTERLY SEDIMENTATION POND INSPECTION REPORT

Mine: Lorencito

Inspection Period: Third Quarter 2024

Inspection Date: 09/30/24

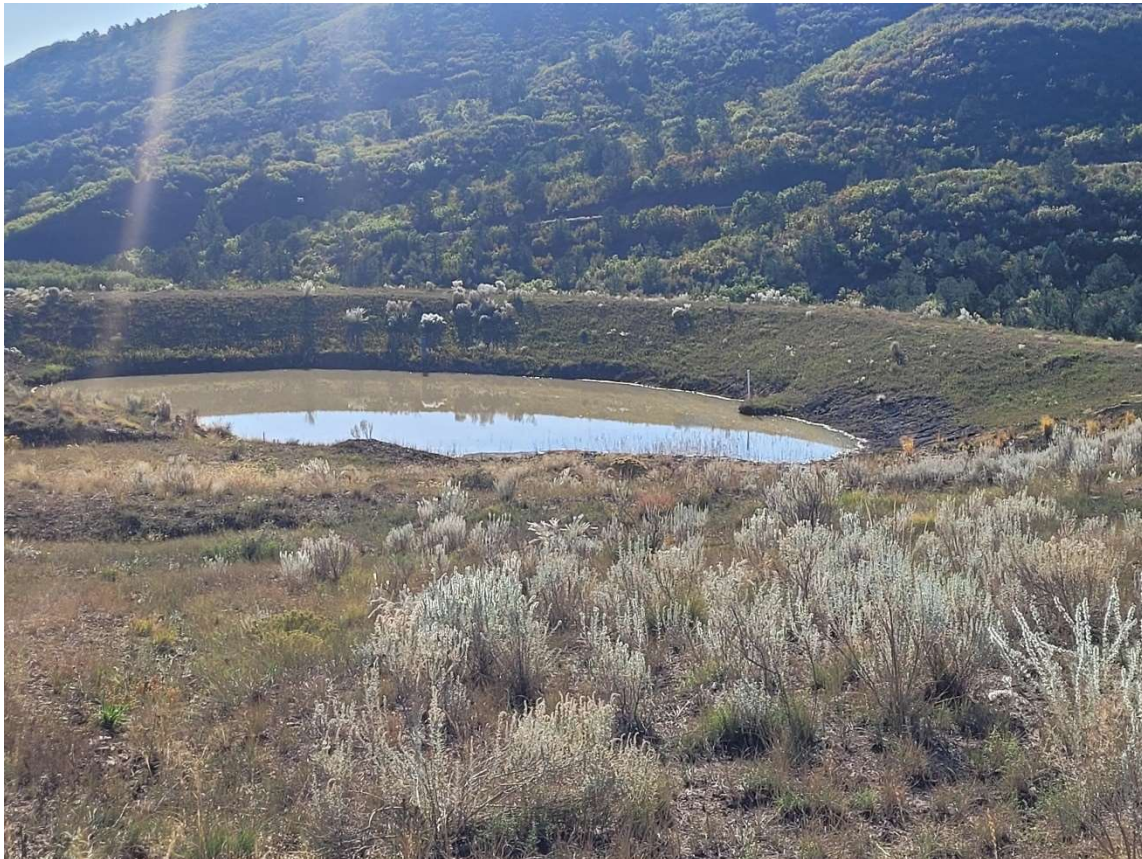
NPDES ID. No.: Pond #6

Pond was holding water at time of inspection, not near the bottom of the decant. Bank was stable during inspection.

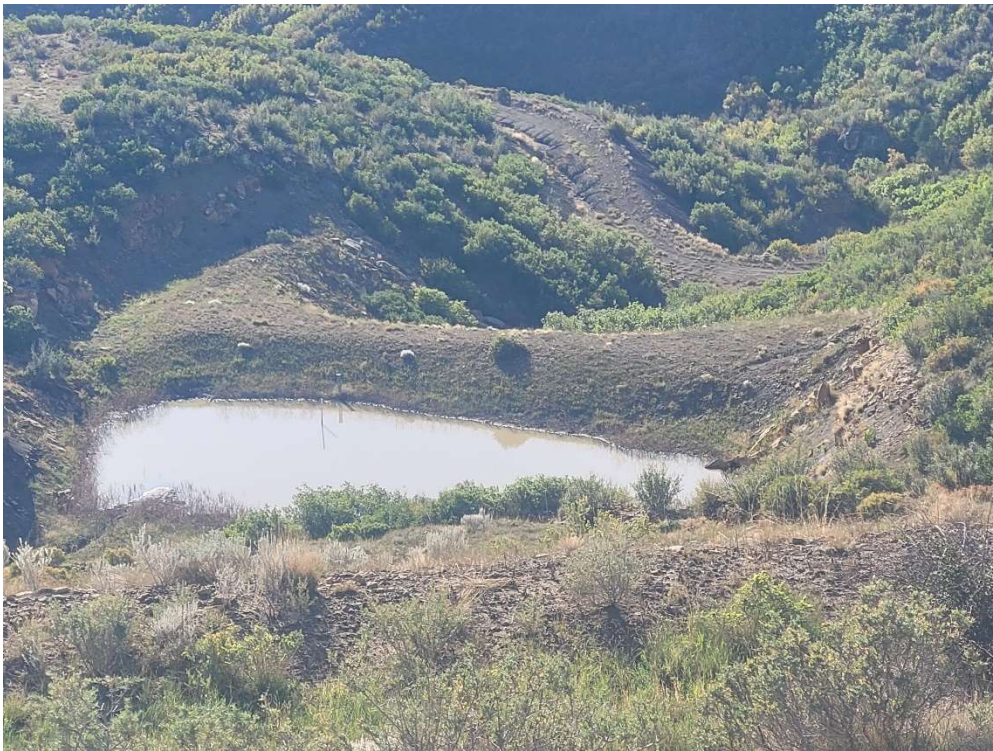
NPDES ID. No.: Pond #9 (North)

Pond was holding some water at time of inspection. Not near the level of the decant.
