**LORENCITO CANYON MINE**  
**Permit No. C-1996-084**

**INSPECTION OF EXCESS SPOIL-FILLS 7, 8, & 9**  
**September 30, 2024**

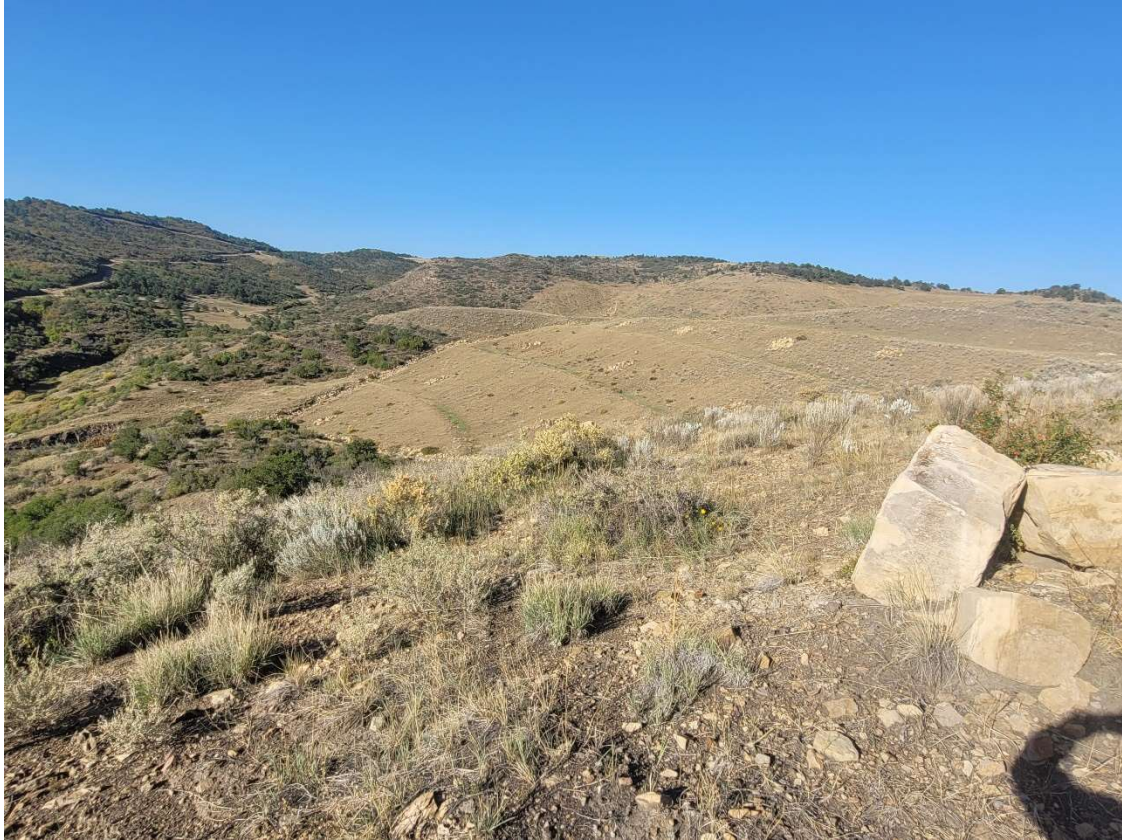
**Fill #7 taken on 9/30/24**

The entire excess spoil fill facility was examined for signs of failure and instability such as tension cracks, ground movement, springs and seeps, and standing water. There was no indication of potential instability at time of inspection. The Fill was slopes were stable and was well vegetated at time of inspection

East armored down drain needs to be monitored and might need a spot that is washed out to be re-armored. All else looks good.

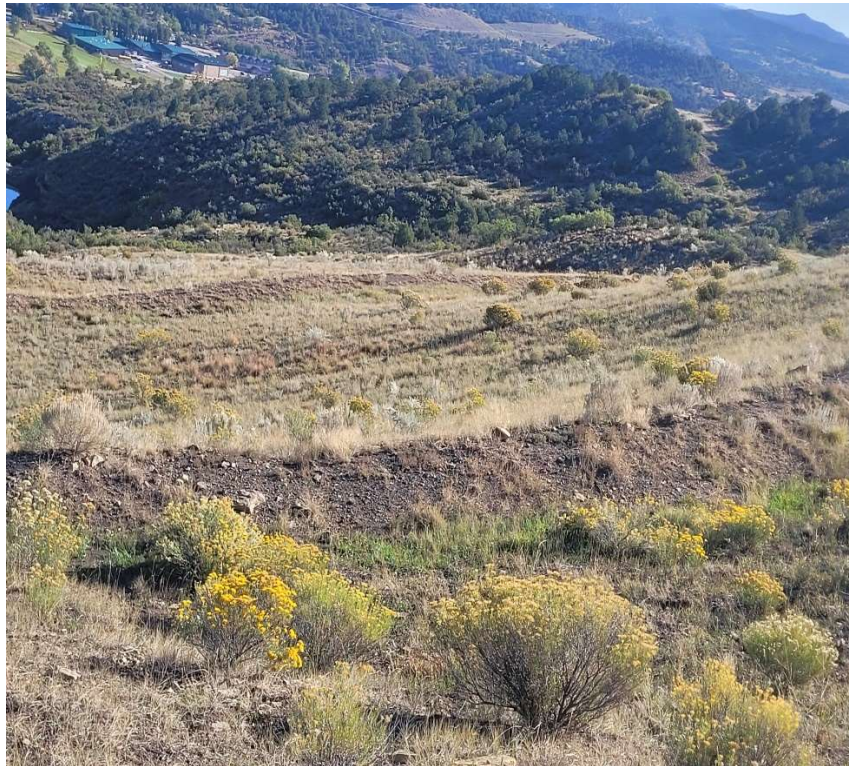
**Fill #8 taken on 9/30/24**

The entire excess spoil fill facility was examined for signs of failure and instability such as tension cracks, ground movement, springs and seeps, and standing water. There was no indication of potential instability at time of inspection.

Fill is in good condition and vegetation is in great condition.

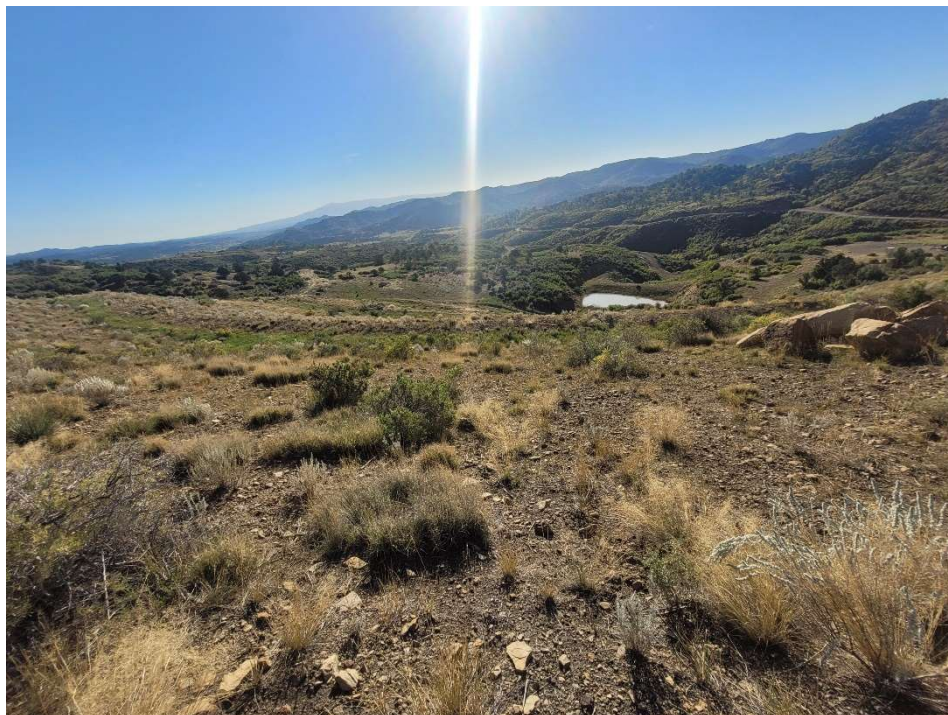
**Fill #9 taken on 9/30/24**

The entire excess spoil fill facility was examined for signs of failure and instability such as tension cracks, ground movement, springs and seeps, and standing water. There was no indication of potential instability at time of inspection.

Overall the site is in good condition.
