MINERALS PROGRAM INSPECTION REPORT
PHONE: (303) 866-3567

MINE NAME: JD-9 Mine	MINE/PROSPECTING ID#: M-1977-306	MINERAL: Uranium and vanadium	COUNTY: Montrose
INSPECTION TYPE: Monitoring	WEATHER: Clear	INSP. DATE: October 02, 2024	INSP. TIME: 14:00
OPERATOR: Highbury Resources Inc.	OPERATOR REPRESENTATIVE: Richard Petersen	TYPE OF OPERATION: 112d-1 - Designated Mining Operation	
REASON FOR INSPECTION: Normal I&E Program	BOND CALCULATION TYPE:	BOND AMOUNT: \$219,050	
DATE OF COMPLAINT: NA	POST INSP. CONTACTS: None	JOINT INSP. AGENCY: U.S. Energy	
INSPECTOR(S): Dustin Czapla	INSPECTOR'S SIGNATURE:

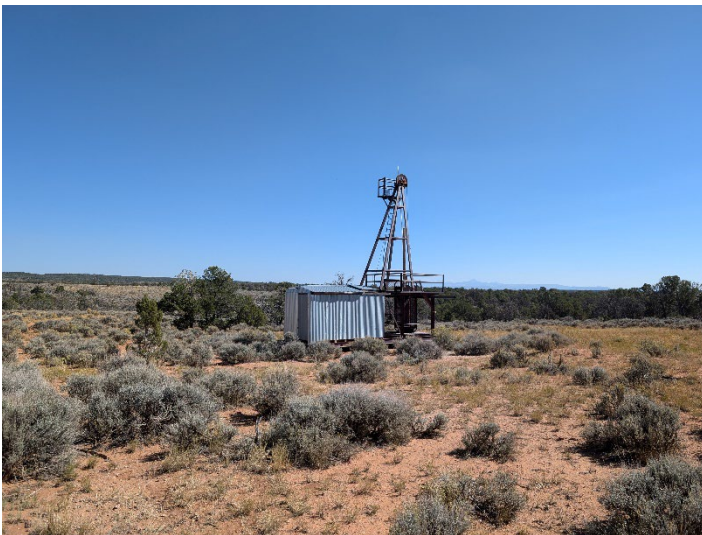
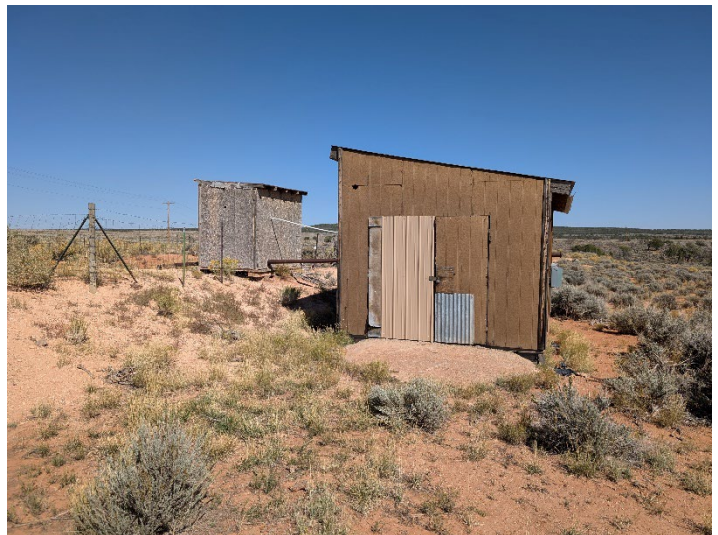
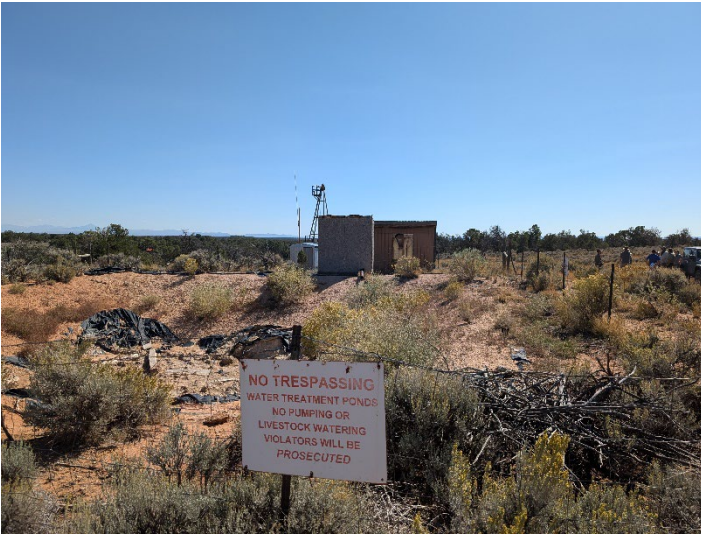
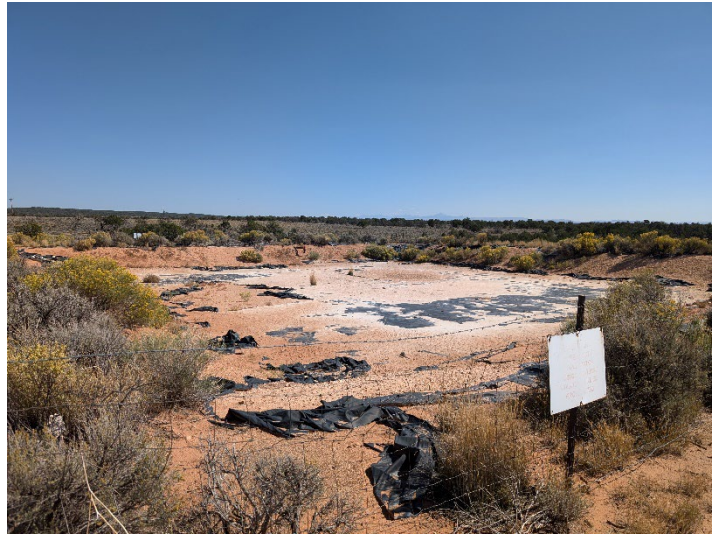
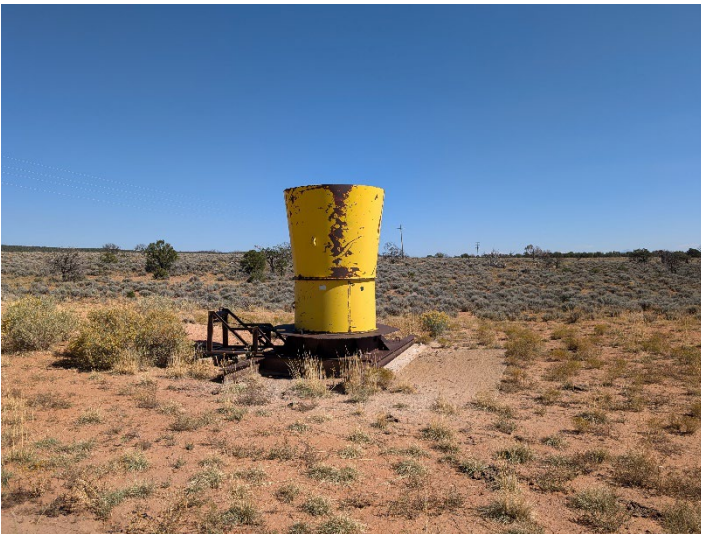
Upper Monogram Area

Vent fans and water treatment plant are located in this area. The water treatment plant is not currently in use. Pond liners are dilapidated and not functional. Water was not observed in any of the ponds. Conditions are similar to those observed during the Division's last inspection. No problems or violations were noted in this area.

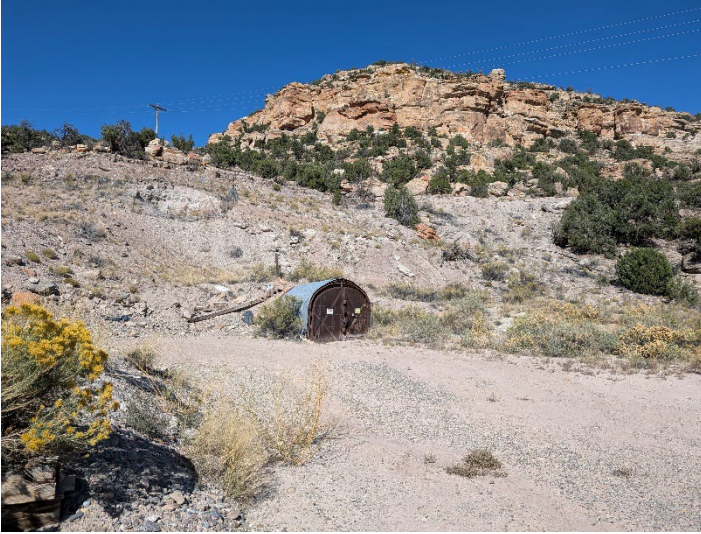
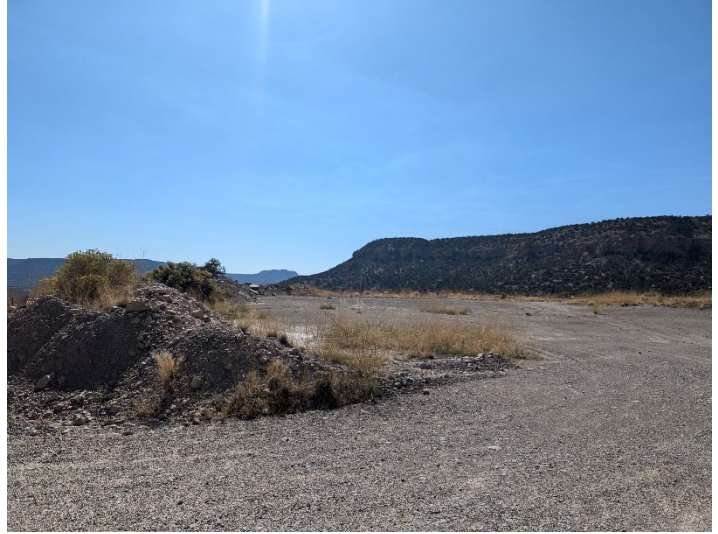
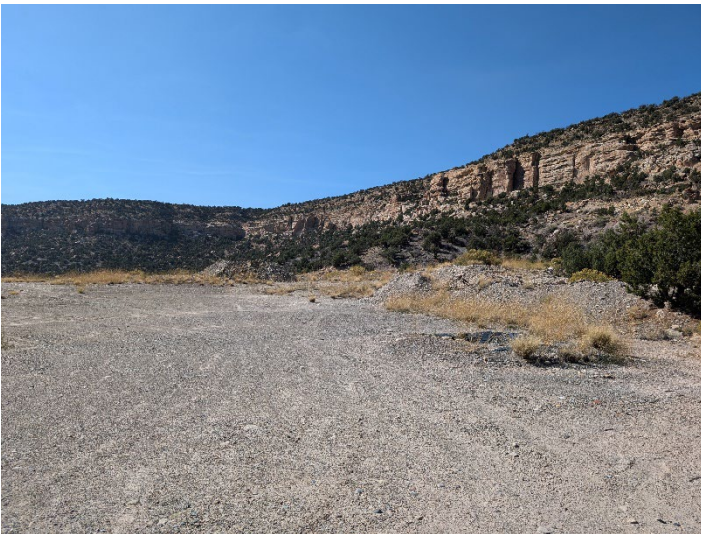
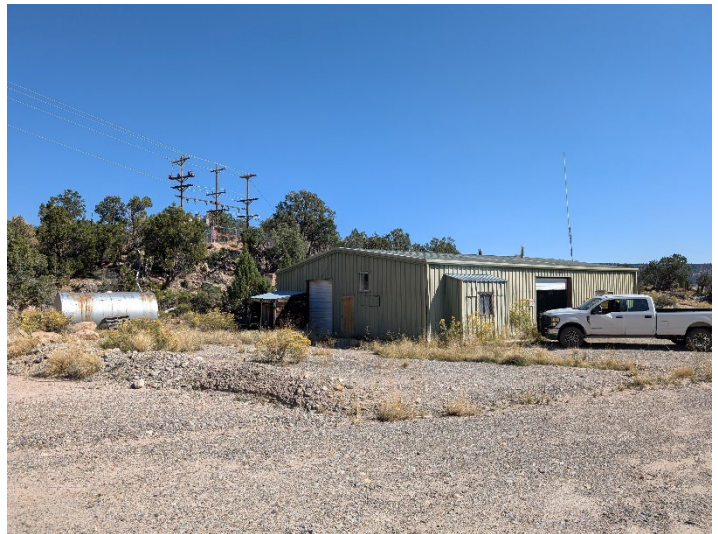
Bull Canyon Area

This area consists of a collapsed portal, a metal building, waste rock pile and associated stormwater control structures. Overall, the area is well kept. Stormwater control structures appear to be maintained and functioning as designed. Conditions are similar to those observed during the Division's last inspection of this area. No problems or violations were noted.
