MINERALS PROGRAM INSPECTION REPORT
PHONE: (303) 866-3567

MINE NAME: JD-6 Mine	MINE/PROSPECTING ID#: M-1977-310	MINERAL: Uranium and vanadium	COUNTY: Montrose
INSPECTION TYPE: Monitoring	WEATHER: Clear	INSP. DATE: October 02, 2024	INSP. TIME: 12:30
OPERATOR: Highbury Resources Inc.	OPERATOR REPRESENTATIVE: Richard Petersen	TYPE OF OPERATION: 110d - Designated Limited Impact	
REASON FOR INSPECTION: Normal I&E Program	BOND CALCULATION TYPE:	BOND AMOUNT: \$46,200	
DATE OF COMPLAINT: NA	POST INSP. CONTACTS: None	JOINT INSP. AGENCY: DOE, BLM	
INSPECTOR(S): Dustin Czapla	INSPECTOR'S SIGNATURE:

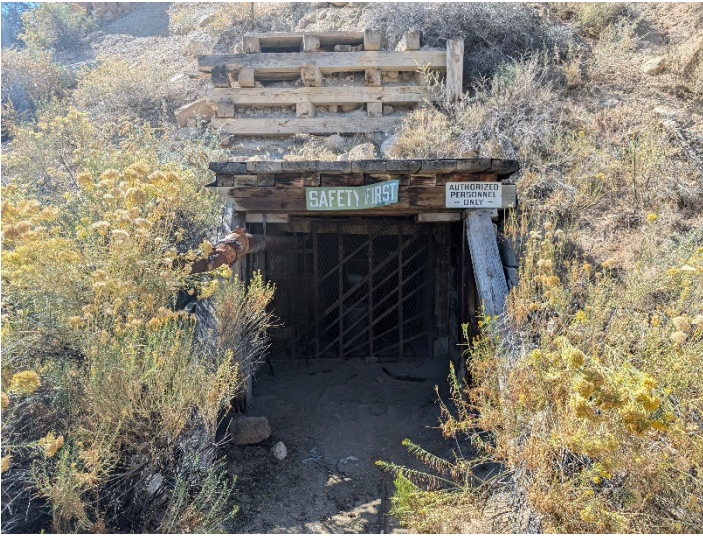
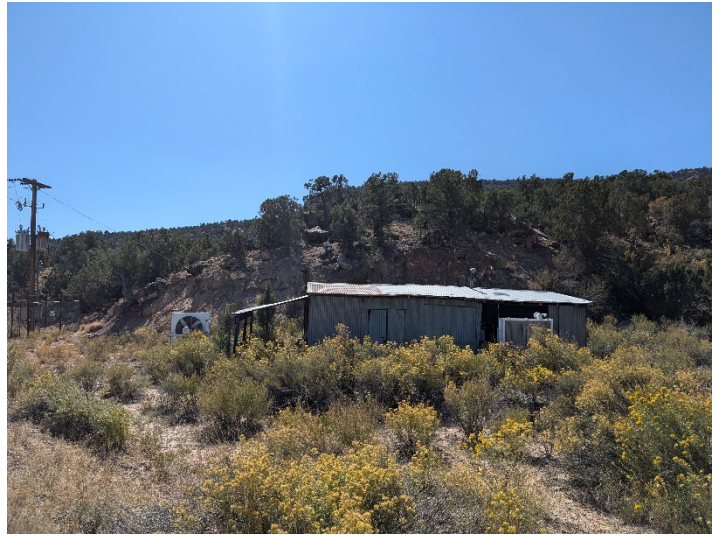
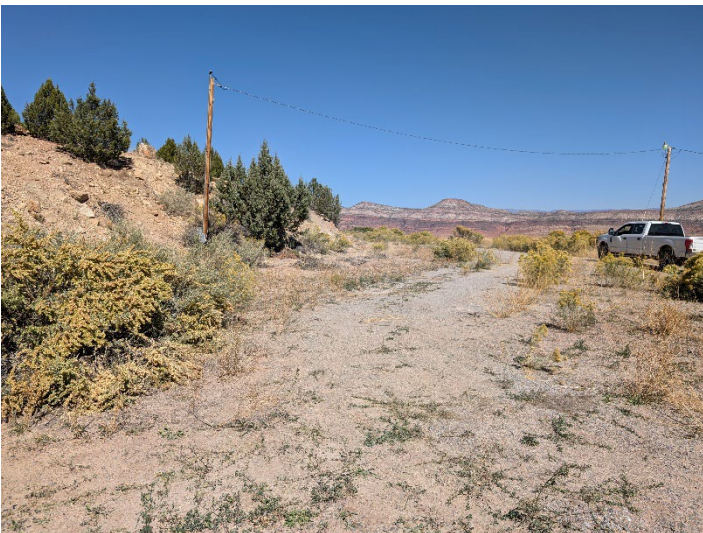
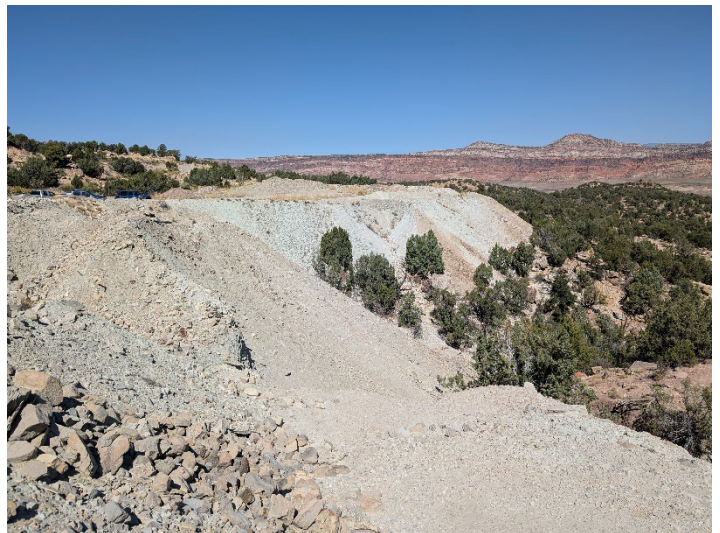
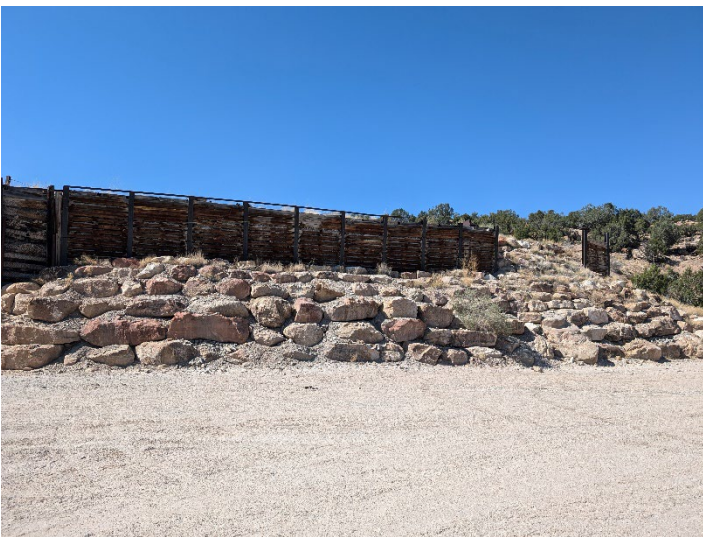
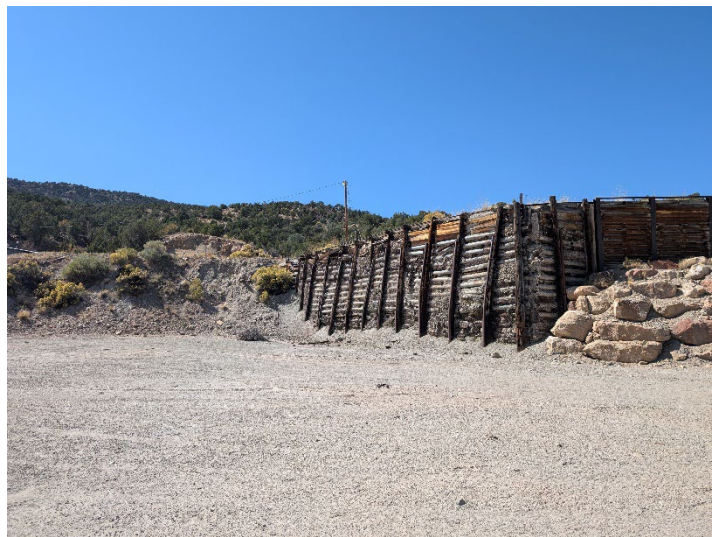
Site activity has been limited to cleanup and maintenance. The repaired retaining wall continues to appear stable.
