**MINERALS PROGRAM INSPECTION REPORT**  
**PHONE: (303) 866-3567**

| <b>MINE NAME:</b><br>Van 4 Shaft | <b>MINE/PROSPECTING ID#:</b><br>M-1997-032 | <b>MINERAL:</b><br>Uranium and vanadium | <b>COUNTY:</b><br>Montrose |
| <b>INSPECTION TYPE:</b><br>Monitoring | <b>WEATHER:</b> Clear | <b>INSP. DATE:</b><br>October 2, 2024 | <b>INSP. TIME:</b><br>14:20 |

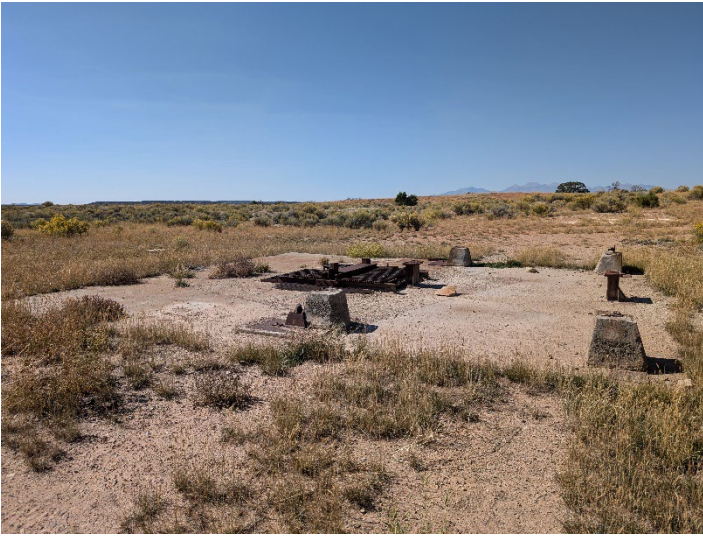
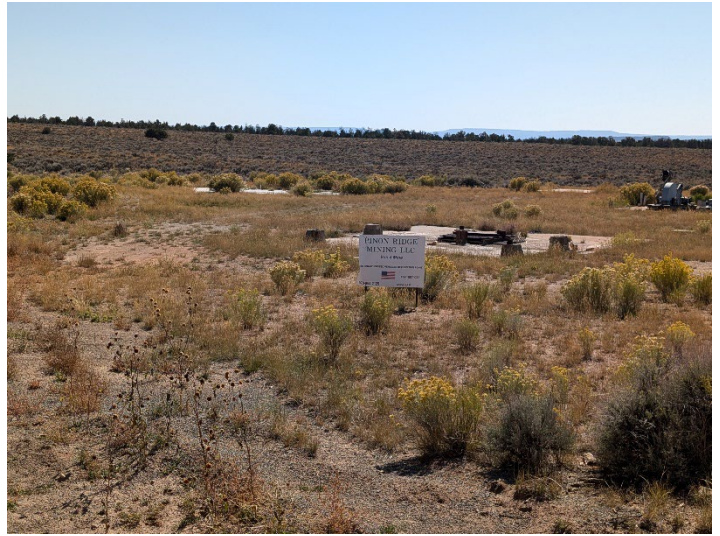
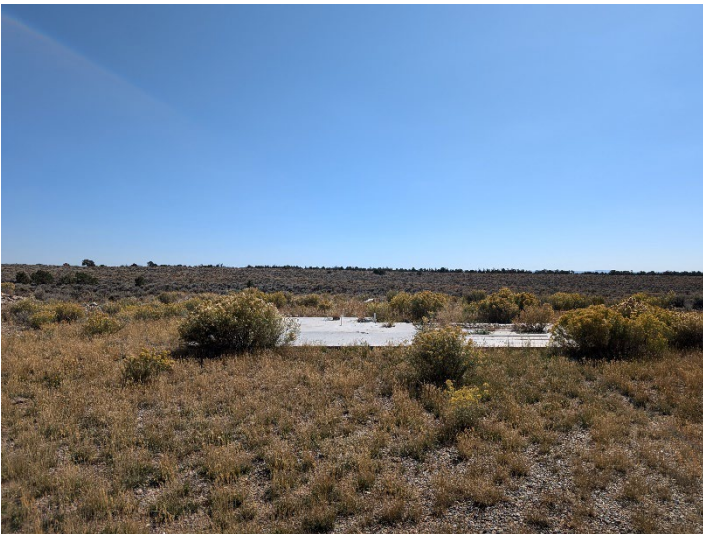
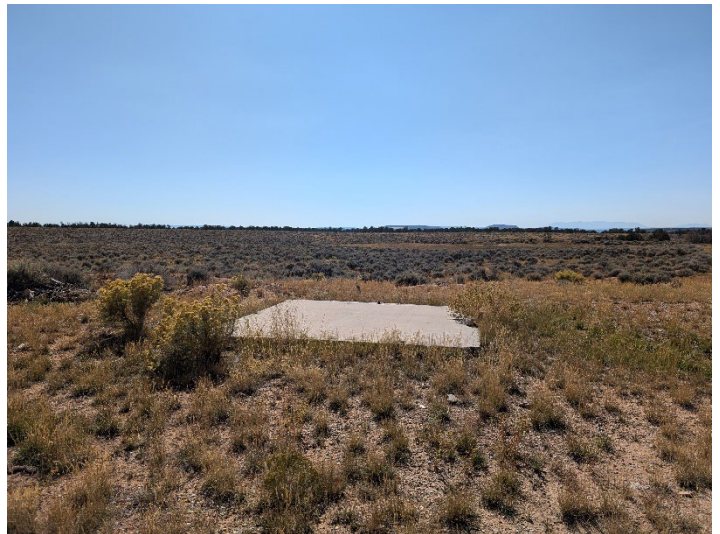
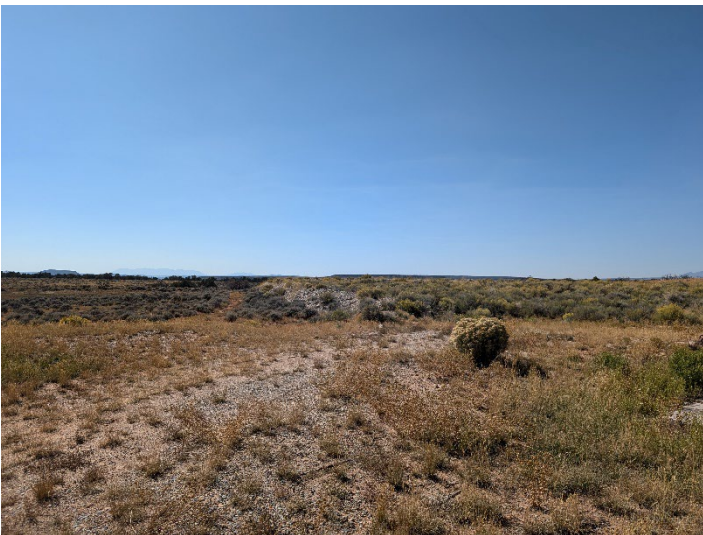
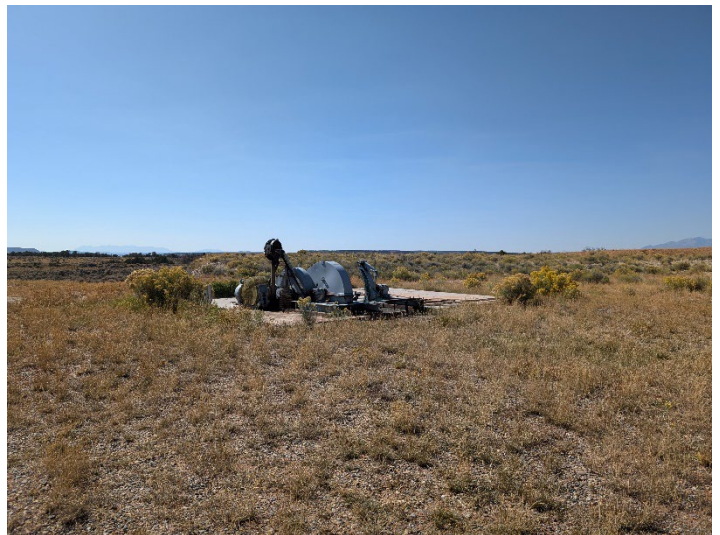
The metal shop building, headframe, shed and hoist house have been removed. The slab foundations are still in place. The hoist winch is still in place. The shaft is secured with metal grating, but not yet sealed.
