**MINERALS PROGRAM INSPECTION REPORT**  
**PHONE: (303) 866-3567**

<b>MINE NAME:</b> C-JD-5	<b>MINE/PROSPECTING ID#:</b> M-1977-248	<b>MINERAL:</b> Uranium and vanadium	<b>COUNTY:</b> Montrose
<b>INSPECTION TYPE:</b> Monitoring	<b>INSPECTOR(S):</b> Dustin Czapla	<b>INSP. DATE:</b> October 2, 2024	<b>INSP. TIME:</b> 15:30
<b>OPERATOR:</b> Gold Eagle Mining, Inc.	<b>OPERATOR REPRESENTATIVE:</b> Don Coram	<b>TYPE OF OPERATION:</b> 112d-1 - Designated Mining Operation	
<b>REASON FOR INSPECTION:</b> Normal I&E Program	<b>BOND CALCULATION TYPE:</b> None	<b>BOND AMOUNT:</b> \$100.00	
<b>DATE OF COMPLAINT:</b> NA	<b>POST INSP. CONTACTS:</b> None	<b>JOINT INSP. AGENCY:</b> DOE, BLM	
<b>WEATHER:</b> Clear	<b>INSPECTOR'S SIGNATURE:</b>

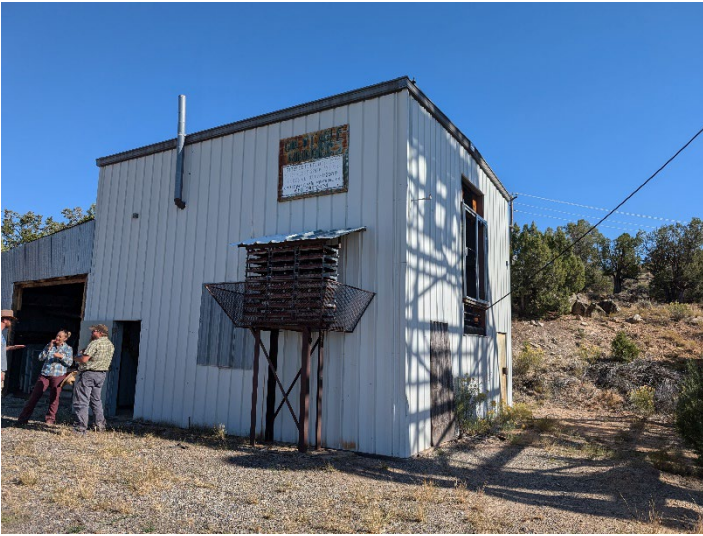
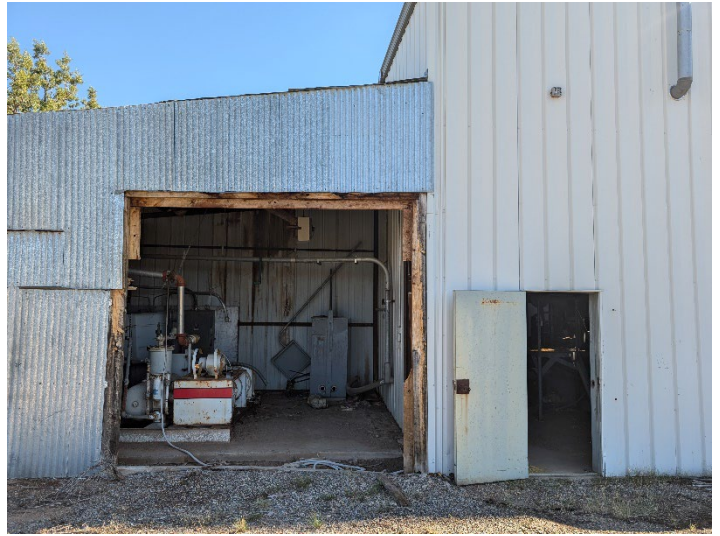
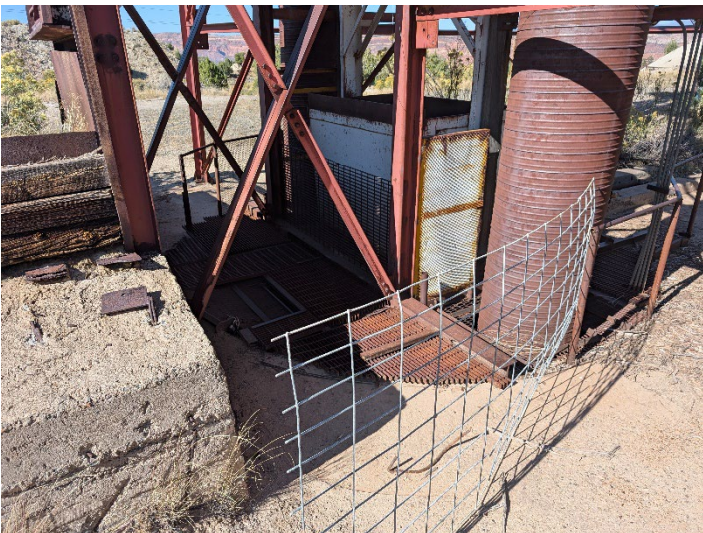
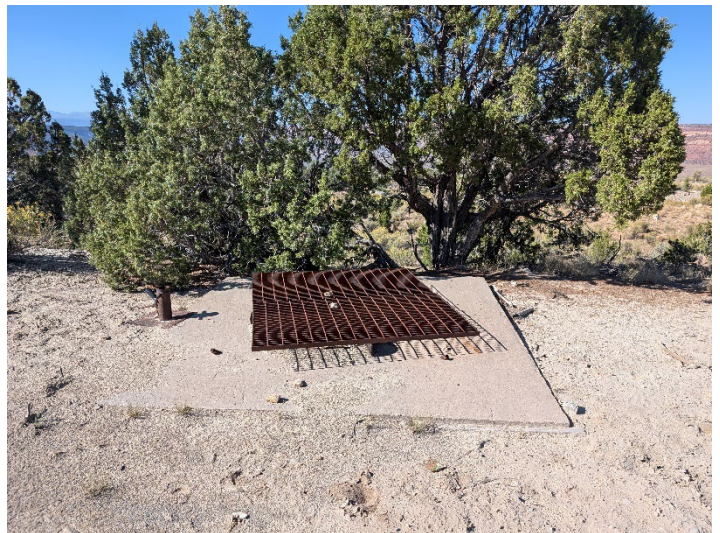
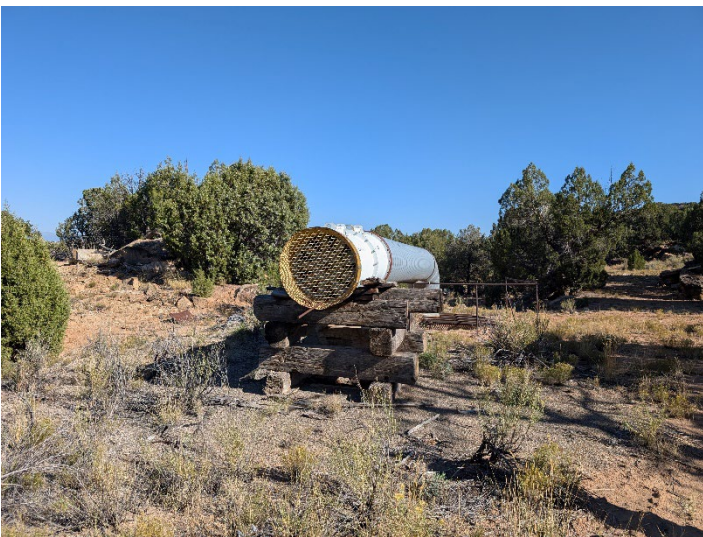
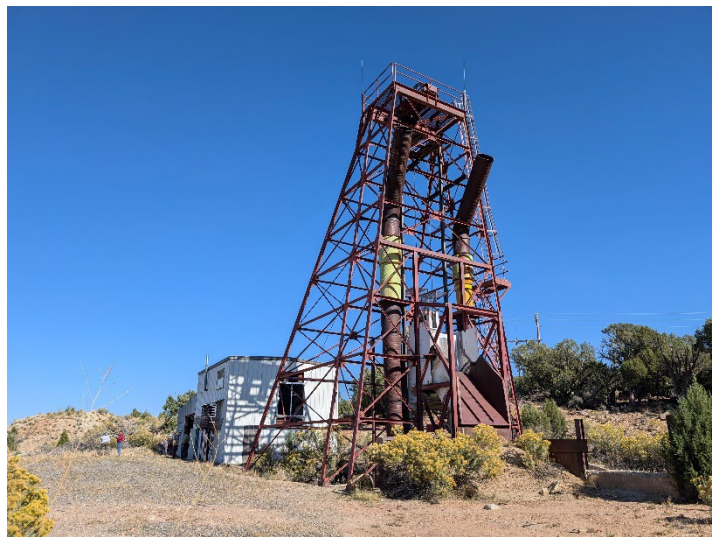
This inspection was conducted as part of the Division of Reclamation, Mining and Safety's (Division) normal monitoring program. Don Coram, representing the operator, was present. Representatives from DOE and BLM were present. Photographs are included with this report to illustrate conditions observed.

Adequate mine identification signage was posted on the hoist house, visible from the entrance to the mine site.

No noticeable activity has occurred at the site since the Division's last inspection.
