QUARTERLY SEDIMENTATION POND INSPECTION REPORT

CDMR Rule 4.05.9(17)

Mine: Lorencito

Inspection Period: Third Quarter 2024

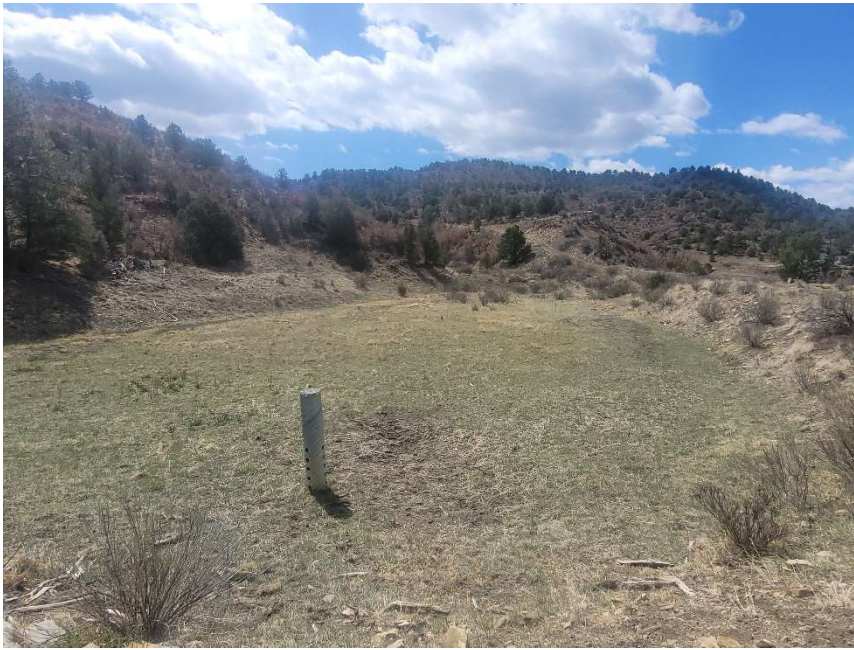
NPDES ID. No.: Pond #5

Explain: Sediment in pond does not appear to be over capacity by visual inspection.

Pond was empty at time of inspection.

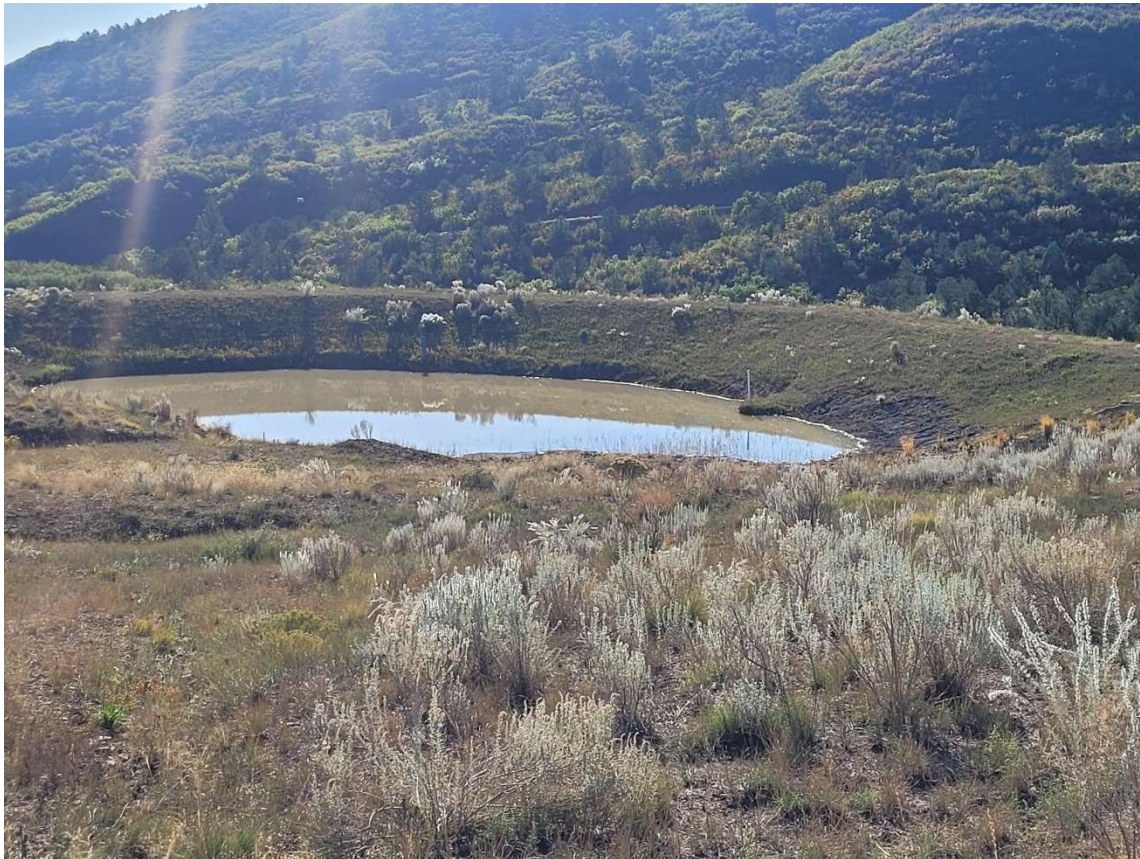
NPDES ID. No.: Pond #6

Pond was holding water at time of inspection, not near the bottom of the decant. Bank was stable during inspection.

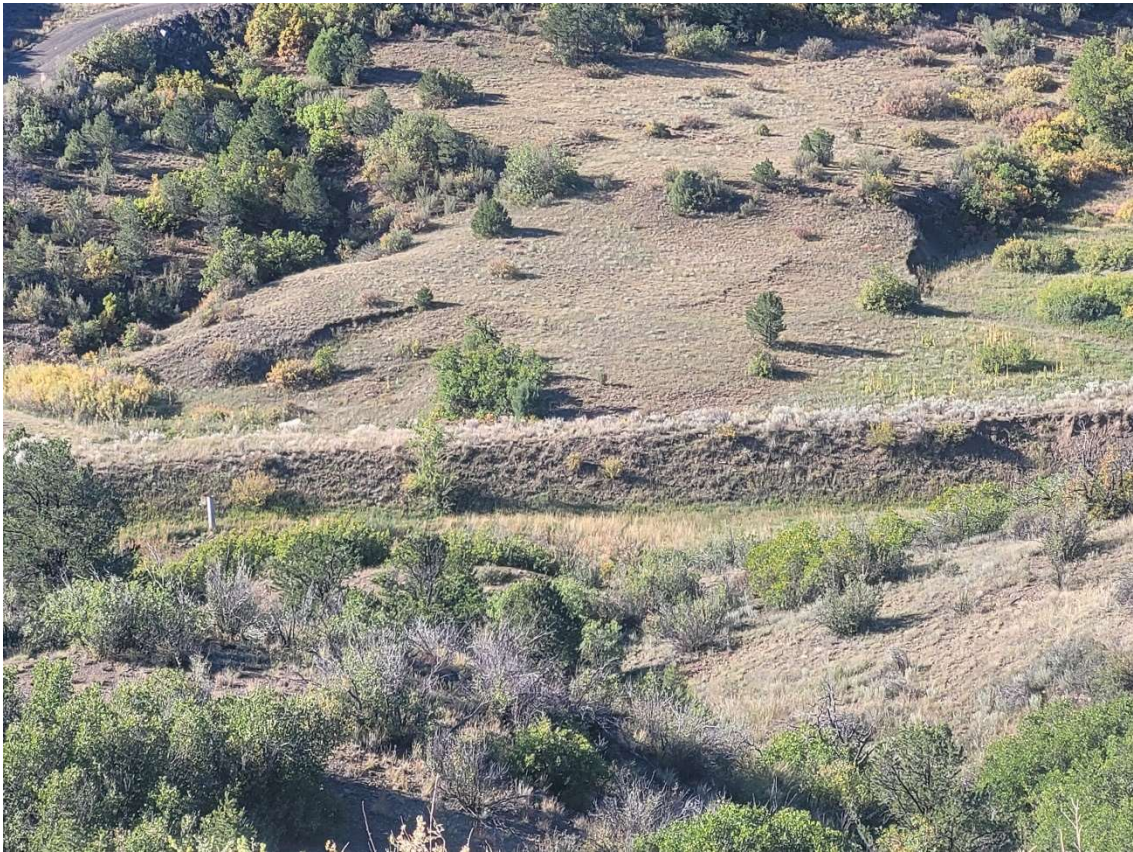
NPDES ID. No.: Pond #7

Pond was holding a small amount of water at time of inspection. Pond Bank in Great Condition.

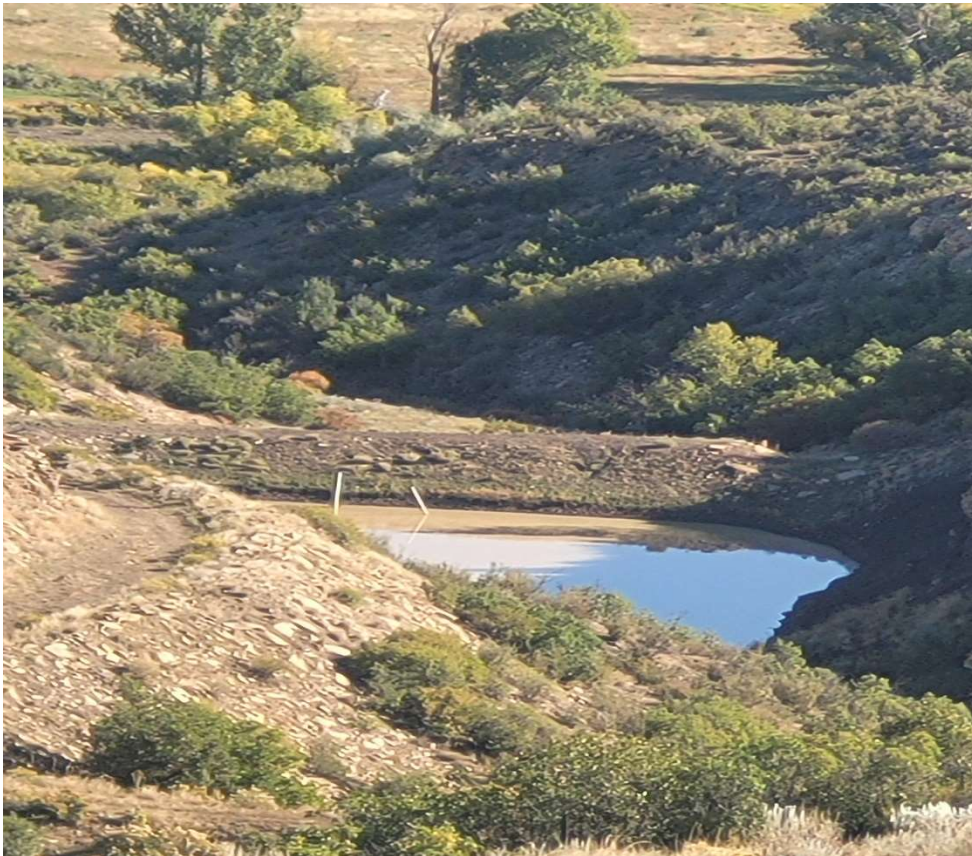
NPDES ID. No.: Pond #8

Pond was holding water at the time of inspection. Appears to have not discharged recently.

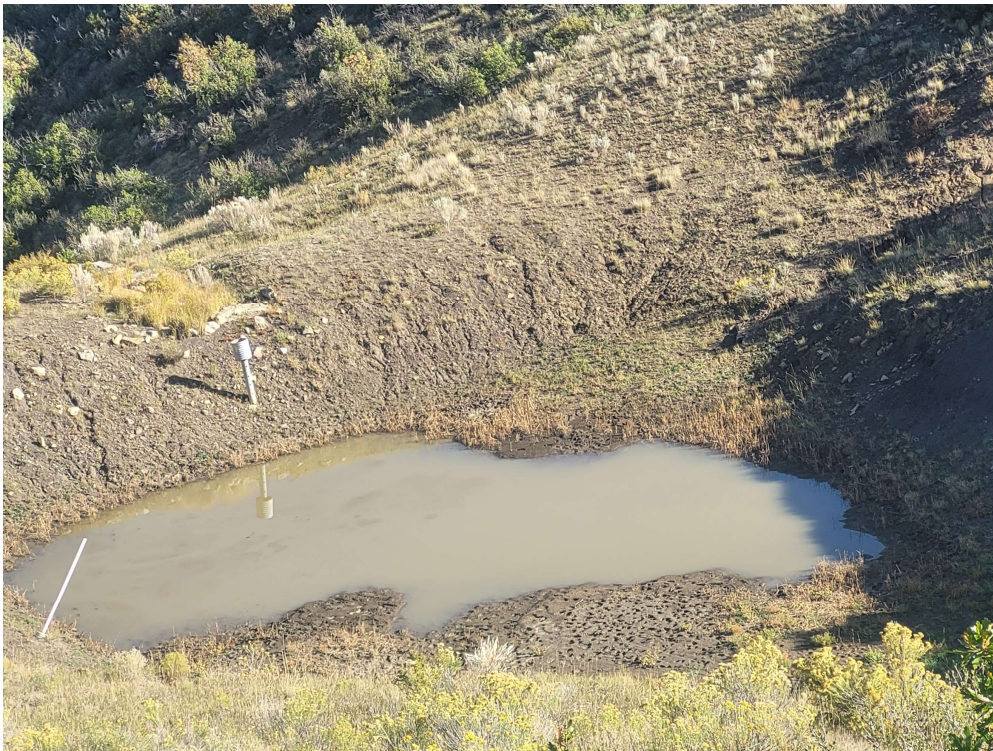
NPDES ID. No.: Pond #9 (North)

Pond was holding some water at time of inspection. Not near the level of the decant.

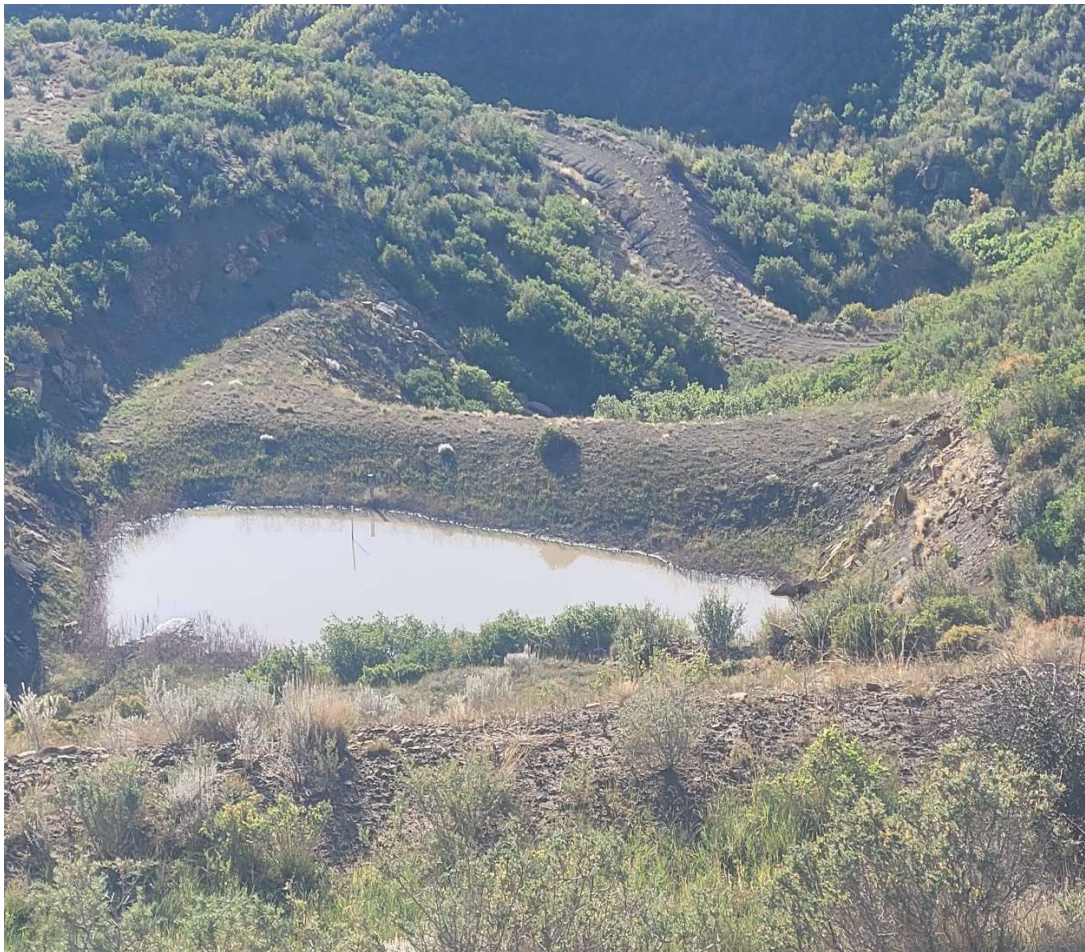
NPDES ID. No.: Pond #9A (South)

Pond was holding water at time of inspection. Does not appear to have recently discharged.
