MINERALS PROGRAM INSPECTION REPORT
PHONE: (303) 866-3567

| MINE NAME: Golden Wonder Mine | MINE/PROSPECTING ID#: M-1978-091-UG | MINERAL: Gold | COUNTY: Hinsdale |
| INSPECTION TYPE: Multi Person Inspection | WEATHER: Clear | INSP. DATE: September 25, 2024 | INSP. TIME: 09:10 |
| OPERATOR: LKA International Inc. | OPERATOR REPRESENTATIVE: Kye Abraham | TYPE OF OPERATION: 110d - Designated Limited Impact | |

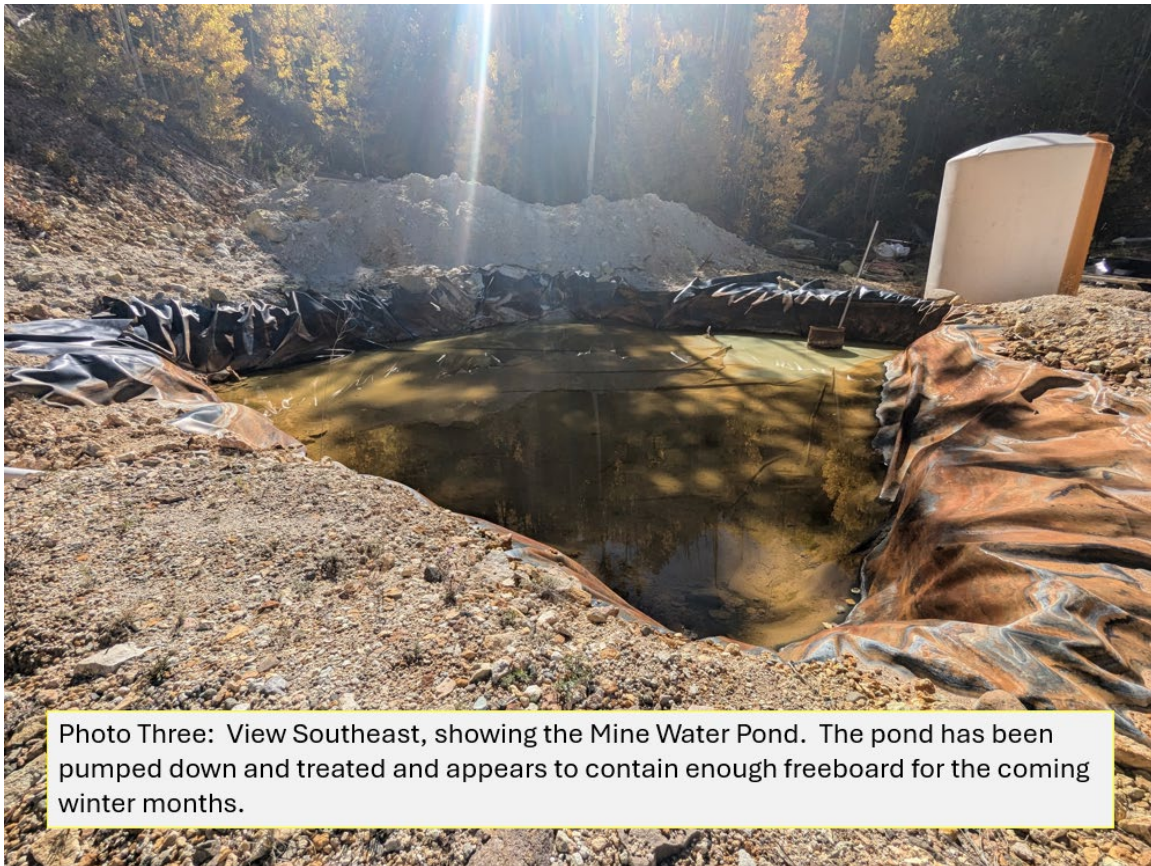
Photo Three: View Southeast, showing the Mine Water Pond. The pond has been pumped down and treated and appears to contain enough freeboard for the coming winter months.

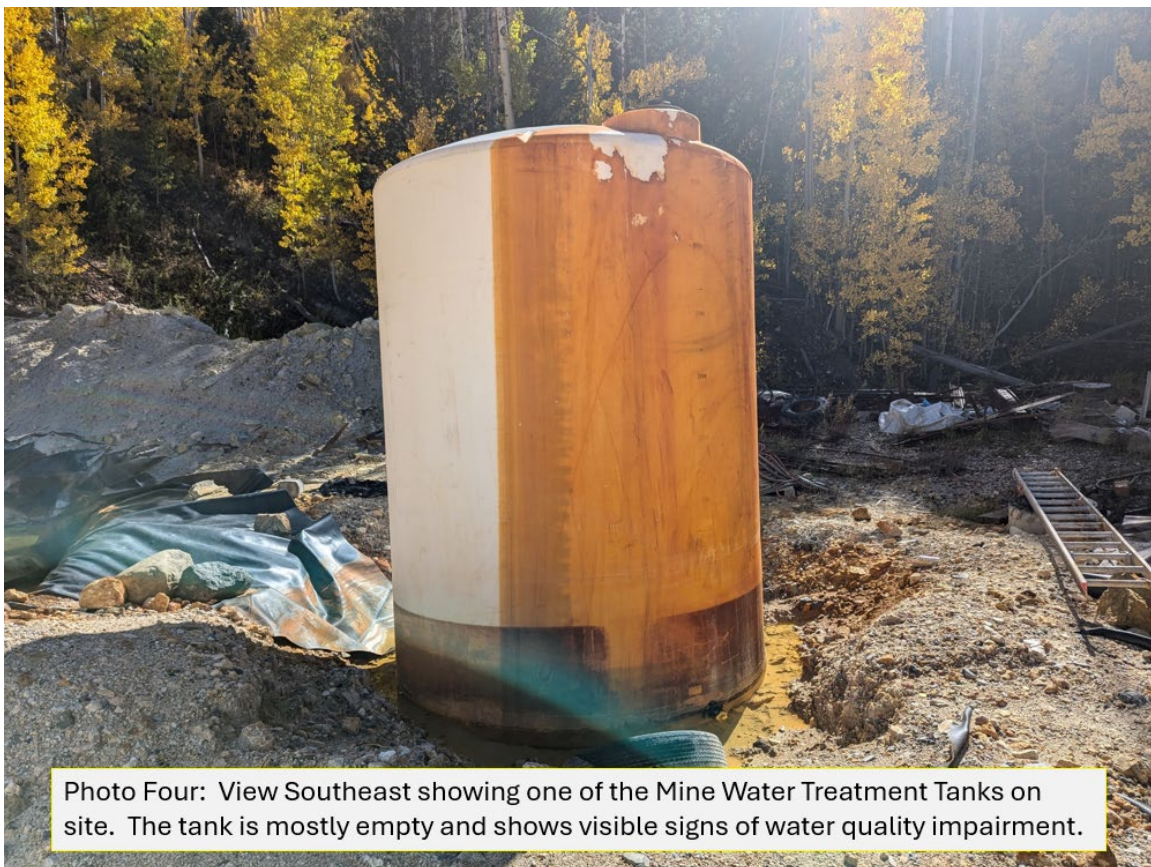
Photo Four: View Southeast showing one of the Mine Water Treatment Tanks on site. The tank is mostly empty and shows visible signs of water quality impairment.

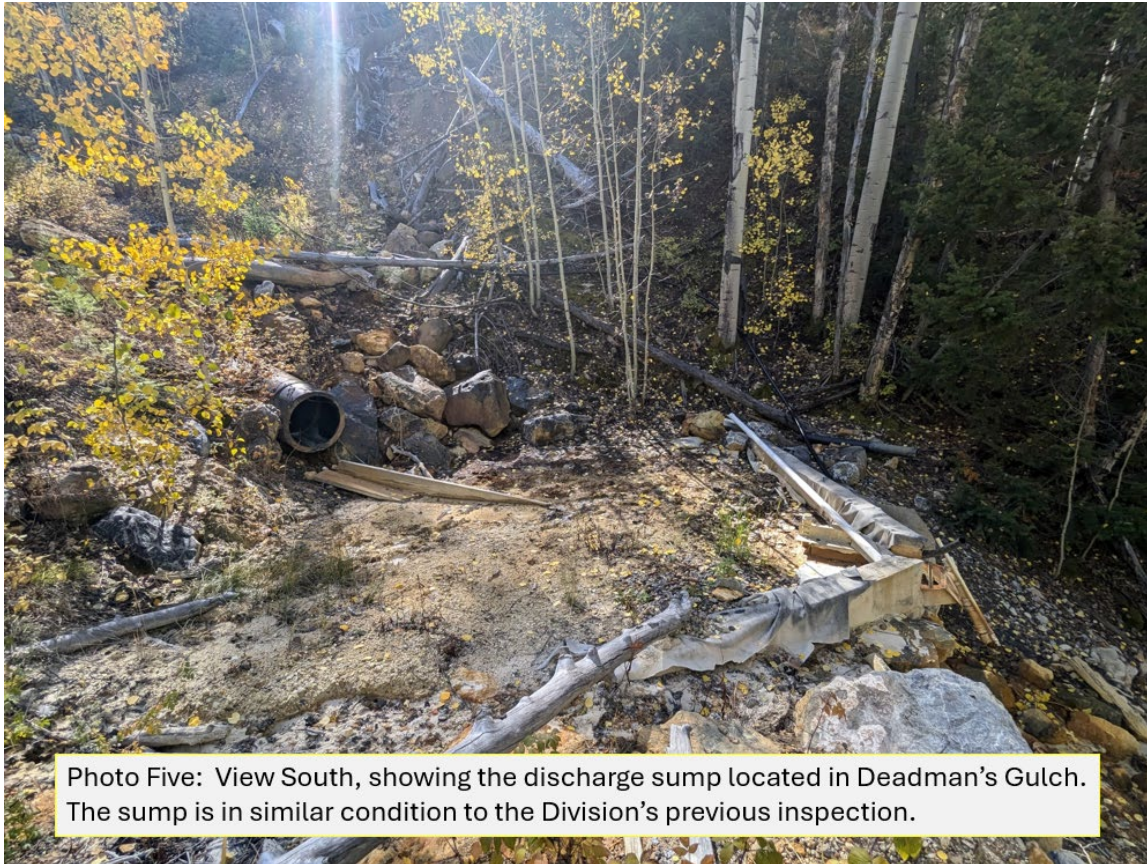
Mine water treatment is achieved by the addition of chemicals to achieve water quality standards, and discharge via PVC pipe to the collection sump located down gradient in Deadman Gulch. The sump was observed and can be seen in Photo Five. The sump acts as a collection and mixing pond for mine discharge water, as well as waters from Deadman Gulch that have been routed around the disturbed area. The sump contained no water and is in similar condition to the Division's previous inspection.

Photo Five: View South, showing the discharge sump located in Deadman's Gulch. The sump is in similar condition to the Division's previous inspection.

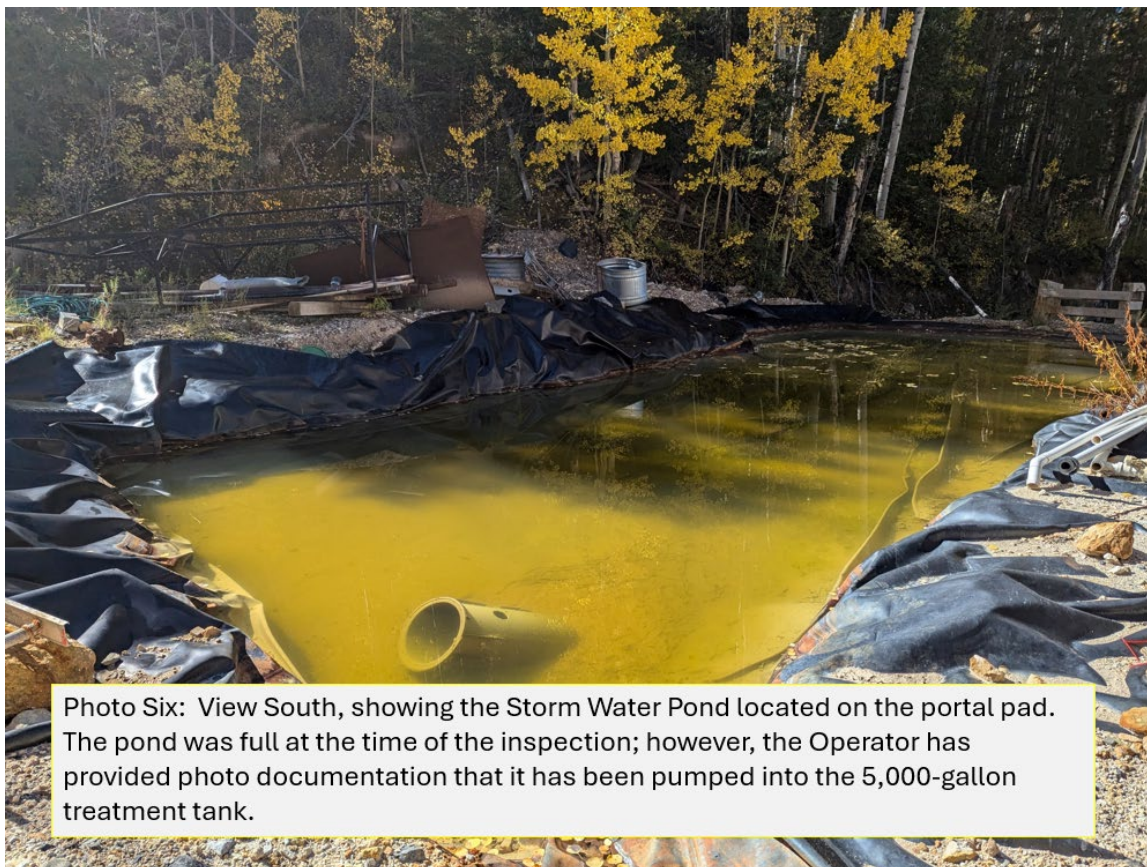
Stormwater flows are controlled along the access road leading to the 6-level portal area by way of a bar ditch and periodic culverts before reaching the pad. Three culverts have been installed along the access road and were observed to be able to function as designed. Storm water collected on the pond and lower portion of the access road is routed to the Storm Water Collection Pond adjacent to the Shop building. The pond can be seen in Photo Six and similar to the mine water collection pond is lined with a synthetic liner. At the time of the inspection the water level was high, and the Operator was advised to pump the water into the treatment tank for increased capacity for the coming winter. Since the date of the inspection, the Operator has completed pumping the Storm Water Pond down and provided photo documentation to the Division. Therefore, it is not considered a problem at this time.

Photo Six: View South, showing the Storm Water Pond located on the portal pad. The pond was full at the time of the inspection; however, the Operator has provided photo documentation that it has been pumped into the 5,000-gallon treatment tank.

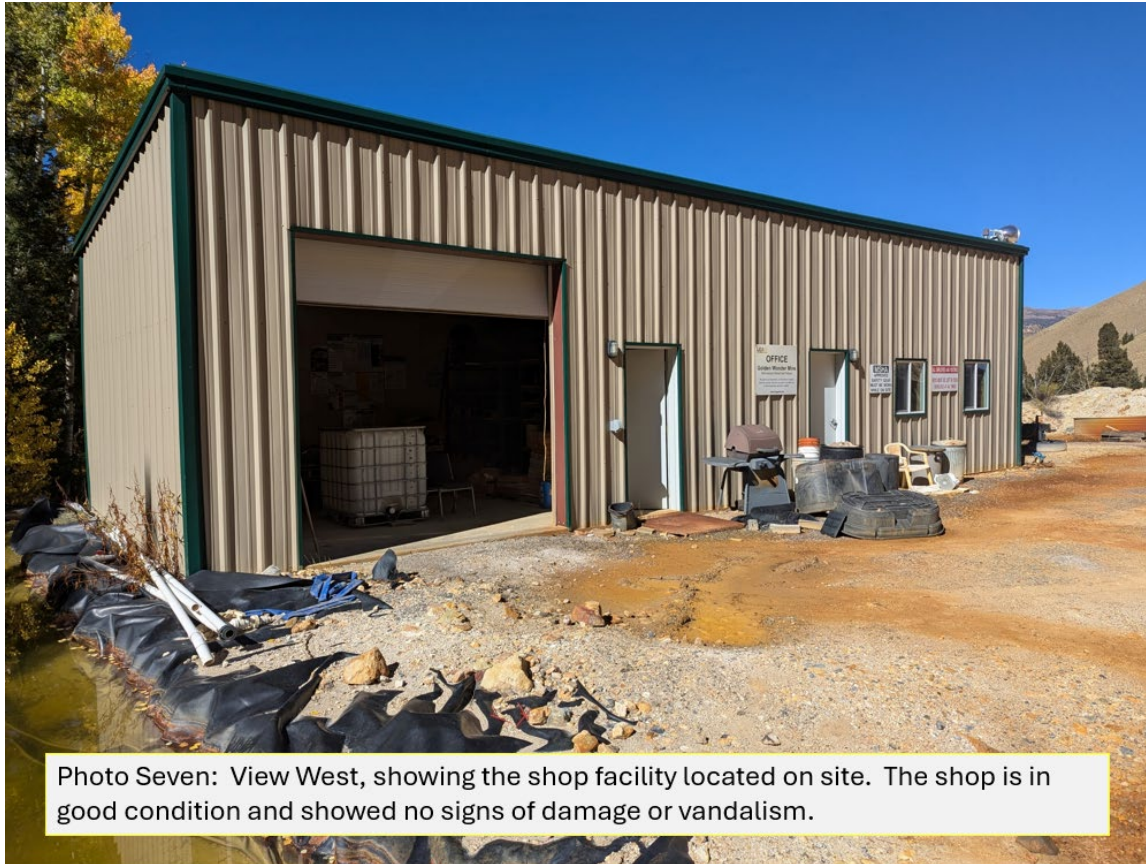
Other surface facilities associated with the 6-level portal area include a shop facility, shown in Photo Seven, which is in good condition and was secure. The shop facility shows no signs of damage, vandalism or attempted unauthorized entry. Adjacent to the shop lies a diesel-powered generator, storage container and crusher equipment used for sizing ore material prior to exportation. Located at the shoulder of the portal pad, lies the waste rock dump. The waste rock dump appeared stable at the time of inspection but did show signs of minor erosion along its face. These erosional features should be monitored by the Operator in the future. The materials storage area is located just to the north of the portal and consists of a concrete pad with pre-cast blocks used as walls and a low-grade ore stockpile.

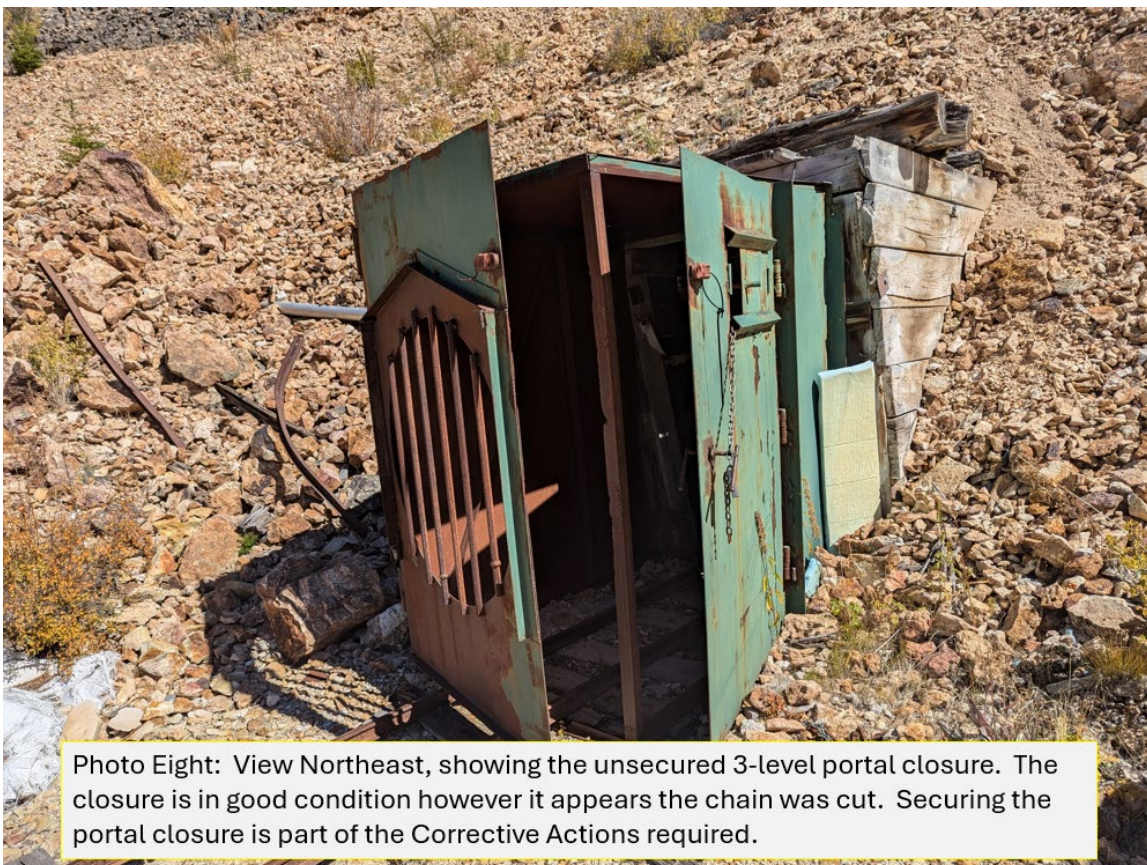
PROBLEM/POSSIBLE VIOLATION: Problem: Additionally, the closure of the 3 Level Portal was found unsecured, and access to the 3 Level Portal Pad was unsecured. This presents a significant safety hazard, access to the disturbed area should be controlled, and the Portal closure should be secured when not in use.

The secondary portion of the permit area is the 3-level portal area. This area consists of a portal, portal pad, waste rock dump and equipment storage areas. The three level portal, shown in Photo Eight, was observed to be unsecured and open. The chain appears to have been cut at some point allowing uncontrolled access. Also, the cable gate that usually prevents unauthorized access to the 3-level area was down. This presents a significant safety hazard, access to the disturbed area should be controlled, and the Portal closure should be secured when not in use. The Operator shall submit a written report to the Division with photo documentation, showing that the portal closure has been secured, and public access is controlled in some manner. The report and photo documentation shall be submitted no later than **Monday December 2, 2024**

CORRECTIVE ACTIONS: The Operator shall submit a written report to the Division with photo documentation, showing that the portal closure has been secured, and public access is controlled in some manner. The report and photo documentation shall be submitted no later than Monday December 2, 2024.

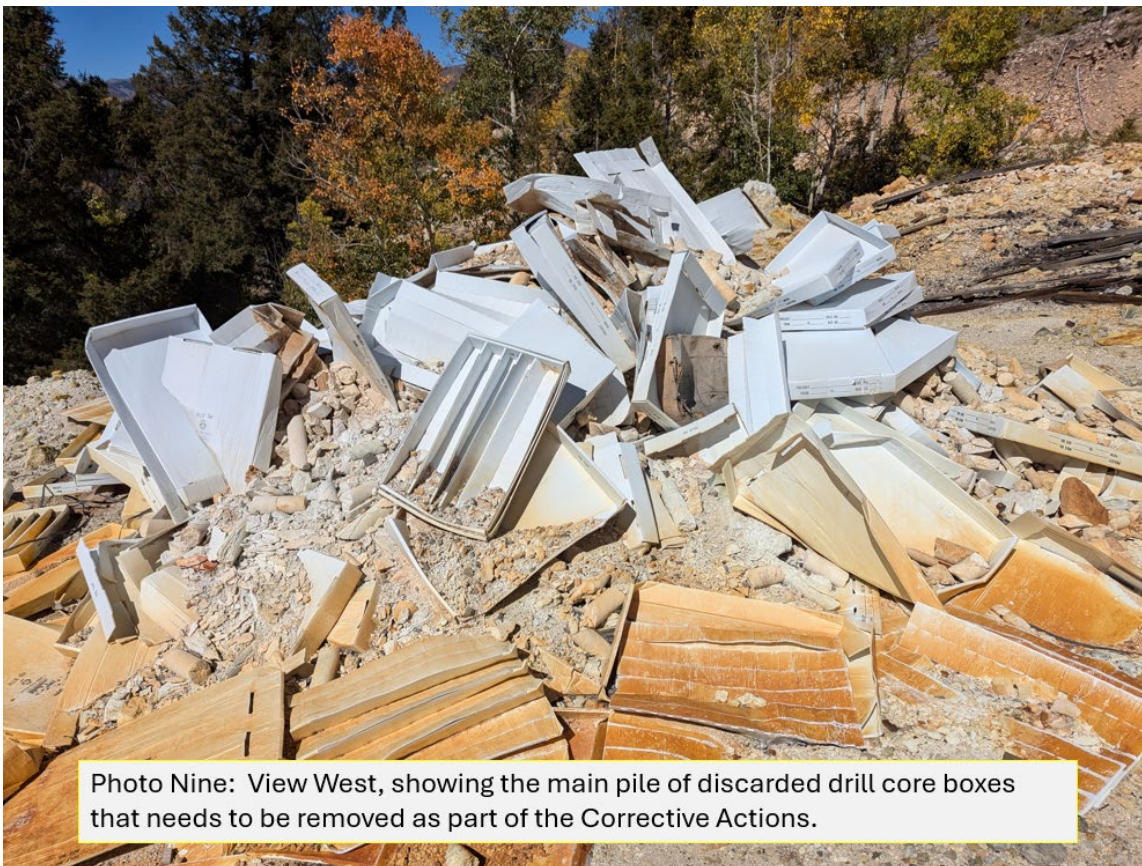
PROBLEM/POSSIBLE VIOLATION: Problem: Trash and refuse was noticed on the site. This is a problem at this time for failure to dispose of refuse in a manner that controls unsightliness or deleterious effects of such refuse pursuant to C.R.S. 34-32.5-116(4)(e). Specifically, drill core boxes are spread across the pad of the 3 Level Portal and have been wind blown into the surrounding areas.

The 3-level portal area has been used as a staging area for drilling operations associated with the Operator's currently held NOI, file no P-2018-010. As a result of using the area for staging, a significant pile of cardboard drill core boxes was left unsecured on site. The main pile, seen in Photo Nine has been exposed to the elements and dispersed across the site and surrounding areas by wind. Photos Ten and Eleven show the scattered boxes that were observed. This is being cited as a problem for failure to dispose of refuse in a

manner that controls unsightliness or deleterious effects of such refuse pursuant to C.R.S. 34-32.5-116(4)(e). The Operator shall conduct cleanup and removal of all associated trash and debris, specifically the cardboard drill core boxes at the 3 level. Cleanup efforts should be conducted, and the Operator shall provide photo documentation that all items have been removed from the site. Photo documentation should be received by the Division no later than **Monday December 2, 2024**.

Photo Nine: View West, showing the main pile of discarded drill core boxes that needs to be removed as part of the Corrective Actions.

CORRECTIVE ACTIONS: The operator shall submit a written notice to the Division with photo documentation, that the trash has been removed from the site by December 2, 2024.

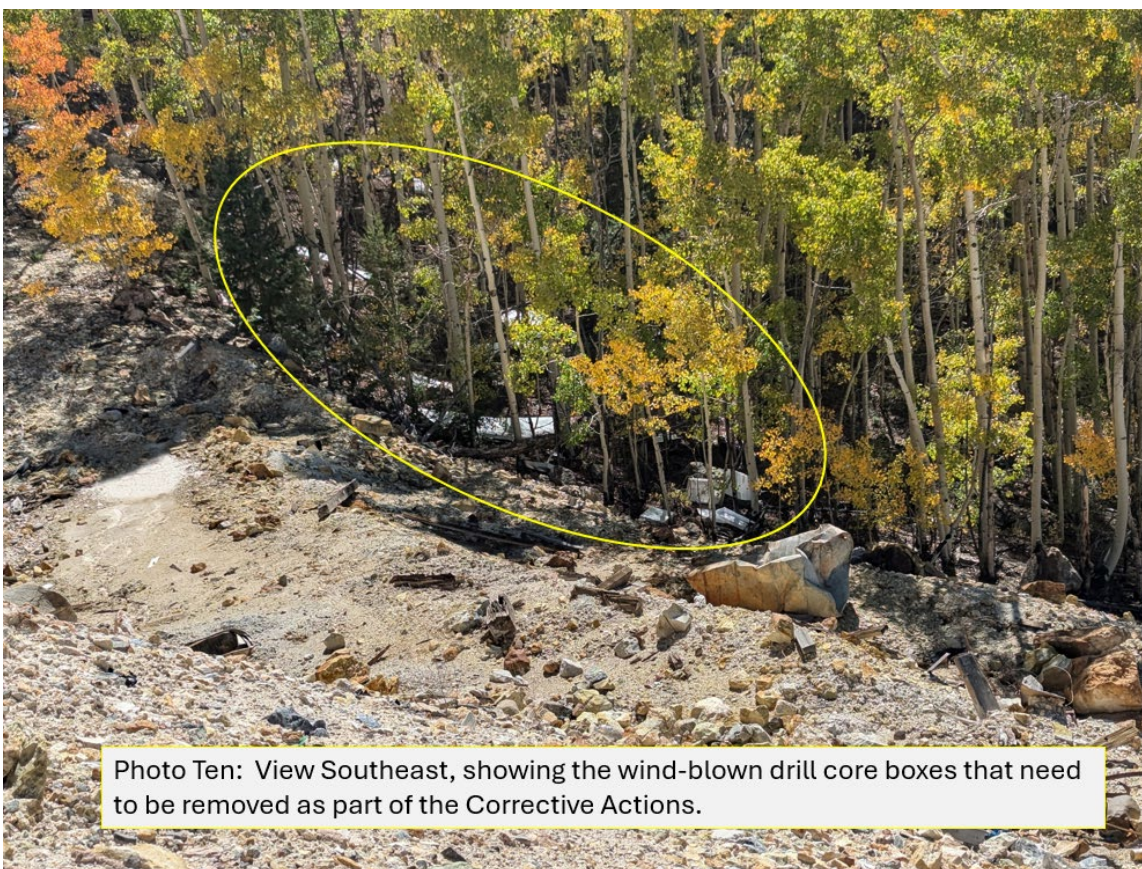
Photo Ten: View Southeast, showing the wind-blown drill core boxes that need to be removed as part of the Corrective Actions.
