**NEW ELK MINE**  
**Permit No. C-1981-012**

**QUARTERLY COAL WASTE BANK INSPECTION REPORT**  
**October 08, 2024**

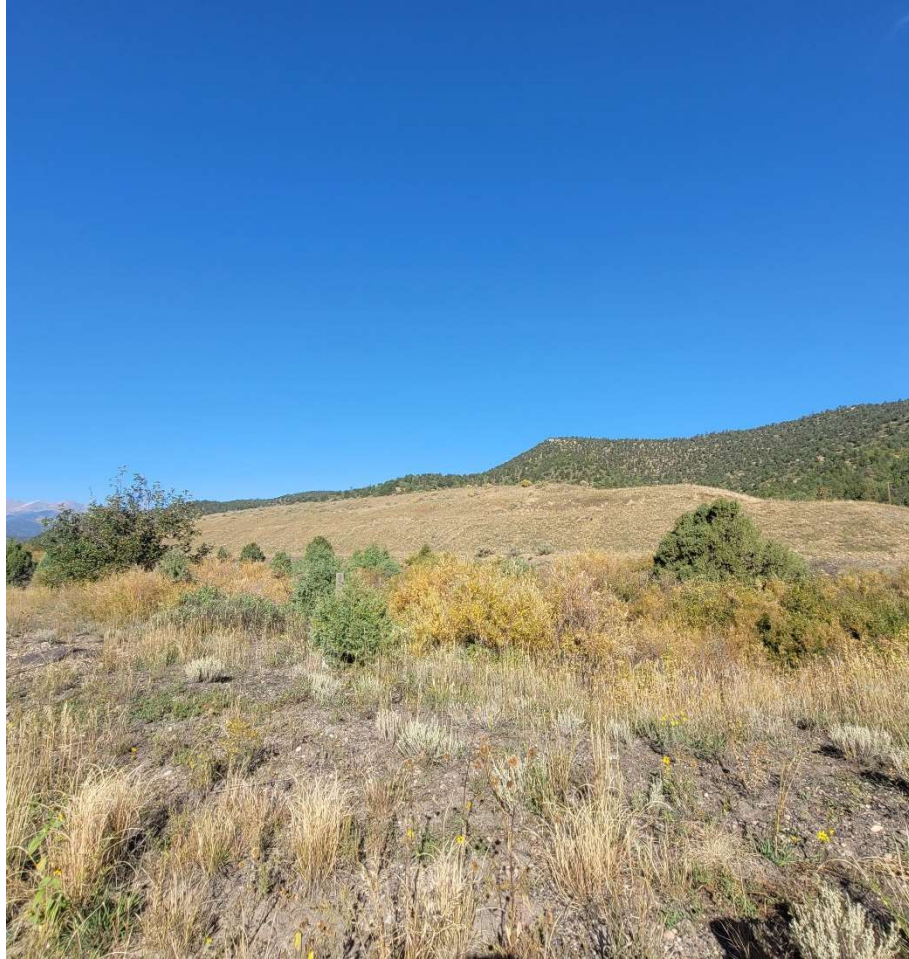
Surface and out slopes of the pile were inspected for visible signs of potential failure or instability. None were observed.

Overall the disposal area is in good condition.

**DWDA #1 South Face Taken on 9/30/24**

Ditch along base of DWDA 1 are clean and in good working order.

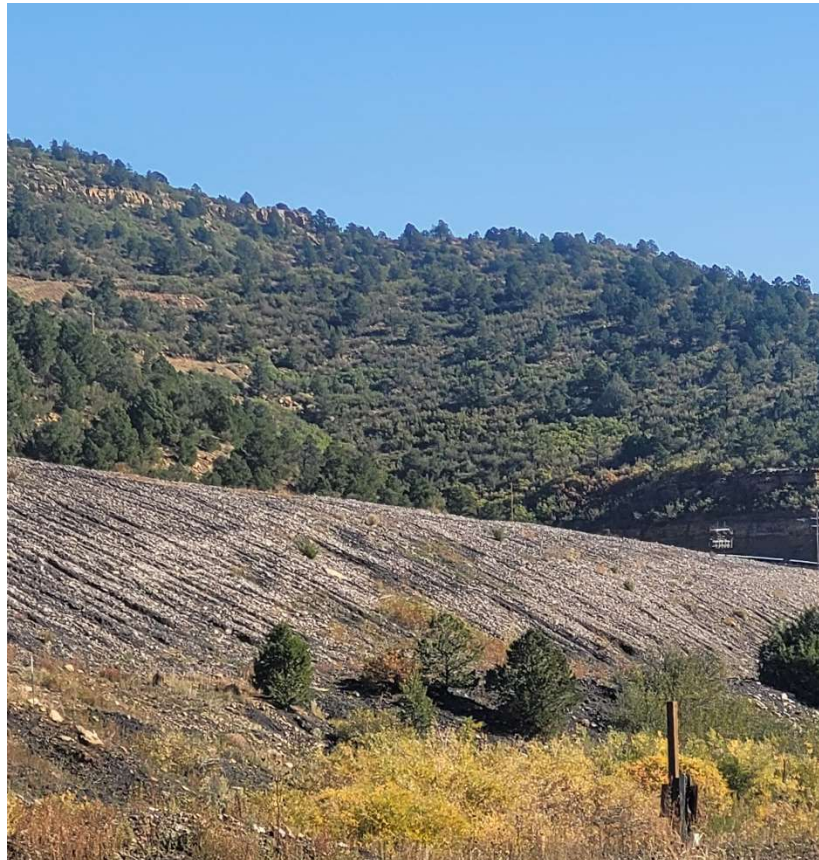
Surface and out slopes of the pile were inspected for visible signs of potential failure or instability. There was some surface erosion but not enough to make the area unstable. In all no signs of failure or instability were observed.

Overall the disposal area is in good condition. The ditch around the southern and western toe was clean and the banks between the pile and the river buffer area was good working order to keep water flowing to the sediment pond on the eastern end of pile.

**DWDA #2 South Face taken on 9/30/24**

The Rills are being monitored and have not gotten any bigger and there is no sediment loading. Operator is evaluating either reclamation of the area or permitting alternative uses of the land north of the Purgatoire River and south of Highway 12. The ditch along the southern face has been cleaned and the berm between DWDA #2 and the river has been reinforced to prevent any run off to reach the river.

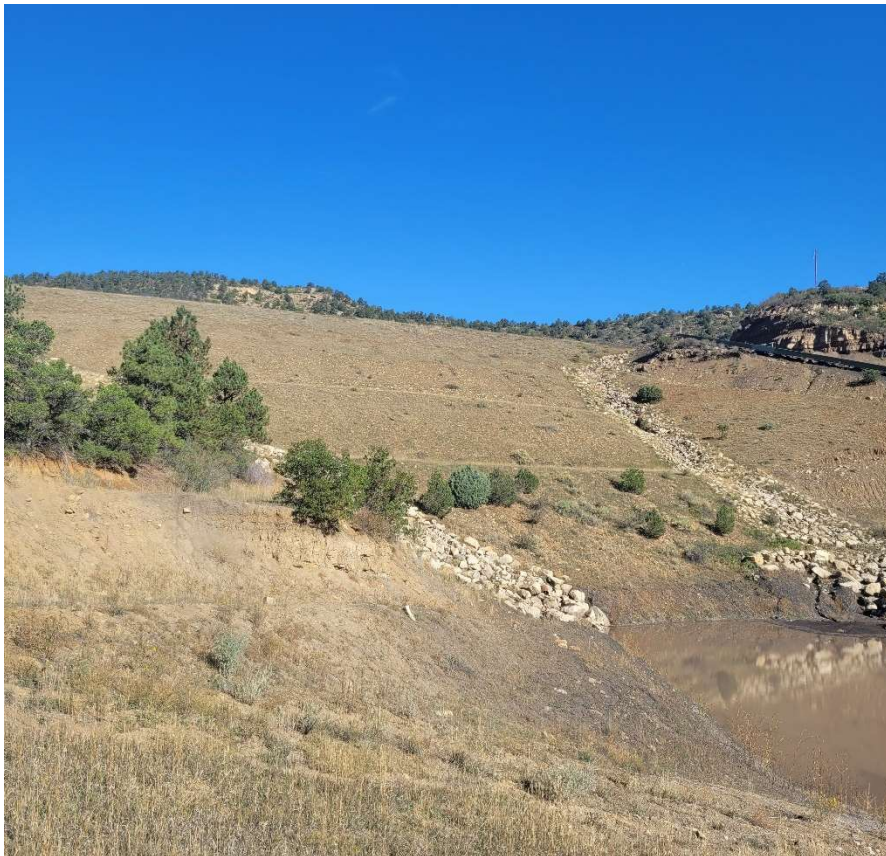
Overall the site is in good condition.

**Face of Refuse Disposal Area taken on 9/30/24**

Work on the Clean Water Ditch above the RDA Area was finished in May of 2024. Cleaning of the ditch, was to help prevent the clean water from flowing on the RDA Area. Ditch Around the back North west corner was cleaned out of sediment and re-established the positive drainage to Pond 8 (Work completed May 2024).
