MINERALS PROGRAM INSPECTION REPORT

MINE NAME: Alamosa Pit No. 2	MINE/PROSPECTING ID#: M-1983-175	MINERAL: Sand and gravel	COUNTY: Alamosa
INSPECTION TYPE: Monitoring	WEATHER: Windy	INSP. DATE: September 5, 2024	INSP. TIME: 13:20
OPERATOR: Southwest Ready-Mix, Inc.	OPERATOR REPRESENTATIVE: Paul Bottini	TYPE OF OPERATION: 112c - Construction Regular Operation

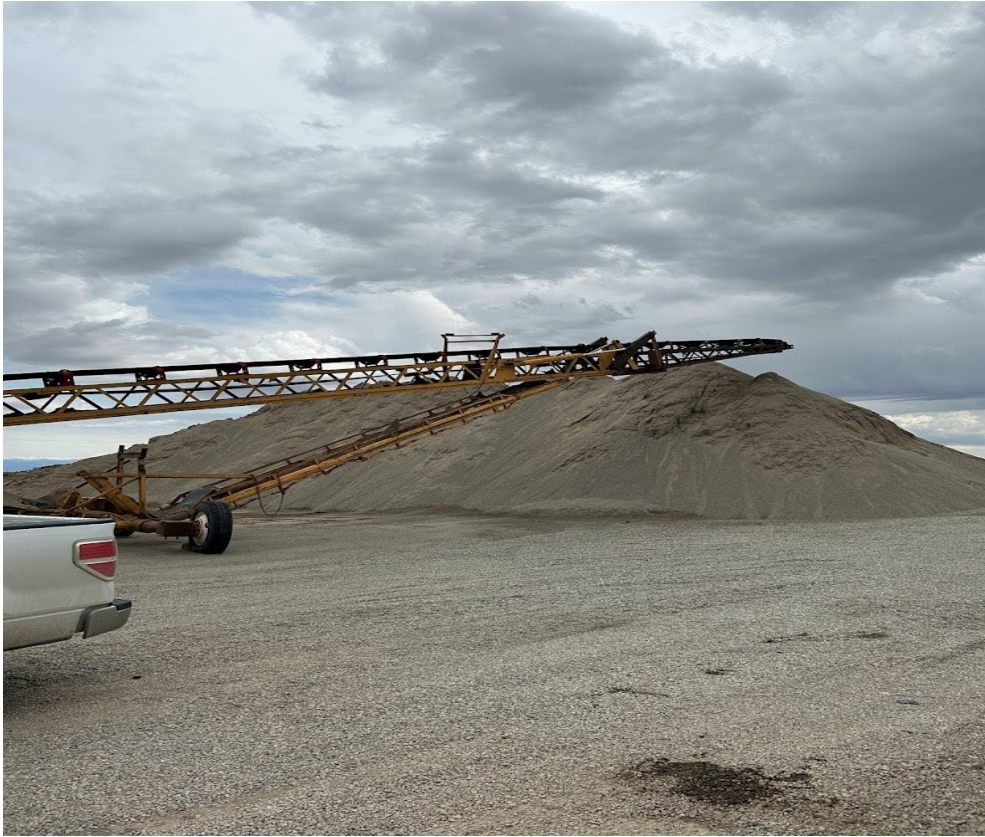
Photo 1: Processing stockpile and conveyer in the middle of the site.

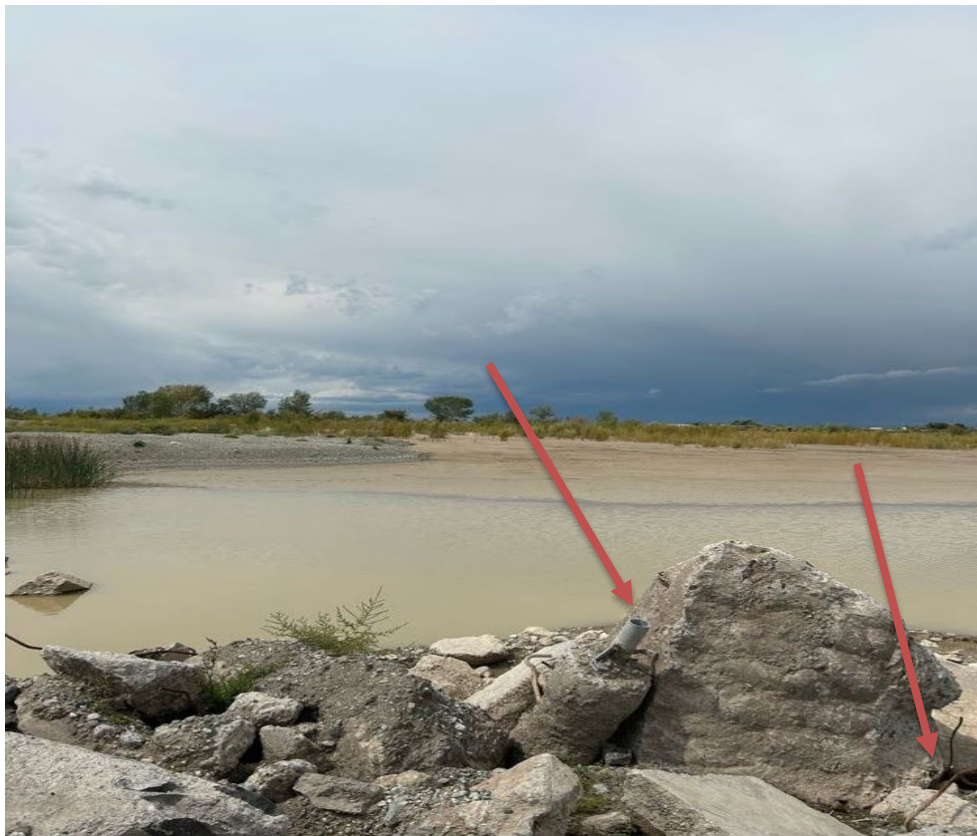
The Operator is approved to import inert backfill material from the King Pit for use as backfill. During this inspection, the DRMS observed rebar, other metal material, a metal drum, wood, plastic and debris scattered throughout the site (see Photos 2-5). This material appears to be mixed in with structural fill material that is used to backfill the open groundwater pit excavations at the site. Based on these observations, this is a possible violation of the following: C.R.S. 34-32.5-116(4)(d) for failure to prevent the release of pollutants to the groundwater from any materials handled, or disposed of within the permit area; C.R.S. 34-32.5-116(4)(e) for failure to dispose of refuse in a manner that controls unsightliness or deleterious effects of such refuse; C.R.S. 34-32.5-116(4)(h) for failure to minimize the disturbance to the hydrologic balance; and C.R.S. 34-32.5-124 and Rule 3.1.5(9) for failure to comply with the conditions of a permit to backfill the pits with inert material in accordance with the approved reclamation plan. Rebar is a solid waste material that is corrosive if exposed to weathering, and wood is putrescible. Trash was also observed in several areas. The Operator

Photo 2: Pond at western portion of site with backfill material along shoreline containing, piping, rebar and concrete.

CORRECTIVE ACTIONS: This possible violation will require a hearing before the Mined Land Reclamation Board (MLRB). The schedule and other details for the MLRB hearing will be provided under a separate document to be sent via certified mail to the Operator.

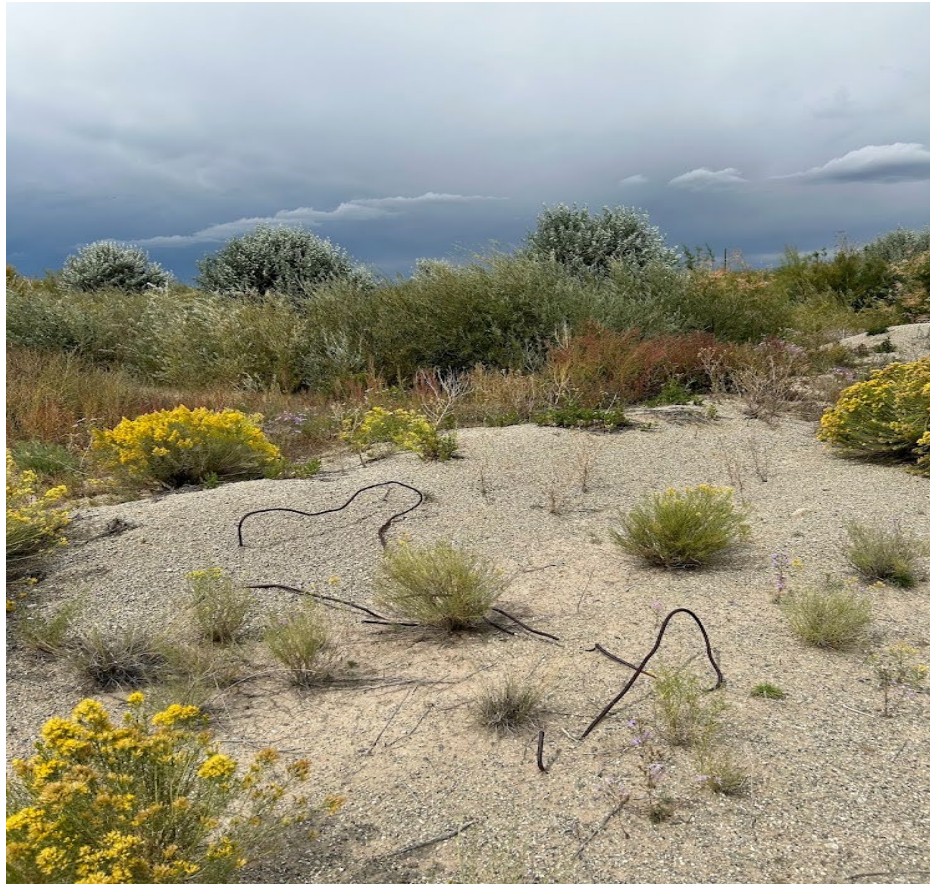
Photo 3: Backfill material containing rebar in eastern portion of site.

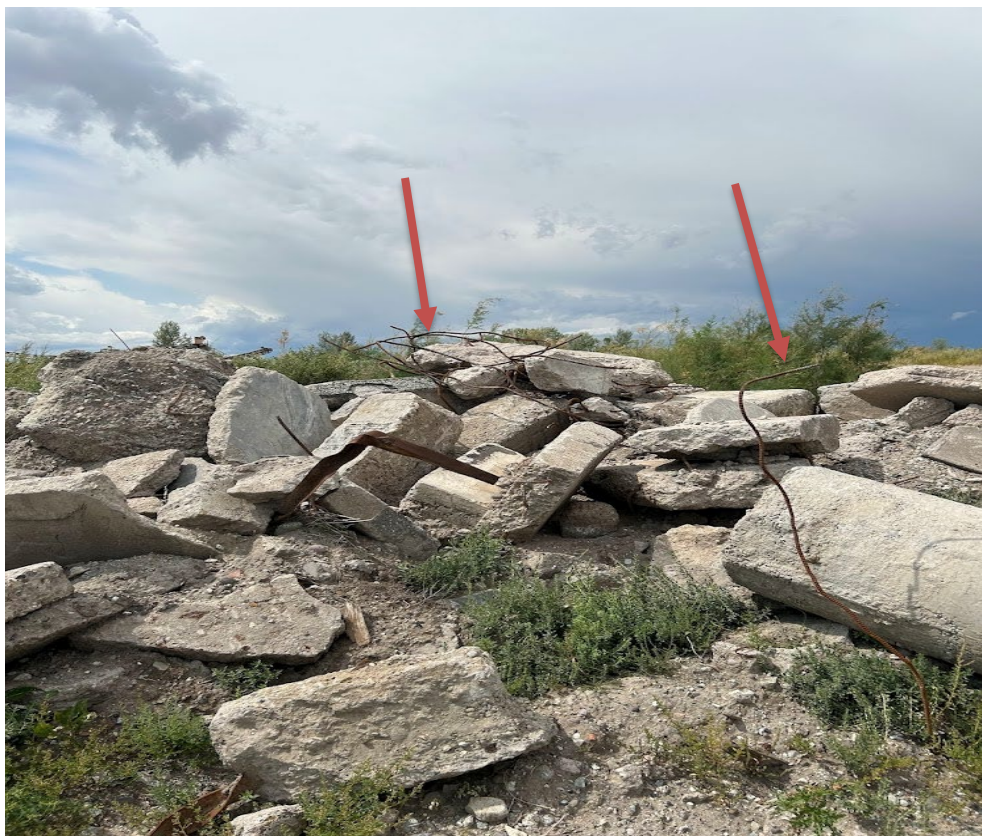
Photo 4: A concrete pile containing rebar and metal in the eastern portion of site.

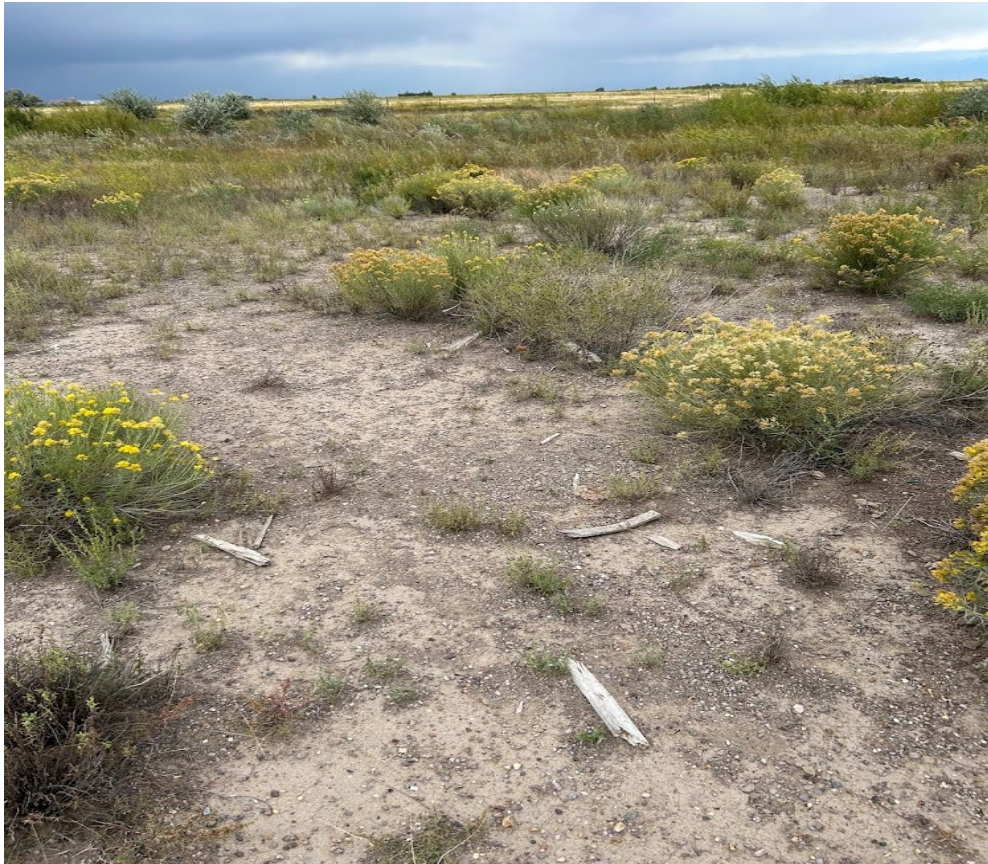
Photo 5: Reclaimed area with backfill containing wood in eastern portion of site.

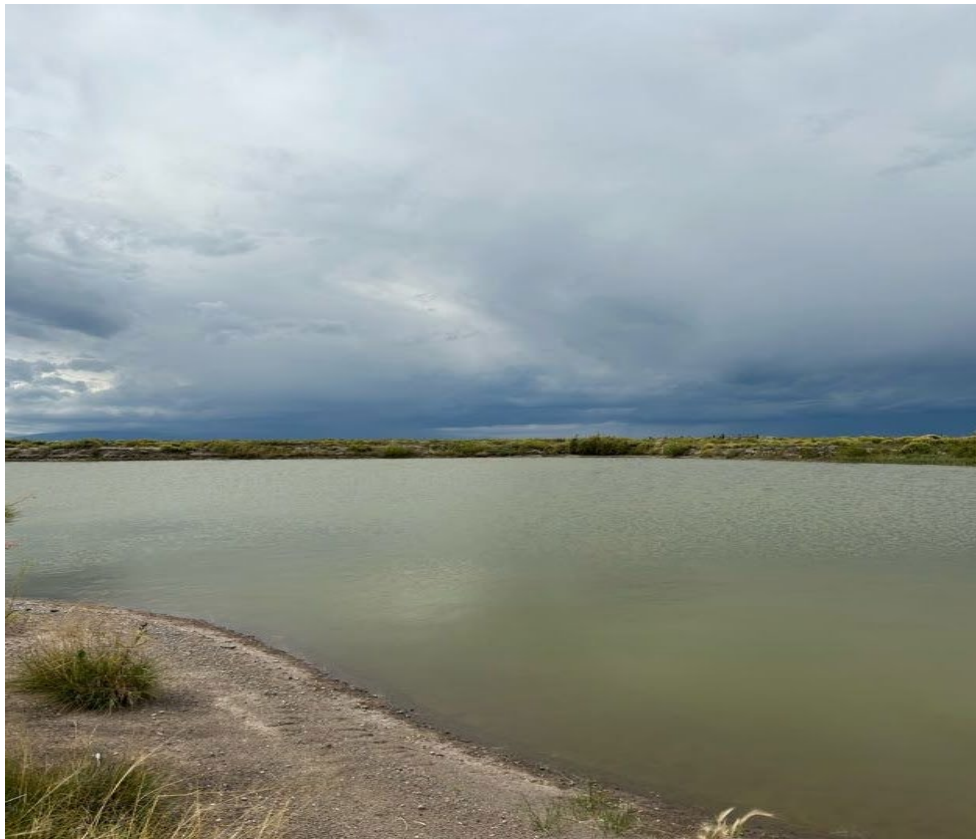
Photo 6: Reclamation pond in western portion of site.

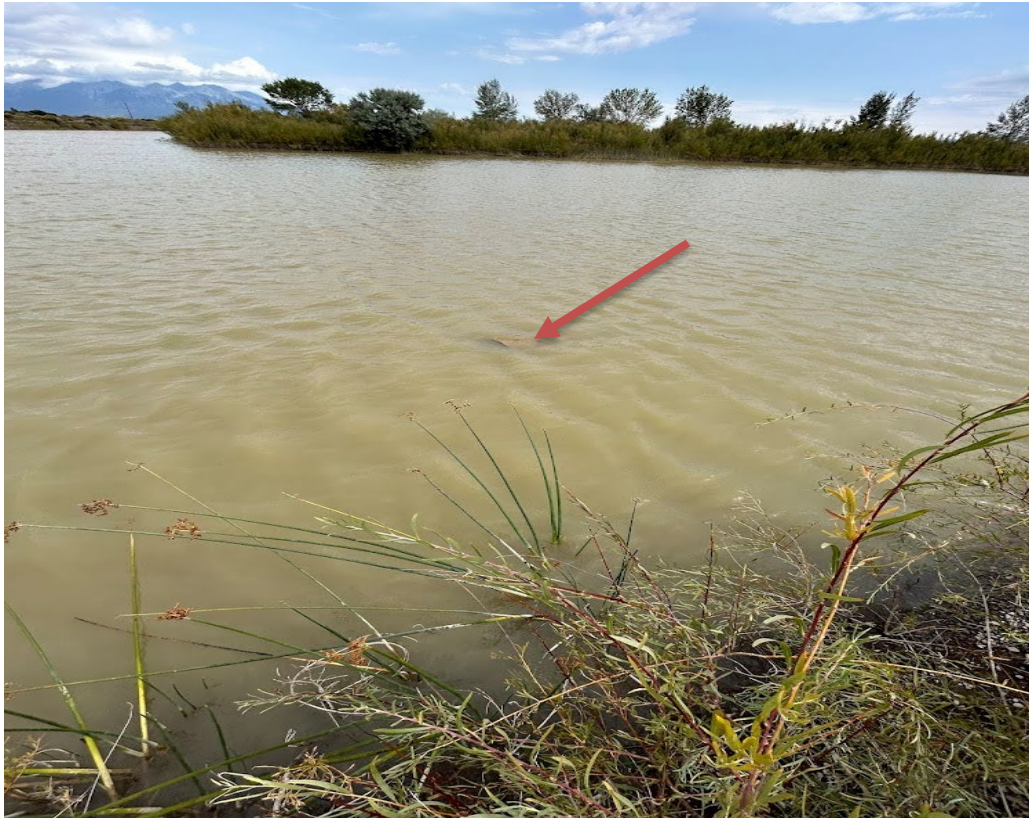
The site contains several ponds with exposed groundwater. The DRMS observed a drum within one of the reclamation ponds (see Photo 7). Heavy corrosion and oxidation of the drum was observed. Due to the corrosive nature of the drums, rebar and metal material, as well as the other debris mixed in with the backfilled material and the contact with groundwater, negative impacts to the groundwater system are likely.

Photo 7: Pond in northern central portion of site containing a partially submerged metal drum.

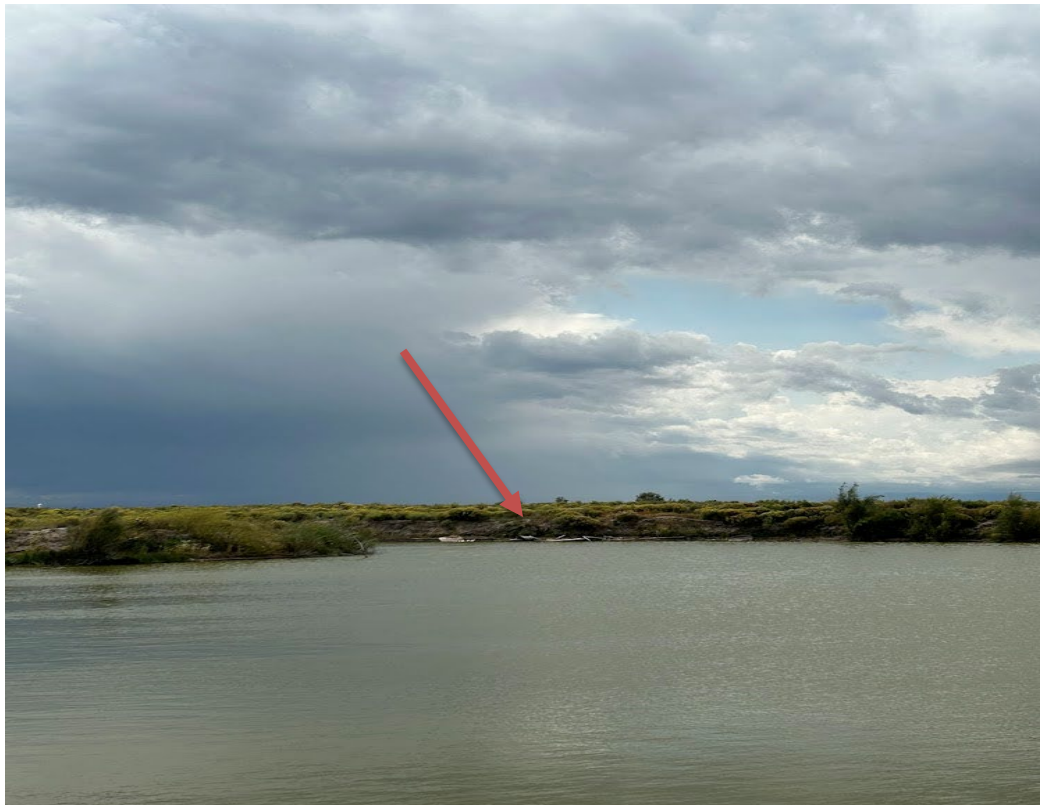
Photo 8: Pond with shoreline containing trash and debris in western portion of site.

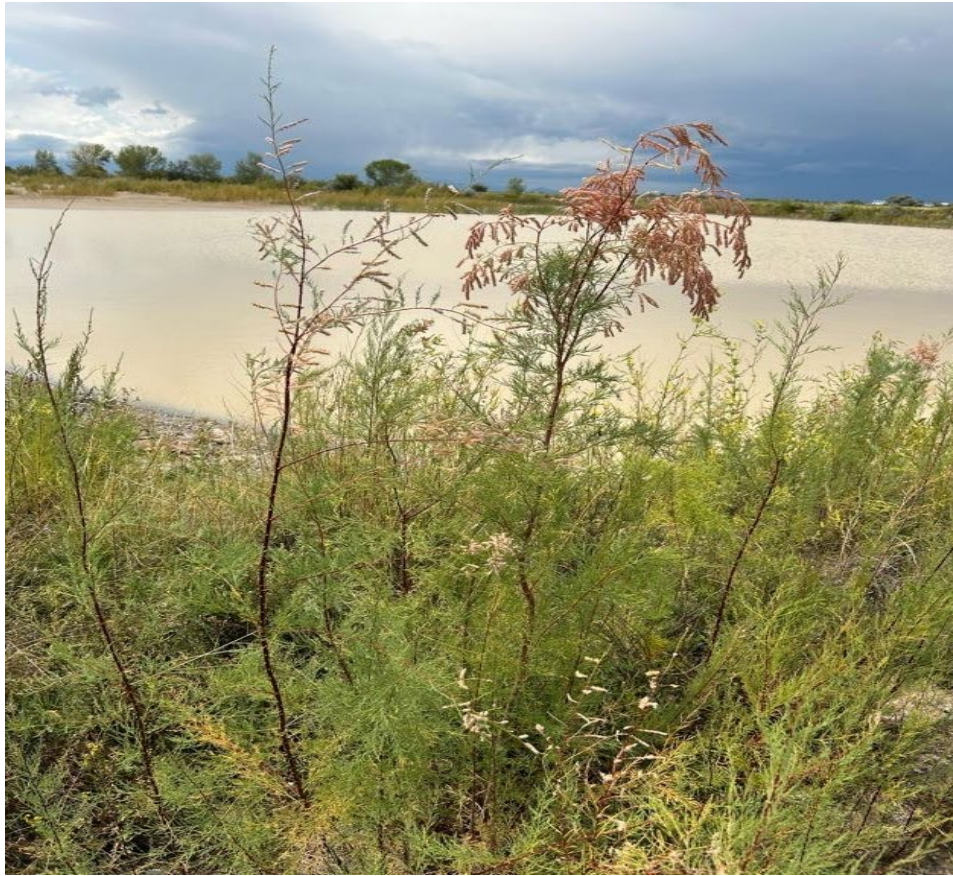
PROBLEM: A significant infestation of several noxious weeds is occurring at the site. List B noxious weed species observed were Tamarisk, Knapweed, Salt cedar, Canada thistle, and Russian olive. This is a problem at this time for failure to employ weed control for all prohibited noxious weeds in accordance with Rule 3.1.10(6).

A significant noxious weed infestation has occurred at the site. Noxious weed species observed were Tamarisk, Knapweed, Salt cedar, Canada thistle, and Russian olive (see Photos 9-12). These species were observed throughout the site, often in thick patches. In accordance with Rule 3.1.10(6) of the Construction Materials Rules and Regulations governing weed control, the DRMS will require the Operator to develop a weed control plan to be employed to control the current infestation and prevent the spread of weeds to the surrounding area.

Photo 9: Tamarisk weed along pond shoreline in eastern portion of site.

CORRECTIVE ACTIONS: The Operator shall develop a Weed Control Plan and submit this plan as well as a timeline for its implementation as a Technical Revision to the permit. The technical revision will be submitted to the Division by the corrective action due date noted below.

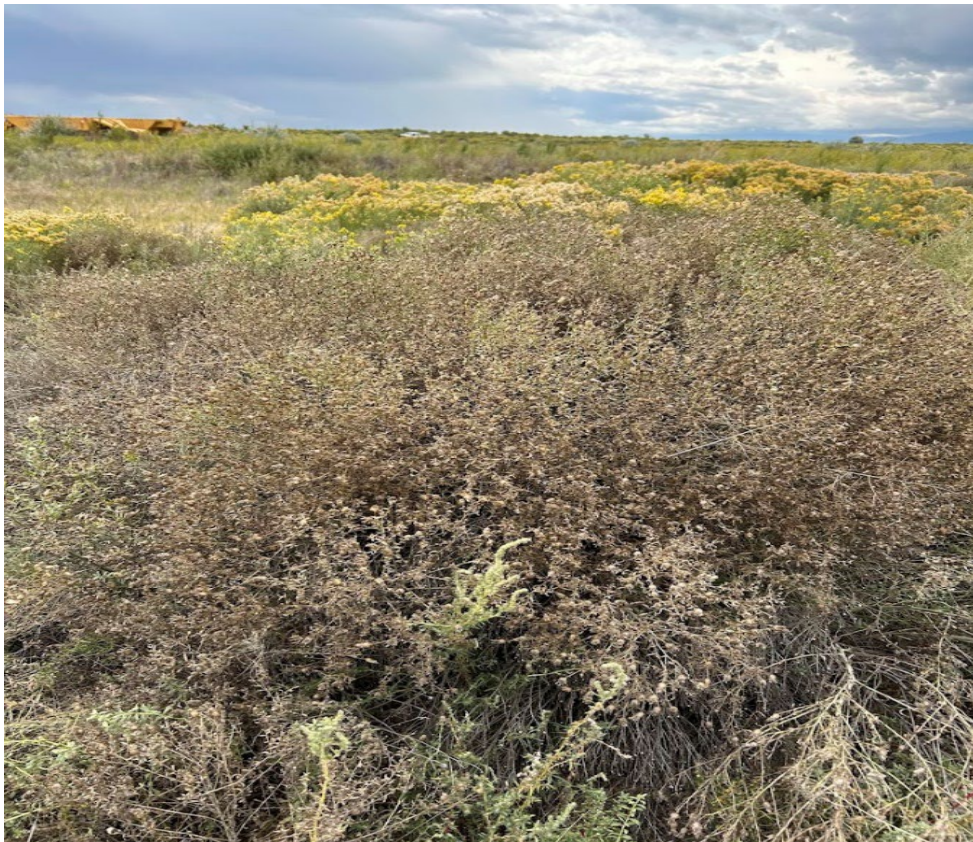
Photo 10: Facing south at Knapweed in western portion of site.

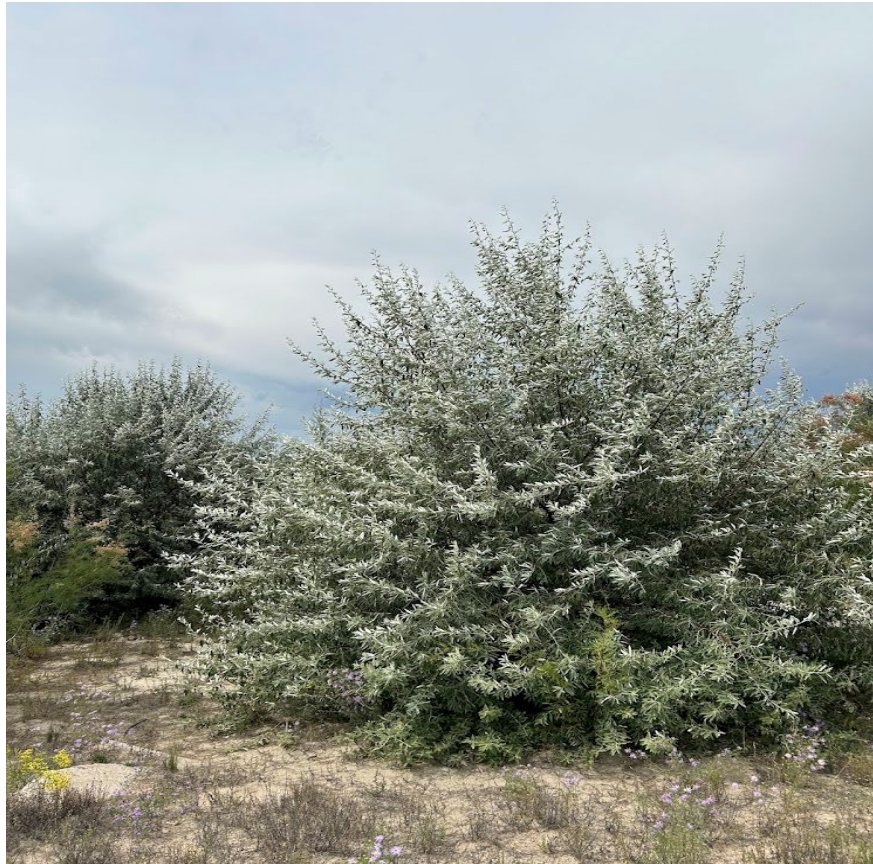
Photo 11: Facing west at Russian olive tree in reclaimed area in eastern portion of site.

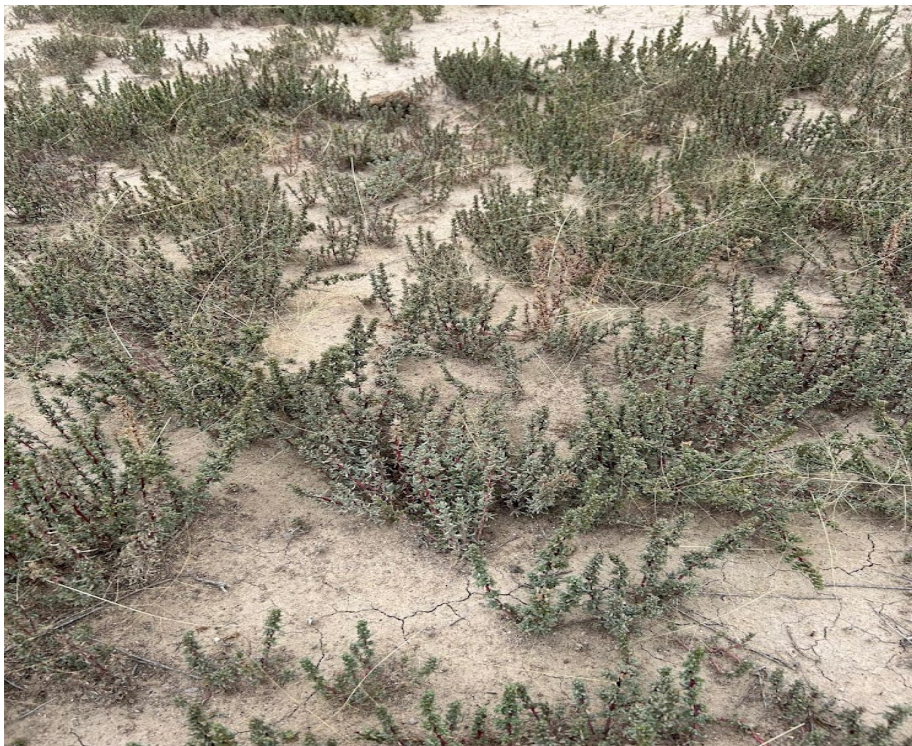
Photo 12: Facing north at Halogeton weed in western portion of site.

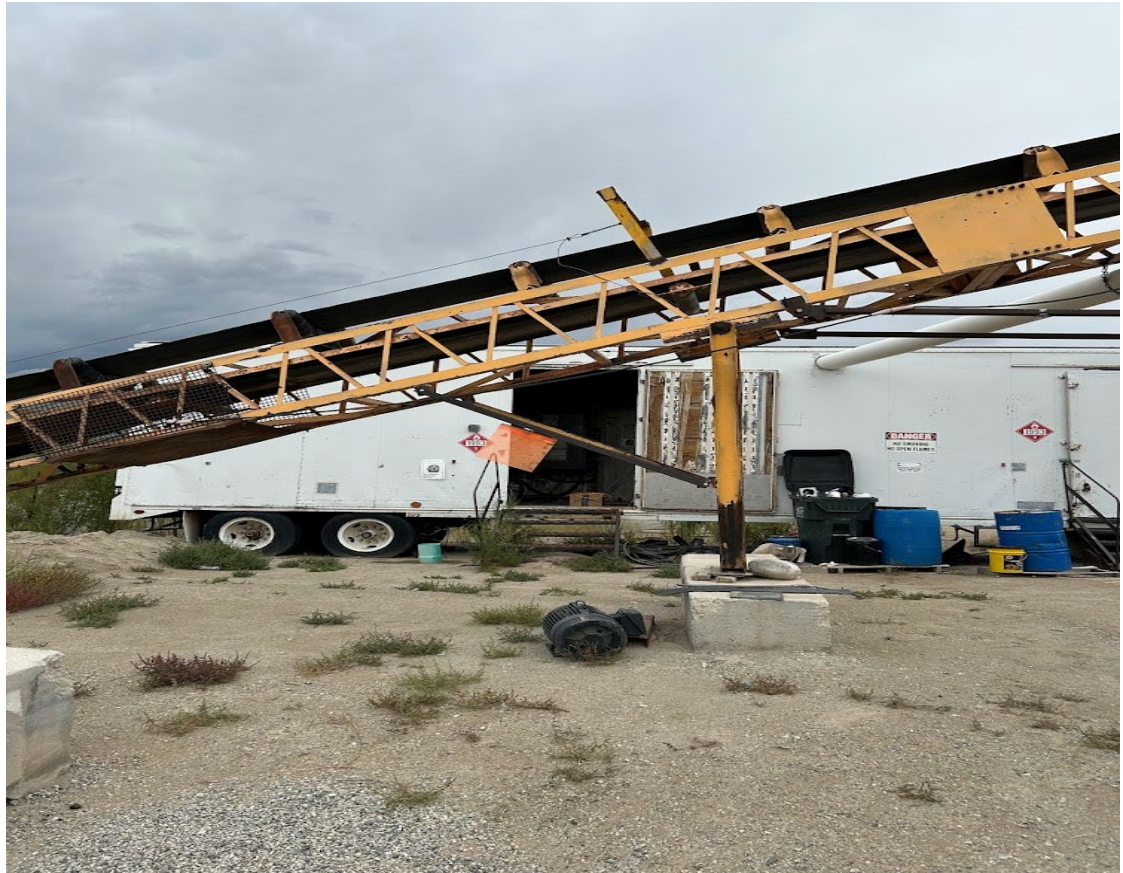
Photo 13: Facing north at trailer, oil tanks within trailer, empty drums, and conveyer.

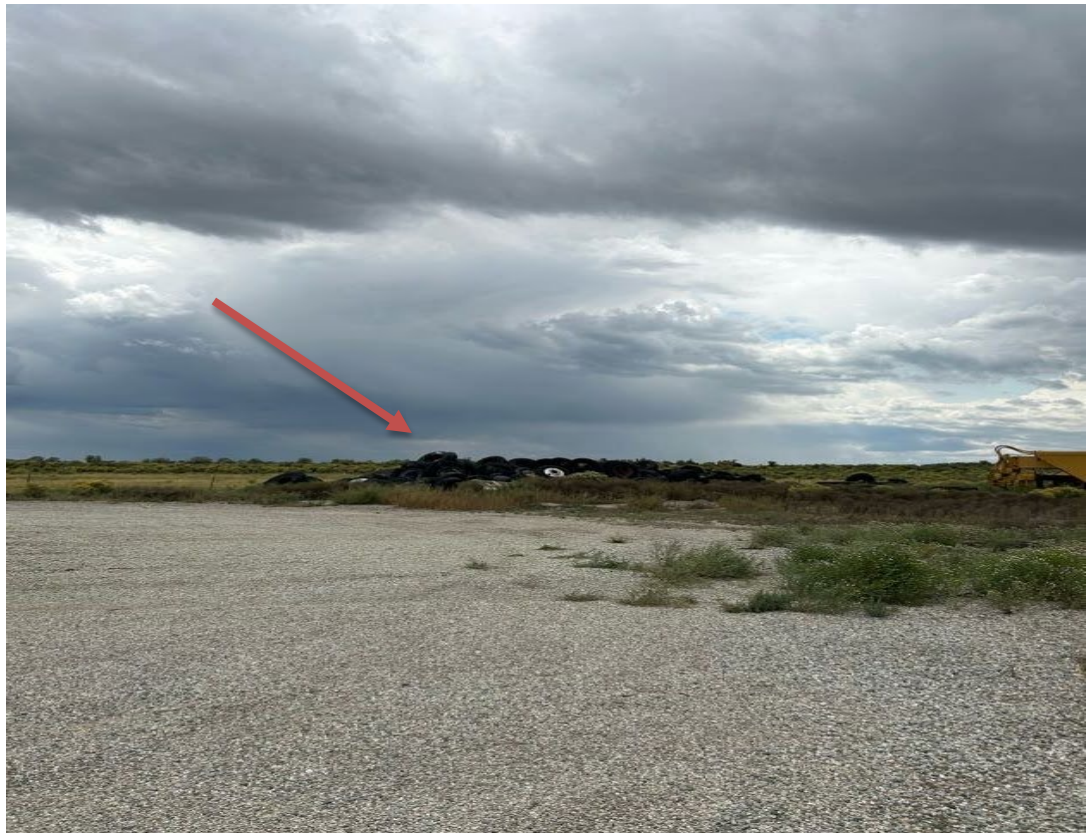
According to the Operator, mining hasn't been conducted in over 20 years. The eastern third of the site consists of a backfilled pit with rough, undulating topography and minor amounts of vegetation. The remaining portion of the site consist of several open pits containing groundwater with the surrounding area consisting of coarse-grained and structural fill material backfilled in the former pits. Thick vegetation has established in patches throughout the site consisting of a significant amount of noxious weeds. The south-central portion of the site is currently being used as a processing area for fine-grained material. The equipment onsite included portable conveyers, a grizzly screener, and two track-mounted dozers. During the time of inspection, the Operator was processing material that appears to be brought in from off-site. The site also contained a trailer with oil tanks and empty blue drums that previously contained water for processing. Several stockpiles of fine-grained material were observed in the western portion of the site. A large stockpile of tires was observed in the southwest corner of the site (see Photo 14).

Photo 14: Facing west at stockpile of tires in southwestern portion of site.

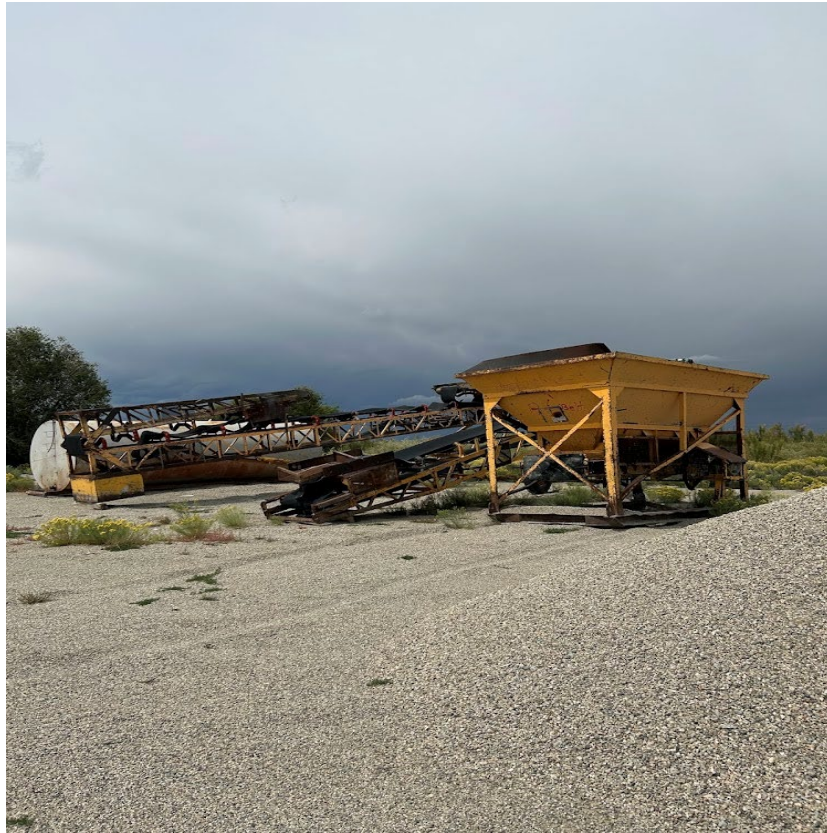
Photo 15: Facing north at grizzly screener and portable conveyers.

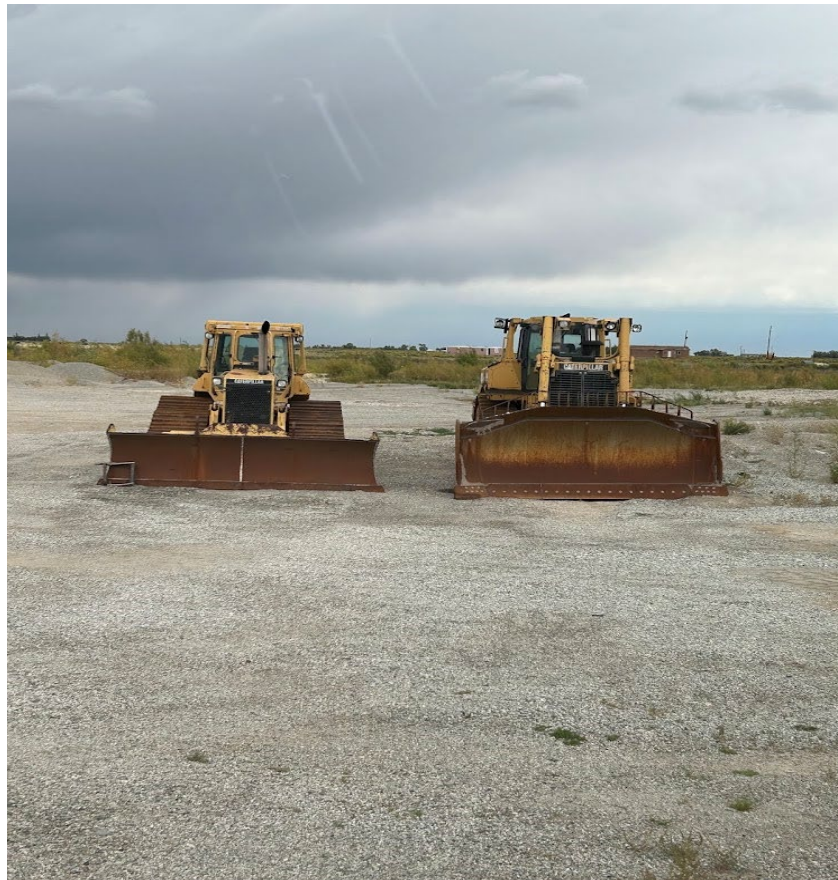
Photo 16: Facing north at track mounted bulldozers
