Re: GCC Energy, LLC, King II Mine CDRMS Permit # C-1981-035 Stoner Engineering: Quarterly Inspection: King I UbX = Water Quality Improvements Inspection 3^{rX} Quarter 202(

Re: King Coal I – Quarterly Water Quality Improvements Inspection

Re: King Coal II - Quarterly Water Quality Improvements Inspection

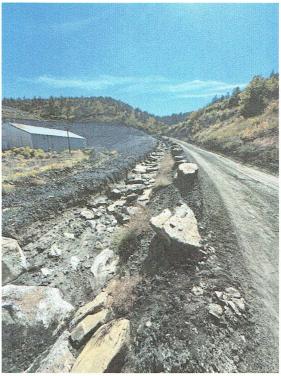
The existing ditches and culverts appear to be generally in good condition and maintenance had clearly been performed since the previous inspection. The upper portion of the treated water ditch (Reach 10), requires maintenance as a result of the recent storm events. A section of riprap was washed down the channel near the top of the upper pile and the runoff eroded the side of the channel near the south, haul road switchback and resulted in erosion to the adjacent slope as noted in the Embankment Inspection Report. The check dams washed out along the haul road along the lower pile have been reconstructed and the ditch armored to minimize erosion during storm events (see Pic. 1). The erosion at the base of Reach 10 at the stilling basin has also been upgraded though will require some minor maintenance as a result of the base of the upper waste pile had also been repaired (see Pic. 3). The grading along the south side of the face of the upper waste pile had also been improved to ensure that surface runoff enters the ditch section without eroding the waste embankment pile.

Pic. 1 –Reach 10 at base of lower pile, channel armoring/reconstruction.

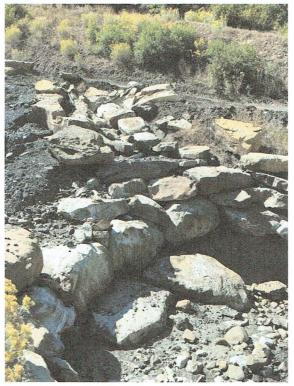
Pic. 2 – Reach 10 stilling basin reconstruction.

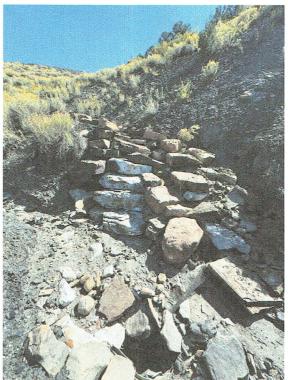
Pic. 3 – Reach 10, culvert under haul road.

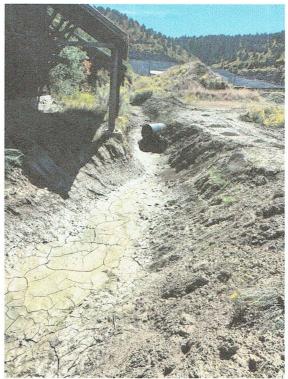
The clear water ditch (Reach 1) was found to be in good condition with all the sediment cleaned out. The sedimentation at the outlet of the west clear water pipe where it enters into the east clear water ditch has been cleaned out (see Pic. 4).

Pic. 4 – Sediment cleared from East clear water ditch discharge into Reach 1.

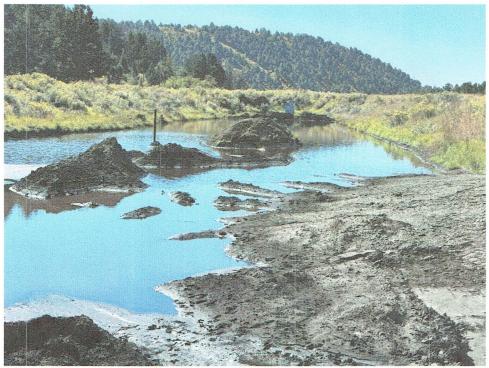
The water quality pond held less water than during the previous inspection (see Pic. 1). The elevation at the bottom of the pond could not be determined due to water within the pond. The current water levels make it difficult to assess the state of the sediment removal operations. It appears that some sediment had been removed had taken place since the previous inspection between storm events. Removal of sediment from the pond is on hold due to current water levels. Excess sediment should be removed from the detention pond as soon as site/weather conditions allow. There is no longer water near the outlet structure (see Pic. 2).

Pic. 1 – Water level in the detention pond after recent storms.

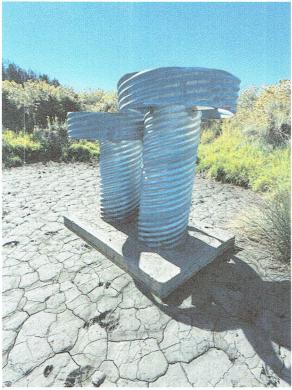
The vegetation, both inside and out of the pond and embankments is well established to minimize the erosion impacts of storm runoff. The outlet structure shows no signs of damage and was functioning as designed at the time of the inspection. The outlet pipes were free from debris, sediment and excessive vegetation. The water quality pond appears to be in generally good condition. There were no signs of weakness or distress to either the outlet structure or the embankment material. The water quality pond appears to have the storage capacity to function as designed.

Pic. 2 - Outlet structure of the pond.

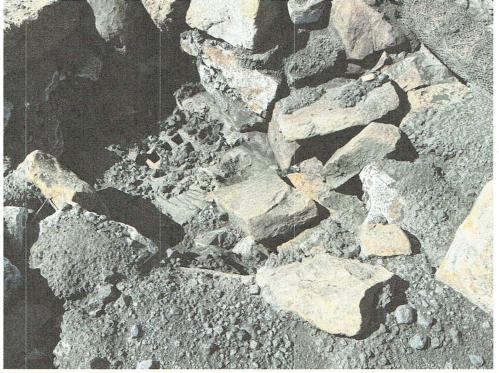
The erosion control structures for the treated water ditch located south of the scale house was found to be in good condition. The inlets located around the conveyor and coal storage piles are in need of some cleaning given operations and the recent storm events (see Pic. 3 & 4). The clear water ditch along the west side of the site had been improved since the previous inspection and was free of sediment and also showed no signs of damage as a result of recent storm events. All ditches should be inspected and repaired as necessary, especially after storm events.

Pic. 3 - Inlet east side of coal piles (vibration table) near east clear water ditch.

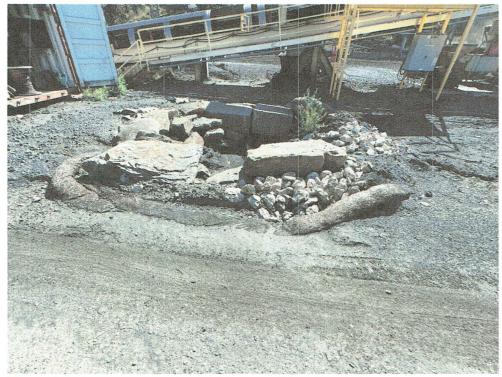
Pic. 4 --Inlet near conveyer, east of power transformers.
