Re: GCC Energy, LLC, King II Mine  
CDRMS Permit # C-1981-035  
Stoner Engineering: Quarterly Inspection: Refuse Pile 3<sup>rd</sup> Quarter 2024

Date: October 4, 2024

Re: King Coal I – Quarterly Waste Pile/Embankment Inspection

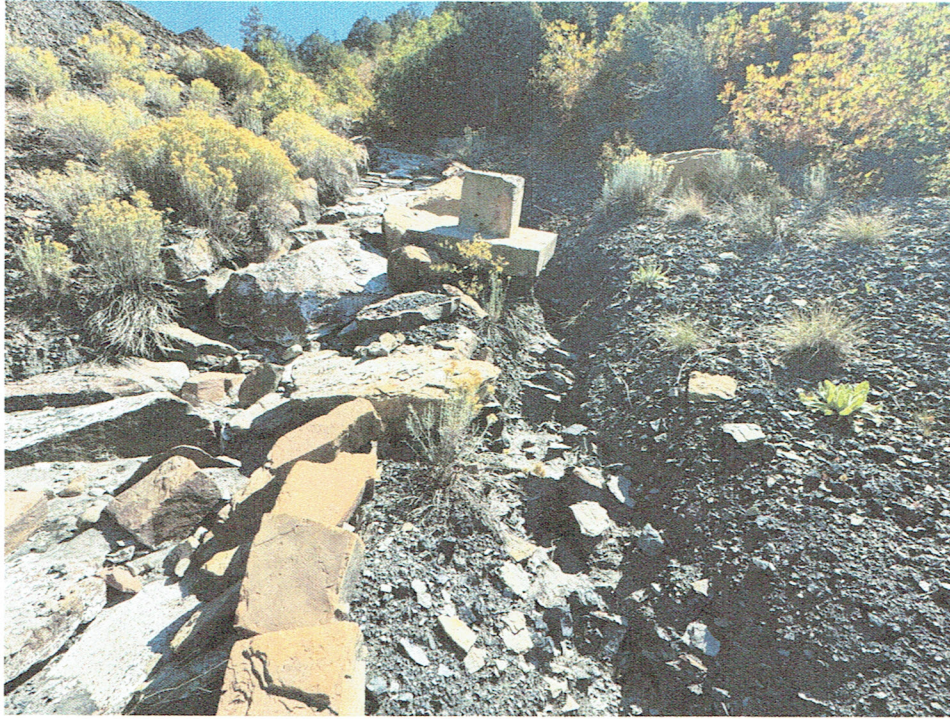
The south treated water ditch (Reach 10) ditch experienced some erosion issues during the recent storm events (see Pic. 1) while the north clear water ditch (Reach 1) appeared to be in generally good shape. The erosion of the south, treated water ditch allows water to escape the channel section east of the south haul road switchback. This water has eroded a portion of the adjacent slope before the topography directs the flows back into the treated water ditch downslope. There was also a section above where the runoff washed riprap down the slope (see Pic. 2). The underlayment held in place but, the riprap should be reinstalled potentially utilizing more angular material. These sections of the ditch need to be repaired, re-established to minimize the potential for erosion.

Pic. 1 –Reach 10, runoff escapes channel section near south switchback.

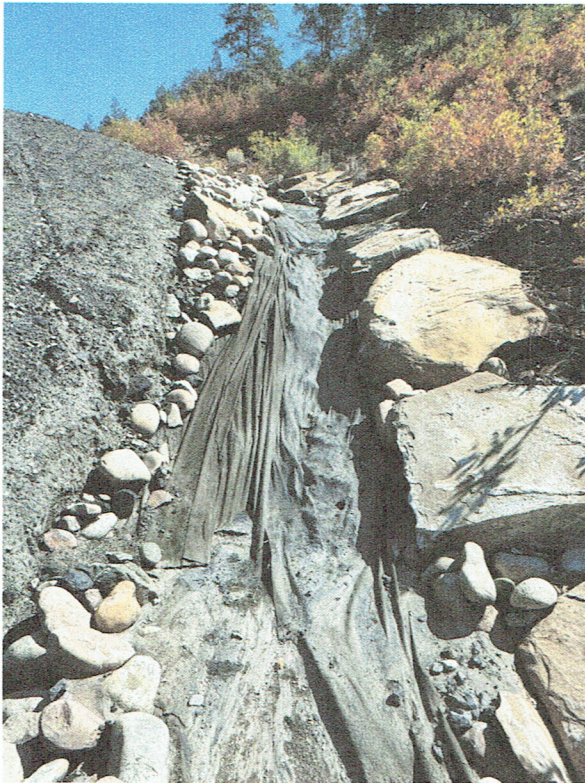
Pic. 2 – Reach 10, upper section channel riprap washed down slope.

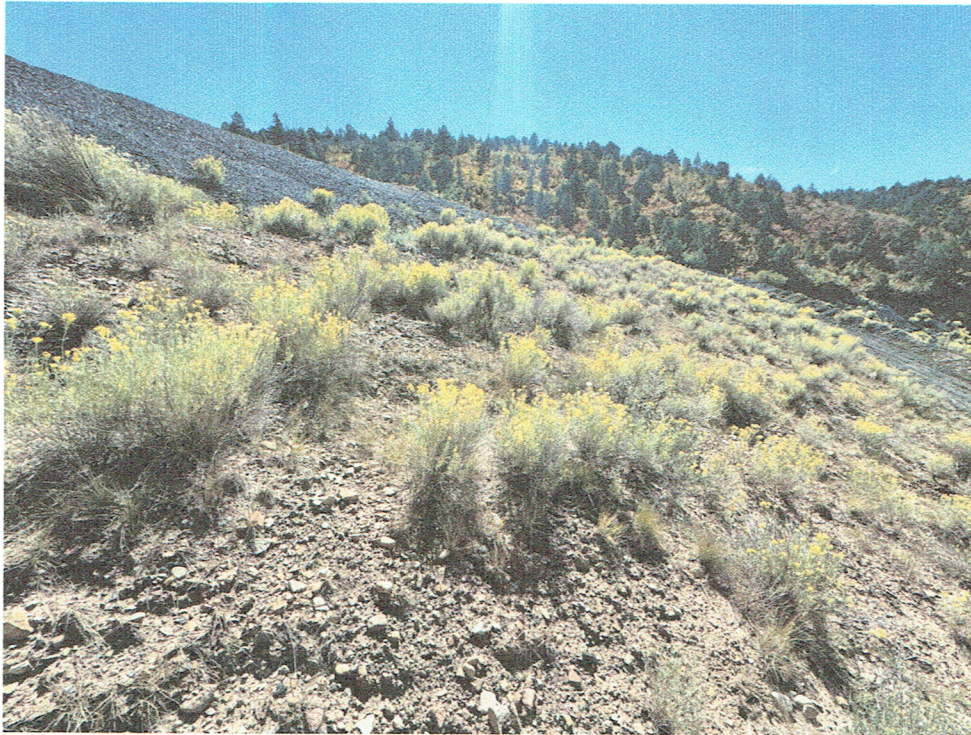
The face of the upper waste embankment pile was found to be in generally good shape (see Pic. 3). There were no signs of instability or sloughing observed on the main waste embankment pile at the time of the inspection.

Pic. 3 – Face of the upper waste pile is in good shape.

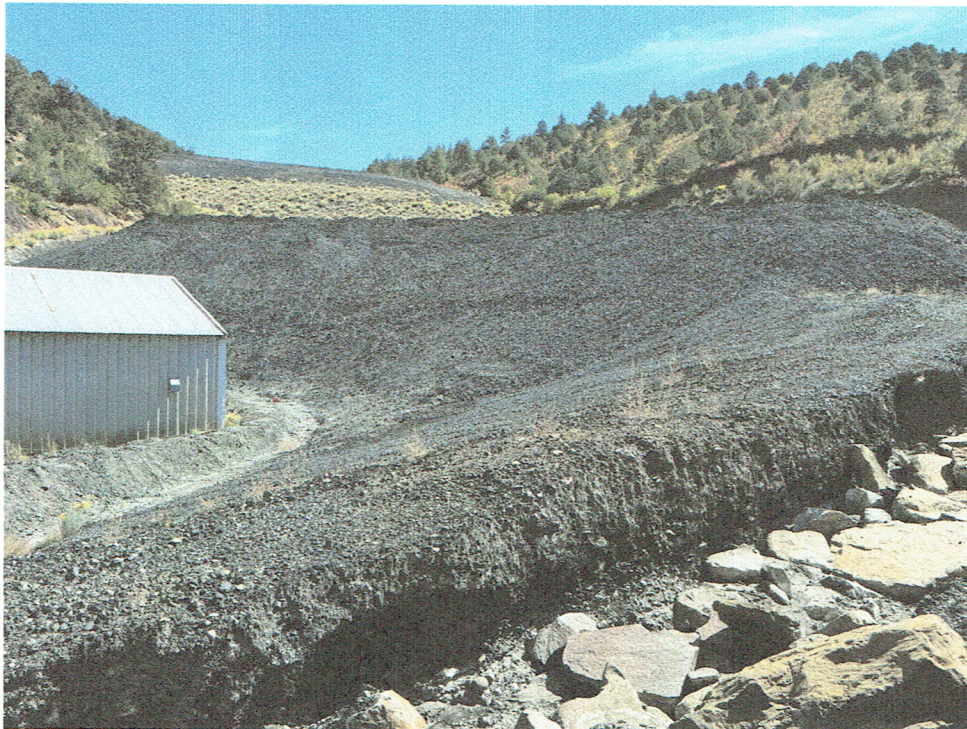
Additional fill material has been placed to the face of the lower waste pile and the washed-out portion of the face has been repaired (see Pic. 4). The face of the lower waste pile is at a consistent height and the required berming is in place at the top of the pile to direct runoff away from the face of the embankment pile.

Pic. 4 – Face of the lower waste pile has been repaired.
