**Inspection Report, Colowyo, C-1981-019**

**PERMIT INFORMATION**

<b>Permit Number:</b> C-1981-019 <b>Mine Name:</b> Colowyo Coal Mine <b>Operator:</b> Colowyo Coal Company L.P. <b>Operator Address:</b> Mr Tony Tennyson 5731 State Highway 13 Meeker, CO 81641	<b>County:</b> Moffat, Rio Blanco <b>Operation Type:</b> Surface <b>Permit Status:</b> Active <b>Ownership:</b> Private
	<b>Operator Representative Present:</b>
<b>Operator Representative Signature: (Field Issuance Only)</b>

<b>Inspection Start Date:</b> September 23, 2024 <b>Inspection Start Time:</b> 11:30 <b>Inspection End Date:</b> September 24, 2024 <b>Inspection End Time:</b> 13:30		<b>Inspection Type:</b> Coal Complete Inspection <b>Inspection Reason:</b> Normal I&E Program <b>Weather:</b> Clear	
<b>Joint Inspection Agency:</b>  None		<b>Joint Inspection Contacts:</b>	
<b>Post Inspection Agency:</b>  None		<b>Post Inspection Contacts:</b>	
<b>Inspector(s):</b>  Hunter Ridley  Ben Hammar	<b>Inspector's Signature:</b>  <i>Hunter Ridley</i>  <b>Signature Date:</b>  October 7, 2024

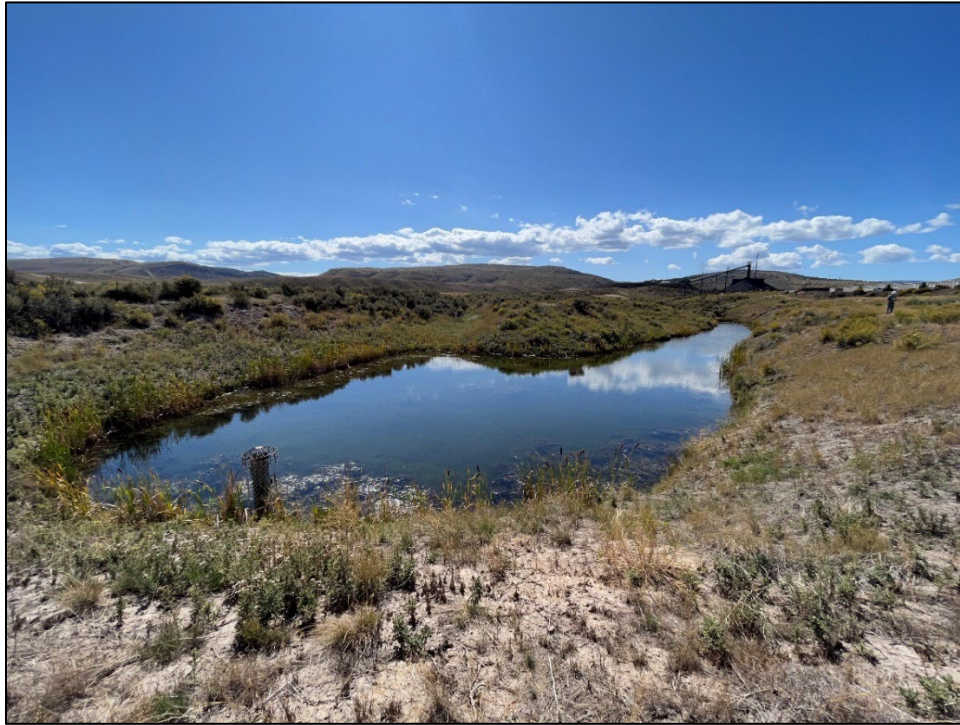
The following ponds in the Loadout Area were inspected this month: Gossard Pond (Photo 2) and Stoker Siding Pond (Photo 1). The Rail Loop Pond was inaccessible due to restricted access from a train being loaded at the site. No problems or erosional concerns were noted. All ponds were noted to be holding water and all ponds had been recently cleaned of vegetation which would hinder containment.

*Photo 1: View south of the spring fed Stoker Siding Pond.*

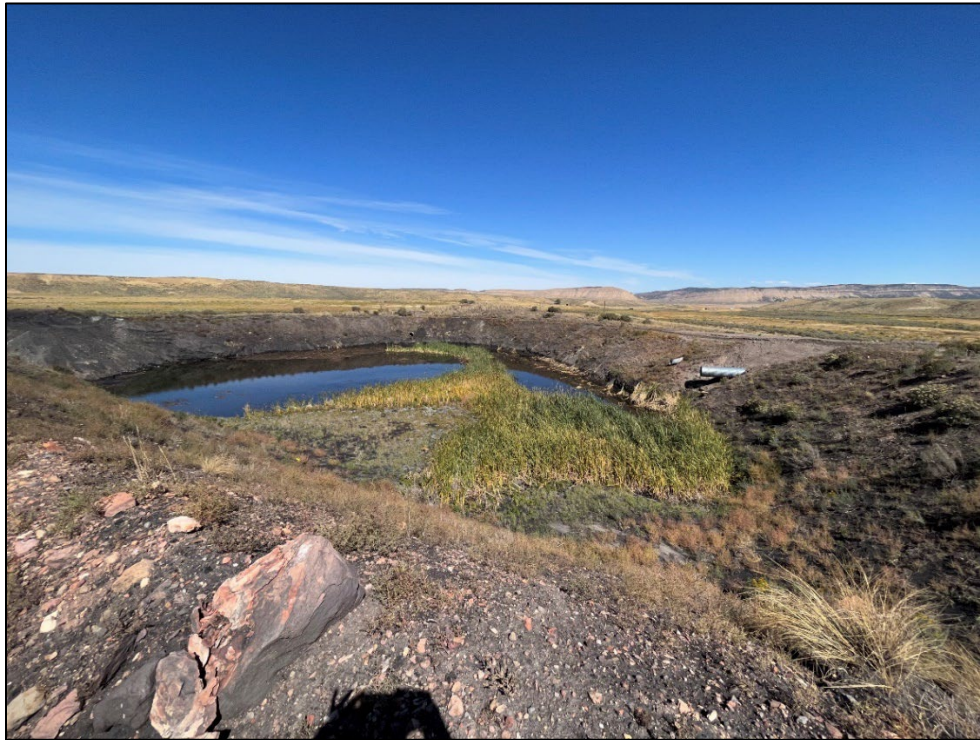
*Photo 2: View northwest of the recently cleaned Gossard Pond.*

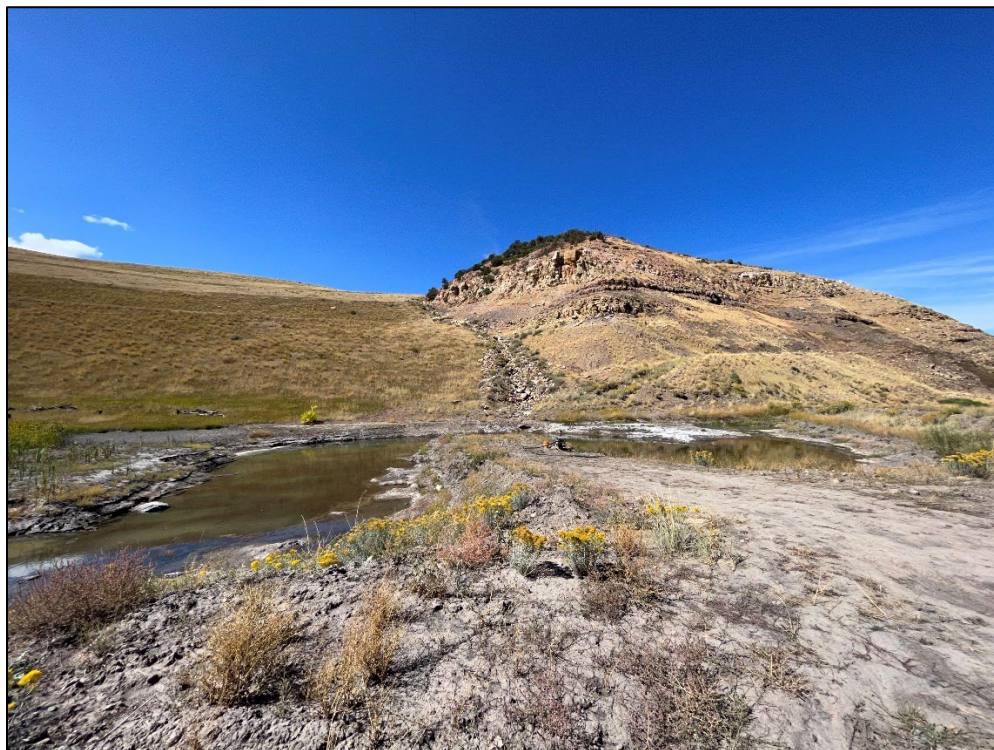
An application for a Phase I, II and III release of 5.5 acres in the East Pit (SL-23) was received by the Division on September 16, 2024. SL-23 proposes to release Streeter Ditch and Streeter Pond (Photo 3). The Division currently awaits the submission of an affidavit of publication for the bond release notice.

Streeter Ditch was observed from below at the Streeter Pond (Photo 3). The areas surrounding the Streeter Ditch and Pond have been Phase III bond released and SL-23 has been submitted to the Division, requesting the Phase III release of both Streeter Pond and Streeter Ditch. The State of Colorado Inactive Mines Program is currently conducting mitigation work for the historical Axial Basin underground coal fire. A drill rig and dozer were noted to be part of these non-mine related distances.

*Photo 3: View west of Streeter Pond and Streeter Ditch, proposed for release under SL-23.*

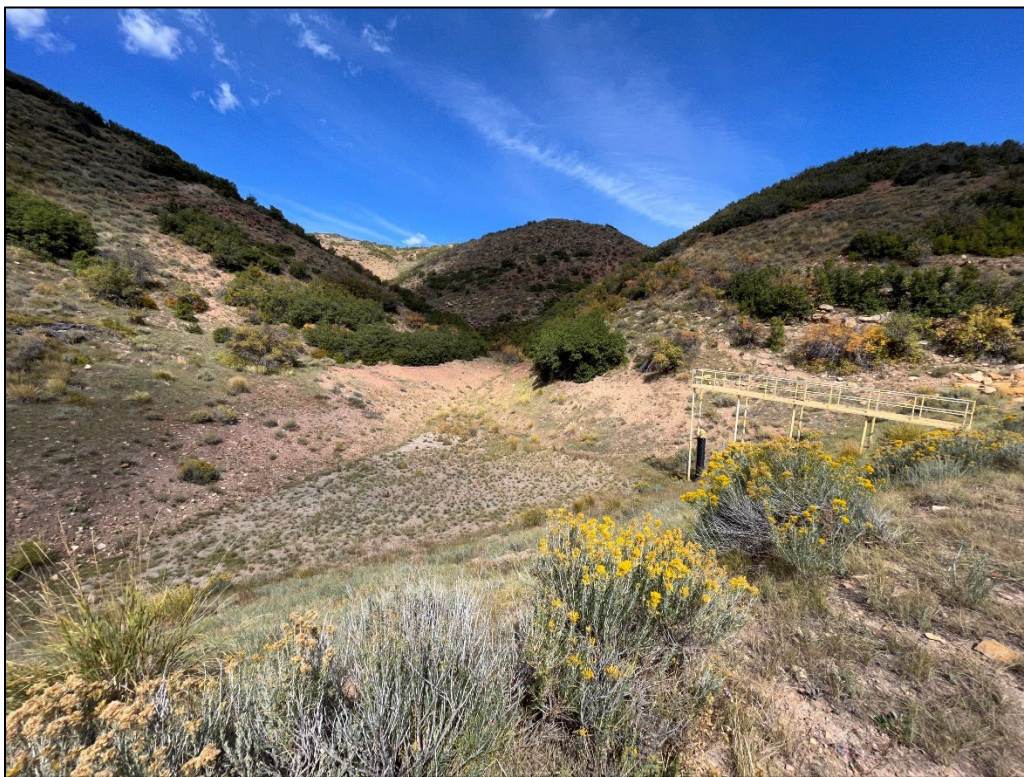
The Streeter Pond, Prospect Pond, and Section 28 Pond, accessible via Hwy 13, were inspected. Streeter and Prospect ponds held water at the time of inspection and all embankments appeared to be stable and vegetated. Section 28 Pond was dry (Photo 4). Section 16 Pond was also inspected (Photo 21). No issues were noted. Section 15 and 16 Ponds are frequented by local elk populations and several young elk were observed during inspection of these areas.

*Photo 4: View north of Section 28 Pond.*

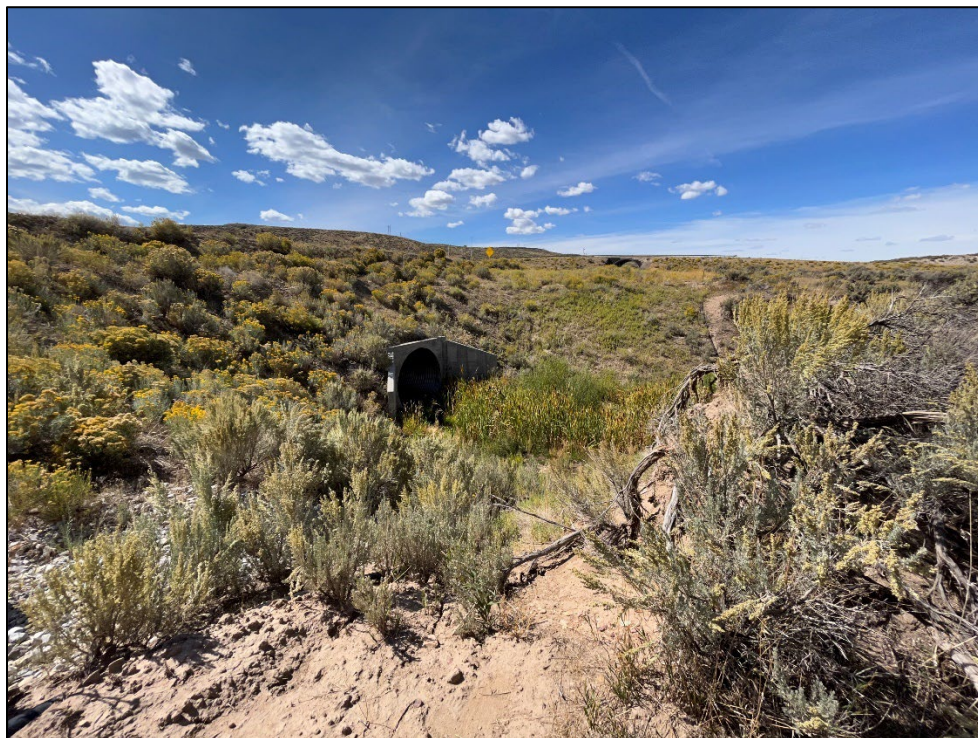
A box culvert near this area was also inspected and found to be free of blockages and had no structural issues (Photo 5). The Temporary Facilities Pond and Wilson storage Pond, located adjacent to the rail loop area were inspected. These ponds collect stormwater from a small facilities storage area. Currently this area is utilized by the highwall mining company as equipment storage. Both ponds were inspected and found to be dry and partially vegetated, having not received water for some time.

*Photo 5: View of a box culvert located adjacent to the rail loop, under the Collom haul road.*

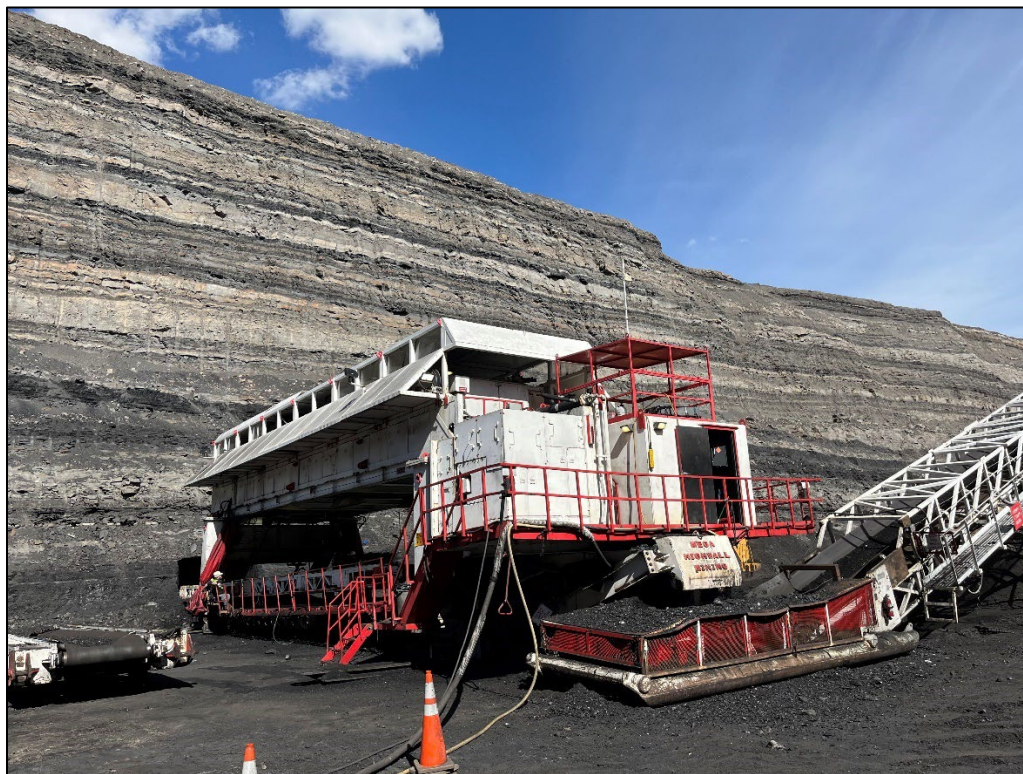
Backfilling was observed in the active cut area in Collom Pit in support of highwall mining operations (Photo 6).

Highwall mining operations were observed to be active in Collom Pit (Photo 6) and a large pile of product was being shaped as the highwall progressed. Truck teams were not observed at the time to be hauling blasted or mined material. A dragline was observed in the south end of Collom Pit moving spoil material (Photo 7). A train of ~100 cars was working its way through the rail loop area just south of CR 51.

*Photo 6: The highwall miner was active in the Collom Pit.*

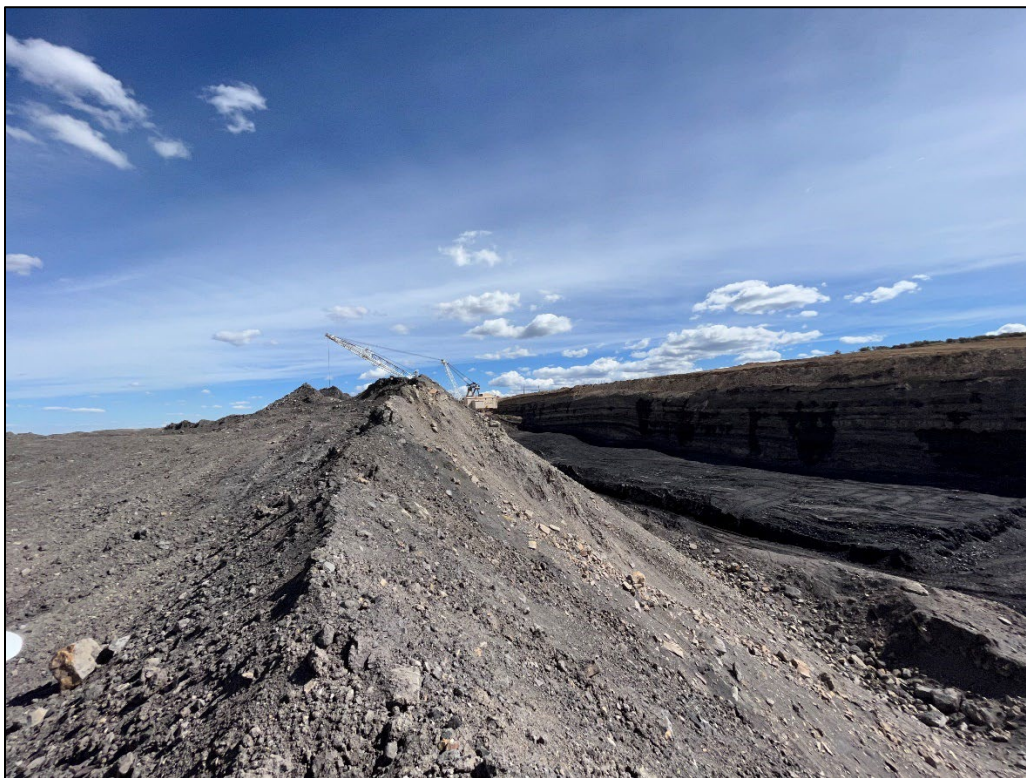
*Photo 7: View southeast of the dragline active in the south end of Collom Pit.*

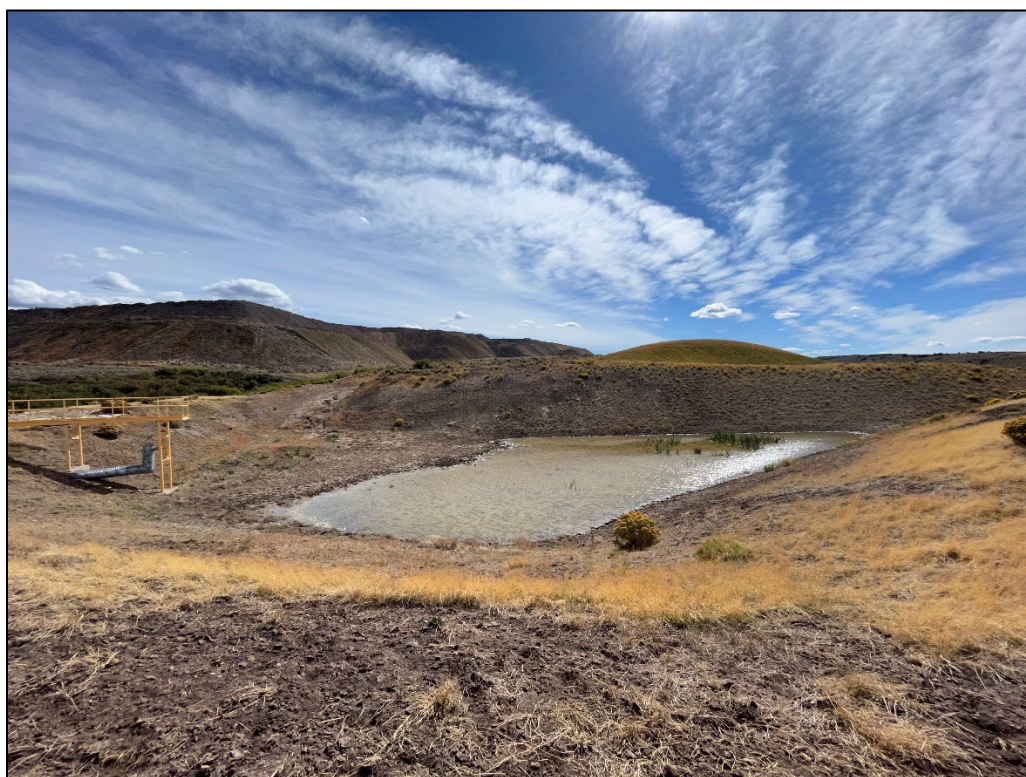
The following Ponds in the Collom Pit area were inspected this month: Section 36 Pond, Sidehill Pond (Photo 8), Middle Pond (Photo 26), Section 25 Pond (Photo 26), and Section 26 Pond (Photo 10). No outstanding problems were noted at any of the ponds. All ponds were holding water. Discharge points remain clear of blockages. The sump area on the western end of Topsoil Pile 26A in Collom Pit was inspected and found to be holding a small amount of water. No issues were observed (Photo 11).

The following ditches in the Collom Pit area were inspected this month: D-1 (Photo 9), D-2 (Photos 11 and 12), D-3, and D-4 (Photo 8). These ditches were observed from vantage points near Collom Pit Ponds and were walked where accessible. All channels appeared to be stable and functioning properly with no signs of major erosion or undercutting.

*Photo 8: View south of Sidehill Pond and Ditch D-4 to the East.*

- Monitor the slump area at Section 26 Pond
- Seed the topsoil pile in the northern section of Collom Pit when conditions allow
- Monitor the small erosional feature in D4, repairs will be necessary if conditions worsen

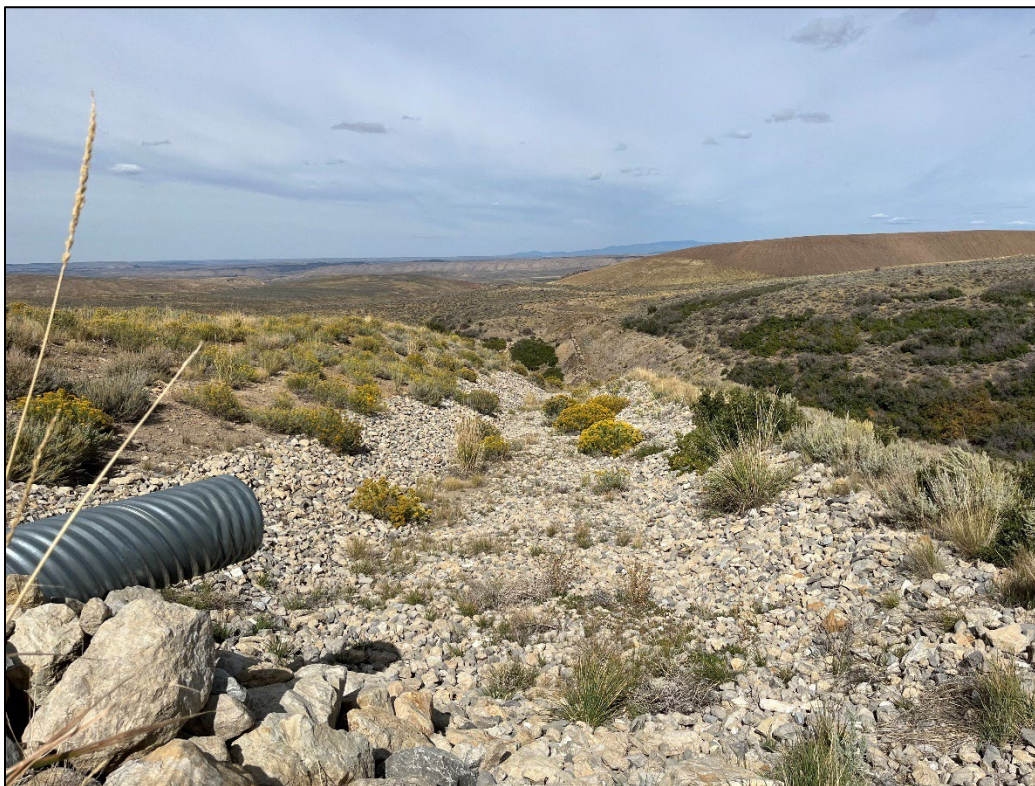
*Photo 9: View north of the Sidehill Pond outlet and Ditch D-1.*

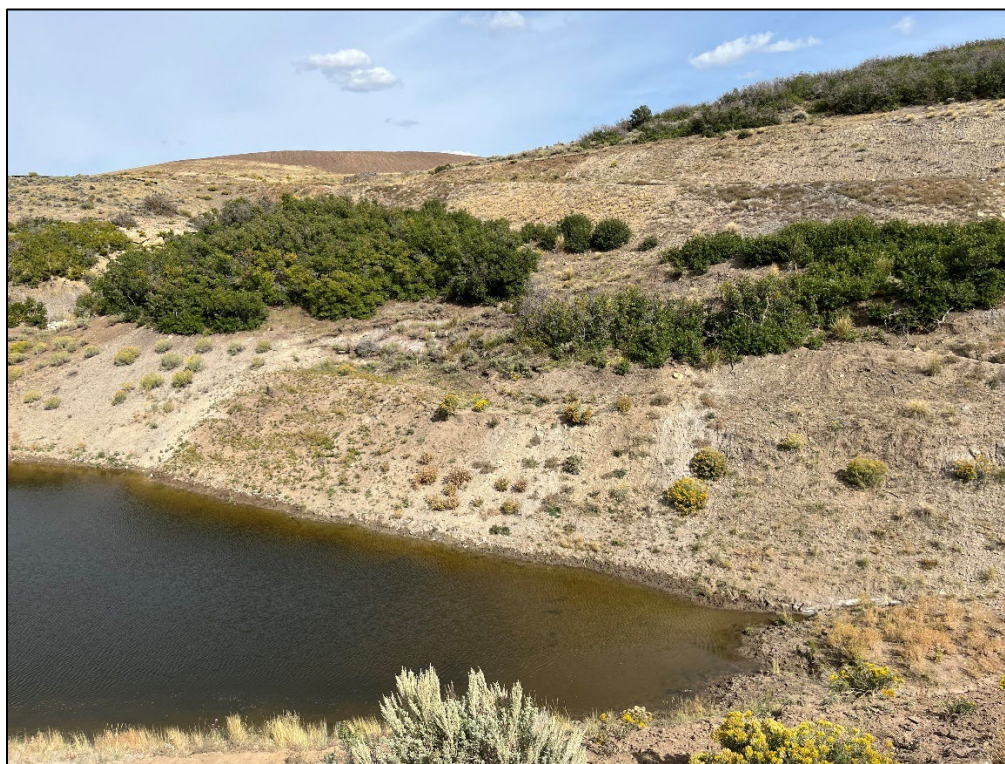
The small slump areas on the east and southwest sides of Section 26 Pond continue to be monitored for signs of movement, but overall remain stable. This southwest slump is likely due to a natural seep. Colowyo should continue to monitor this area closely for exaggerated signs of movement or degradation.

*Photo 10: View northeast of Section 26 Pond and the monitored slump area.*

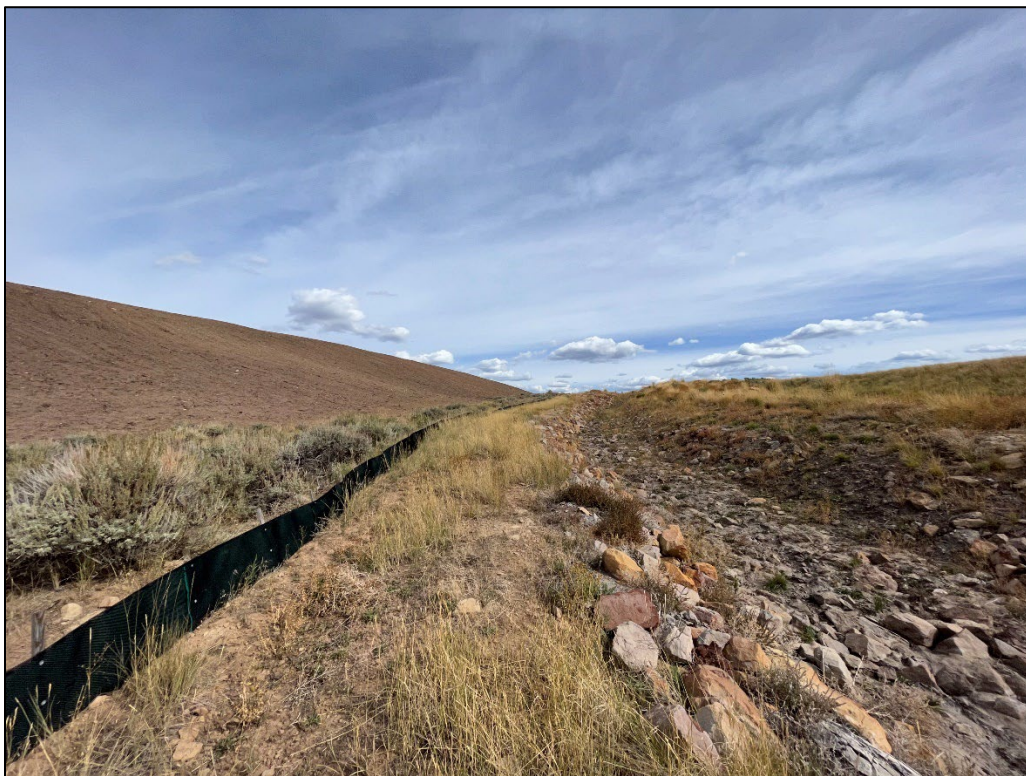
Topsoil piles across the site contained appropriate markers. Topsoil Pile 26A, behind Section 26 Pond, will need to be seeded when conditions allow before the winter season (Photo 11). An ERTEC ‘S-Fence’ is located around the base of topsoil pile 26A. However, the state of mature vegetation behind this fence would allow for this BMP to be removed should Colowyo wish to do so. The sump which collects runoff from topsoil pile 26A was inspected, found to be functioning properly, and holding a small amount of water.

*Photo 11: View east of Ditch D-2 and Topsoil Pile 26A.*

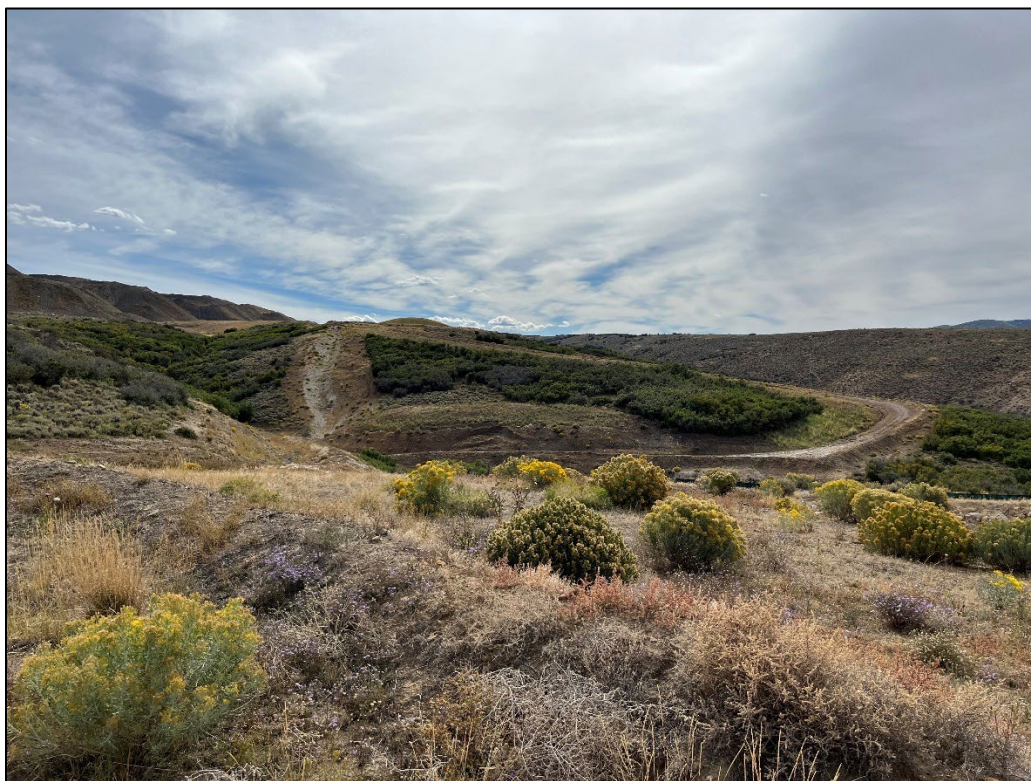
*Photo 12: View south of Ditch D-1 from the western end of Ditch D-2.*

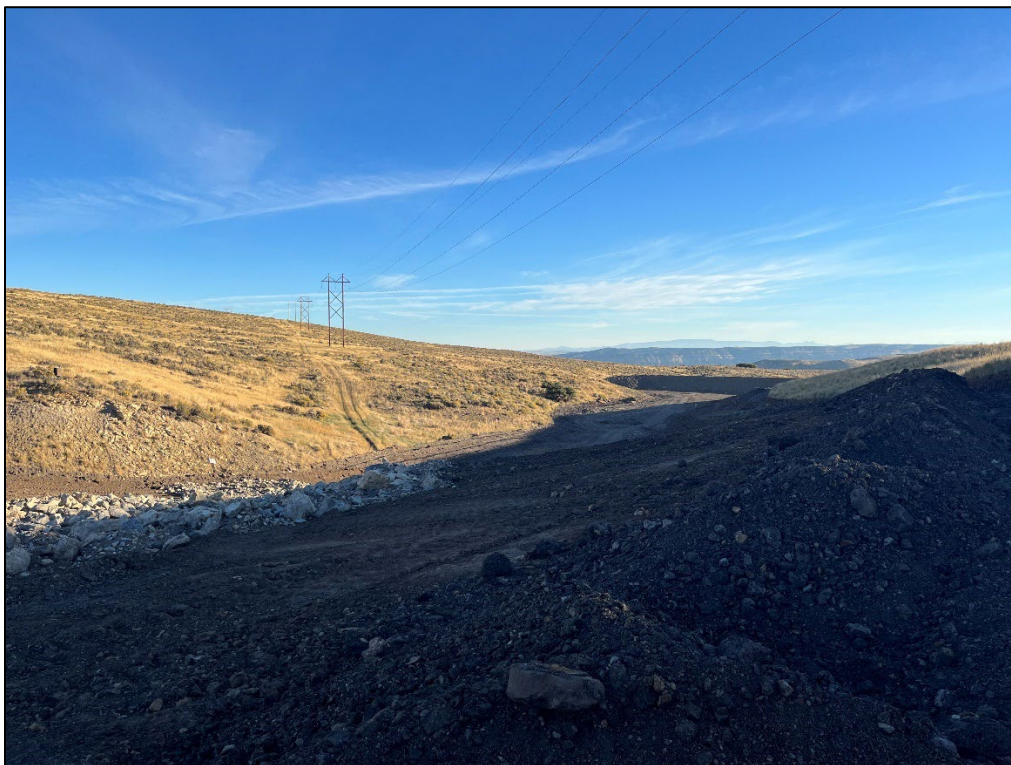
An application for Technical Revision 164 (TR-164) was received and called complete by the Division on September 19, 2024. TR164 provides as-builts for the Upper and Lower Section 3 Ponds (Photos 13 and 14). The Decision Date for TR 164 is November 19, 2024.

The Upper and Lower Section 3 Ponds in the East Pit have been completed (Photos 13 and 14). The approved access road around these ponds is also in place. As-built design materials are currently being reviewed by the Division under the submission of Technical Revision 164 (TR-164). These ponds were approved in TR-155 and are located within Streeter Ditch directly below the primary crushing facility at Colowyo. These sediment ponds will be used in a series, with the Lower Section 3 Pond being a non-discharging structure.

*Photo 13: View East of the completed Lower Section 3 Ponds.*

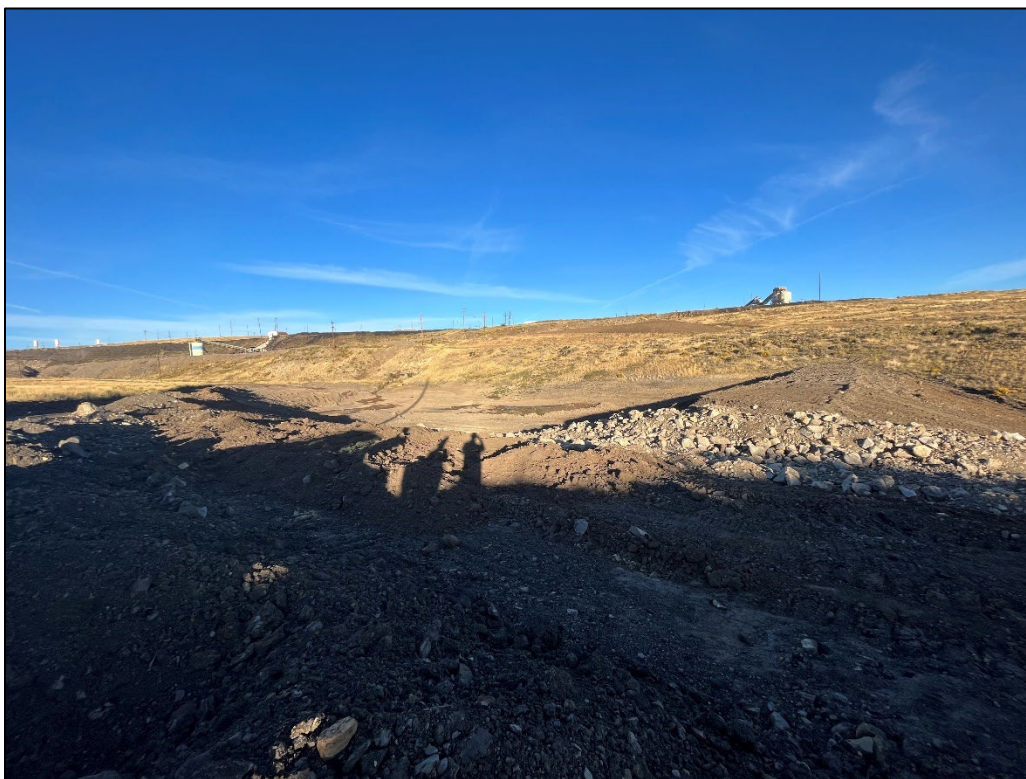
*Photo 14: View north of the completed Upper Section 3 Pond.*

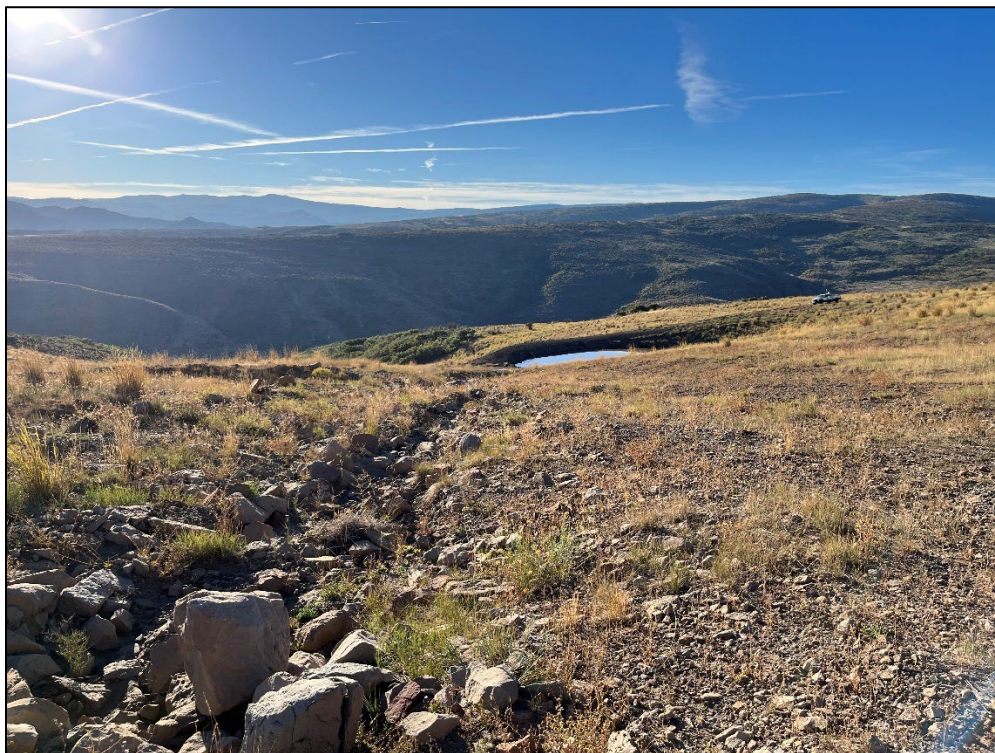
Reach 1, 2, and 3 of Prospect Ditch were observed, along with stock ponds PD1 and PD2 (Photo 15). No issues are noted.

*Photo 15: View east of stock pond PD2 and Reach 3 of Prospect Ditch.*

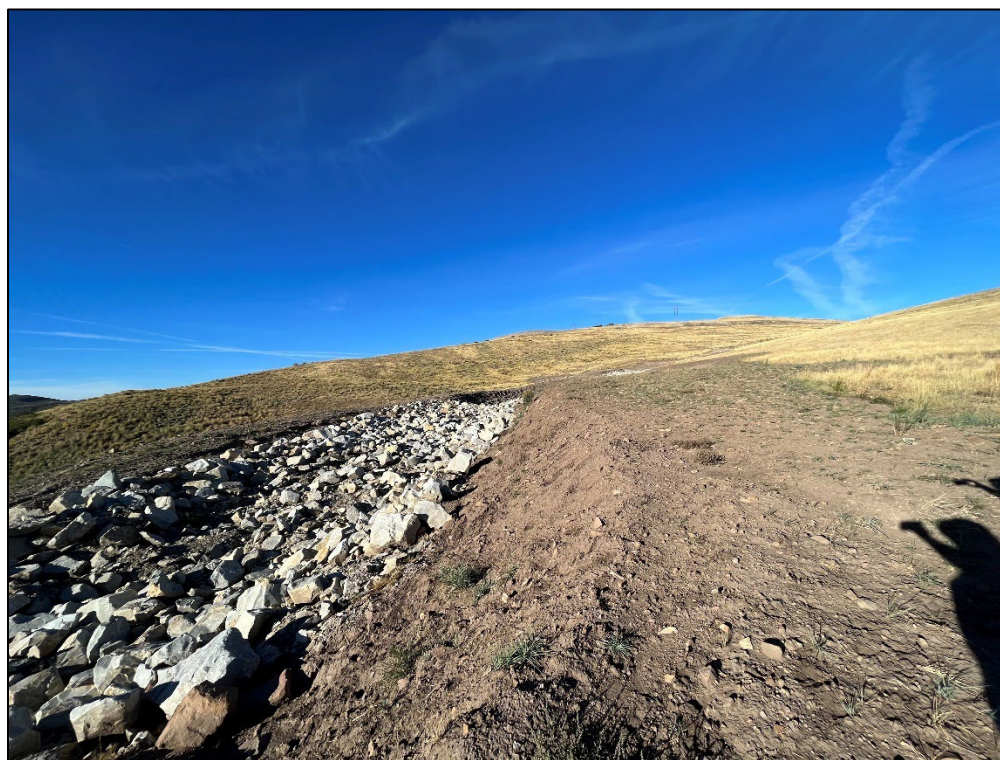
The following ditches in the East Pit were observed during the inspection: Section 15 Ditch, Prospect Ditch, Final East Pit Ditch and the North Tributary of East Pit Ditch. The following stock ponds were also observed: PD1, PD2, NTEP1 (Photo 16), EP1, EP2, and EP3. Streeter Ditch will be inspected in full at the Division's upcoming bond release inspection.

*Photo 16: View north of Reach 1 of the North Tributary, East Pit Ditch. Stock pond NTEP1 is located above.*

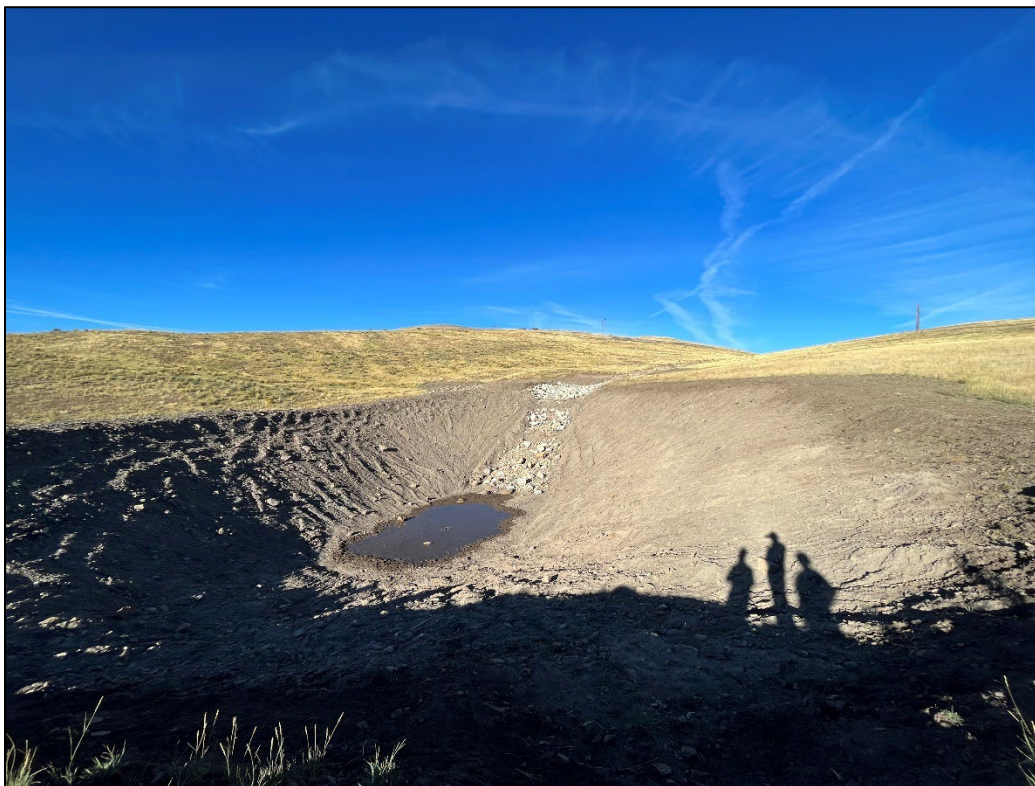
Final East Pit Ditch was inspected on foot and from vantage points. The ditch was mostly dry, and no signs of erosion or obstruction were observed. Gabion boxes are in place along Final East Pit Ditch and remain well constructed. EP3 (Photo 17) and EP1 (Photo 19) were observed on foot. These were both holding a small amount of water. Reach 2 and Reach 1 (Photo 18) of Final East Pit Ditch were observed

*Photo 17: View west of stock pond EP3.*

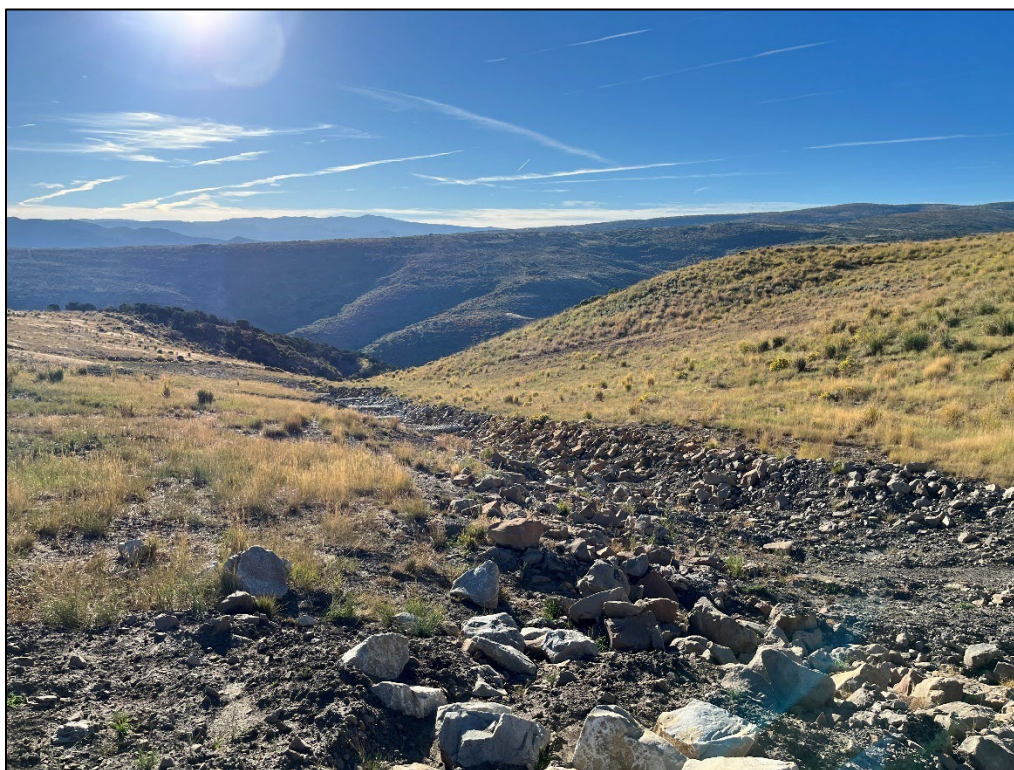
from EP1 and EP3 and noted to be stable. Reach 3 and EP2 were observed from a vantage point along the access road to Section 15 Pond.

*Photo 18: View east of Reach 1 of the Final Eat Pit Ditch.*

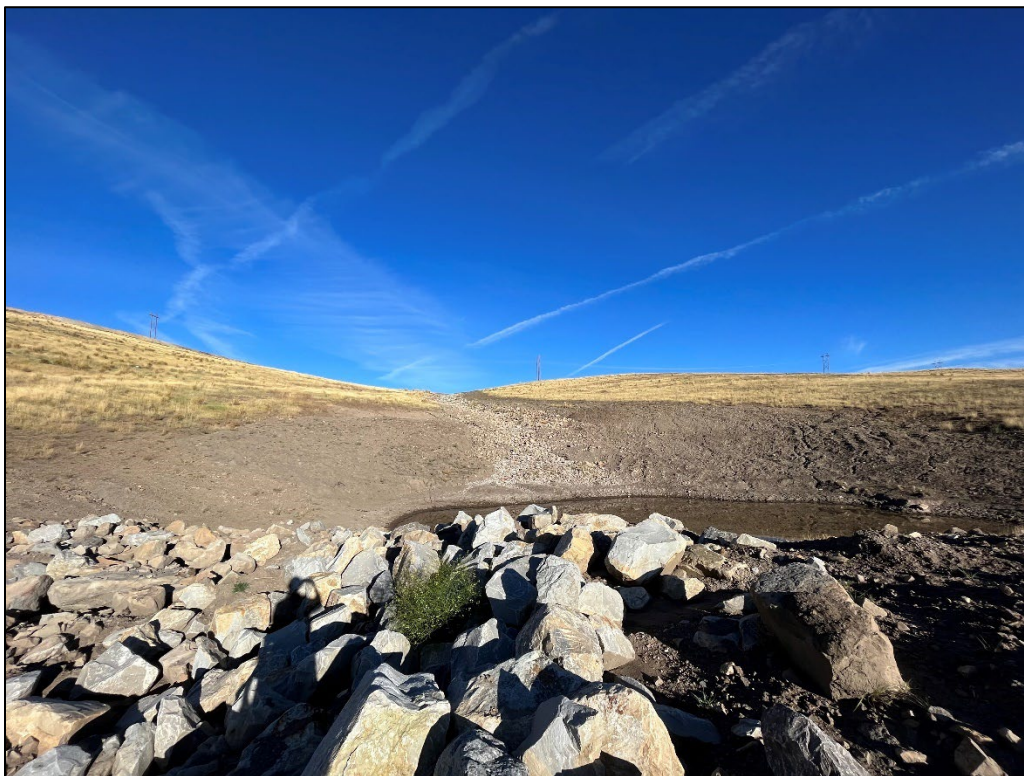
*Photo 19: View west of stock pond EPI.*

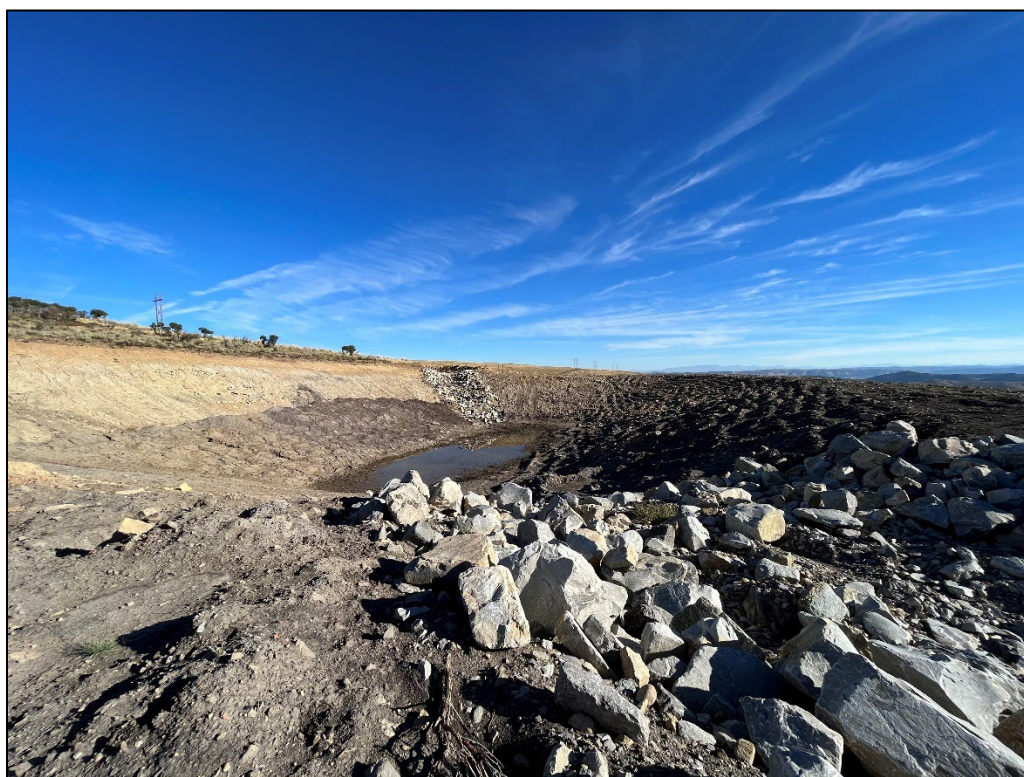
Section 15 Ditch was viewed from the vantage point provided by its access road and was observed to be stable. Section 15 Pond was observed on foot (Photo 20). No erosional issues were noted at either feature and gabion boxes were functioning properly at Section 15 Pond.

*Photo 20: View of Section 15 Pond.*

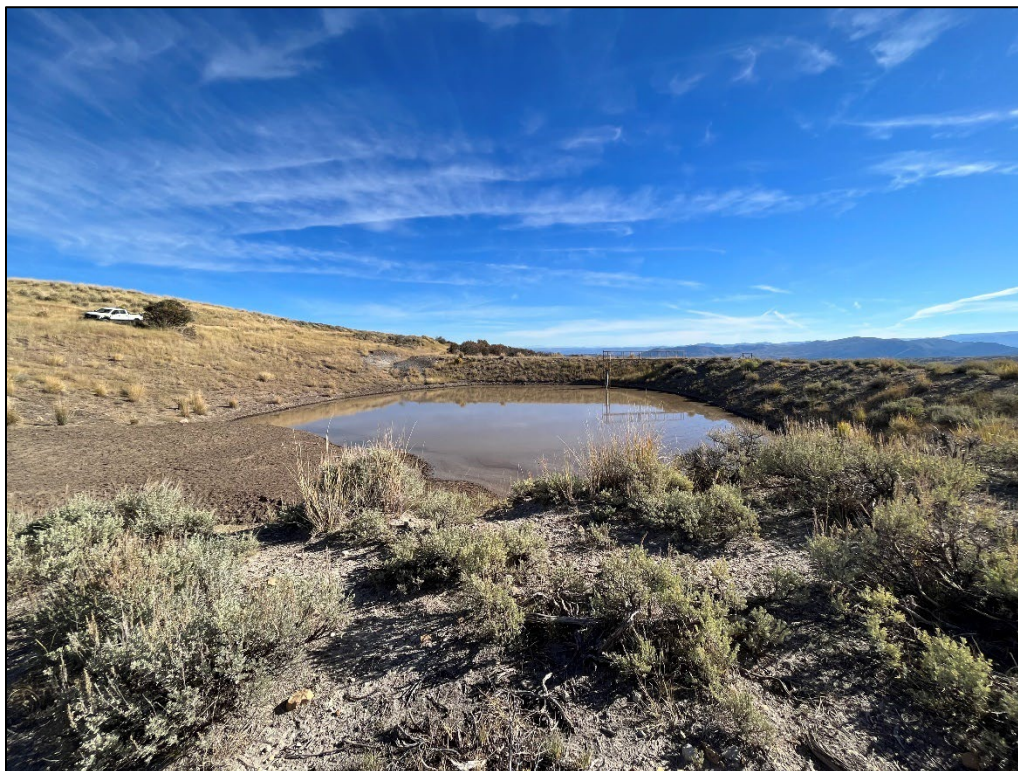
*Photo 21: View of Section 16 Pond.*

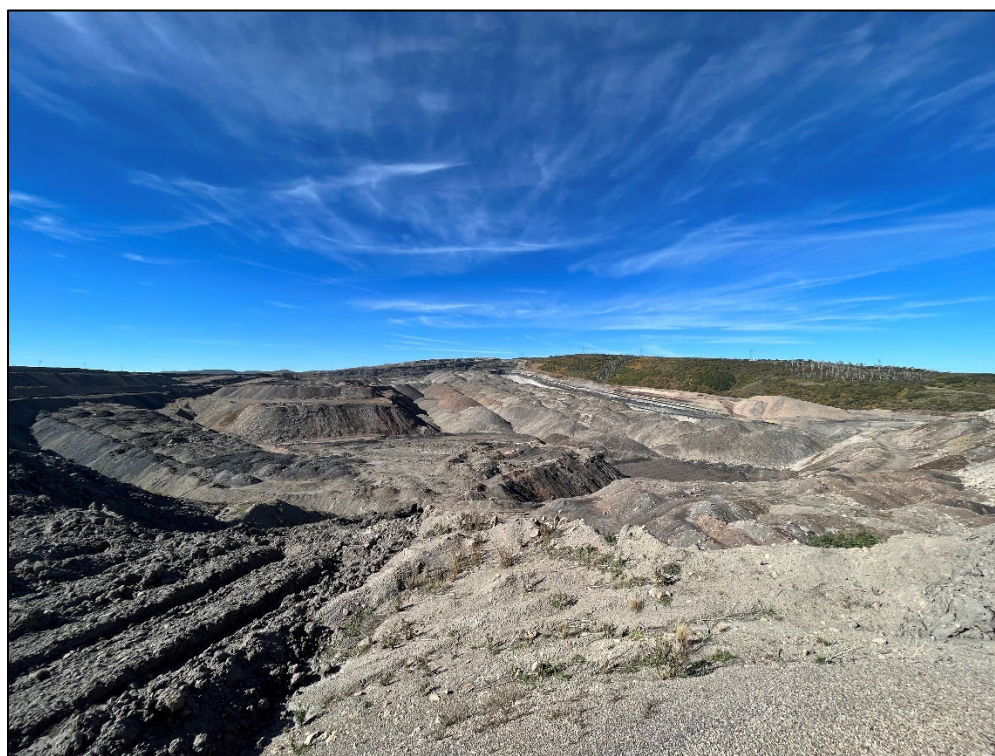
No active backfill operations were observed in the South Taylor Pit during the inspection but backfill operations had progressed since the Division's last inspection (Photo 22). In times of active operation, spoil is excavated from a temporary pile located north of the pit. A highwall of product remains to the west for possible future use.

*Photo 22: View into the South Taylor Pit, currently being backfilled, with continued benching in the southwest corner.*

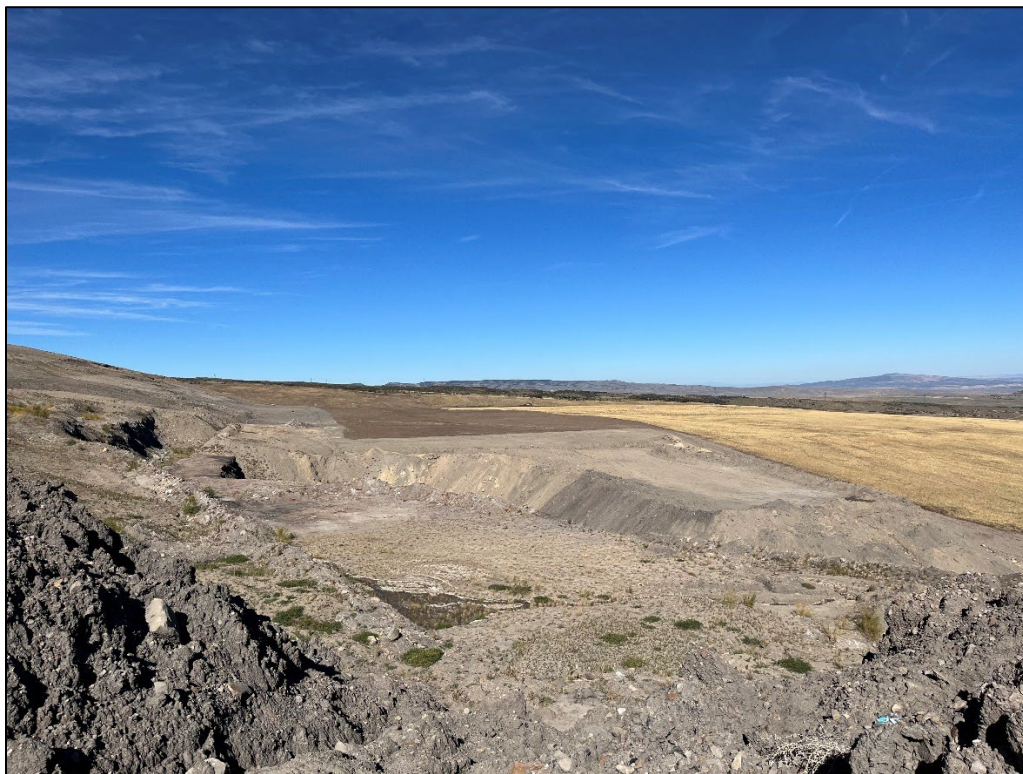
West Pit is near completion in terms of backfill operations. A new area at the southern end of the West Pit has been recently backfilled, graded, and topsoiled (Photo 23). Topsoil Pile 9B was used to topsoil this area. Seeding is planned for the fall as weather conditions allow.

*Photo 23: View west of the recently graded and topsoiled area of West Pit.*

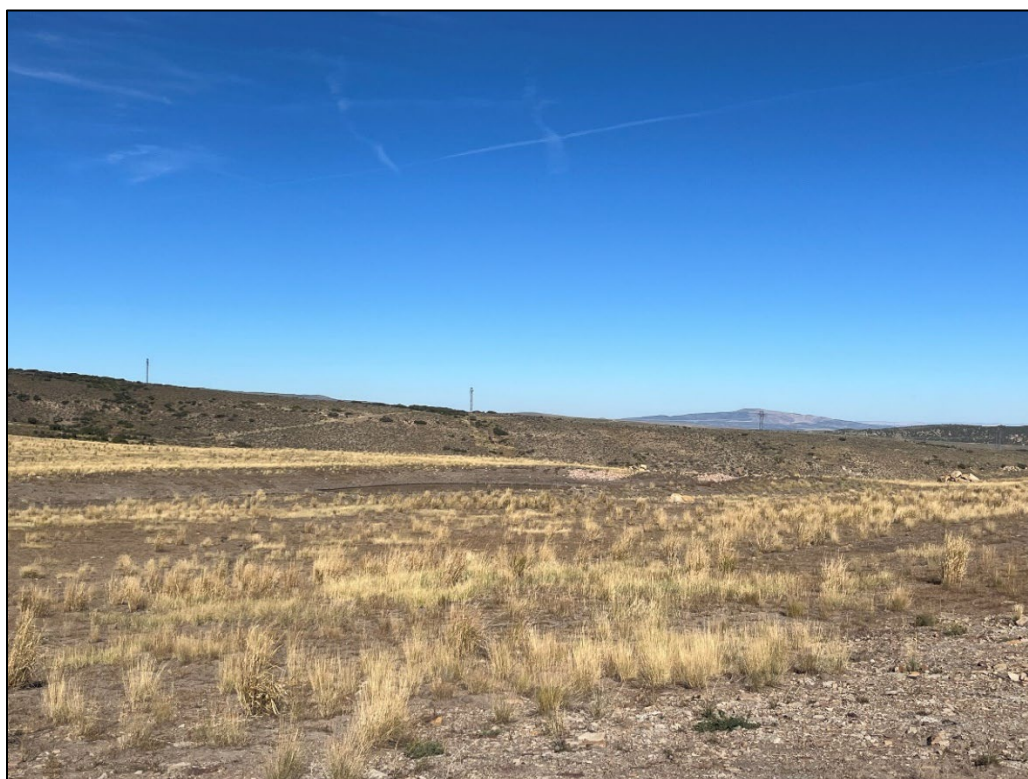
Final reclamation for the rest of West Pit will likely be some of the last reclamation done on site at Colowyo. Other areas of the West Pit, to the north, have been both backfilled and reclaimed. The Division inspected these areas and found vegetation to be mature and stable (Photo 24).

*Photo 24: View west of ETD1 in West Pit.*

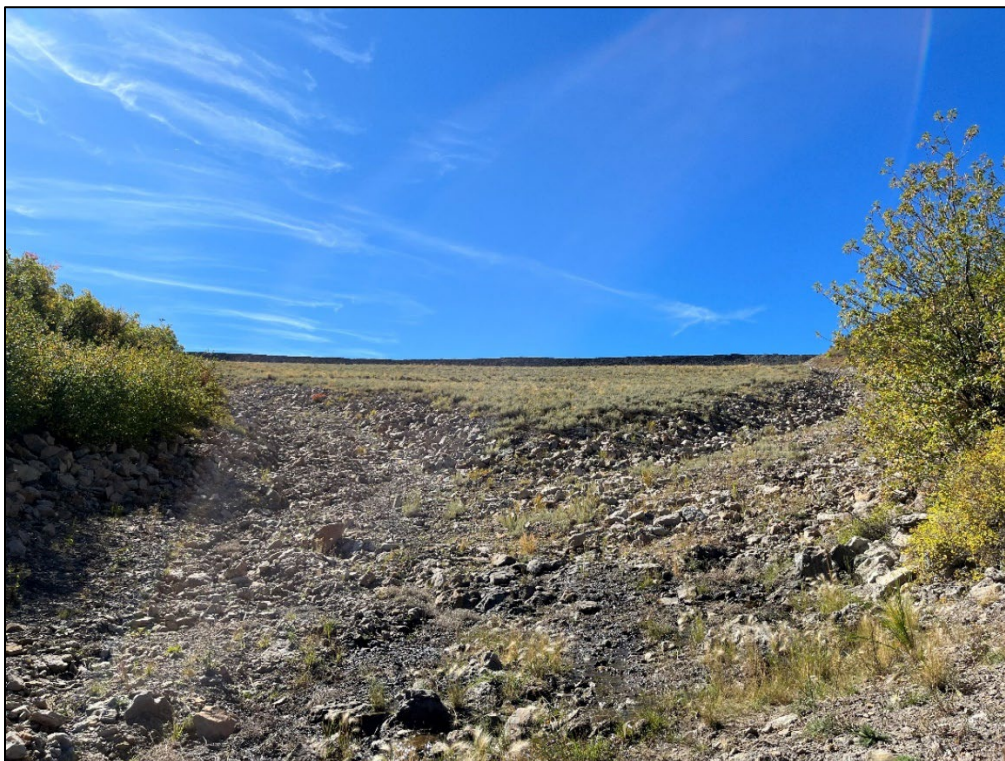
West Taylor Pond was inspected this month as part of the observance of the West Taylor Valley Fill (Photo 25). West Taylor Pond was holding water, embankments were stable, and water was flowing directly from the valley fill to the pond. Inlets and outlets remained free of obstruction or vegetative debris. The ETD1 stock pond was also inspected, which was holding a small amount of water (Photo 24). No issues were observed. The northern and southern reaches of the East Taylor Ditch, which are part of a tributary to East Taylor Ditch, were also visually inspected and found to be stable and free of issues with erosion or cutting.

The West Taylor Valley Fill area was inspected from below at the West Taylor Pond (Photo 25). No major erosional issues were noted. The face is well covered with vegetation, which is predominantly made up of sagebrush and native grasses. Water was clearly flowing through the fill’s underdrain and into West Taylor Pond, as designed. The valley fill has a prism system in place which personnel at Colowyo use to track and potential movement on the fill slope.

*Photo 25: View upwards at the valley fill area south of West Taylor Pond.*
