**Inspection Report, Colowyo, C-1981-019**

**PERMIT INFORMATION**

<b>Permit Number:</b> C-1981-019 <b>Mine Name:</b> Colowyo Coal Mine <b>Operator:</b> Colowyo Coal Company L.P. <b>Operator Address:</b> Mr Tony Tennyson 5731 State Highway 13 Meeker, CO 81641	<b>County:</b> Moffat, Rio Blanco <b>Operation Type:</b> Surface <b>Permit Status:</b> Active <b>Ownership:</b> Private
	<b>Operator Representative Present:</b>
<b>Operator Representative Signature: (Field Issuance Only)</b>

<b>Inspection Start Date:</b> September 23, 2024 <b>Inspection Start Time:</b> 11:30 <b>Inspection End Date:</b> September 24, 2024 <b>Inspection End Time:</b> 13:30		<b>Inspection Type:</b> Coal Complete Inspection <b>Inspection Reason:</b> Normal I&E Program <b>Weather:</b> Clear	
<b>Joint Inspection Agency:</b>  None		<b>Joint Inspection Contacts:</b>	
<b>Post Inspection Agency:</b>  None		<b>Post Inspection Contacts:</b>	
<b>Inspector(s):</b>  Hunter Ridley  Ben Hammar	<b>Inspector's Signature:</b>  <i>Hunter Ridley</i>  <b>Signature Date:</b>  October 7, 2024

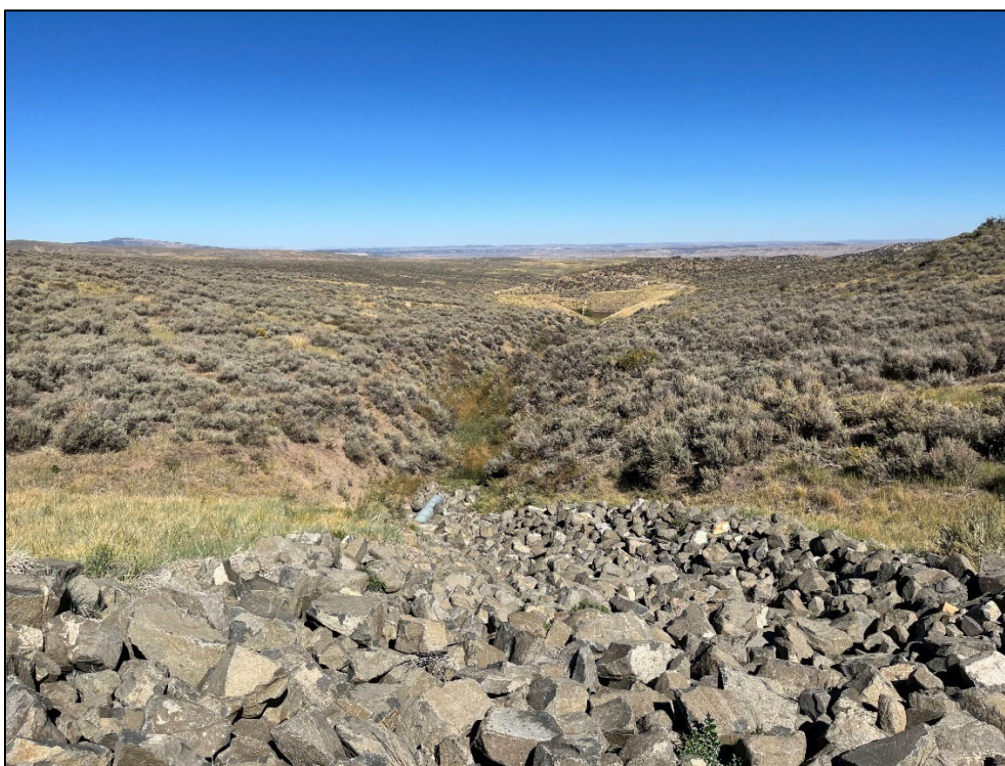
The following Ponds in the Collom Pit area were inspected this month: Section 36 Pond, Sidehill Pond (Photo 8), Middle Pond (Photo 26), Section 25 Pond (Photo 26), and Section 26 Pond (Photo 10). No outstanding problems were noted at any of the ponds. All ponds were holding water. Discharge points remain clear of blockages. The sump area on the western end of Topsoil Pile 26A in Collom Pit was inspected and found to be holding a small amount of water. No issues were observed (Photo 11).

*Photo 26: View north of the outlet for Section 25 Pond, Middle Pond is visible in the distance.*
