MINERALS PROGRAM INSPECTION REPORT
PHONE: (303) 866-3567

MINE NAME: 15 Road Gravel Pit	MINE/PROSPECTING ID#: M-2002-114	MINERAL: Sand and gravel	COUNTY: Mesa
INSPECTION TYPE: Monitoring	WEATHER: Clear	INSP. DATE: September 24, 2024	INSP. TIME: 13:00
OPERATOR: Oldcastle SW Group, Inc. dba United Companies of Mesa County	OPERATOR REPRESENTATIVE: Jesse Farmer	TYPE OF OPERATION: 112c - Construction Regular Operation	
REASON FOR INSPECTION: Normal I&E Program	BOND CALCULATION TYPE: Complete Bond	BOND AMOUNT: \$854,778.31	
DATE OF COMPLAINT: NA	POST INSP. CONTACTS: None	JOINT INSP. AGENCY: None	
INSPECTOR(S): Amy Yeldell	INSPECTOR'S SIGNATURE:

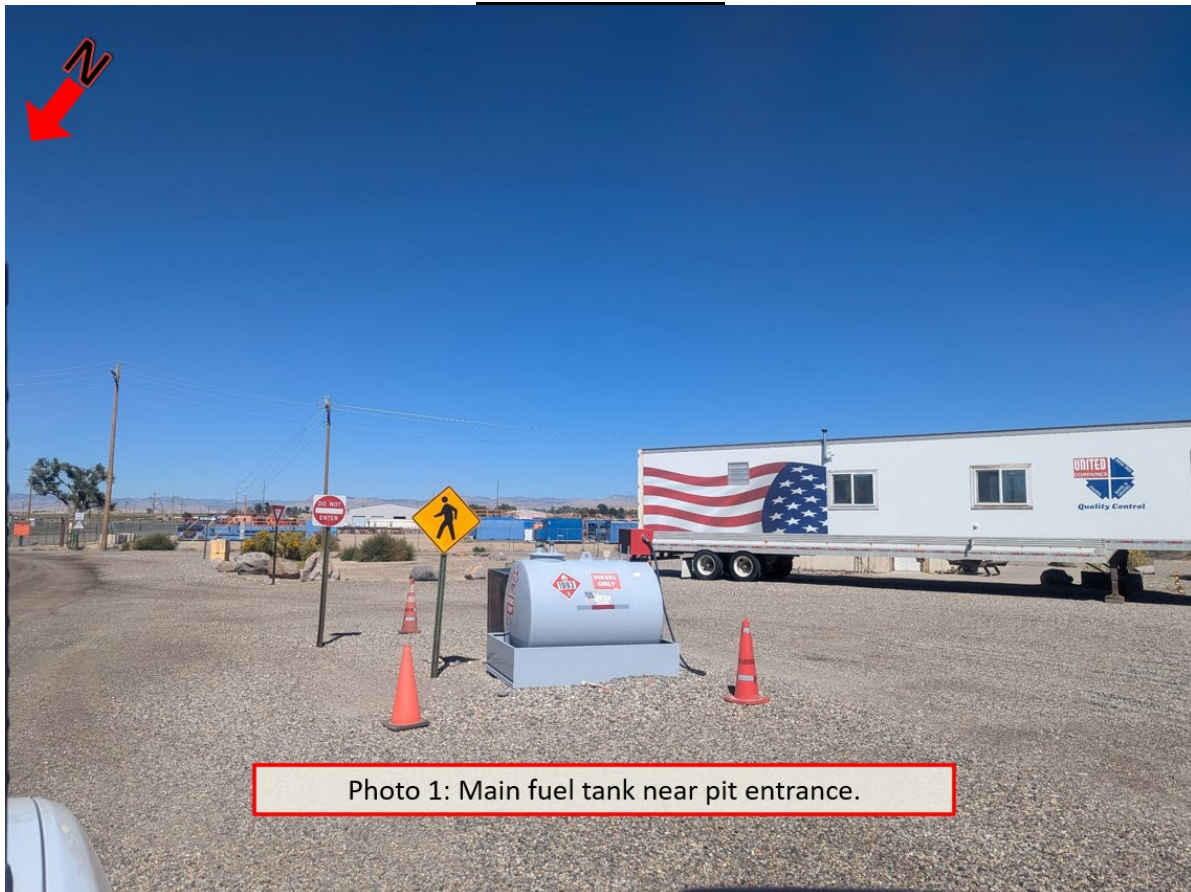
There are several fuel tanks located throughout the site for the pumps and heavy equipment. The primary fuel tank for equipment is located near the pit entrance and scale house (Photo One). All observed tanks were in secondary containment. No other hydrocarbons or other hazardous materials were observed.

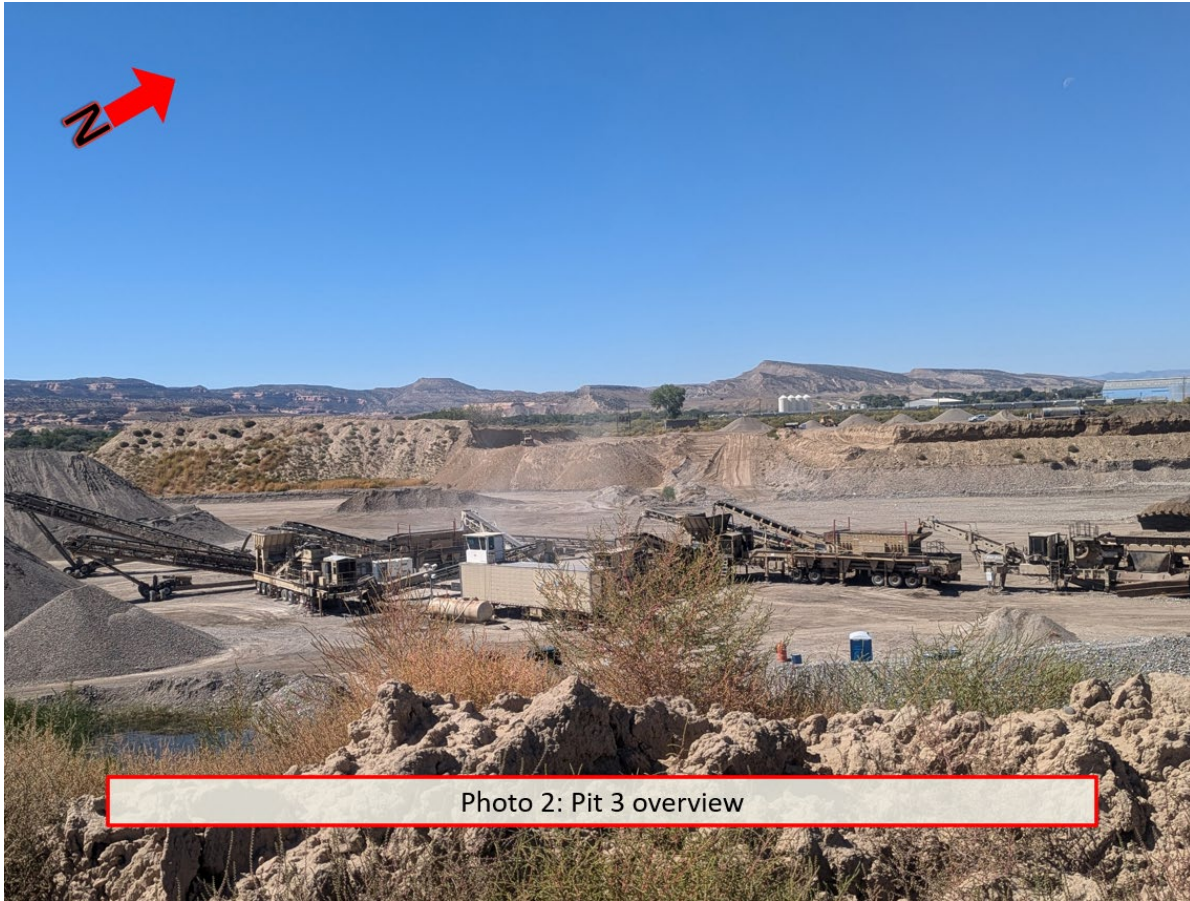
Photo 2: Pit 3 overview

Both excavations and backfilling are occurring within Pit 3. The excavated pit area of Pit 3 is approximately 27 acres. Backfilling is taking place in the northwest corner adjacent to the quanset structure. The overburden being transported is coming from the stripping of the western center highwall within Pit 3. The pit is excavated to a depth of approximately 20 feet. Most highwalls are near vertical to 1H: 1V except along the ramps. All slopes aside from the northing bank can be cut/fill. The northern slope requires backfill. Note that the Mine Plan states that slopes while mining will only be a 2H: 1V. Some benching is present where overburden is being stripped, approximately 10 feet. Staff estimates that there is approximately 5,000 LF of highwall within Pit 3. (Photos 2-5)

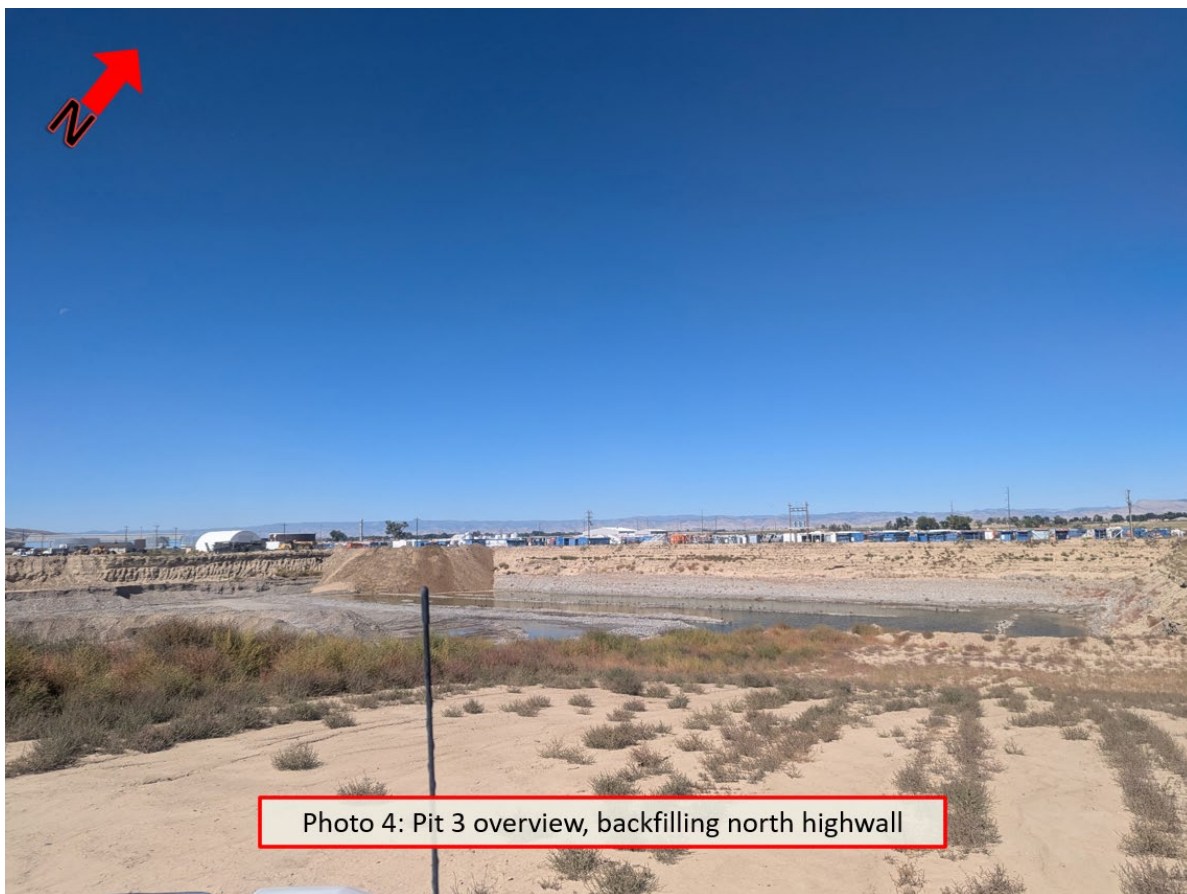
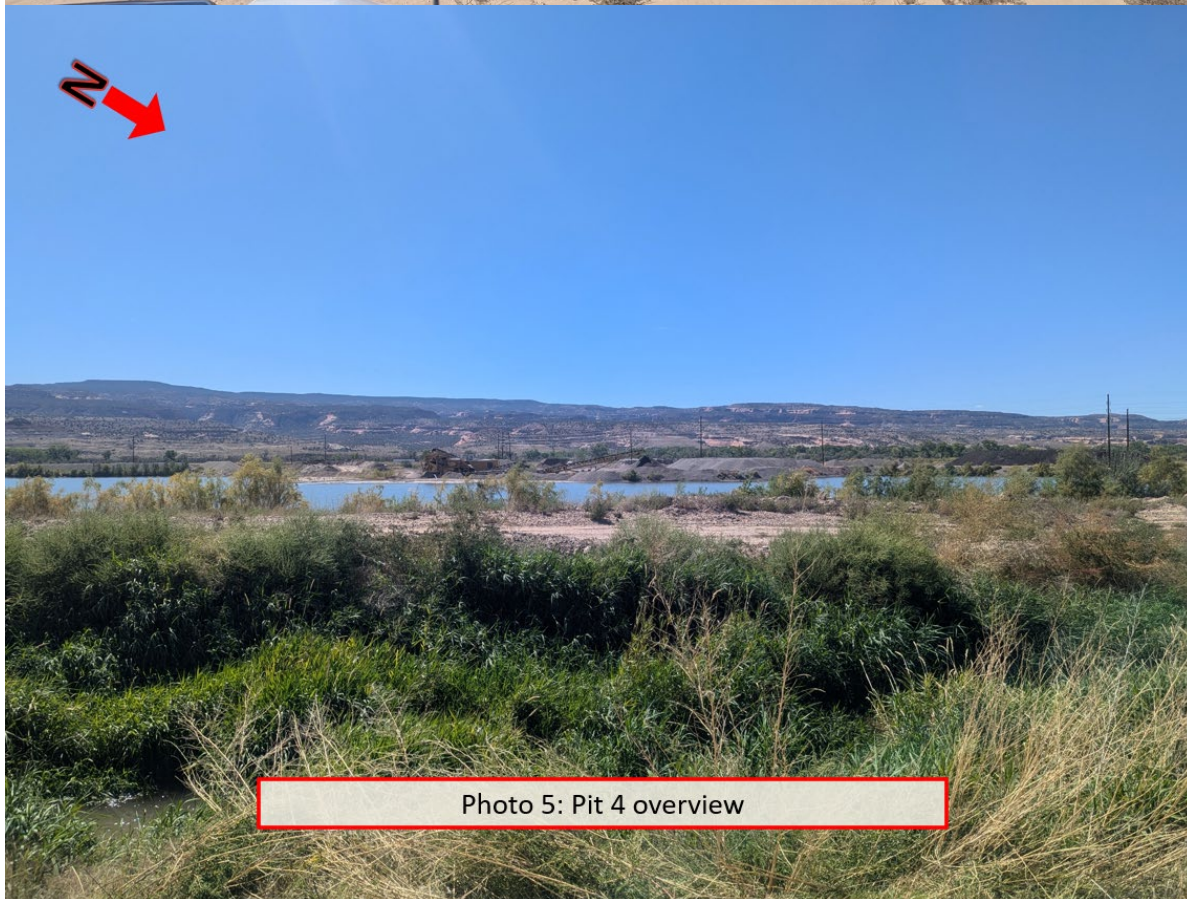
The southern portion of Pit 4 is a lake being used for the wash plant. Given that the lake is inundated the Division cannot confirm highwall configurations. Per the 2024 Annual Report, the operator indicated that this pond is reclaimed. Likely some minimal grading will be required in the areas adjacent to the wash plant. The Division will assume 5007 LF of 2H: 1V to a 3H: 1V at 20 ft H cut/fill per Exhibit L for bonding. (photos 5 and 6)

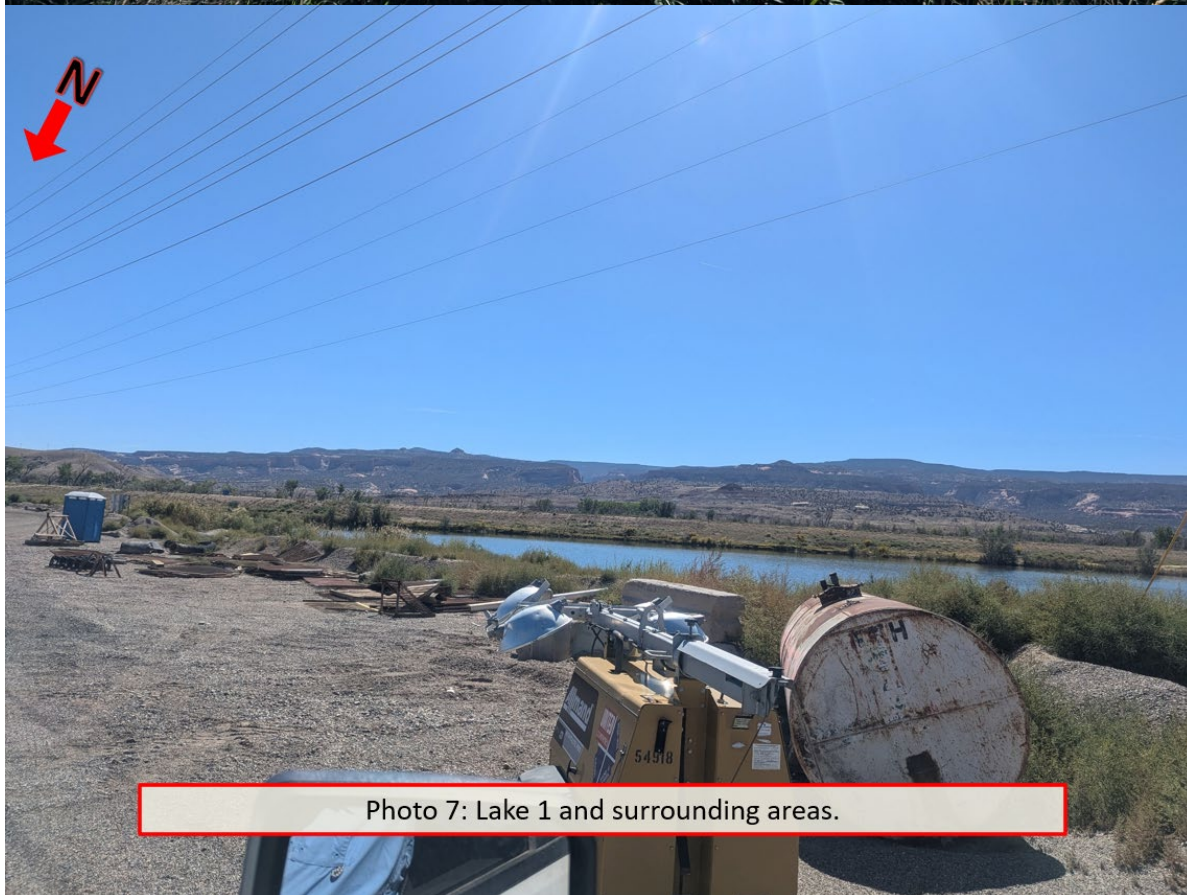
Photo 7: Lake 1 and surrounding areas.

Lake 1 appears to be in final reclamation given that no changes have occurred in 10 or more years. It is unclear if this pond was ever seeded or if vegetation has volunteered. Per the most recent annual report it was not indicated as being reclaimed. Previous notes regarding bonding state that wetlands bench and seeding is complete. While only a portion of the rangeland areas has been seeded. The general lake configuration of Lake 1 does not match the approved reclamation plan. The wetlands shelf on the northwestern end of the lake does not appear to be installed nor has the southwestern shelf. Overall, a lake of approximately 26 ac is present while the reclamation plan calls for 17.6 ac. Final reclamation shall be completed or the Reclamation Plan should be updated to reflect site conditions. (Photos 7 & 8)

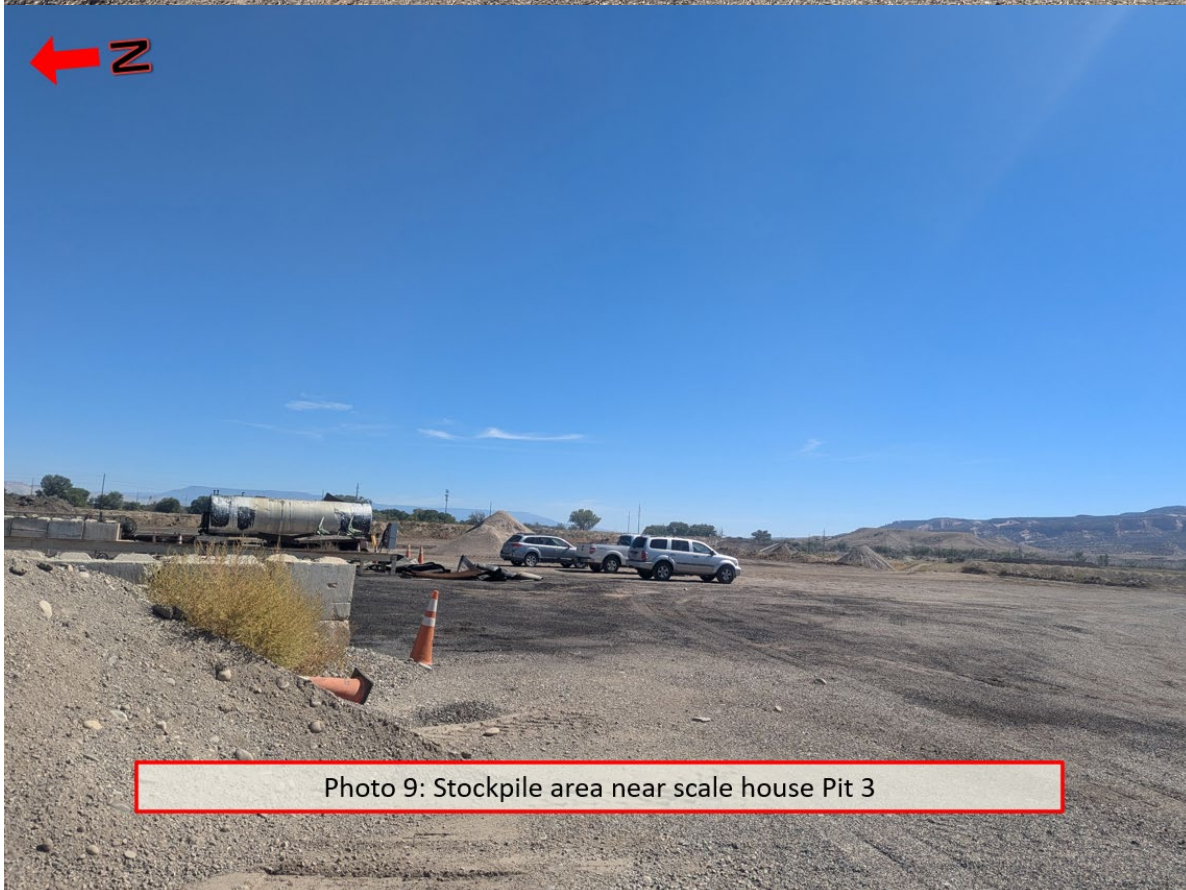
There is a scale and scale house located near the entrance of the pit. There is also an office building and Quanset Storage structure on the northwest side of Pit 3. (photos 9 & 10)
