MINERALS PROGRAM INSPECTION REPORT
PHONE: (303) 866-3567

MINE NAME: Yankee Gulch Minerals Project	MINE/PROSPECTING ID#: M-1999-002	MINERAL: Carbonates	COUNTY: Rio Blanco
INSPECTION TYPE: Monitoring	WEATHER: Clear	INSP. DATE: September 25, 2024	INSP. TIME: 10:00
OPERATOR: American Soda LLC	OPERATOR REPRESENTATIVE: Celina Akin	TYPE OF OPERATION: 112d-3 - Designated Mining Operation	
REASON FOR INSPECTION: Normal I&E Program	BOND CALCULATION TYPE: None	BOND AMOUNT: \$5,178,424.00	
DATE OF COMPLAINT: NA	POST INSP. CONTACTS: None	JOINT INSP. AGENCY: None	
INSPECTOR(S): Amy Yeldell	INSPECTOR'S SIGNATURE:

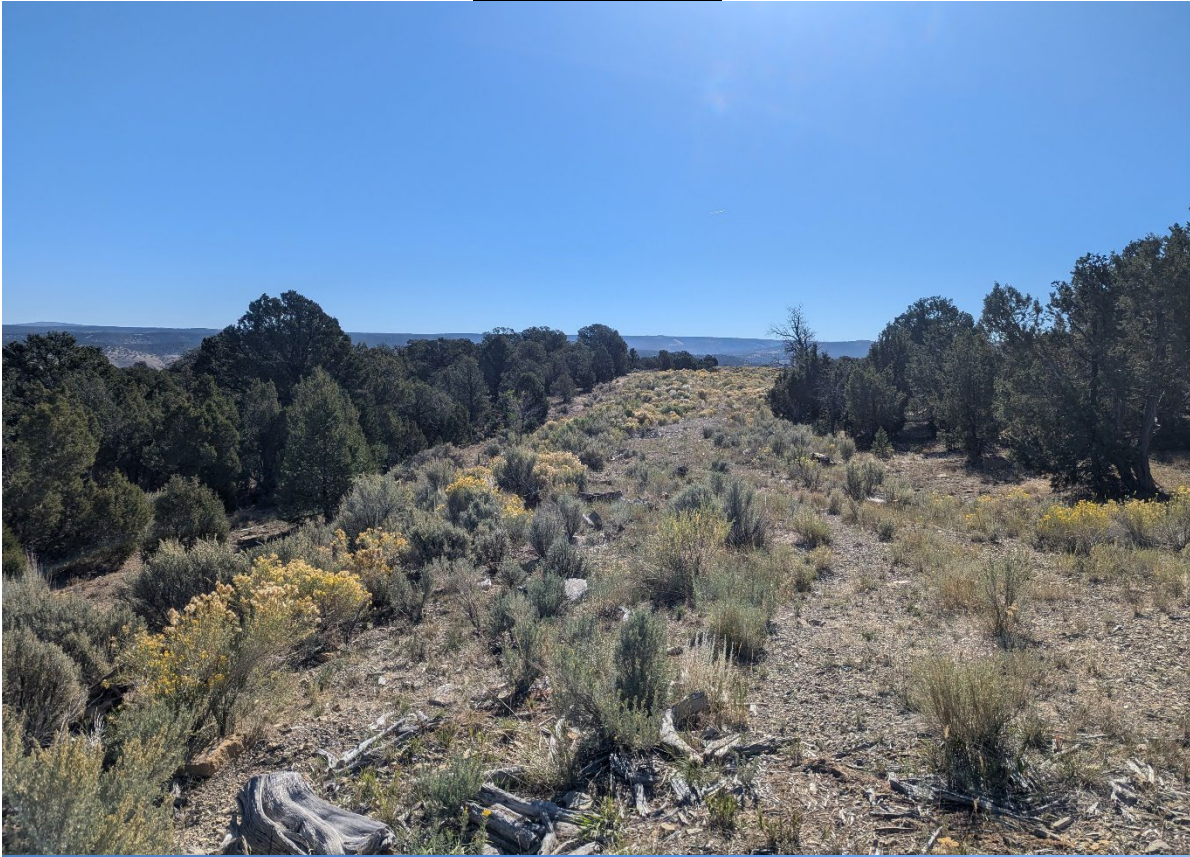
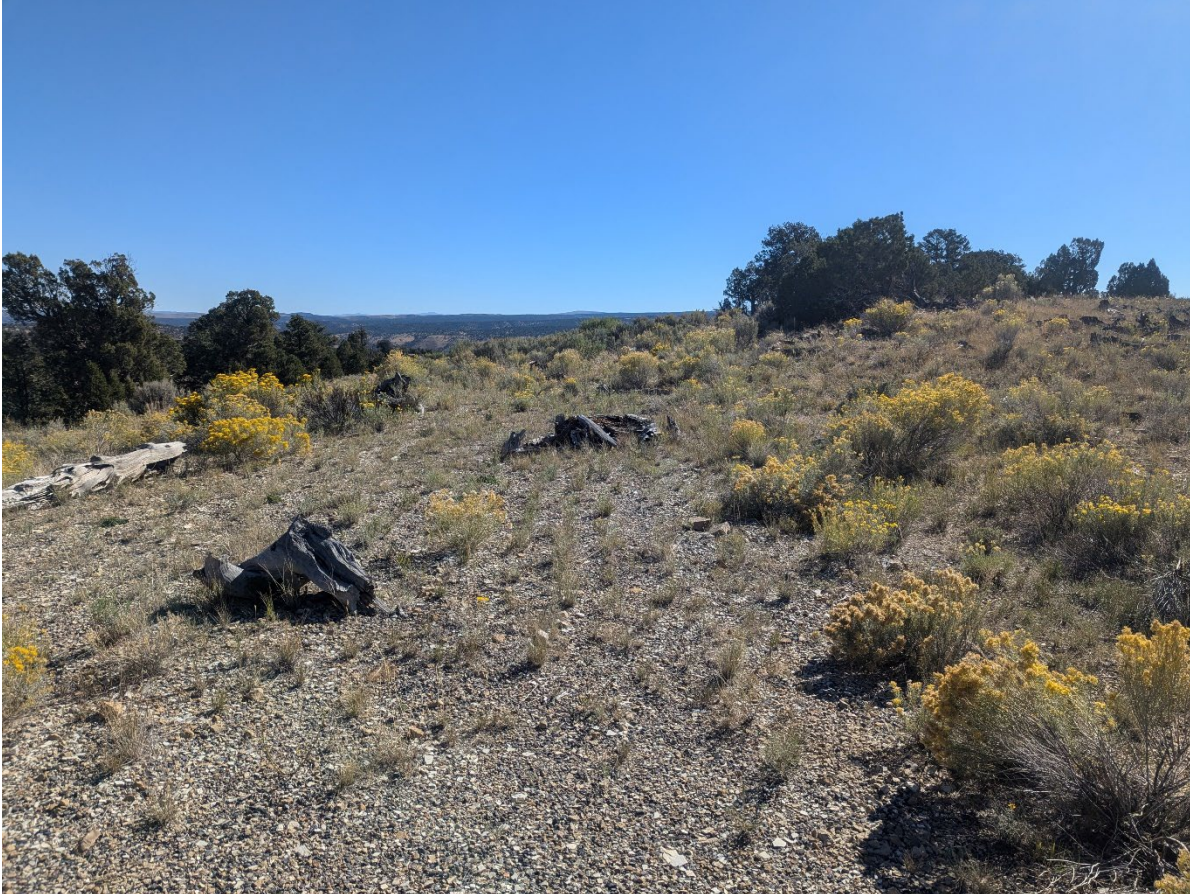
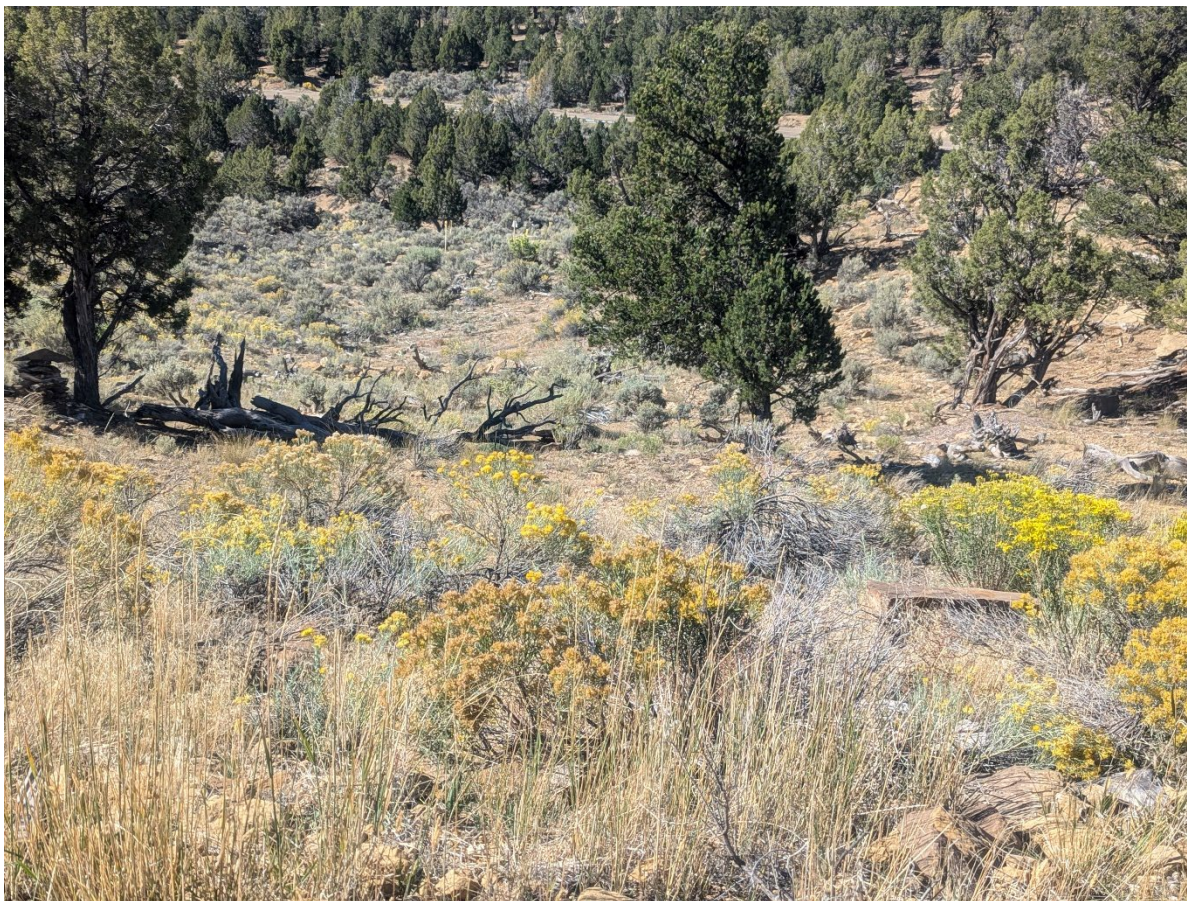
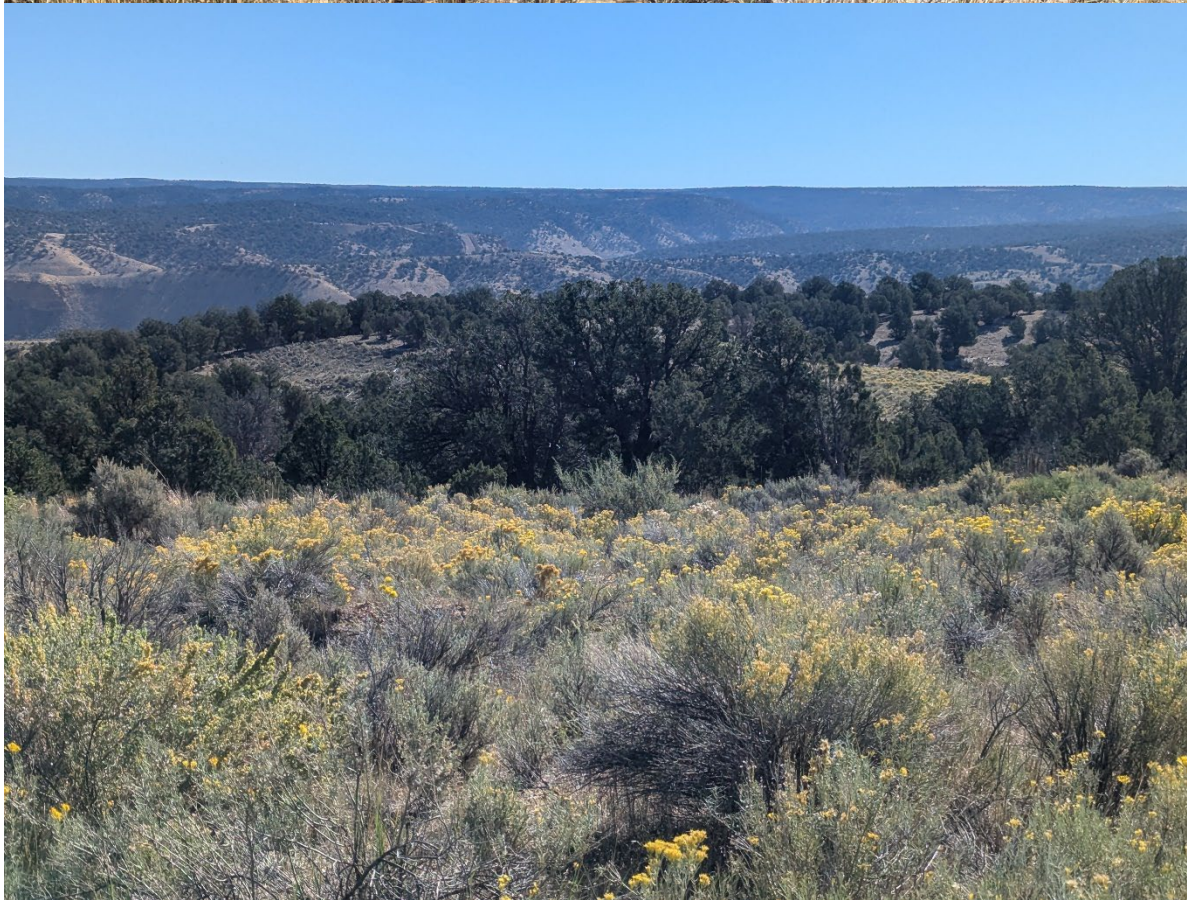
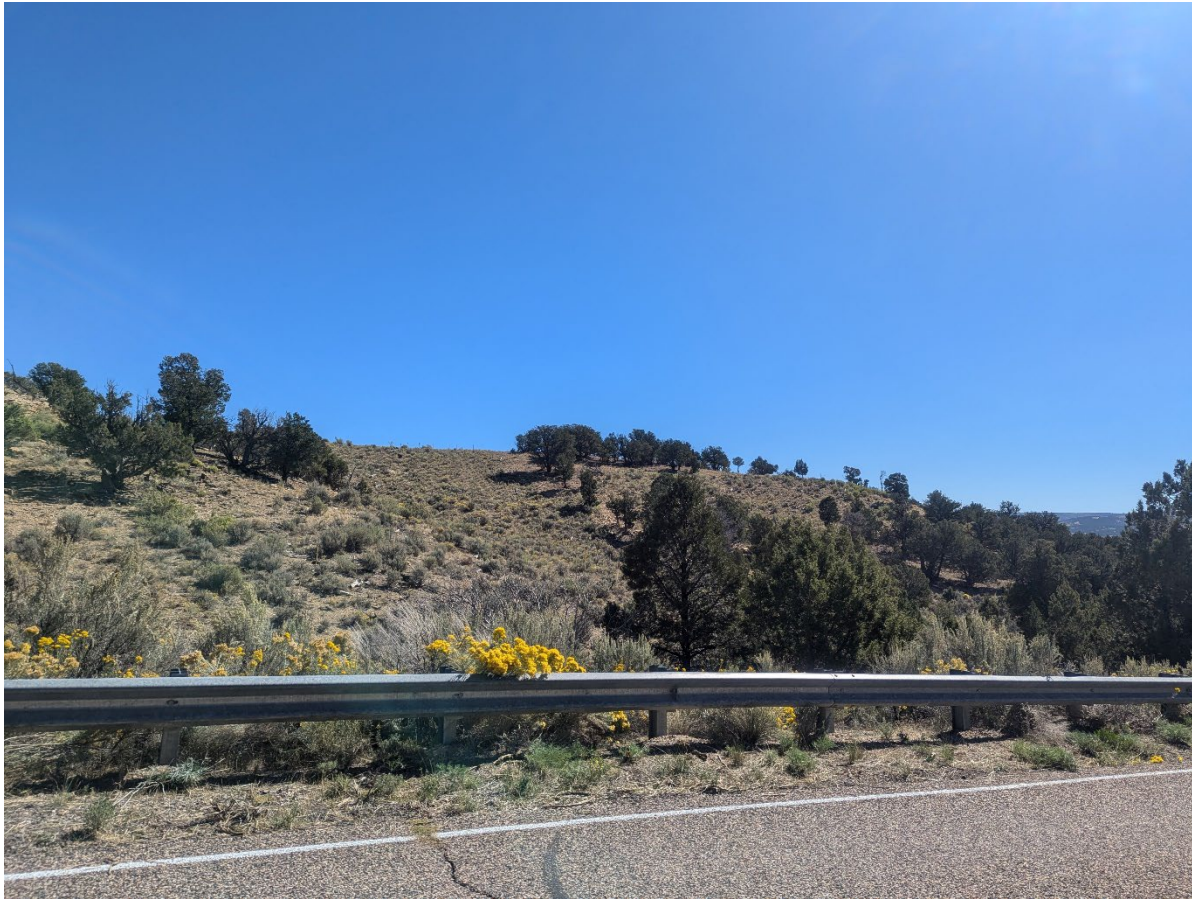
The Division walked the pipeline/access roads and pads along the ridge, see photos 1-6

Affected lands have been seeded and vegetation is well established. Generally, reclaimed areas are a diverse blend of grasses, forbs and shrubs. Overall, vegetative cover and density is comparable to the surrounding

undisturbed areas. Little to no weeds were observed. The operator should continue noxious weed management so long as the site remains permitted. Treatments with backpack sprayers and/or via horse are preferred at this time to limit vehicle disturbances to successfully reclaimed areas. Vegetation appears to be stabilizing the soils well and no signs of excessive erosion or sedimentation were observed. Of the portions of the well field observed, the Division feels that final reclamation has been achieved.

Given the vast nature of this site the Operator shall provide photo documentation (drone or aerial would also be helpful) of all pads and roads demonstrating that all affected lands have been reclaimed and that vegetation establishment is sufficient.

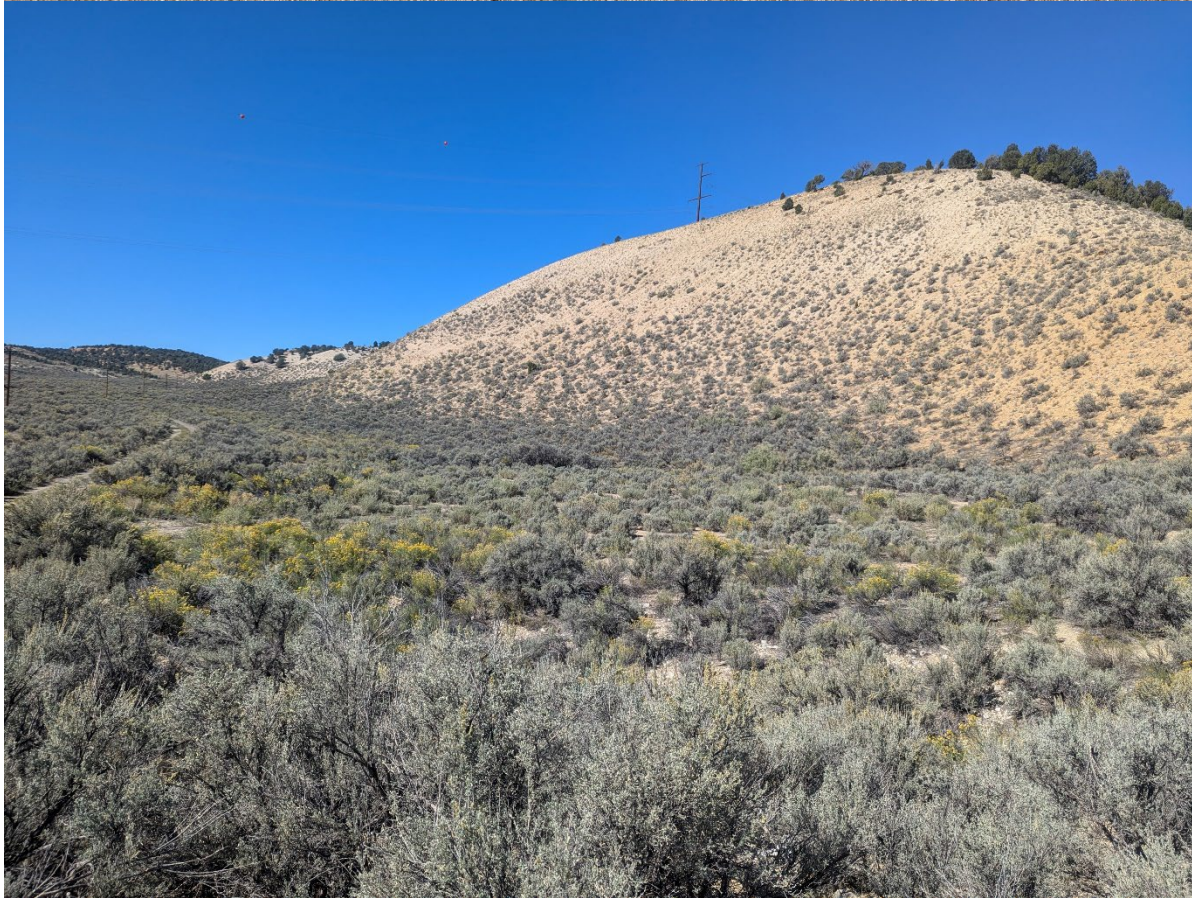
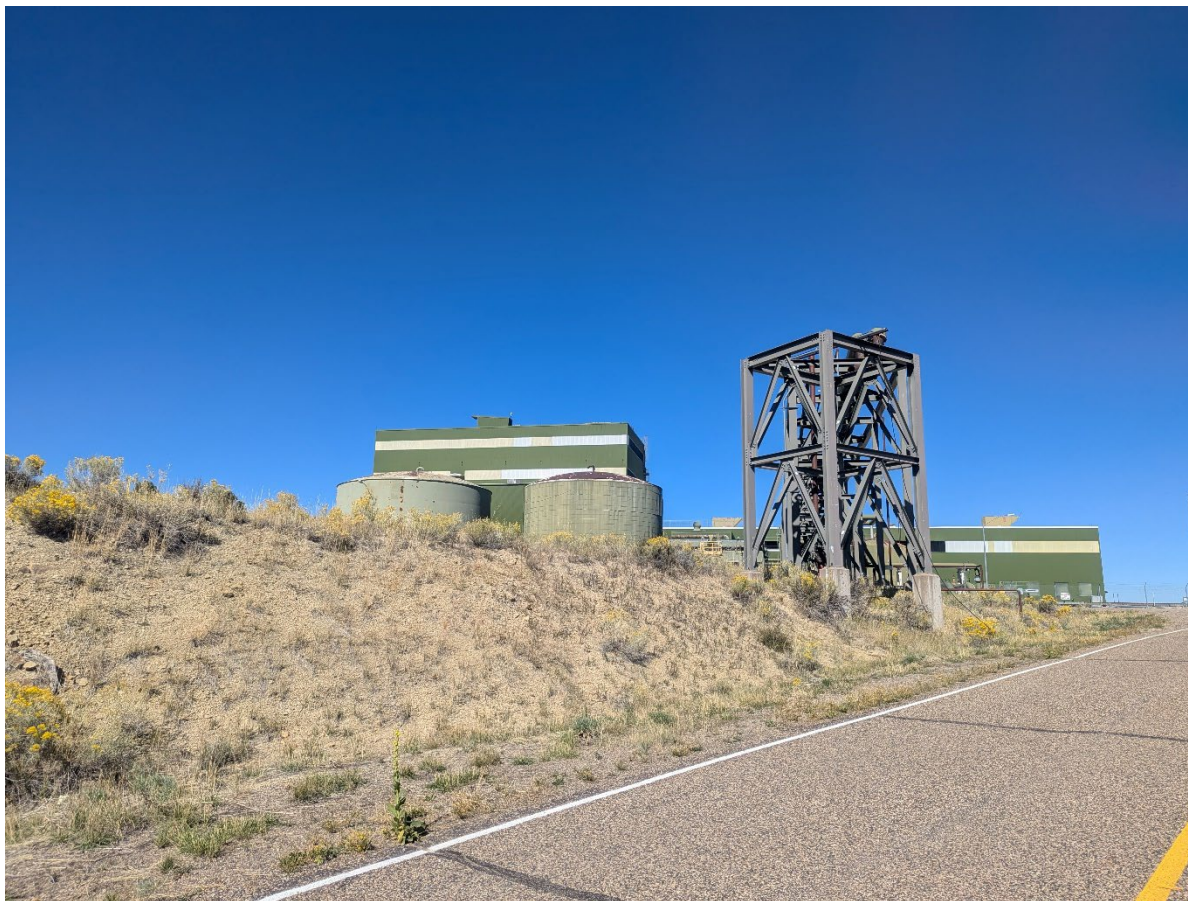
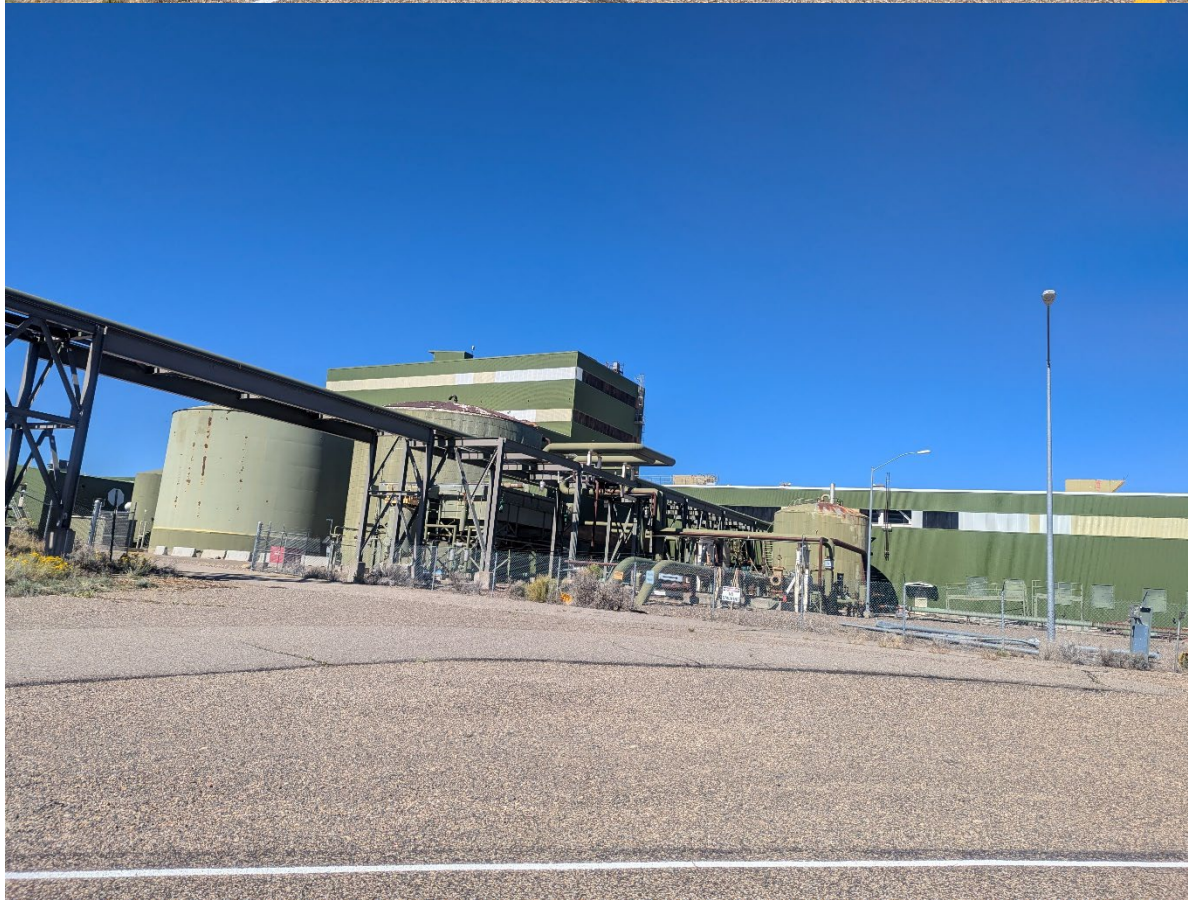
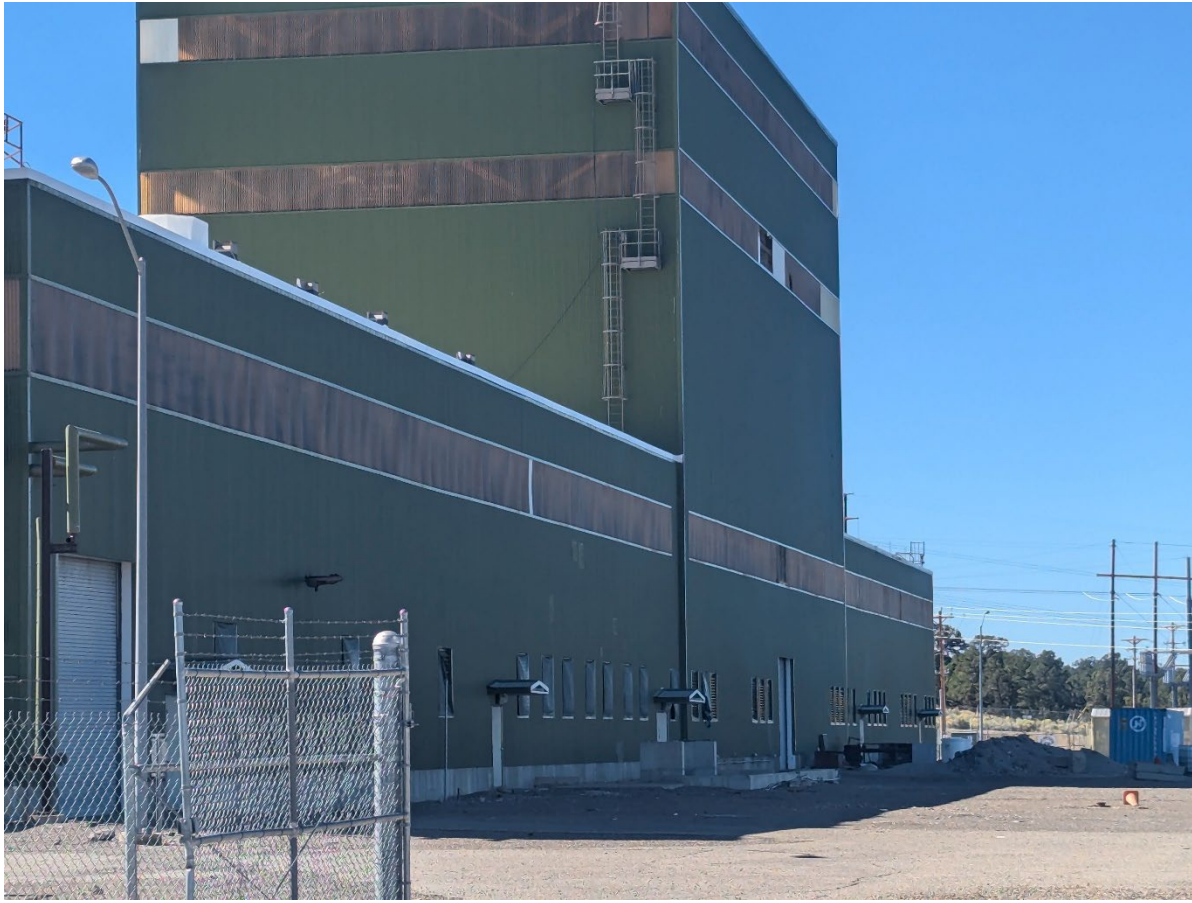
The plant area was also inspected, see photos 6-9. According to Ms. Akin this asset (building, equipment, land, etc.) has been transferred to another operator. Please provide the Division with documentation that American Soda is no longer responsible for the maintenance or removal of this feature. AM-1 changed the postmine land use for this area to commercial industrial, and therefore the area is eligible for a release.

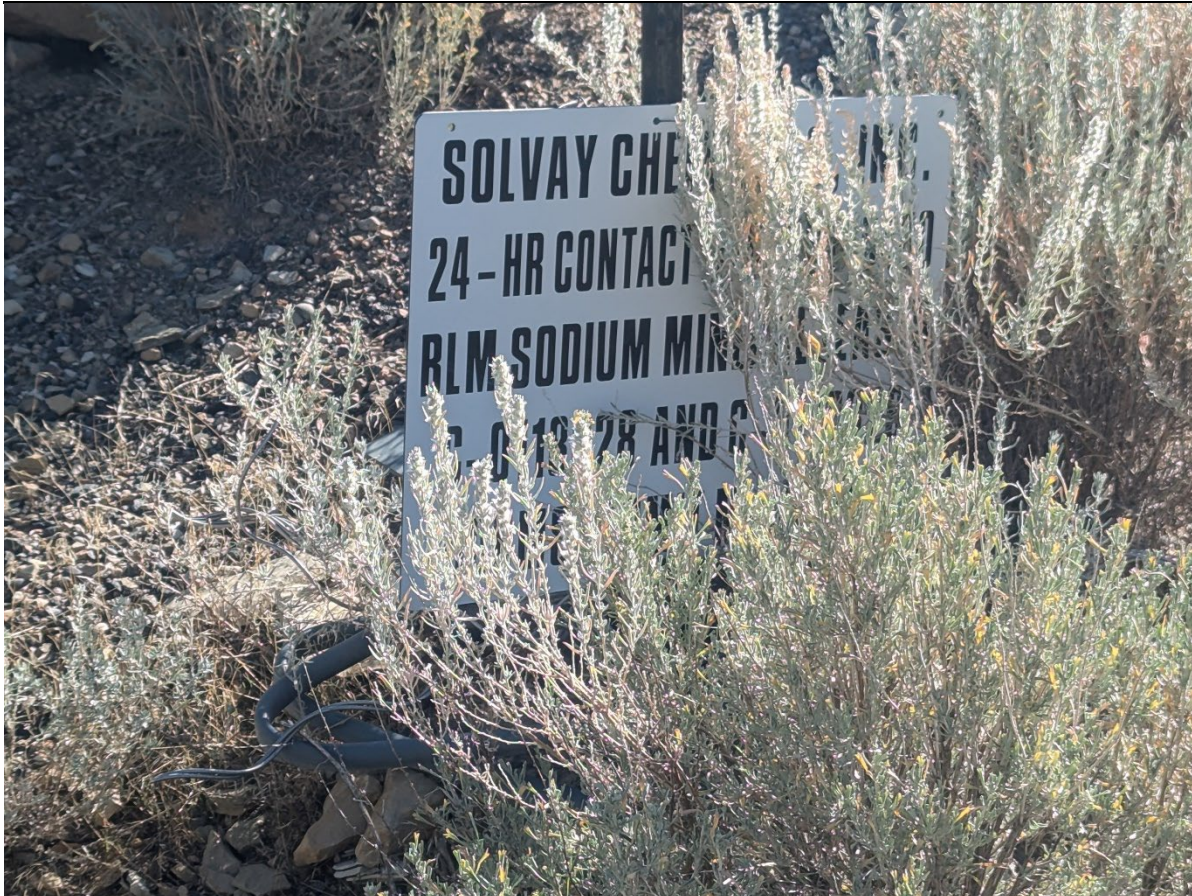
A mine sign was posted at the entrance to the mine site as required by Rule 3.1.12(1). (Photo 10).
