Two Rivers Pit M-1998-038 Inspection Report

MINERALS PROGRAM INSPECTION REPORT
PHONE: (303) 866-3567

MINE NAME: Two Rivers	MINE/PROSPECTING ID#: M-1998-038	MINERAL: Gravel	COUNTY: Pueblo
INSPECTION TYPE: Surety-Related Inspection	WEATHER: Cloudy	INSP. DATE: August 21, 2024	INSP. TIME: 08:00
OPERATOR: Fremont Paving & Redi-Mix, Inc.	OPERATOR REPRESENTATIVE: Ms. Jodi Schreiber	TYPE OF OPERATION: 112c - Construction Regular Operation	
REASON FOR INSPECTION: Surety Related	BOND CALCULATION TYPE: None	BOND AMOUNT: \$481,375.00	
DATE OF COMPLAINT: NA	POST INSP. CONTACTS: None	JOINT INSP. AGENCY: None	
INSPECTOR(S): Jocelyn Carter	INSPECTOR'S SIGNATURE:

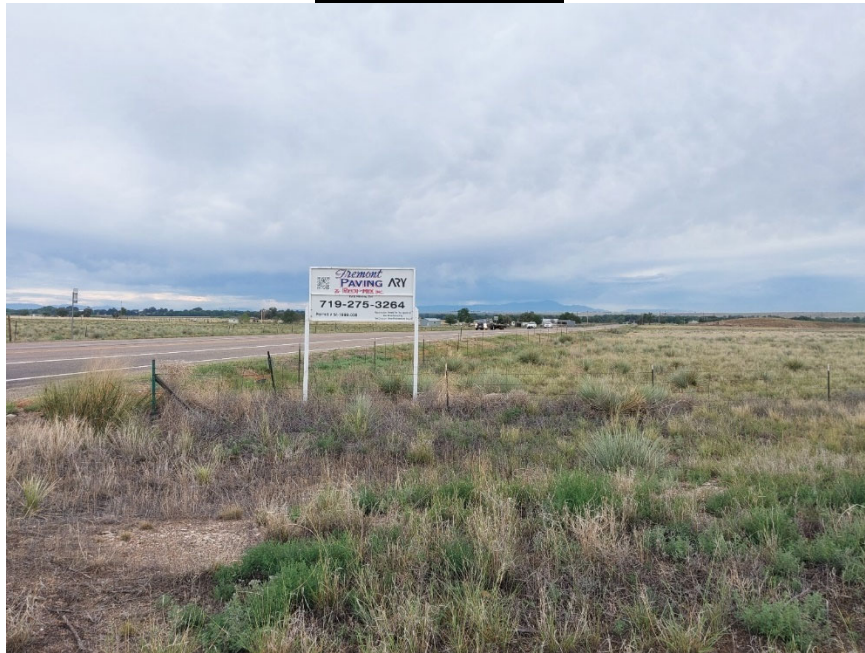
The mine sign required by Rule 3.1.12(1) was observed and located along Highway 50 (see Photo #1). Permit boundary markers were observed along the northwest portion of the boundary (see Photos #12 and #13). The northeast section of the permit boundary crosses to the north side of the Arkansas River before going to the south. This section of the permit boundary is not accessible. According to Ms. Shreiber, boundary markers are not posted in this section and will probably not be installed because of inaccessibility.

Photo #1: Mine sign in accordance with Rule 3.1.12(2), at the entrance of the mine, located on the north side of U.S. Highway 50.

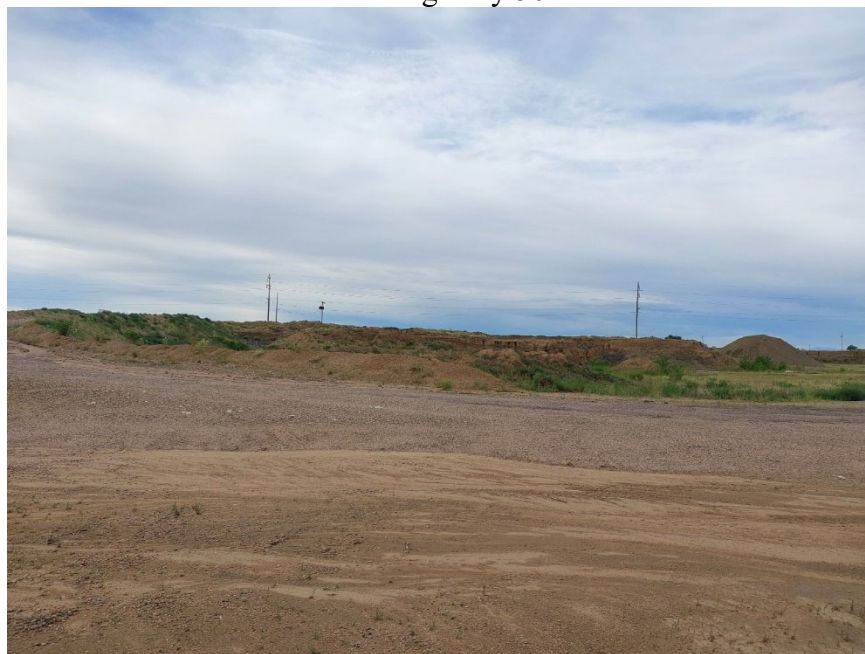
There were a few stockpiles observed in the current pit area, the south-central portion of Phase 1 (see map below and Photo #2). Ms. Shreiber confirmed that one of the stockpiles is a topsoil stockpile but was not able to confirm which stockpile is being preserved for topsoiling during reclamation operations.

Photo #2: View of the current operation area in Phase 1, looking south. The highwall can be seen in the far background with stockpiles in front.

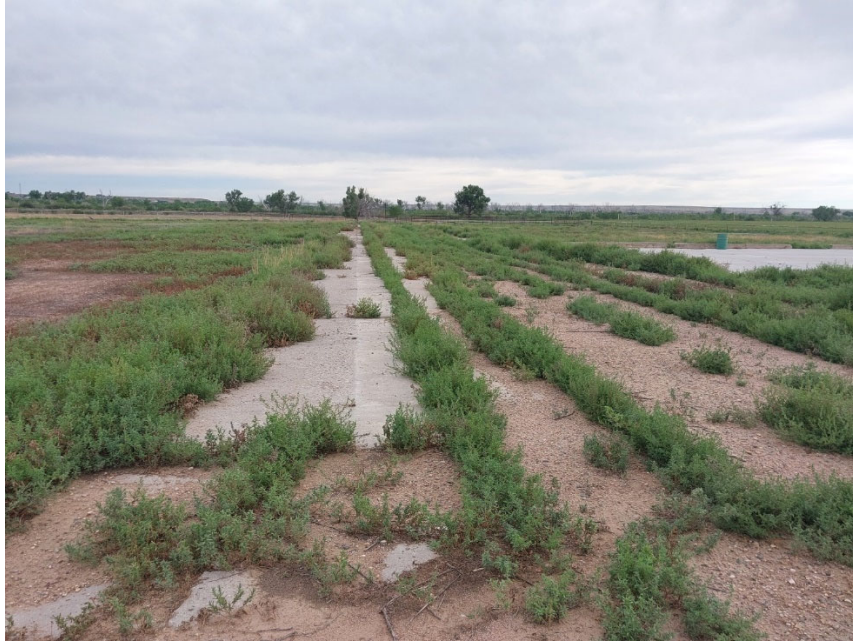
Photo #3: View of internal road that is located between Phase 2 and Phase 4, looking to the north northeast.

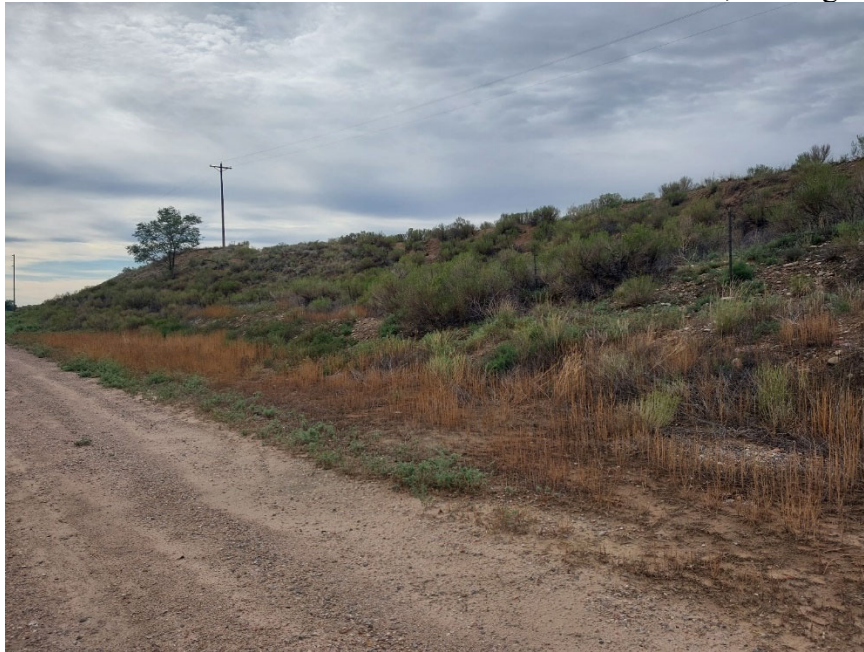
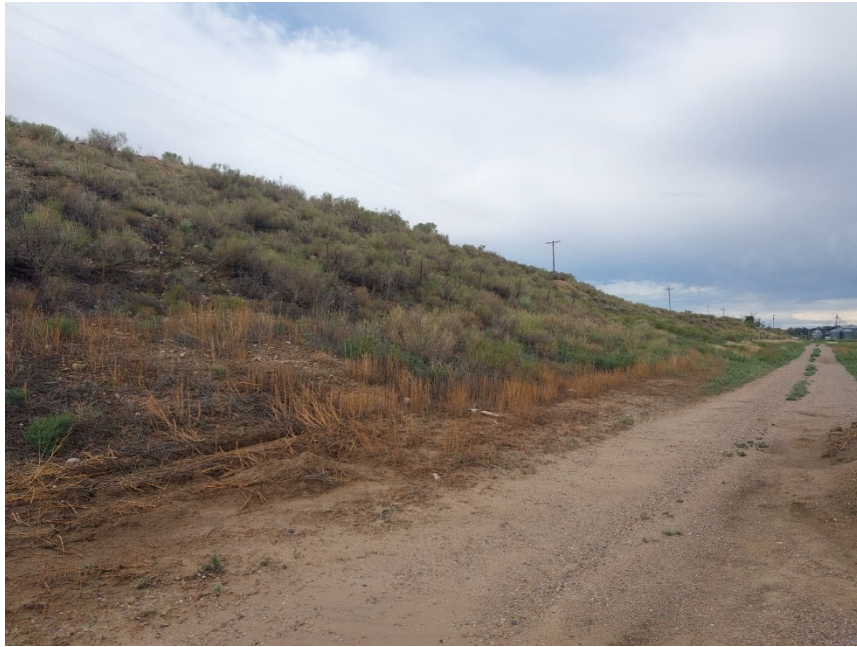
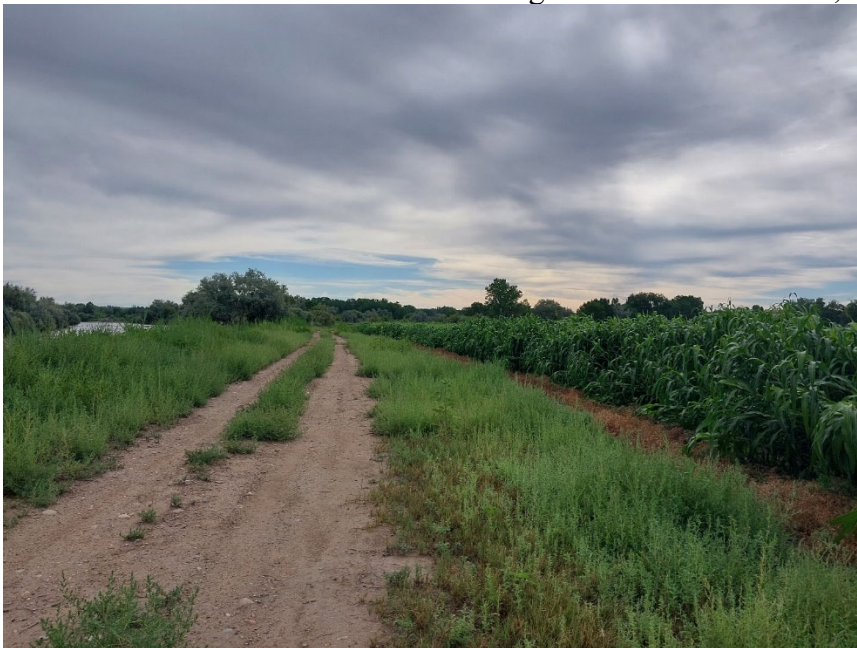
The roads appeared to be in good condition at the time of the inspection (see Photos #4 - #6).

Photo #4: View of internal road that runs east-west along the base of the terrace, looking southeast.

Photo #5: View of the internal road that runs east-west along the base of the terrace, looking to the west.

Photo #6: View of internal road the leads to the Arkansas River within Phase 6, looking northeast.

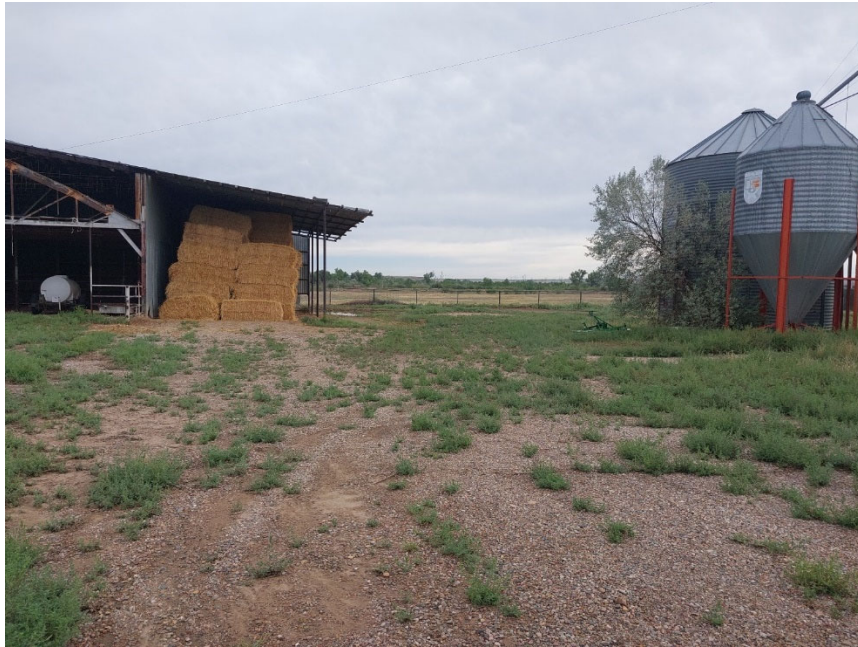
Photo #7: View of the structures located in Phases 2 and 3 that will be demolished as operations progress through Phase 2.

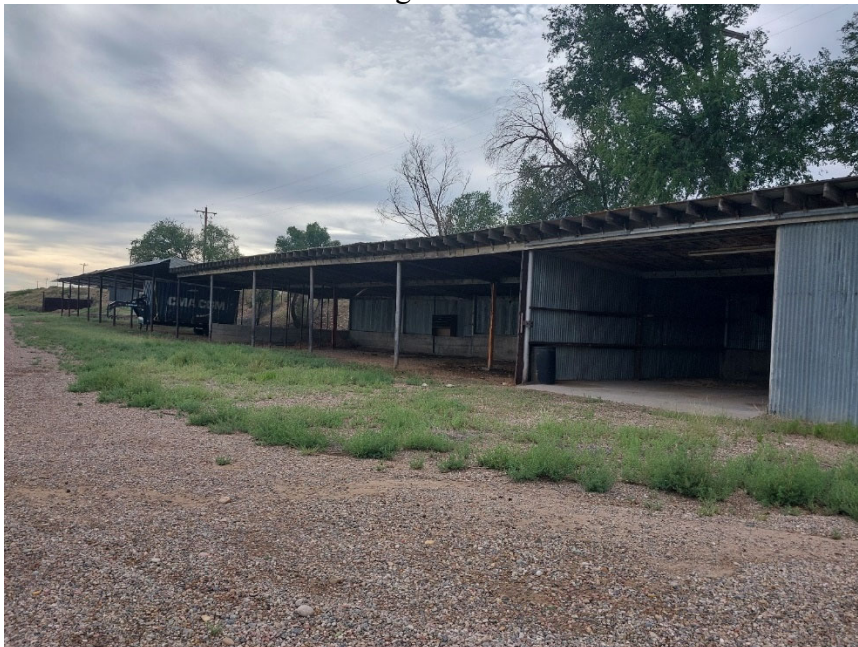
Photo #8: View of structure located in Phases 2 and 3 that will be demolished as operations progress through Phase 2.

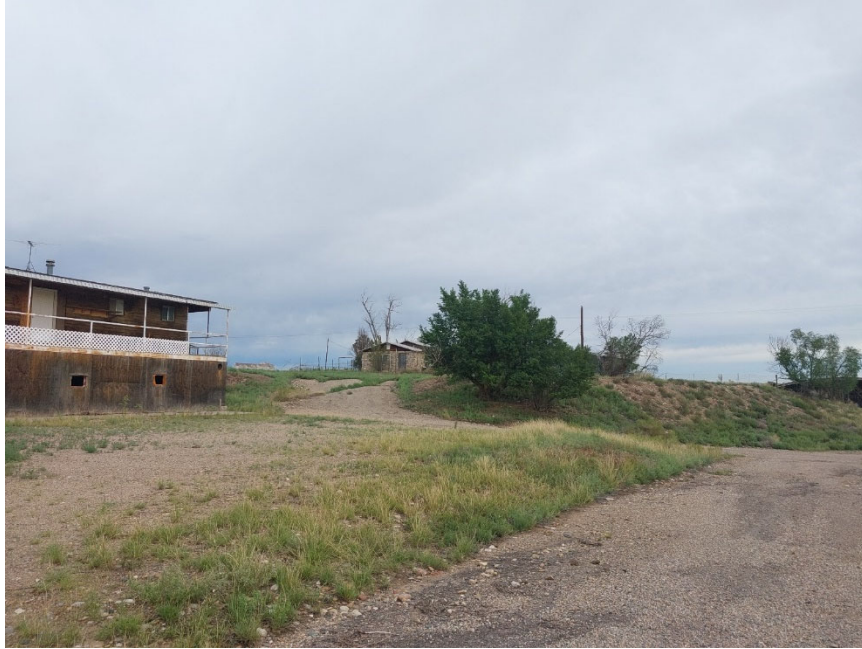
Photo #9: View of structures located in Phases 2 and 3 that will be demolished as operations progress through Phase 2.

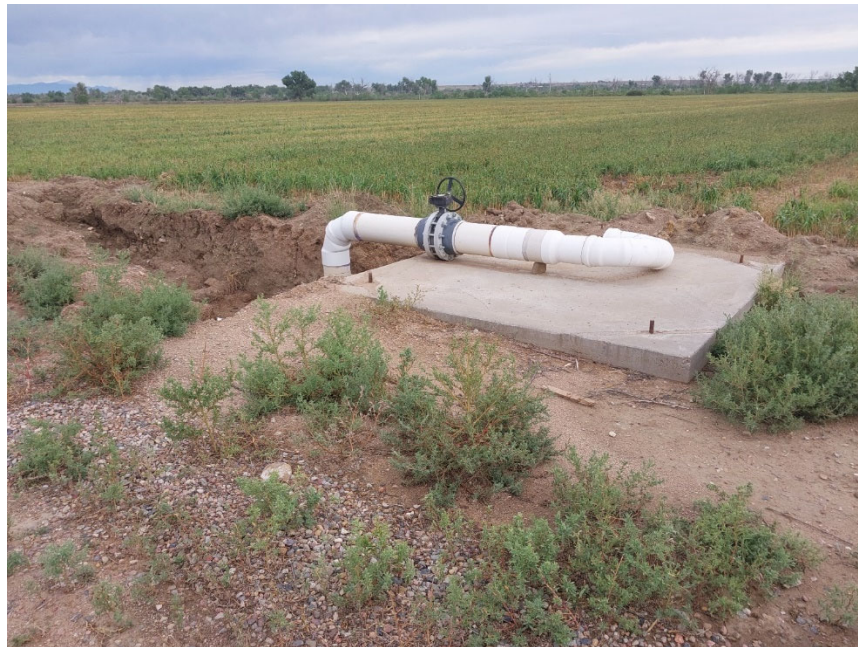
Mining activities were not occurring at the time of the inspection, there was no equipment on site. According to Ms. Schreiber, FPRM have not operated at the site since they acquired the site from the previous operator in February of 2023. There was a scale observed on site, located along the road in Phase 1 (see map), the scale will remain on site and be used by the Operator. There are several uninhabited structures within the permit area (see Photos #7 - #9). According to Ms. Schreiber and the AM-1 application, these structures will be demolished as mining operation progress into Phase 2. There is also an irrigation system on the permit area that will be removed during mining operations (see Photos #10 and #11). The irrigation system will be replaced during reclamation operations.

Photo #10: Irrigation system access point located on the lower portion of the permit area, looking to the northwest.

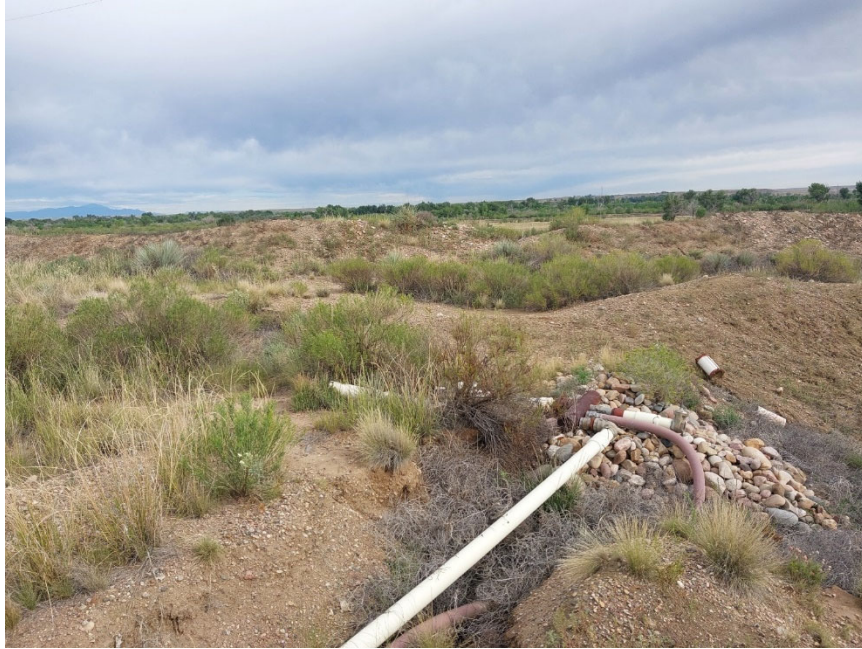
Photo #11: Irrigation system access point located on the higher terrace of the permit area, looking to the northwest.

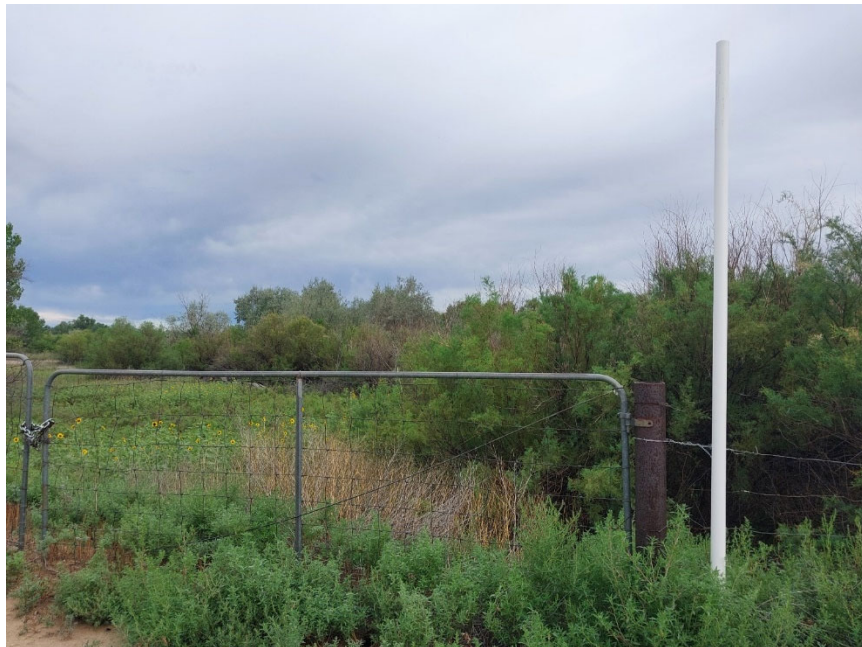
Photo #12: Permit boundary marker located on the east side of the Arkansas River at the northeast corner of the permit area.

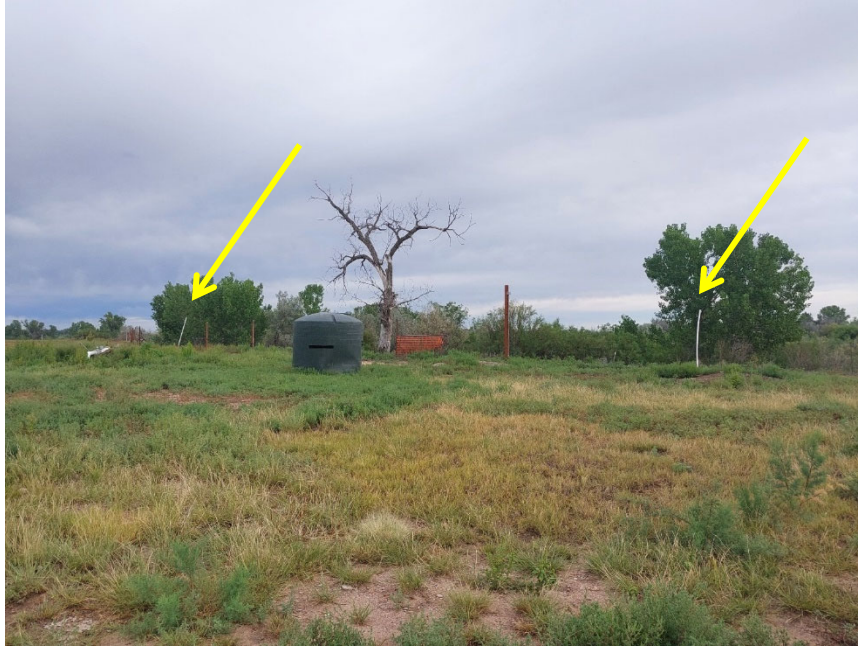
Photo #13: Permit boundary markers located along the north side of the permit area, west of the Arkansas River portion, yellow arrows pointing to the boundary markers.

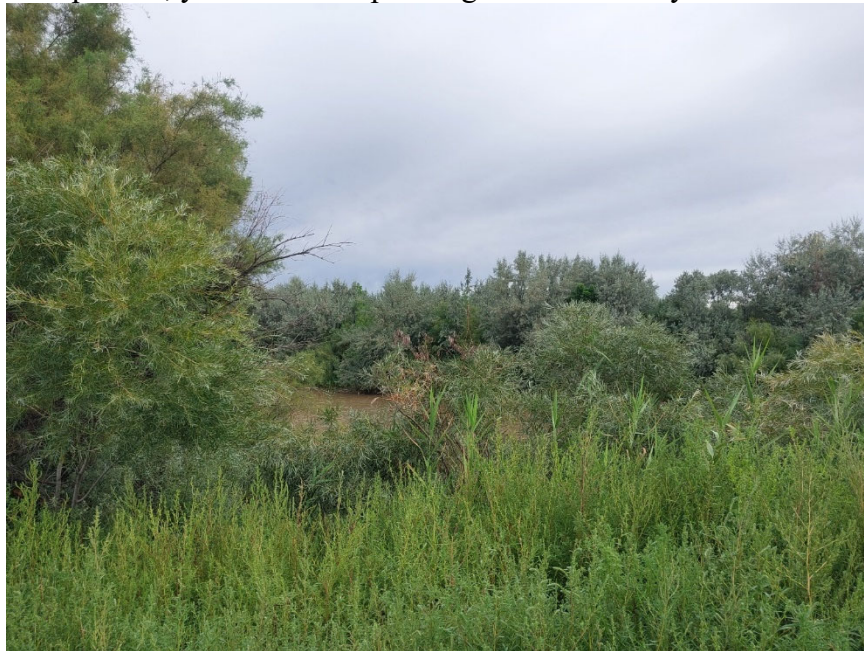
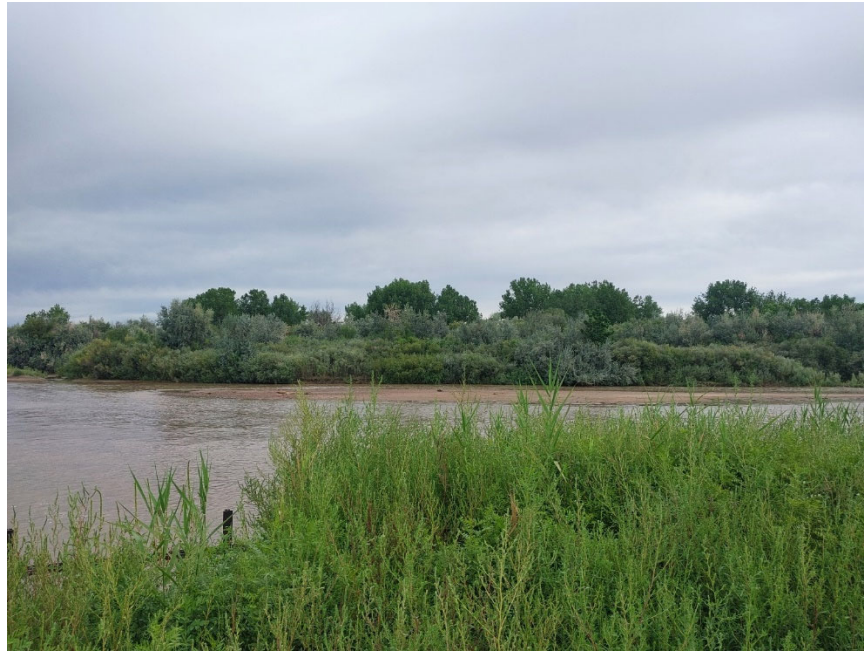
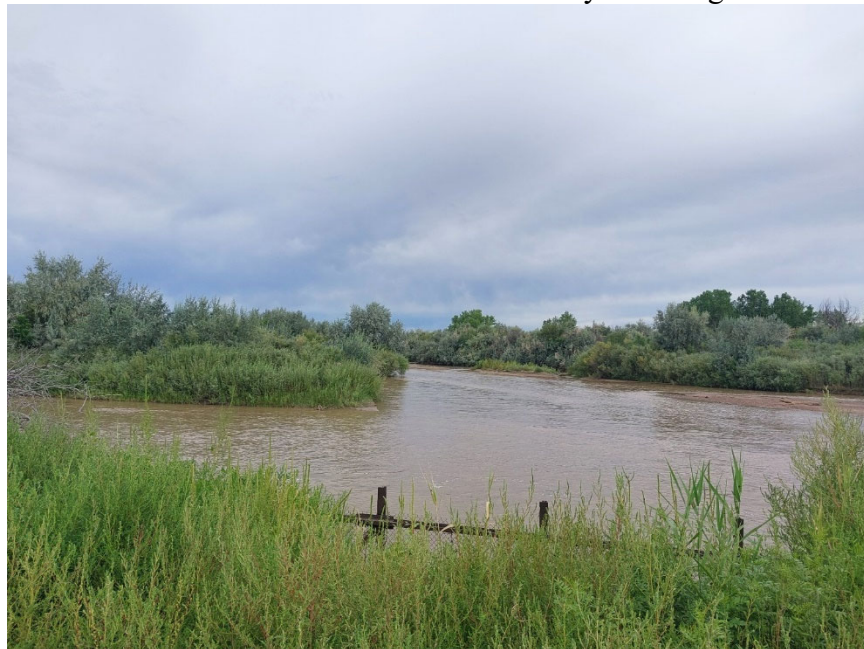
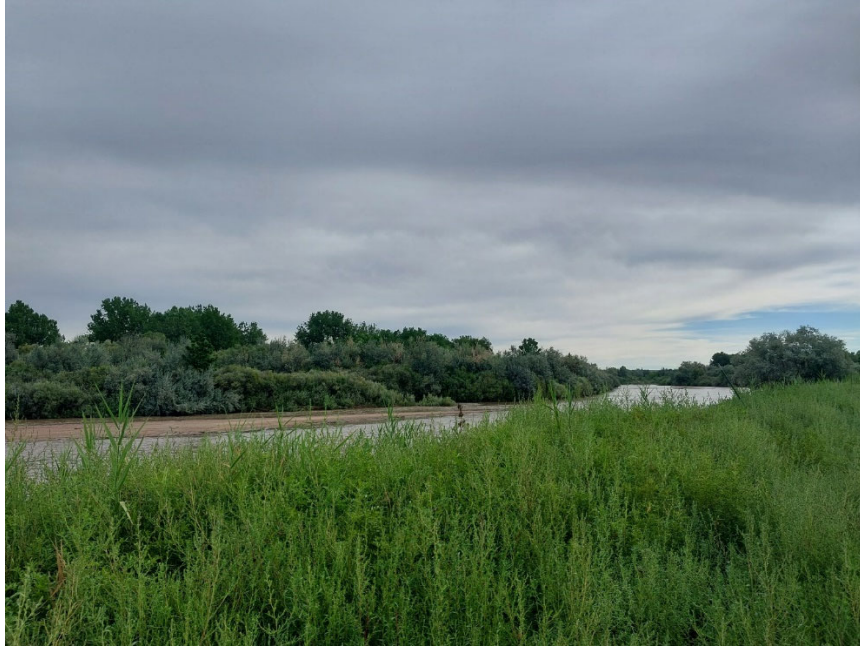
As stated, the proposed new permit boundary includes a section of the Arkansas River. The section of the river appeared to be stable with plenty of healthy habitat areas (see Photos #14 - #17). There did not appear to be any negative impacts to the wildlife in the area because of the mine operation to date. The operation and approved pit boundaries for future mining will maintain a distance of 400 feet from the riverbank.

Photo #14: View of the portion of the Arkansas River that is within the permit area. There are no boundary markers in this area due to inaccessibility. Looking north.

Photo #15: View of the portion of the Arkansas River that is within the permit area. There are no boundary markers in this area due to inaccessibility. Looking north.

Photo #16: View of the portion of the Arkansas River that is within the permit area. There are no boundary markers in this area due to inaccessibility. Looking upstream.

Photo #17: View of the portion of the Arkansas River that is within the permit area. There are no boundary markers in this area due to inaccessibility. Looking downstream.

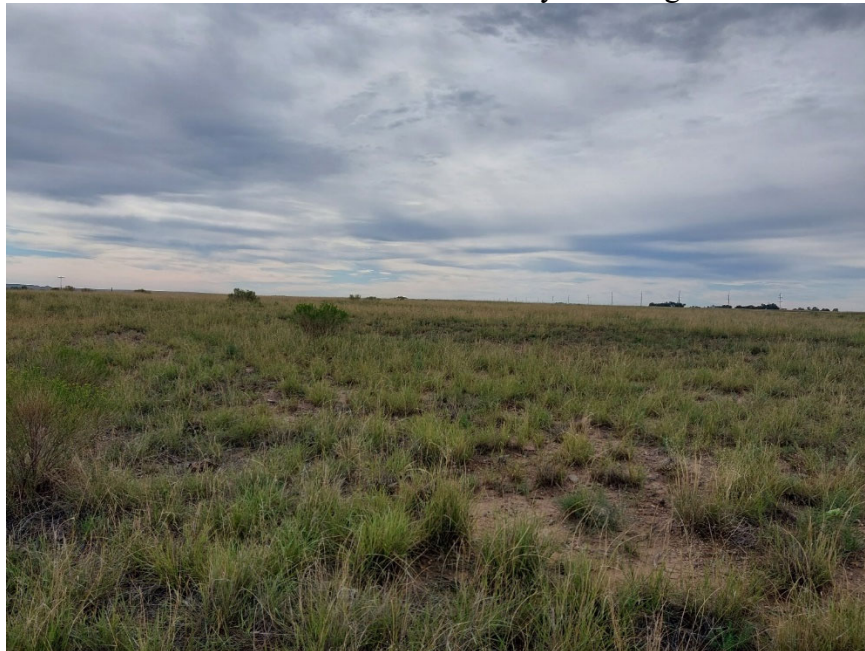
Photo #18: Area of Phase 1 that was reclaimed by previous operator. Looking to the southeast.

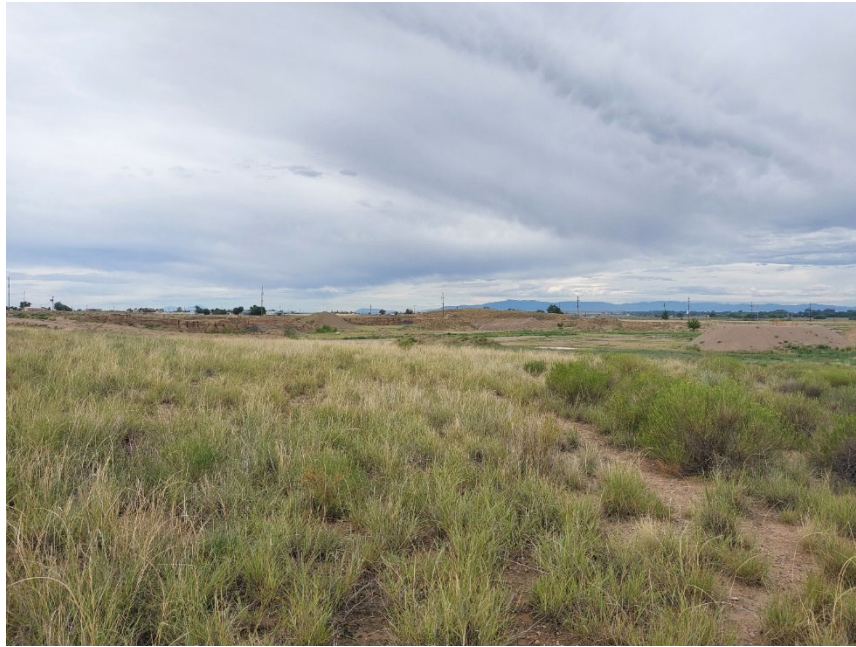
Photo #19: Area of Phase 1 that was reclaimed by previous operator. Looking to the southwest, the current mining area can be seen in the background.
