PERMIT INFORMATION

Permit Number: C-1981-015 Mine Name: Fruita No 1 & 2 Operator: Dorchester Coal Company Operator Address: Greg Lewicki 9054 South Forrest Drive Highlands Ranch, CO 80126	County: Mesa Operation Type: Underground Permit Status: Revoked Ownership: Private
	Operator Representative Present: NA
Operator Representative Signature: (Field Issuance Only)

INSPECTION INFORMATION

Inspection Start Date: September 30, 2024 Inspection Start Time: 10:50 Inspection End Date: September 30, 2024 Inspection End Time: 11:55		Inspection Type: Coal Complete Inspection Inspection Reason: Normal I&E Program Weather: Clear	
Joint Inspection Agency: None		Joint Inspection Contacts: None	
Post Inspection Agency: None		Post Inspection Contacts: None	
Inspector(s): Clayton Wein	Inspector's Signature: <i>Clayton Wein</i> Signature Date: 10/10/2024

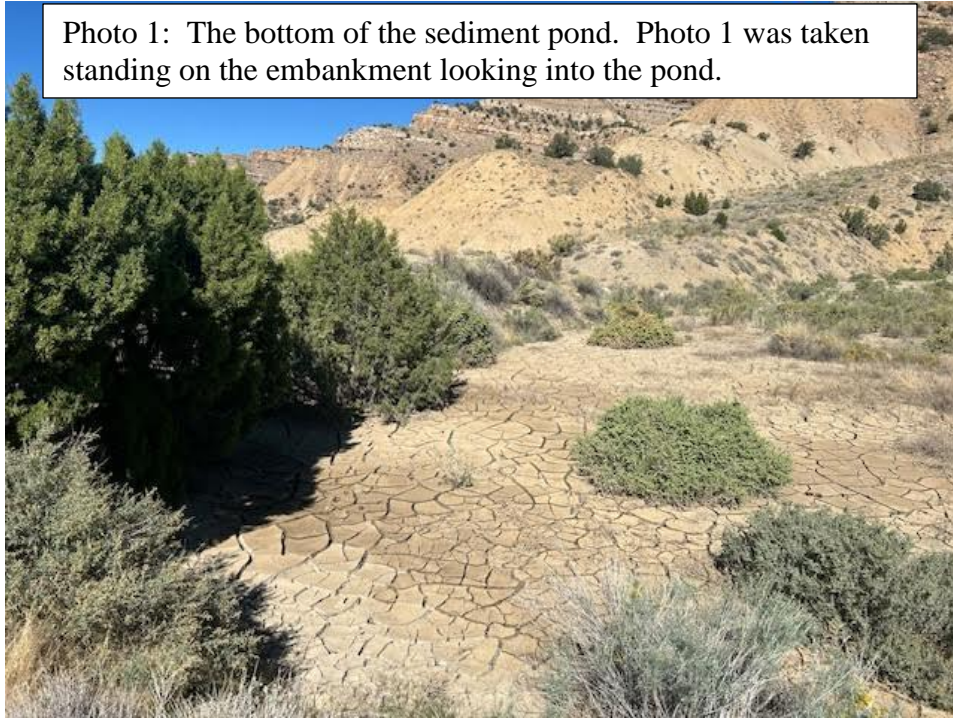
The sediment pond and reclaimed haul road showed evidence of recent water flows from large precipitation events that occurred in August and September. The sediment pond showed evidence of water being stored as dried mud was seen in the bottom of the pond (Photo 1). The outlet also showed indications of discharge due to flow marks in the sand and the plants in the bottom of the outlet all being folded over in the direction of the exit of the outlet. There were no off-site impacts observed. The spillway for the outlet appeared to have functioned as designed. Further up on the reclaimed haul road, there is a section where the reclamation curves around a steep drainage. There was evidence of flow across the reclamation and down the drainage into the sediment pond. There were plants folded over in the direction of the flow path and markings in the dirt from water were observed (Photo 2). The reclamation was stable and no down cutting of the reclaimed surface had occurred.

Photo 1: The bottom of the sediment pond. Photo 1 was taken standing on the embankment looking into the pond.

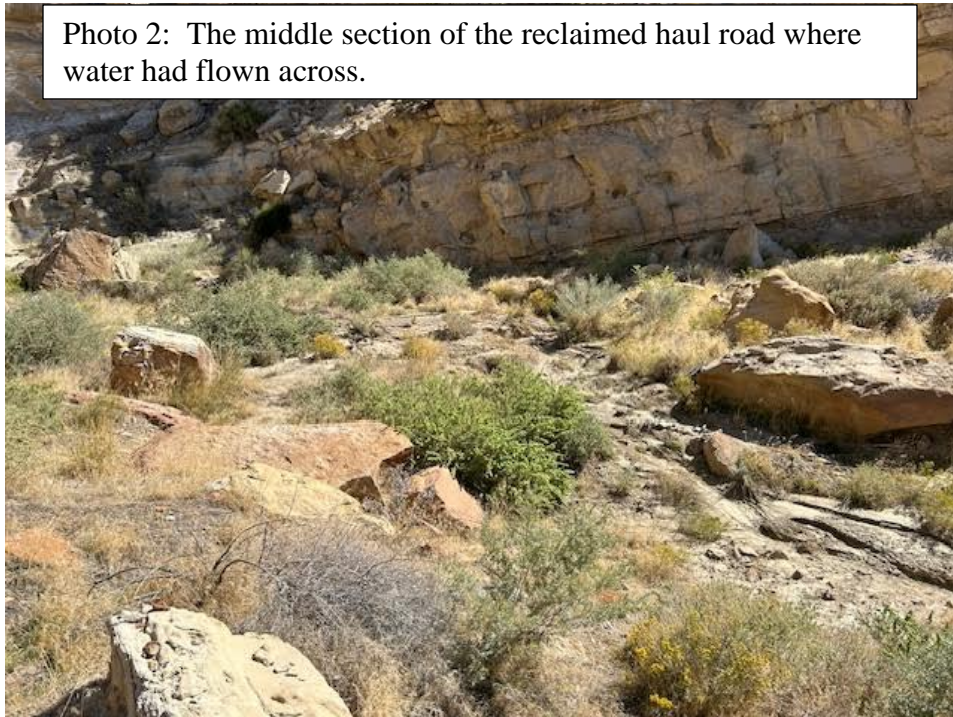
Photo 2: The middle section of the reclaimed haul road where water had flown across.

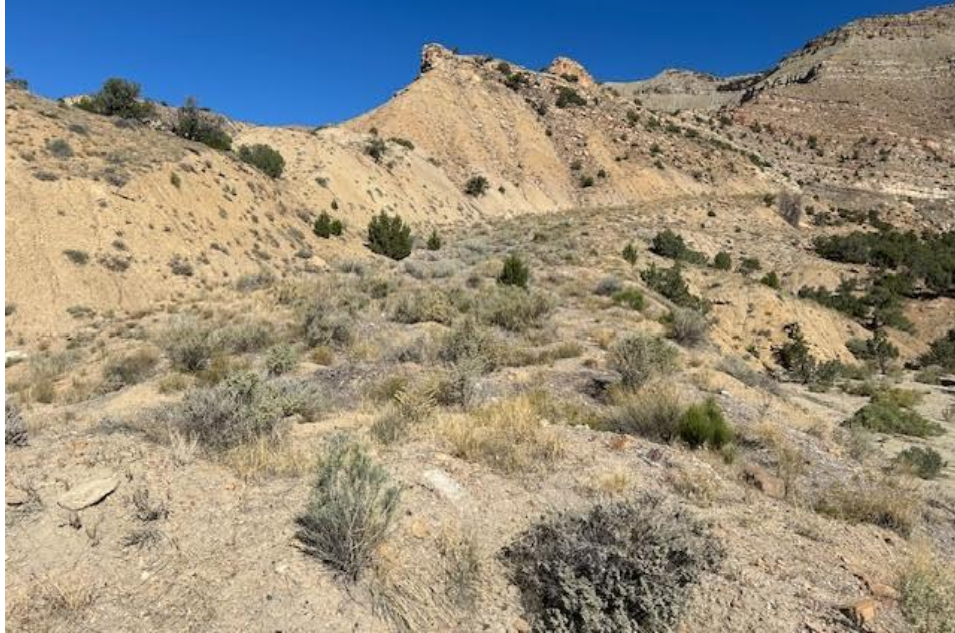
The reclaimed haul road extends from the southern portion of the permit area, up the face of the Bookcliffs, and onto the reclaimed portals bench. The lower portion of the reclaimed haul road was covered with vegetation and stable (Photo 3). There were a couple of places where there was evidence of minor amounts of water that had flowed across the reclaimed haul road and into the drainage on the east side. The flows did not cut into the reclamation and there were no indications of instability as a result of the flows. No off-site impacts were observed. The middle section of the reclaimed haul road was stable with vegetative cover (Photo 4). There were no erosional concerns identified. As mentioned above there was an area on the steep slope above and below the curve where water had flowed across the reclamation and down the drainage. The reclamation was stable and no damage had occurred. The upper portion of the reclaimed haul road was stable with no erosional features. The reclamation was covered with vegetation.

Photo 3: The Lower section of the reclaimed haul road.

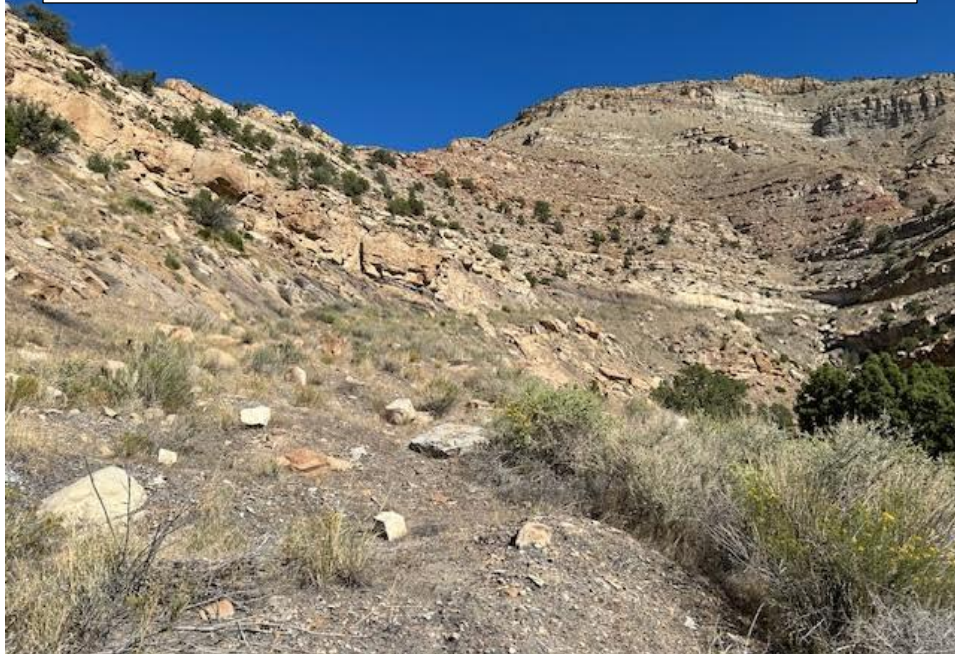
Photo 4: The middle section of the reclaimed haul road.

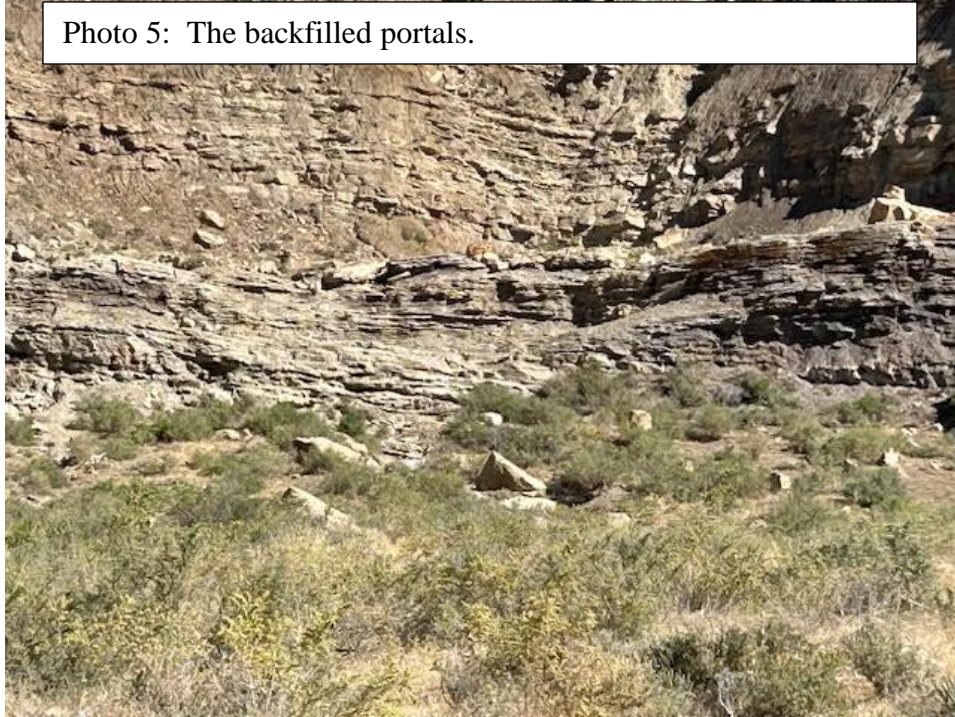
The reclaimed portals bench was stable with no erosional features. Vegetation on the reclamation was doing well. The slope covering the backfilled portals was stable with vegetative cover (Photo 5). There were no indications of sloughing or settling. The slope of the portals bench was stable and had some vegetative cover. The slope is steep and south-facing. No major erosional features were identified. There is a riprap lined channel from the edge of the portals bench, down the steep slope to the drainage below (Photo 6). The riprap channel was stable. There did not appear to be any significant changes in the minor erosion on the edges of the channel. The Division has documented the minor erosion in previous inspection reports.

Photo 5: The backfilled portals.

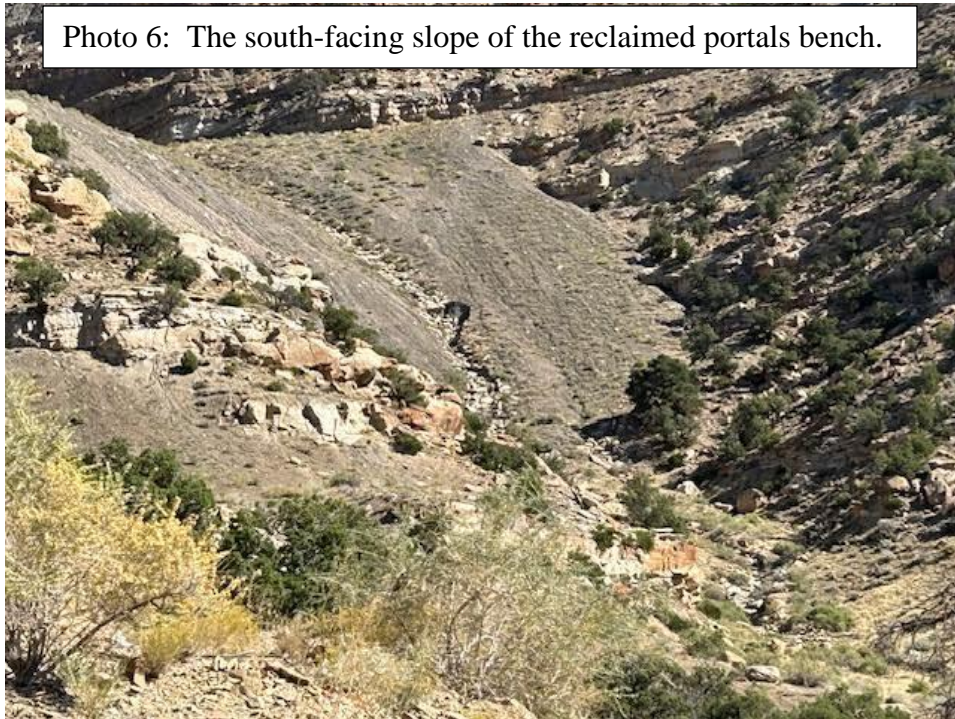
Photo 6: The south-facing slope of the reclaimed portals bench.
