MINERALS PROGRAM INSPECTION REPORT PHONE: (303) 866-3567

MINE NAME:	MINE/PROSPECTING ID#:	MINERAL:	COUNTY:
JH Sand & Gravel Pit #1	M-1979-131	Sand and gravel	Crowley
INSPECTION TYPE:	WEATHER:	INSP. DATE:	INSP. TIME:
Surety-Related Inspection	Cloudy	August 21, 2024	11:30
OPERATOR:	OPERATOR REPRESENTATIVE:	TYPE OF OPERATION:	
JH Sand & Gravel, LLC	Jim McCuistion and Gerald Korinek	112c - Construction Regular Operation	
REASON FOR INSPECTION:	BOND CALCULATION TYPE:	BOND AMOUNT:	
Surety Related	None	\$77,365.00	
DATE OF COMPLAINT:	POST INSP. CONTACTS:	JOINT INSP. AGE	NCY:
NA	None	None	
INSPECTOR(S):	INSPECTOR'S SIGNATURE:	SIGNATURE DATE:	
Jocelyn Carter	Jon Rato	October 10, 2024

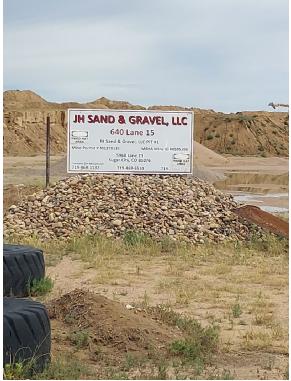
There is a sign posted at the entrance of the pit area as required by Rule 3.1.12(1) (see Photo #1). The permit boundary markers were verified (see Photos #2 and #3), there were a few markers that were no longer in place on Mr. Gerald and Norman Korinek's property. The missing markers are not considered an issue at this time as they would need to be removed based on the proposed permit boundary after the approval of the submitted AR-1.

Photo #1: Mine sign posted at pit entrance per Rule 3.1.12(1).

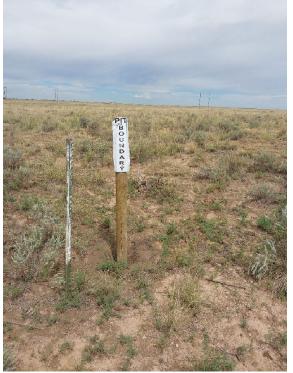
Photo #2: Permit boundary marker located in the northwest corner of the permit area, looking northwest.

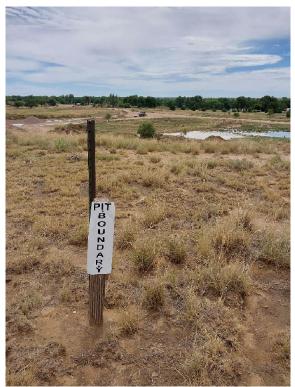
There was some standing water observed in the active pit area, given the recent storms in the area, the standing water is not considered an issue by the Division (see Photo #3).

Photo #3: Permit boundary marker located along County Lane 15 on the west section of the permit boundary, looking east southeast. Active pit area can be seen in the background with several pools of standing water from recent storm events.

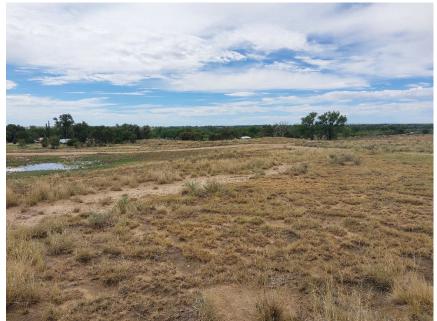
County Lane 15 runs north-south along the west side of the permit area and County Lane 13 runs east-west along the south portion of the permit area, both roads appeared to be in good condition with no issues (see Photos #4, #5, #6, and #12).

There were no noxious weeds observed on site in the areas that are being requested to be released. The vegetation on the lands being requested for release appeared to be well vegetated and includes some wooded vegetation (see Photos #4 - #13).

Photo #4: View from the lower west permit boundary area looking southeast at the land owned by Quarter Circle LT, Inc north of County Lane 13 that is proposed to be released.

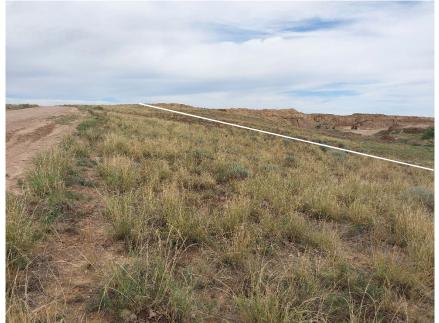
Photo #5: View of the permit area from the lower west portion of the permit boundary along County Lane 15 (seen on the left side) looking northeast at the section of land owned by Quarter Circle LT, Inc proposed for release located west of the active pit area, between the white line (approximate location) and the road.

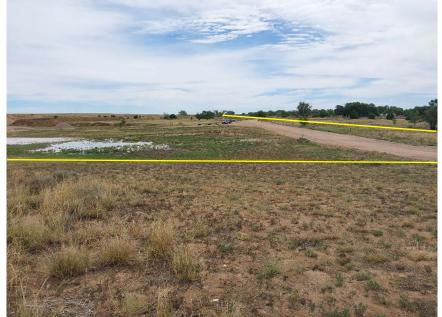
Photo #6: View from lower west portion of the permit area looking east at portions of land that are proposed for release. The yellow lines represent to approximate locations of the new permit boundary; land below the bottom line (owned by Quarte Circle LT, Inc) and above the top line (owned by Mr. Gerald and Norma Korinek) are proposed for release.

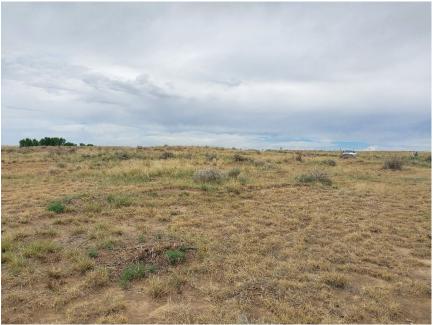
Photo #7: View of the lands located on Quarter Circle LT, Inc property in the southwest corner of the permit area, looking northwest.

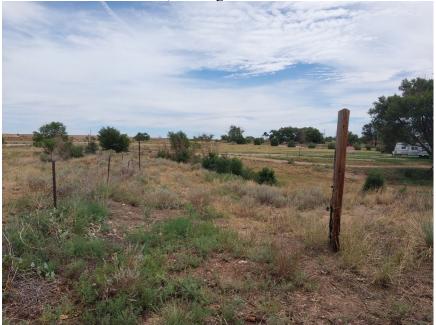
Lands owned by Mr. Korinek that are within the permit boundary have some equipment, implements, materials, some pre-law disturbances, and a small structure on site (see Photos #8 - #11, #13, and #14). When asked about his satisfaction with the reclamation of the area during the inspection, Mr. Korinek stated that he is happy with the conditions and does not object to the lands being released from the permit area.

Photo #8: View of the lands located on Mr. Gerald and Norma Korinek's property in the southwest corner of the permit area, looking east.

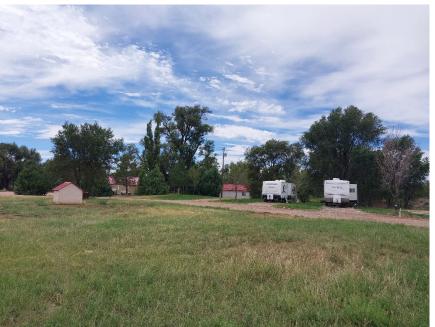
Photo #9: View of the lands located on Mr. Gerald and Norma Korinek's property in the southwest corner of the permit area, looking south.

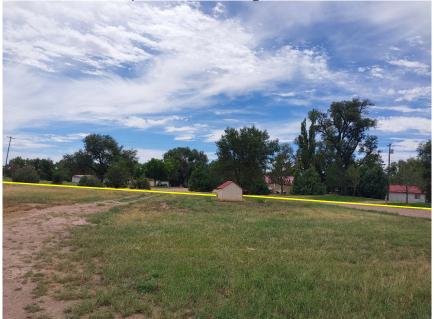
Photo #10: View of the lands located on Mr. Gerald and Norma Korinek's property in the southwest corner of the permit area, looking southeast. Lands below the yellow line are proposed for release.

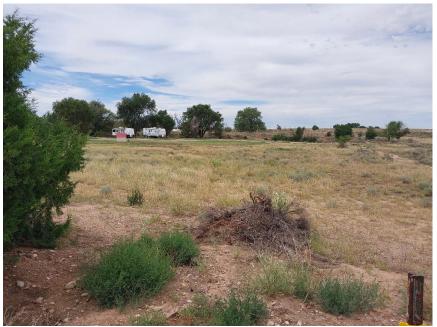
Photo #11: View of the lands located on Mr. Gerald and Norma Korinek's property in the southwest corner of the permit area, looking west from the east property line.

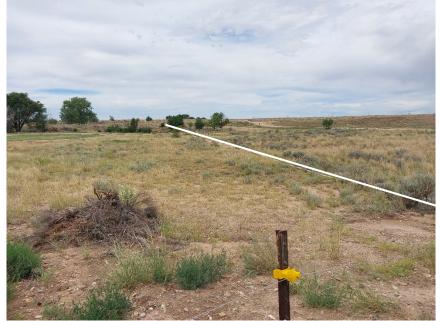
Photo #12: View of the lands located on Mr. Gerald and Norma Korinek's property in the southwest corner of the permit area, looking west from the east property line. County Lane 13 can be seen on the right side of the photo, the area to the left of the while line is proposed for release.

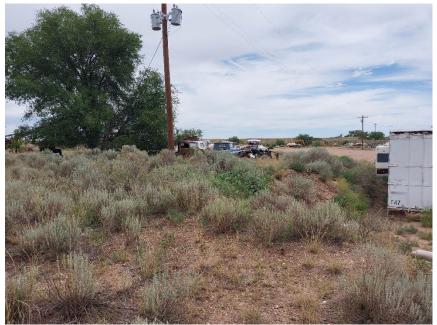
Photo #13: View of lands located on Mr. Gerald and Norma Korinek's property, looking to the northeast from the west portion of the permit boundary. Equipment that can be associated with mining can be seen in the photo.

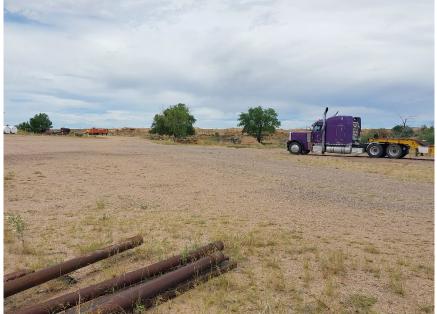
Photo #14: View of lands located on Mr. Gerald and Norma Korinek's property, looking north from the southeastern portion of the permit area. Materials and equipment that can be associated with mining can be seen in the photo.
