**MINERALS PROGRAM INSPECTION REPORT**  
**PHONE: (303) 866-3567**

<b>MINE NAME:</b> Nahcolite Project	<b>MINE/PROSPECTING ID#:</b> M-1983-194	<b>MINERAL:</b> Carbonates	<b>COUNTY:</b> Rio Blanco
<b>INSPECTION TYPE:</b> Monitoring	<b>WEATHER:</b> Clear	<b>INSP. DATE:</b> September 25, 2024	<b>INSP. TIME:</b> 13:30
<b>OPERATOR:</b> Natural Soda LLC	<b>OPERATOR REPRESENTATIVE:</b> Roy McClung	<b>TYPE OF OPERATION:</b> 112d-3 - Designated Mining Operation	
<b>REASON FOR INSPECTION:</b> Normal I&E Program	<b>BOND CALCULATION TYPE:</b> None	<b>BOND AMOUNT:</b> \$4,466,425.00	
<b>DATE OF COMPLAINT:</b> NA	<b>POST INSP. CONTACTS:</b> None	<b>JOINT INSP. AGENCY:</b> U.S.BLM	
<b>INSPECTOR(S):</b> Amy Yeldell	<b>INSPECTOR'S SIGNATURE:</b>

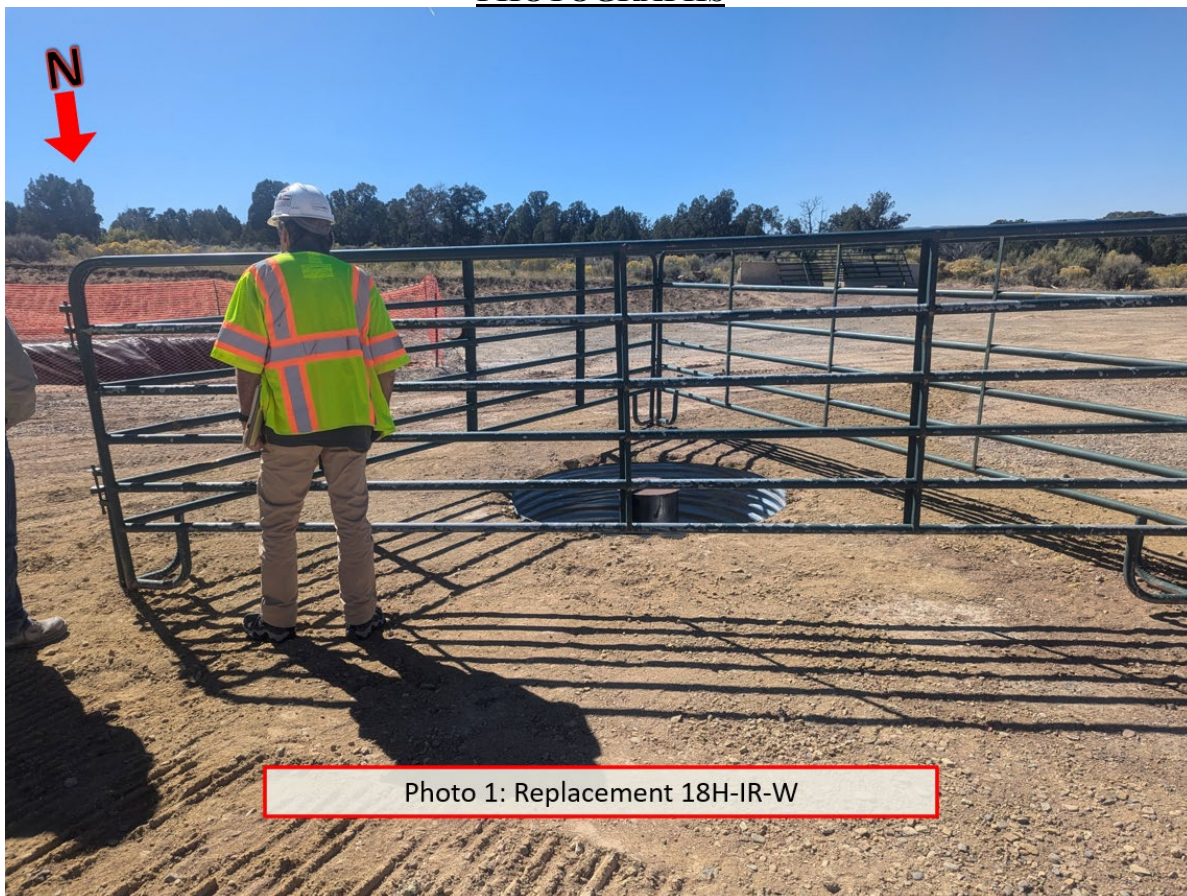
The replacement 18H-IR-W well has the conductor set (Photo One). Drilling is anticipated to start in early October. The existing pit has been cleaned out to make more room to accommodate the new drill cuttings. The corner of the pad had to get reshaped for the new well location. The corner of the topsoil piled was carved out and the soil moved to increase the footprint of the pad within the existing disturbance (Photo Two).

Photo 1: Replacement 18H-IR-W

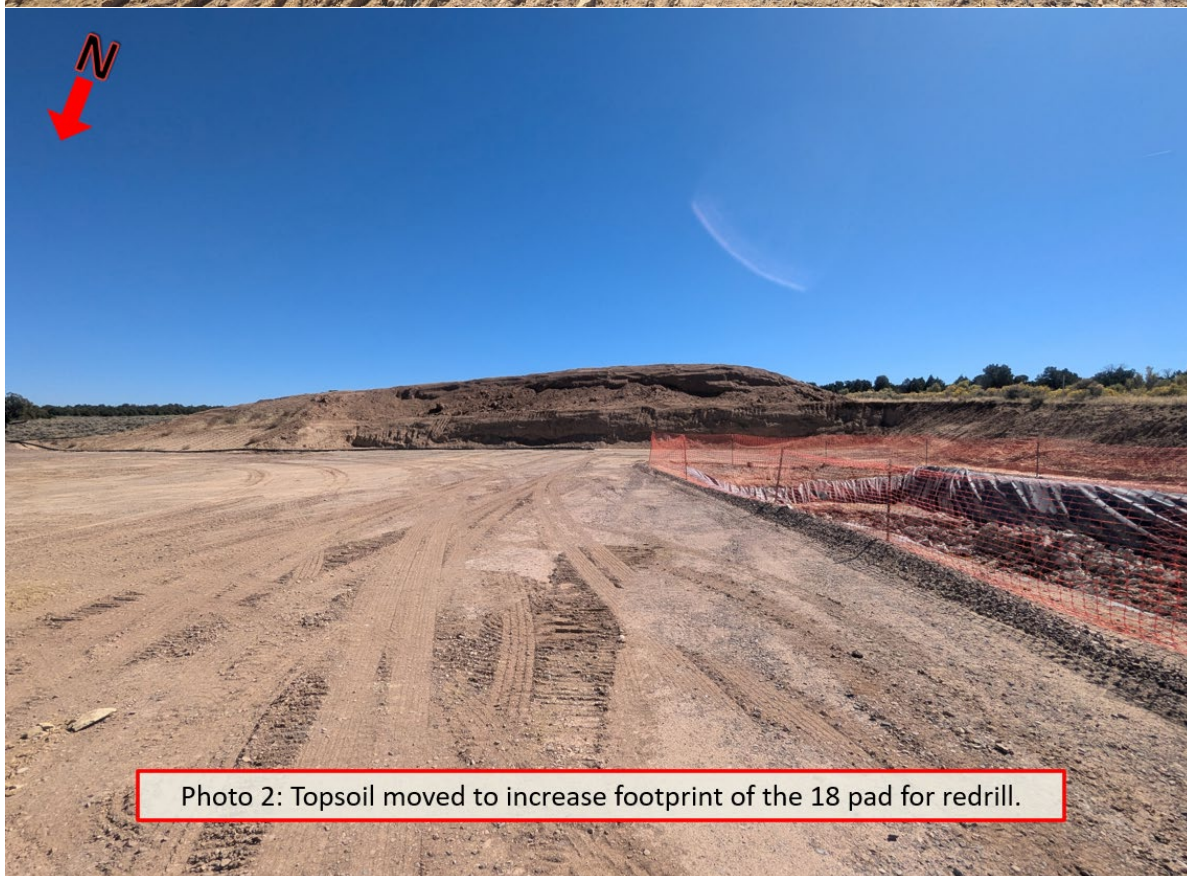
The 18H-1V topsoil stockpile does not appear to have been seeded yet. Given that it will not be reapplied in the near future. In general all topsoil shall be reseeded. Likely the portion of the 18H-IR-E topsoil that was moved also need additional seeding.

Photo 2: Topsoil moved to increase footprint of the 18 pad for redrill.

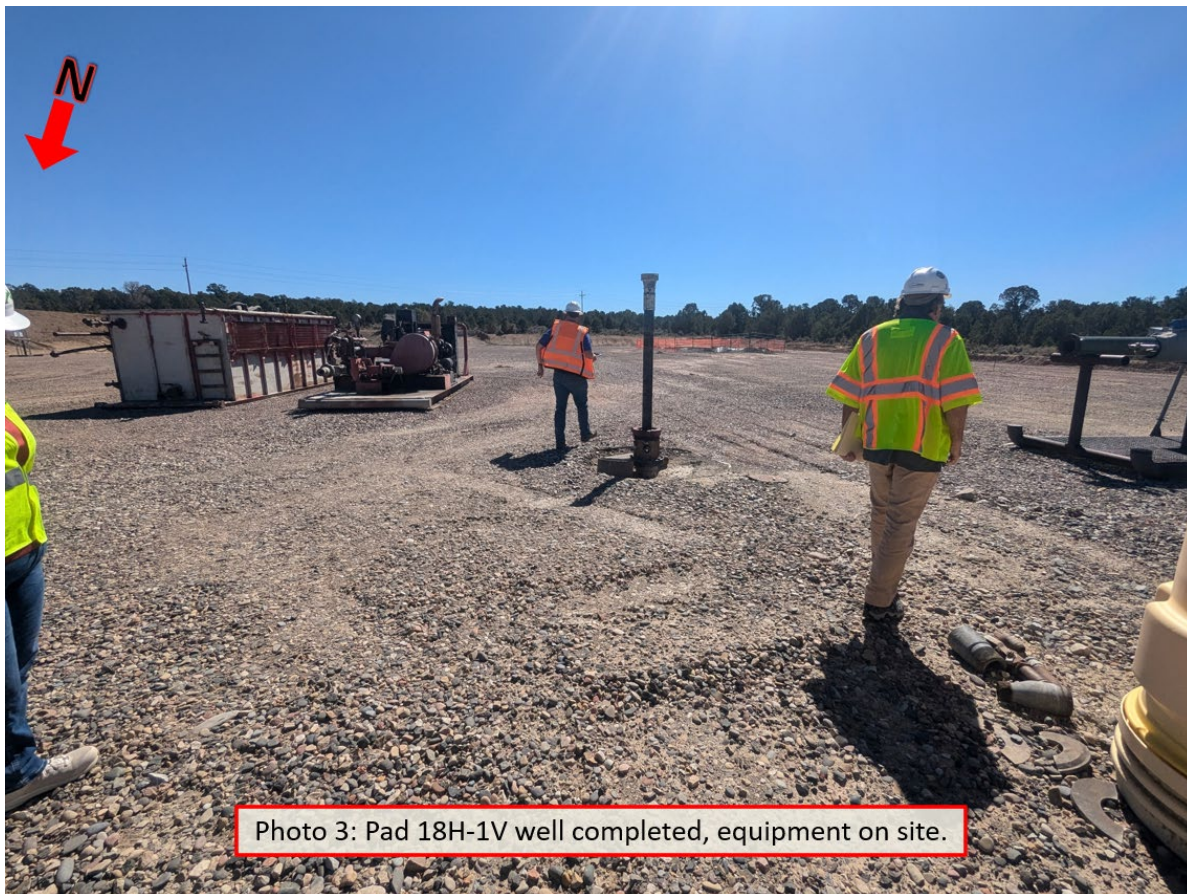
18H-1V is completed but not tied in. The pit remains open. The drill rig is no longer on site. Some equipment associated drilling remains on site (Photo Three). The previously noted spill has been cleaned up (Photo Four).

Photo 3: Pad 18H-1V well completed, equipment on site.

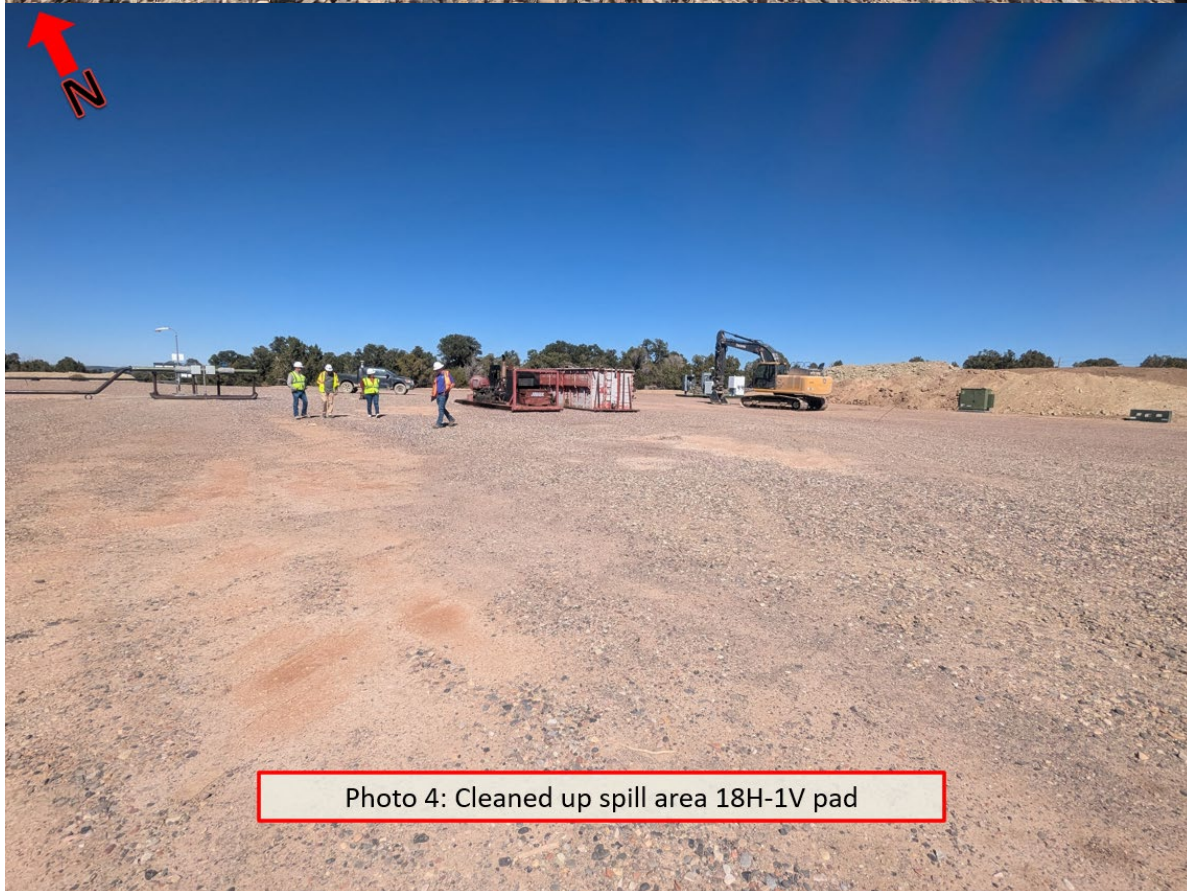
Photo 4: Cleaned up spill area 18H-1V pad

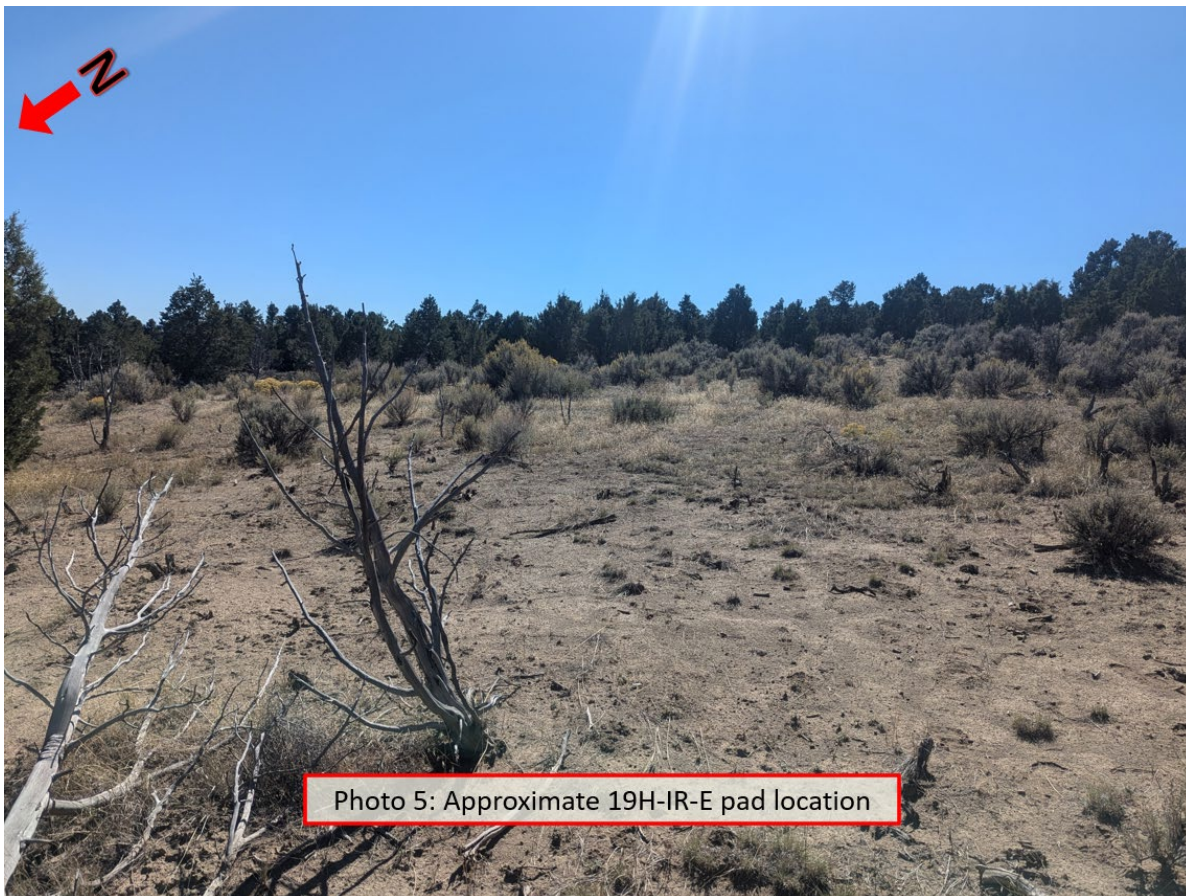
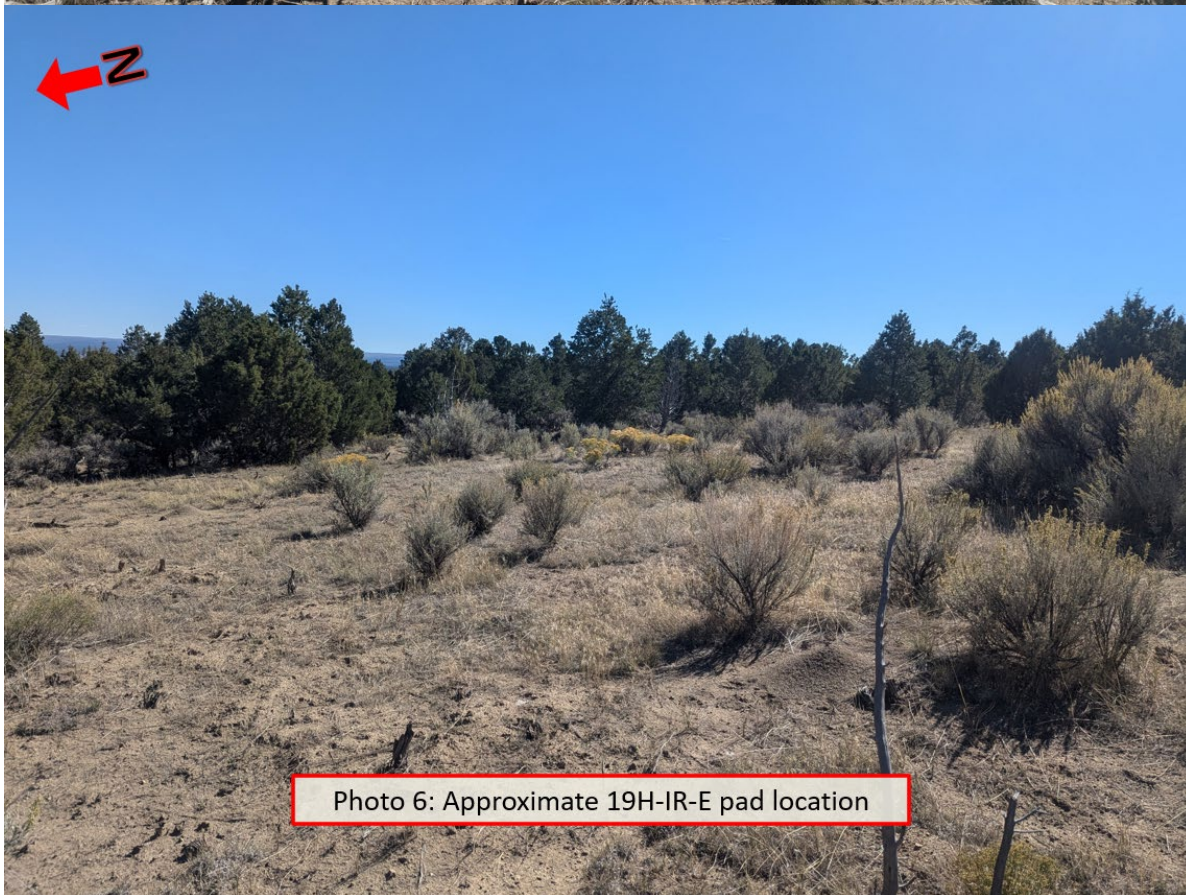
The Division observed the anticipated location of the 19H-IR-E well pad. The APD has been sent to the BLM but to date the Division has no revision regarding this new pad location. A short access road will be required. The pad location is a mix of shrubs and grasses with the understory being primarily Cheatgrass. Some woody material removal will be required. (Photos Five and Six)

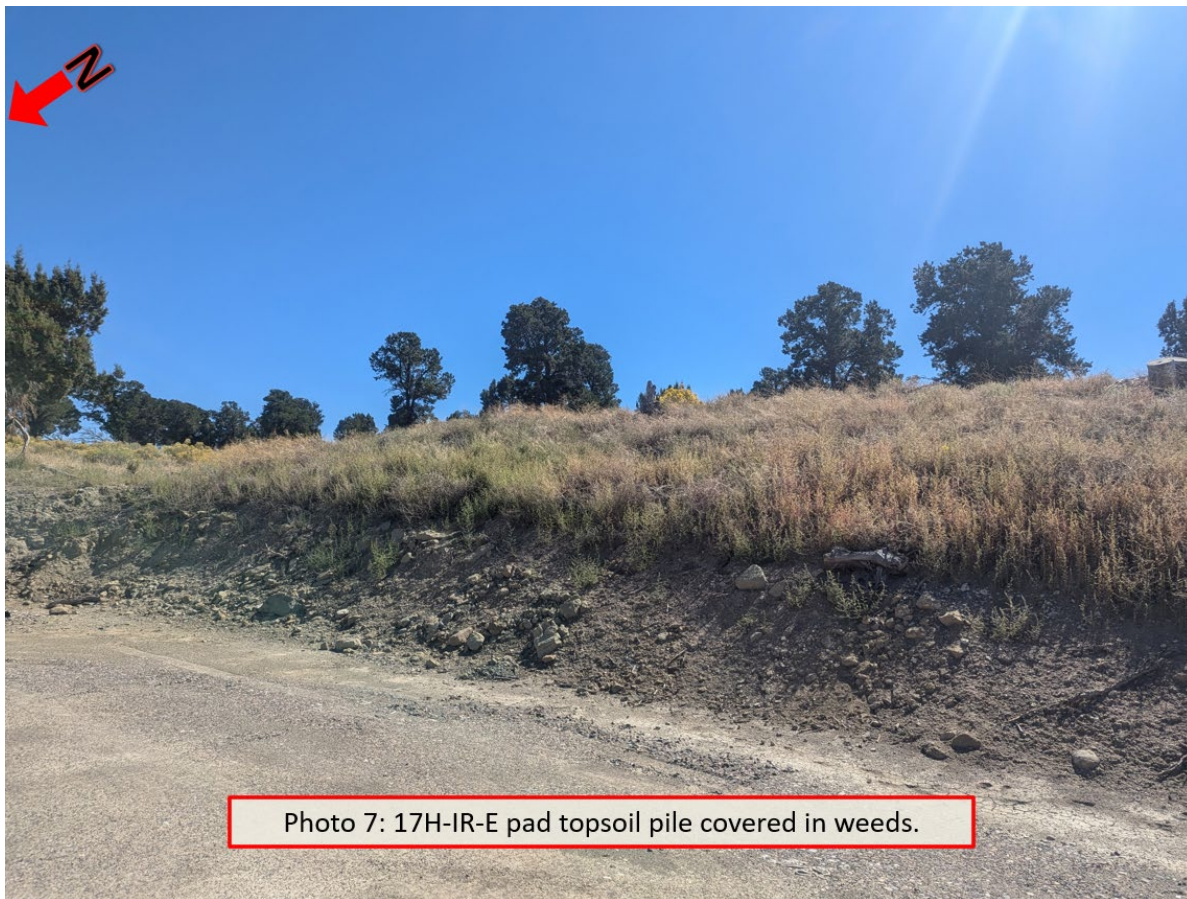
The topsoil stockpile of the 17H-IR-E pad is overrun with Russian Thistle (Photos Seven and Eight). Noxious weed management applies to topsoil stockpiles as well as active and reclaimed well pad areas. The operator needs to aggressively manage the noxious weeds on this stockpile. Following up by seeding the stockpile will help protect the stockpile moving forward.

Photo 7: 17H-IR-E pad topsoil pile covered in weeds.

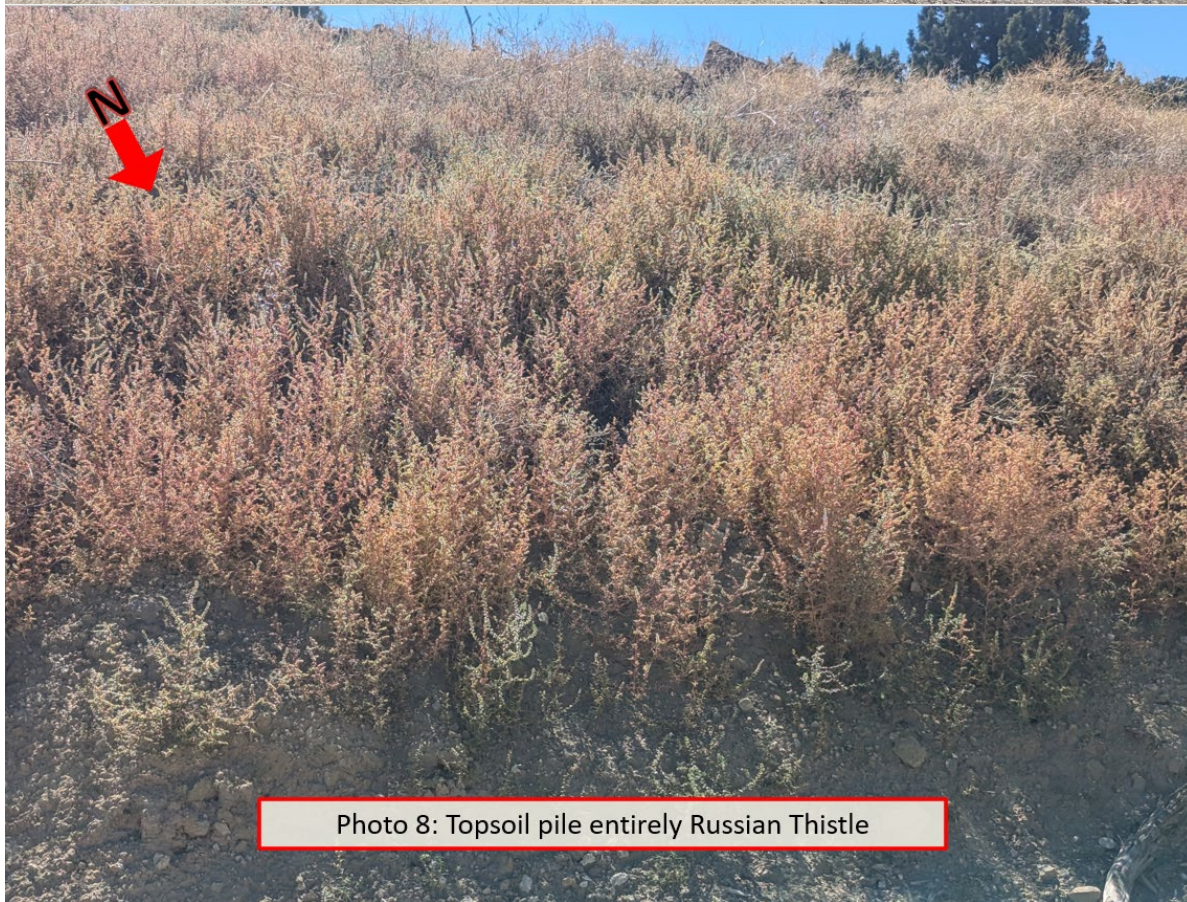
Photo 8: Topsoil pile entirely Russian Thistle
