MINERALS PROGRAM INSPECTION REPORT
PHONE: (303) 866-3567

MINE NAME: Tellier Gravel Pit	MINE/PROSPECTING ID#: M-1998-058	MINERAL: Sand and gravel and material for construc	COUNTY: Routt
INSPECTION TYPE: Monitoring	WEATHER: Clear	INSP. DATE: September 20, 2024	INSP. TIME: 08:00
OPERATOR: Oldcastle SW Group, Inc. dba United Compa	OPERATOR REPRESENTATIVE: Jesse Farmer	TYPE OF OPERATION: 112c - Construction Regular Operation	
REASON FOR INSPECTION: Normal I&E Program	BOND CALCULATION TYPE: None	BOND AMOUNT: \$104,116.00	
DATE OF COMPLAINT: NA	POST INSP. CONTACTS: None	JOINT INSP. AGENCY: None	
INSPECTOR(S): Brock Bowles	INSPECTOR'S SIGNATURE:

Subject: Topsoil Reclamation
Observations, Tellier Gravel Pit,
25505 County Road 33A, Routt
County, Colorado.

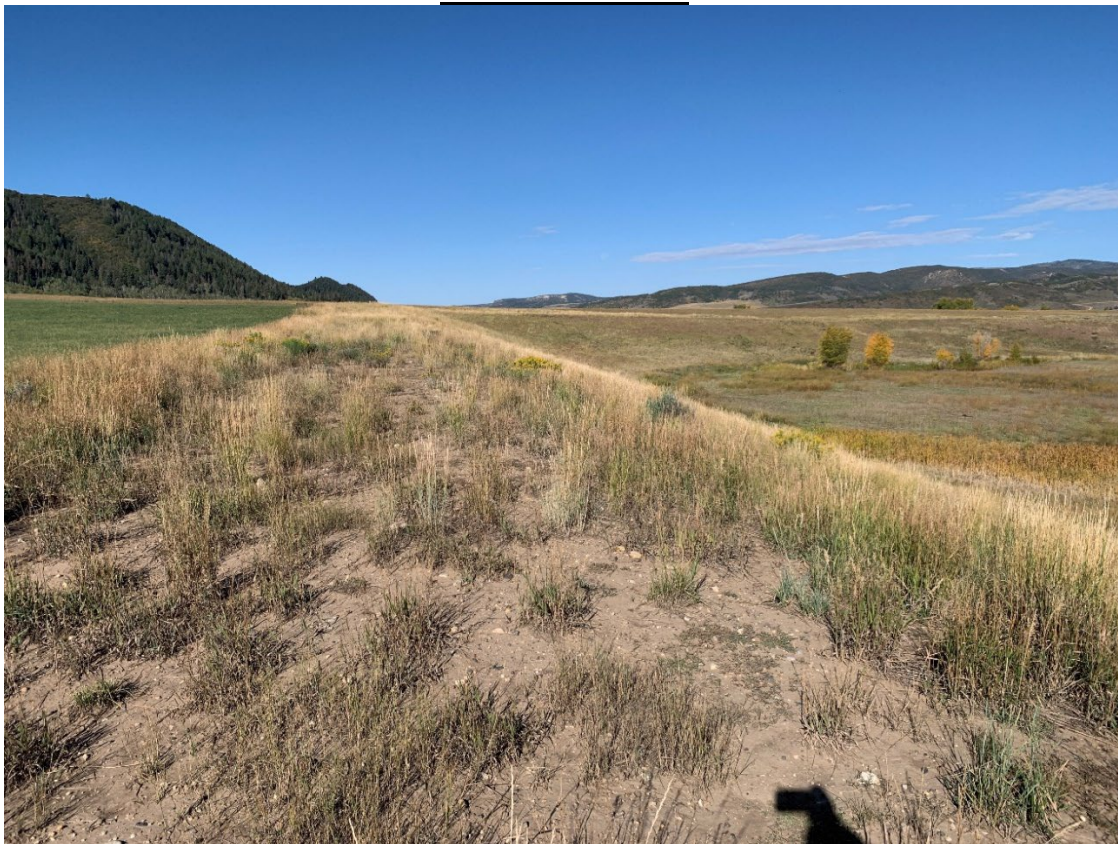
The pit consists of two main pit areas, a north pit and a south pit. The pits areas are separated by a 50-foot-wide gas line easement. The easement was not disturbed except the very east end where the pit access road crosses it. The slopes of the pit areas were graded 3h:1v on the west and south sides (photo 1). The sides of the gas line easement were also graded 3h:1v. No erosion features were noted in these areas.

Photo 1 – Southwest corner of south pit, side slopes graded 3h:1v.

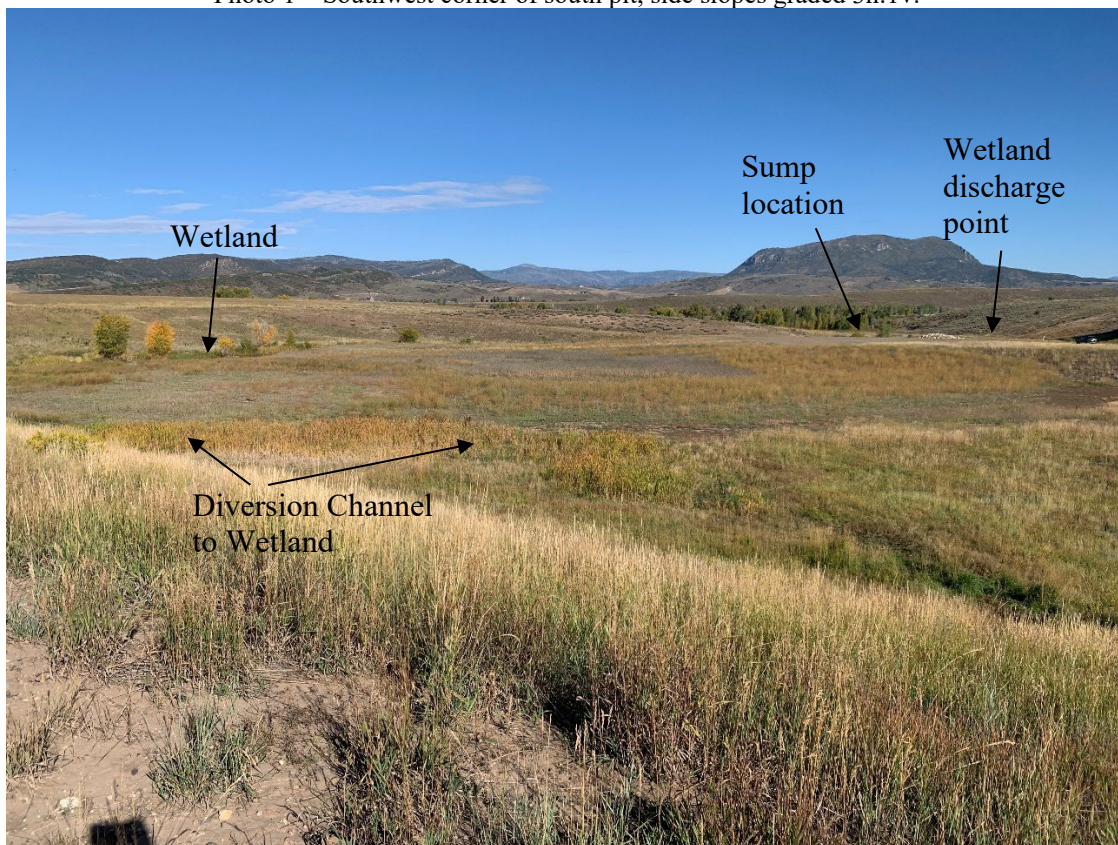
The southern pit area is sloped to the west where the water is directed into a wetland area along the western side (photo 2). A drainage pipe has been installed that drains the wetland area to the unnamed drainage along the eastern boundary of the pit area.

The southern pit area is sloped to the west and south where the water is collected by a channel and directed to a wetland area along the western side of the pit area (see photo 2 for locations of wetland structures). The channel and wetland area have a dense stand of cattails. A couple of little frogs and ducks were seen in the wetland area.

A buried drainage pipe has been installed from the wetland to the natural unnamed drainage. The inlet to the drainage pipe from the wetland was not located in the dense foliage. The drainage pipe directs the water to the northeast into a sump area which is located south of the gas line easement and just west of the access road. The sump area also contained dense foliage. A transfer box with a gate valve was located in the sump area. Water could be heard running through the transfer box, although it was hard to see the water in the box due to the thick vegetation around it. Water is then directed from the transfer box to the unnamed drainage east of the sump area. The top of the outlet pipe was seen but it was under water. It is assumed the water was discharging due to the area around the outlet pipe was flooded.

Photo 2 – South pit, facing north, wetland structure locations

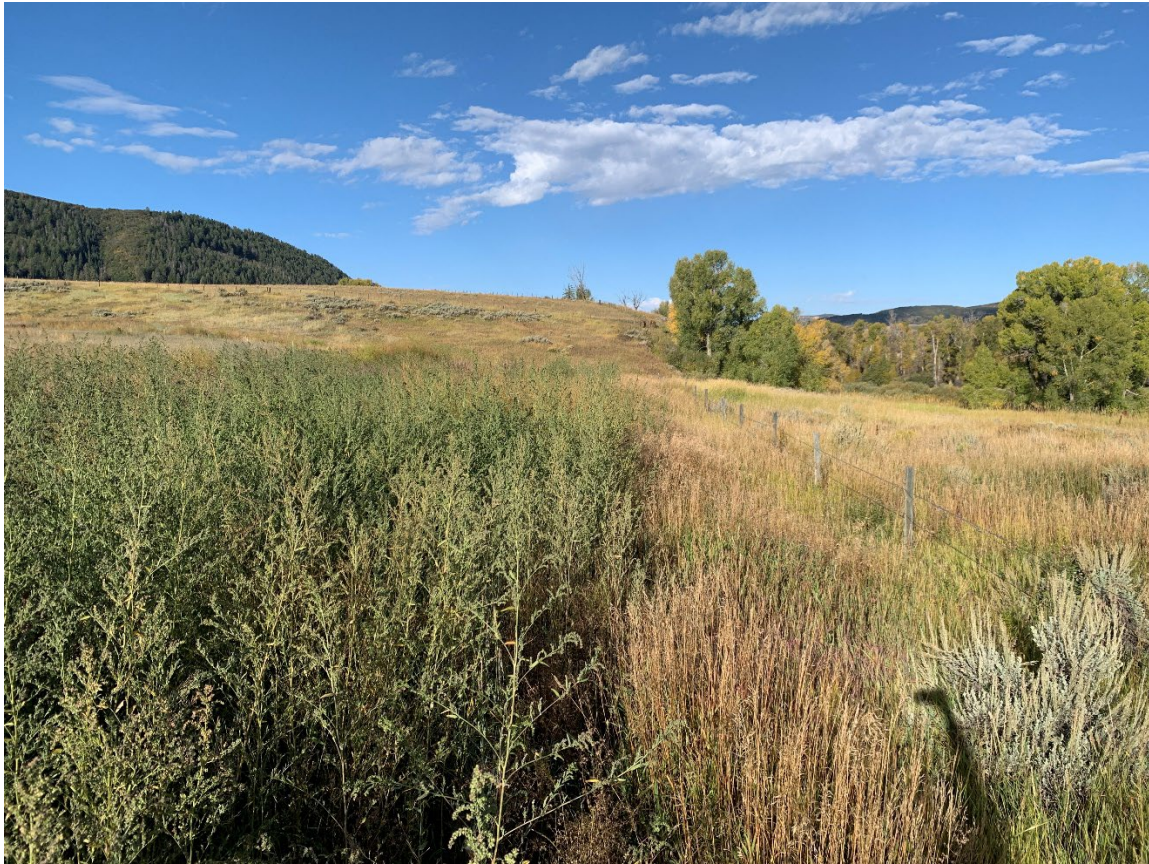
One of the topsoil stockpiles was located along the northern fence line while the mine was in operation. The footprint of this former stockpile is currently covered in a dense, tall stand of kochia (photo 3).

Photo 3 – A tall stand of kochia growing in the location of the former topsoil stockpile along the northern fence line

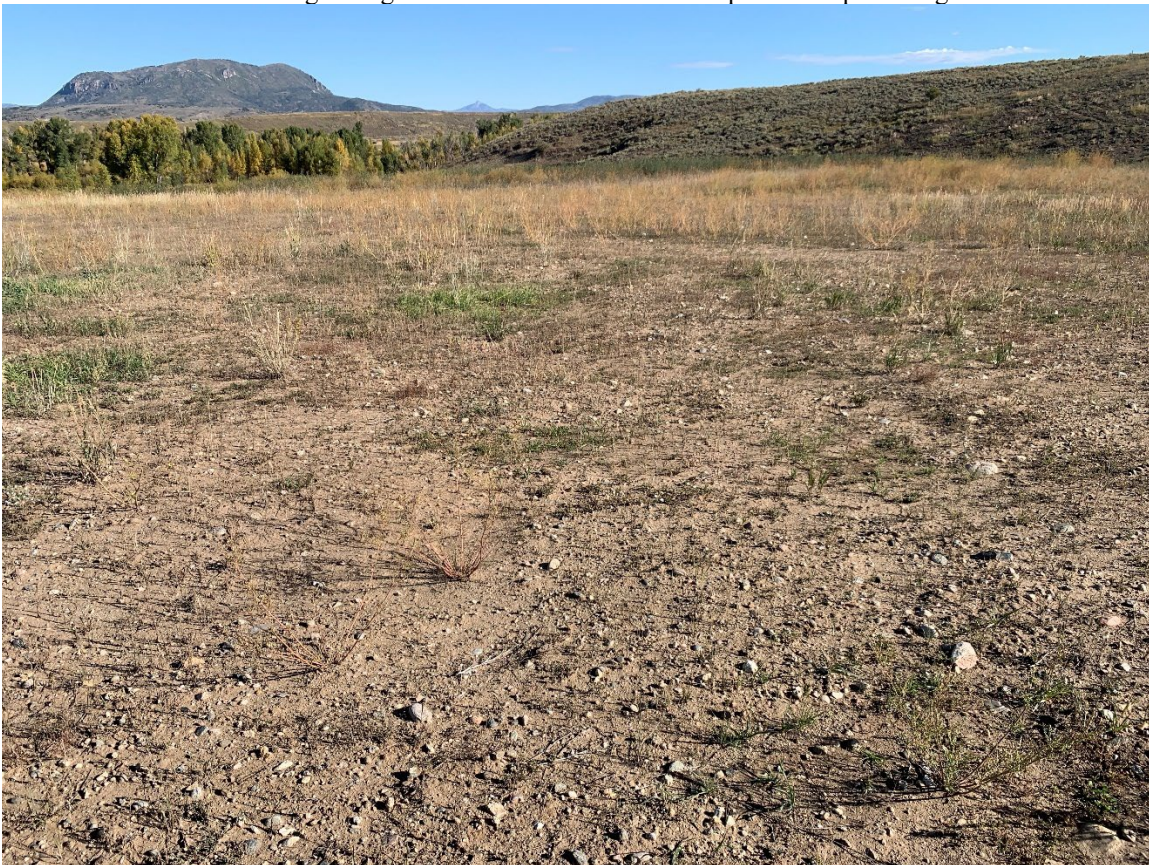
The Division observed that gravelly material covered large sections of the pit floor surface area. Rocks ranging in size from ½ inch to 3 inches in diameter were observed (photo 4). The soil surface also appeared to have areas of dense clay. This was evident by the hardness of the soil and stunted plant growth compared to adjacent areas (photo 5). Several of the test holes used by NWCC for their report were observed (photo 6). Mr. Tellier dug into some of these test holes with a hand shovel to clear out the debris that settled in the holes. The holes were about 6 inches deep. Rocks and gravelly material were observed throughout the depth of the holes along with clods of clay.

The Division has determined that topsoil has not been replaced to an average depth of at least 1 foot across the mine site.

Photo 4 – North pit area (facing northeast) has a significant amount of rocks

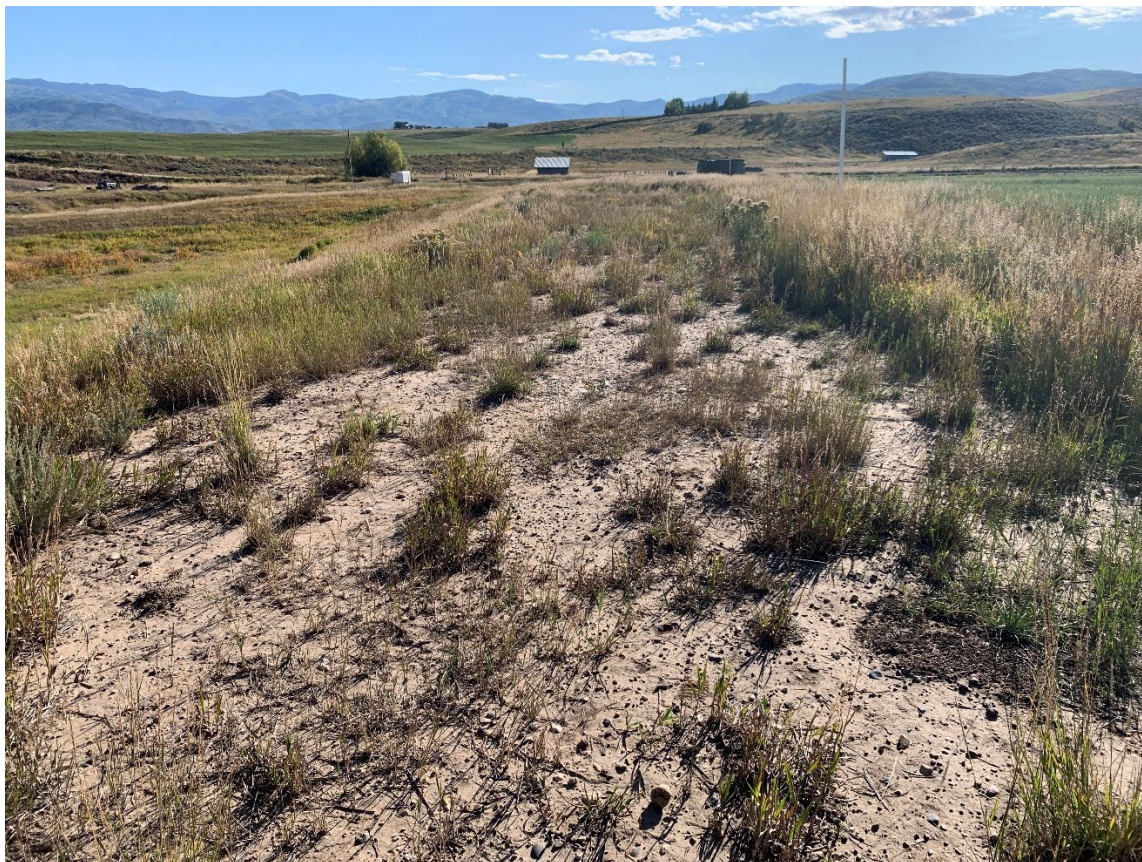
Photo 5 – hard packed soil and sparse vegetation along southern permit boundary

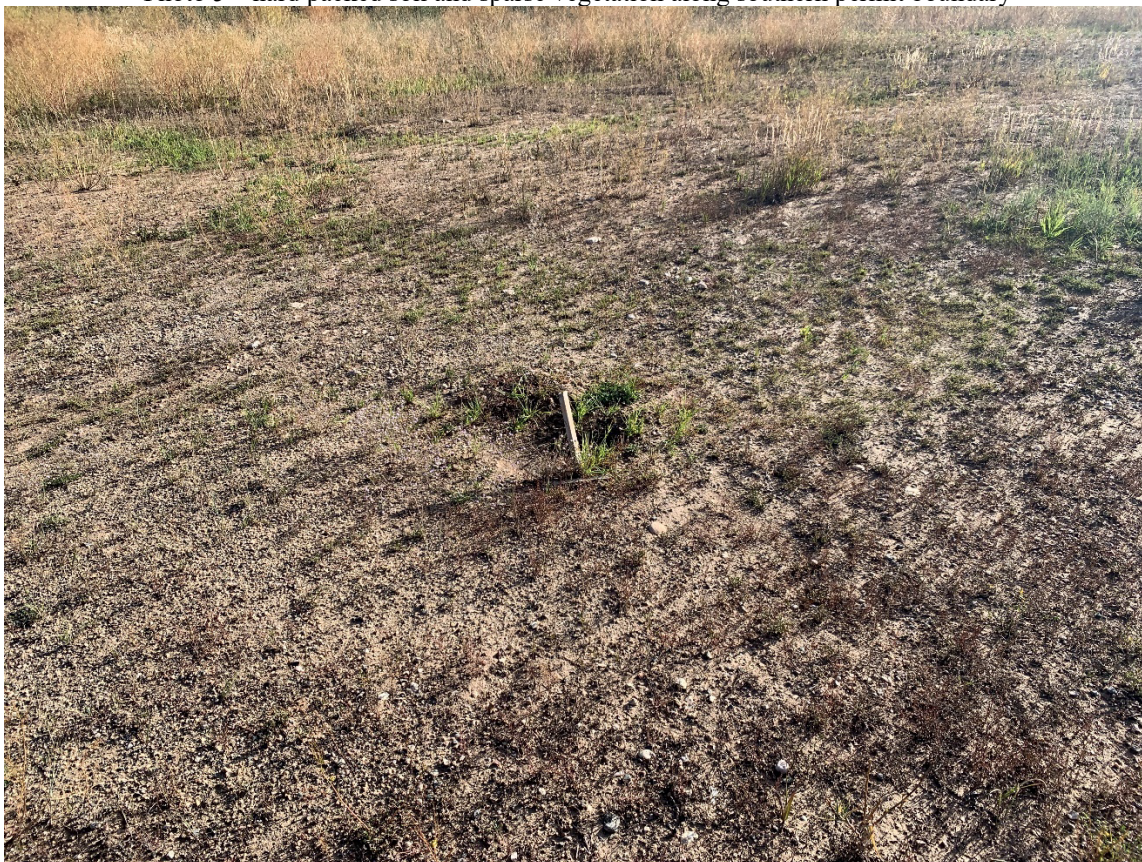
Mr. Tellier hired a third-party consultant, NorthWest Colorado Consultants, Inc., to conduct a soil survey to determine the amount of topsoil that was re-applied across the site. NWCC concluded that the required depth of topsoil was not replaced on the site (see attached report).

Photo 6 – One of the test holes used for the NWCC report.

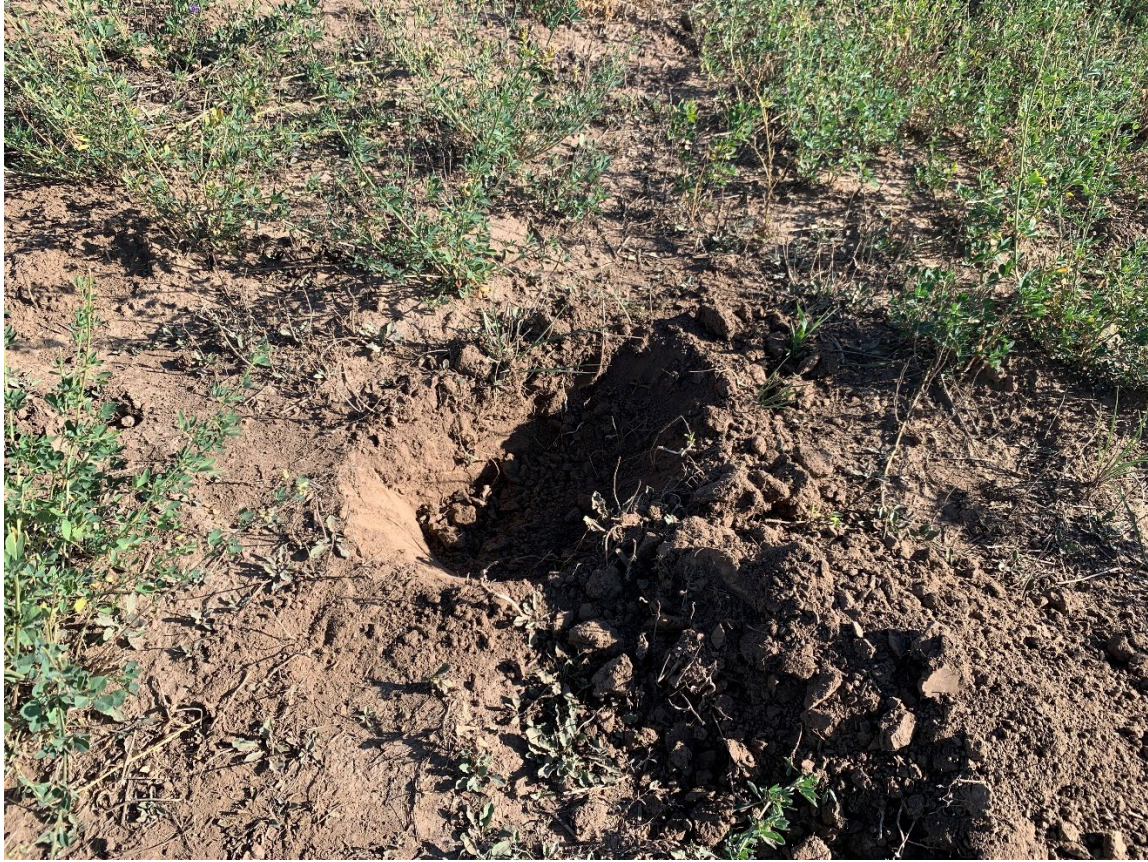
Mr. Tellier dug a test hole in his alfalfa field, which is also classified as 68- Rabbitears loam, to show what Rabbitears loam looks like (photo 7). The test hole is located about 25 feet south of the southern permit boundary (see attached map). The soil in this test hole was consistent with the NRCS soil description for Rabbitears loam. Rocks were not observed on the surface of the soil nor were any seen in the hole. The soil texture was consistent, no clods of clay were seen.

Photo 7 – Test hole in adjacent field showing Rabbitears loam.

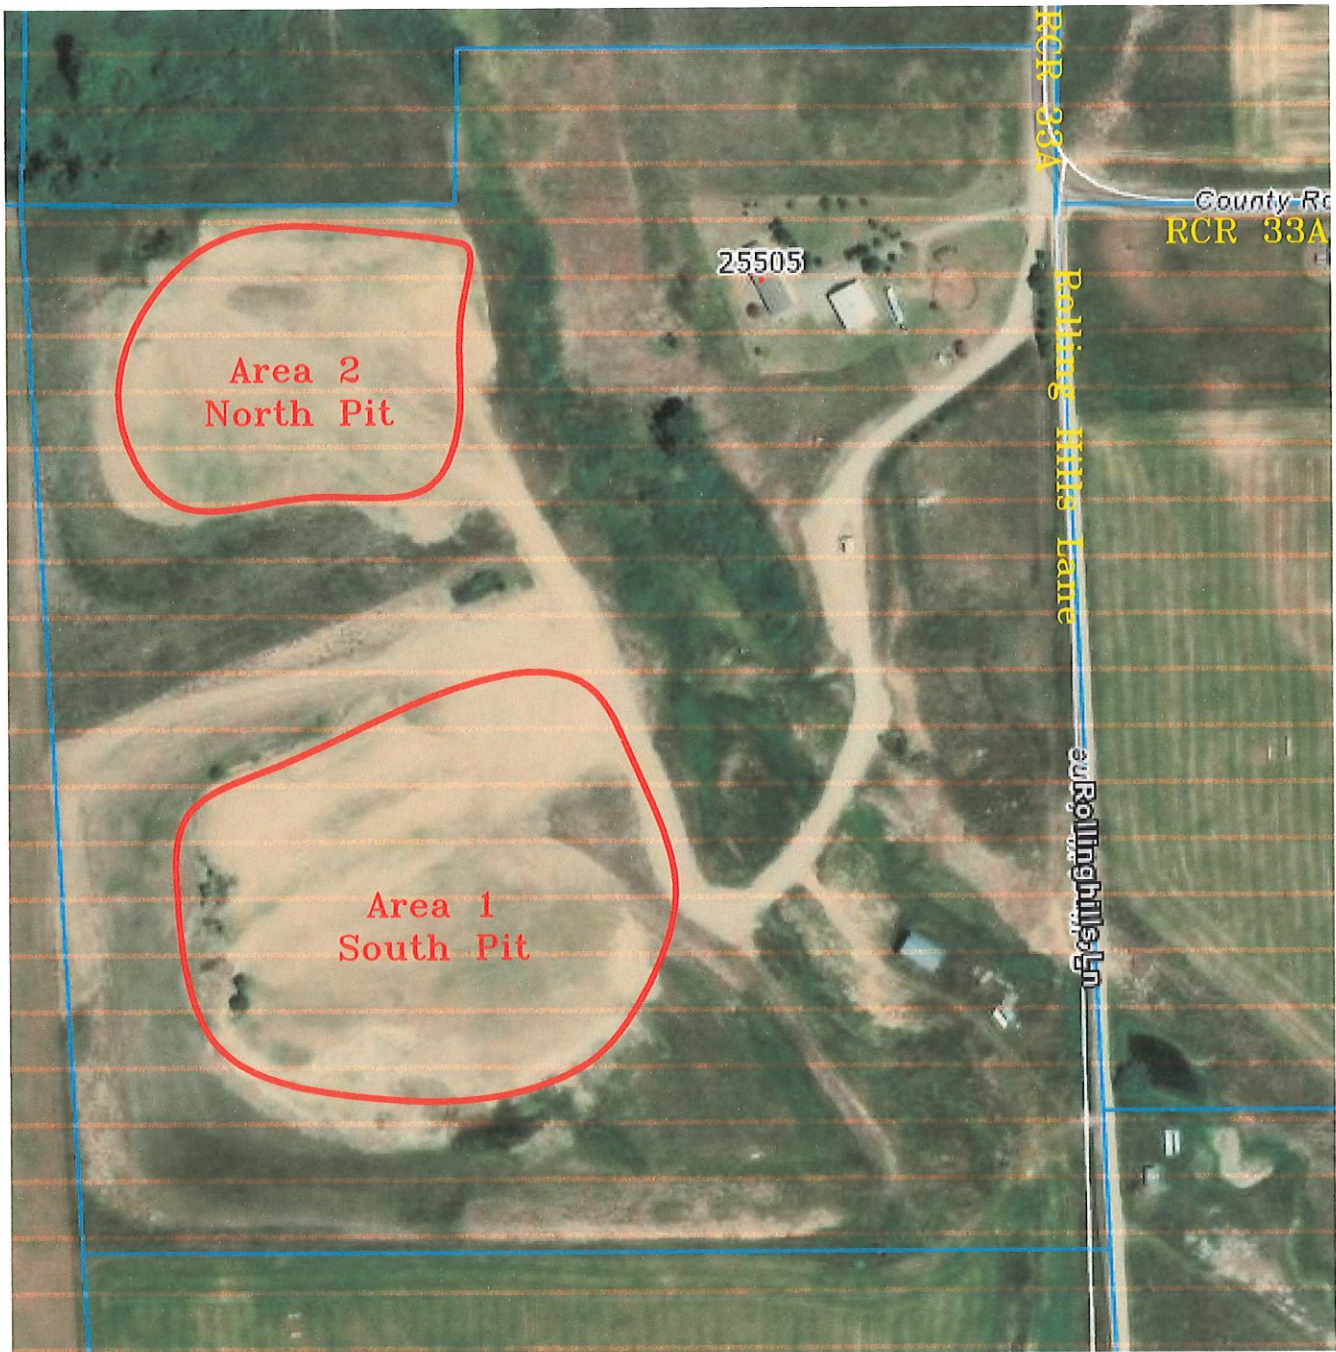
Job Name: Tellier Gravel Pit		Job No. 24-13404	
Location: 25505 County Road 33A, Routt County, Colorado		Figure #1

NWCC understands that gravel mining operations at the site have ceased and two remaining areas were recently reclaimed with topsoil materials and seeded. A site plan showing the two reclaimed areas, south pit and north pit, are shown in Figure #1.

Topsoil Reclamation Observations: NWCC visited the project site on July 2, 2024. The client excavated seventeen shallow test holes by hand across the south pit and five shallow test holes across the north pit to evaluate the topsoil reclamation completed in 2023. NWCC observed the excavation of the test holes and measured the depth of the topsoil fill materials. Based on our observations and measurements, the topsoil reclamation materials were generally 1 to 3 inches in thickness across the site. Isolated areas of 4 to 5 inches of topsoil were observed in three of the seventeen holes observed in the south pit. The topsoil materials were underlain by a mixture of clays and gravels. In addition, clays and gravels were mixed into the topsoil materials. Also, significant areas of gravels were observed at the ground surface across both areas. Some debris was also observed across the ground surface. Sparse grasses were observed across the reclaimed area and the vegetation primarily consisted of weeds.

Based on our observations of the test holes advanced across the site, it does not appear the required depth of topsoil fill materials were placed in the reclamation of the site. The topsoil materials should be relatively free of gravels and clay materials and contain organic matter sufficient to promote revegetation.
